## **Electroluminescence Imaging of Photovoltaic Modules**

**M.T Malefafana<sup>1,2</sup>, L. Pratt<sup>2,\*</sup>, M. Basappa Ayanna<sup>2</sup>, K. Roro<sup>2</sup>**  
**<sup>1</sup>Tshwane University of Technology, Department of Physics,  
Pretoria, South Africa**  
**<sup>2</sup>Council for Scientific and Industrial Research (CSIR), South  
Africa**

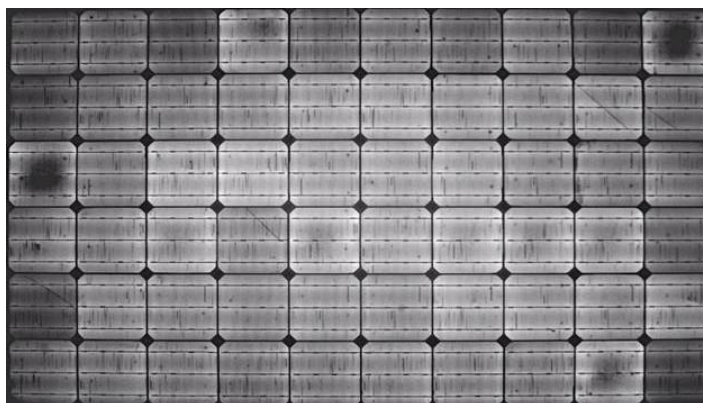
Figure 4.2 shows a typical mono-crystalline module (18000-29). This module consists of 60 pseudo-square cells, three interconnect ribbons, and no grain boundaries. This image also shows four visibly cracked cells (diagonally oriented lines) and defects associated with the growth of the ingot (dark blobs in the centre of the cells).

Figure 4.2 EL image of mono-crystalline module with pseudo-square cells, three interconnect ribbons, and no grain boundaries

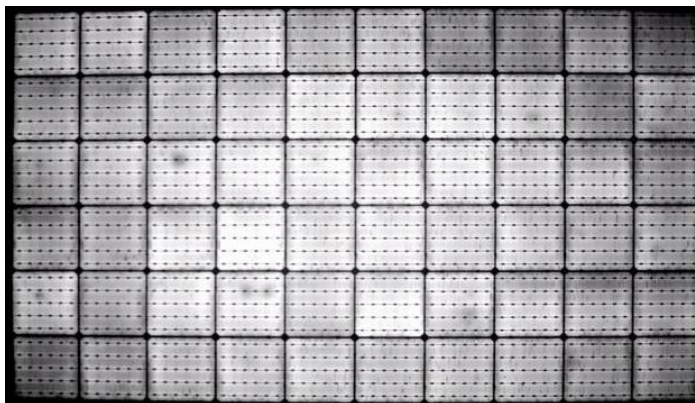
Figure 4.3 and 4.4 shows the front and back side of a bifacial module made from mono-crystalline cells and five interconnect ribbons (18000-51). Dark spots in the cells can be seen at the same location from the front and back side of the module, after rotating the image accordingly. The backside image clearly shows the junction box and the nameplate label to a lesser extent. The image from the backside is also slightly darker overall, so it's tempting to conclude the efficiency on the backside is lower. While the backside efficiency of bifacial solar PV module is lower than the front side, it would be wrong to conclude this from the EL image. The overall intensity level in the image may be a function of the camera settings, the power supply settings, and the post-processing.

Figure 4.3 EL image of Bifacial mono crystalline module: front side

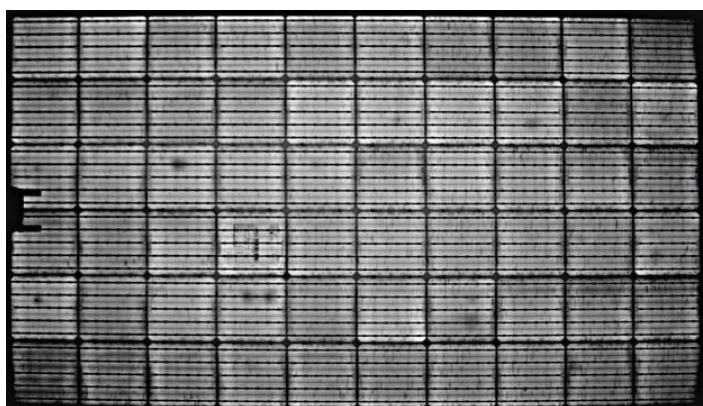
Figure 4.4 EL image of Bifacial mono crystalline module: back side

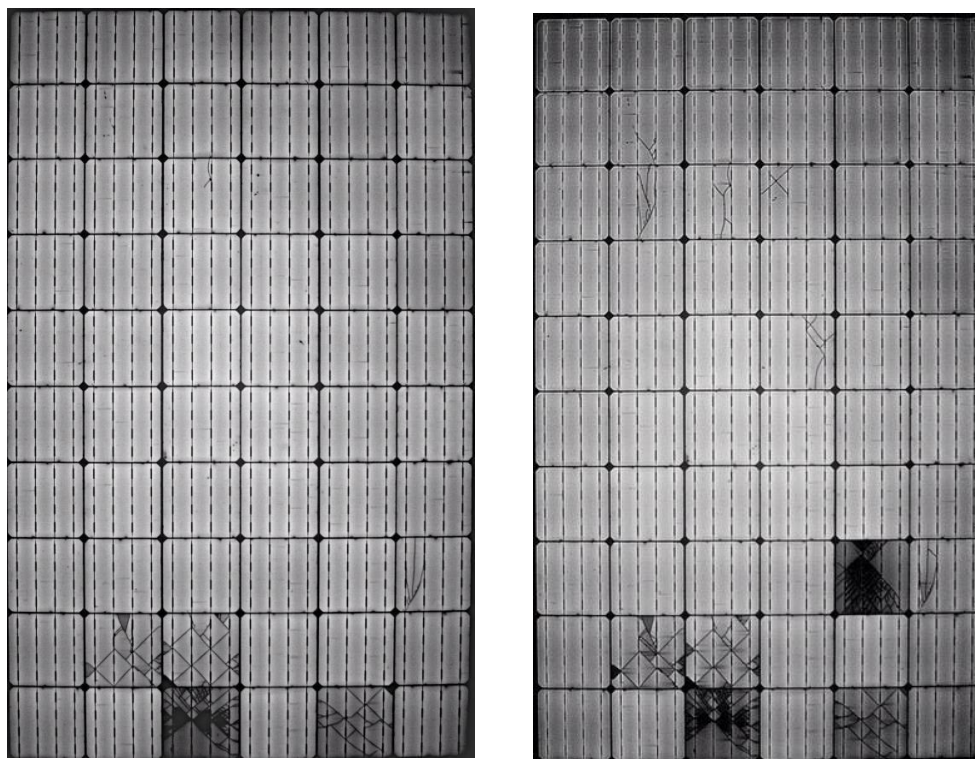
Microcracks can have disproportionately large impacts on module performance when the microcracks lead to inactive areas greater than 8-10% of the cell area (Köntges et al., 2010). Figure 4.5 shows a mono-crystalline module with a number of cells impacted by cracks (18000-22). The cells with line cracks will generally not reduce performance significantly, but the cells with large black areas highlight inactive areas. The inactive areas can lead to reduced cell current which then reduces the overall substring current. Line cracks also have the potential to grow and create inactive areas over time, depending on the orientation of the crack and additional stress that might occur on the module. For instance, the original image of this module on the bottom left hand side showed far fewer cracks and smaller inactive areas. After a handling mishap, the additional stress caused new cracks to form, minor line cracks to grow and inactive regions to darken (image on the bottom right hand side). The module was leaning against the wall in portrait orientation and fell over on to the floor.

Figure 4.5 EL image of monocrystalline PV module with cracked cells and inactive areas as received (left) and post handling mishap (right)

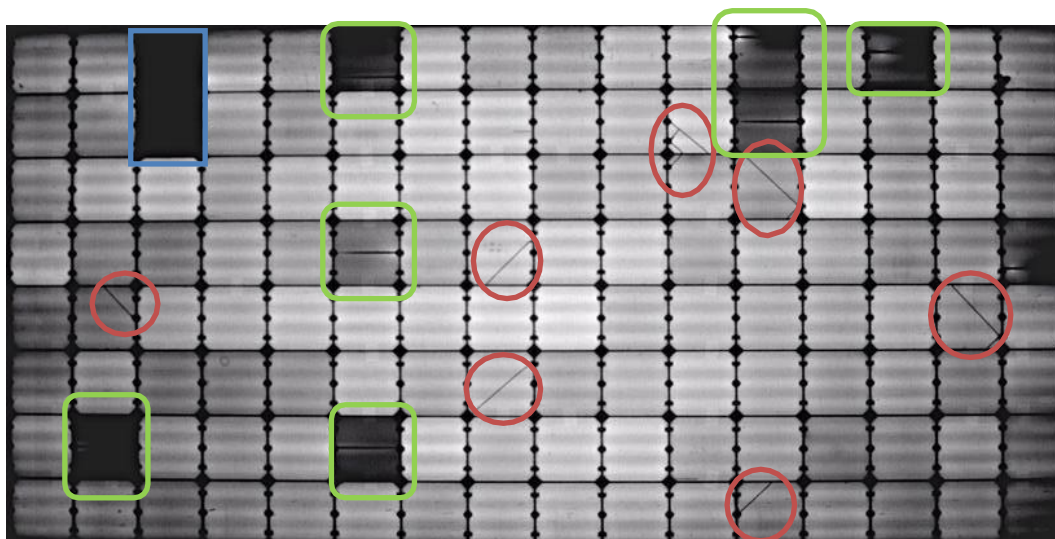
Figure 4.6 shows an EL image of a mono-crystalline module as received (18000-32). The typical interconnect ribbons does not exist, and instead the 'dog-bone' type interconnect can be seen in the vertical space between two adjacent cells which is typical of a back contact module. In this example, there are a number of cracked cells and dark regions. The dark cells likely have a negative impact on performance. Module power measured 2% lower on this module compared to a similar module (18000-31) from the same batch with a cleaner EL image.

Figure 4.6 EL image with defects

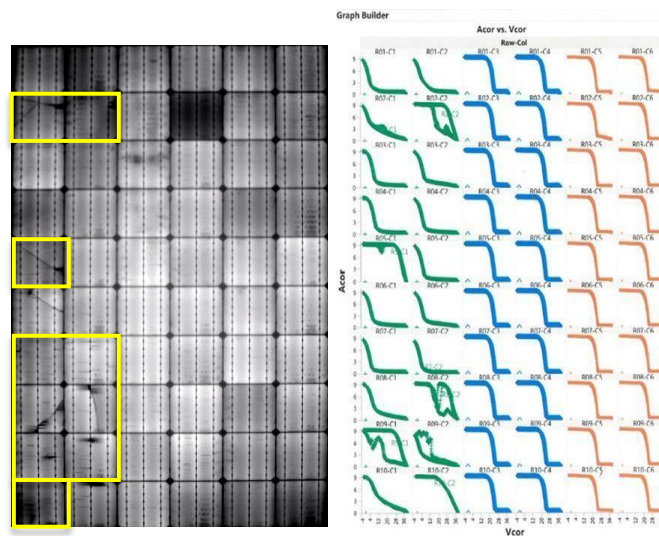
Figure 4.7 shows an EL image from a module that exhibited hotspot burn marks on the backsheet (18012-01). It is suspected the damage is from a nearby lightning strike. The module was removed from the CSIR dual axis PV plant and investigated further with EL, hotspot per IEC 61215-2:2016, and electrical measurements. The hotspot endurance test is conducted during certification testing to ensure modules are designed and built in a manner to minimize the hotspot impact due to a number of conditions including faulty cells. An experimental hotspot endurance test of was carried out on good substrings to see if we could induce additional burn marks. By analysing the shaded IV curves in Figure 4.7, the cell in row 2, column 5 was identified as a potential low shunt resistance cell. The backsheet temperature did not exceed 150 °C during the hotspot endurance test on this cell, nor did it cause any burn mark. Based on this outcome, it's unlikely that the burn marks were caused by hotspots arising from defects in the cells or from poor manufacturing.

Figure 4.7 EL image and corresponding shaded cell IV curves.  
Yellow squares indicate cells with burn marks on the backsheet

In the next step, the presence of burn marks and cracked cells were correlated. Perhaps the cracked cells were arcing and creating excessive heat leading to the burn marks. The cracked cell in row 5, column 1 was subjected to the hotspot endurance test in the same method described above. This cracked cell was allowing full module power to pass through the cell during all three shaded cell IV curves. The backsheet temperature reached 160 °C during the hotspot endurance but failed to show any additional damage to the backsheet. Furthermore, the correlation between cracked cells and burn marks for this module was not statistically significant based on a contingency analysis of the 20 cells in the substring.

Further investigation confirmed that the bypass diode in the faulty substring had failed in open circuit. The shaded IV curves confirm the proper function of the bypass diodes for the substring in the centre and right side of the module, and abnormal operation for the bypass diode in the substring on the left side. Post removal of the potting material in the junction box, the bypass diode bond was found to be debonded from the junction box connection point.
