# Design and Construction of Sustainable Climate Resilient Rural Access Road Infrastructures

Julius Joseph Komba, Raquel Langa, Phil Paige-Green, Benoit Verhaeghe and Refiloe Mokoena

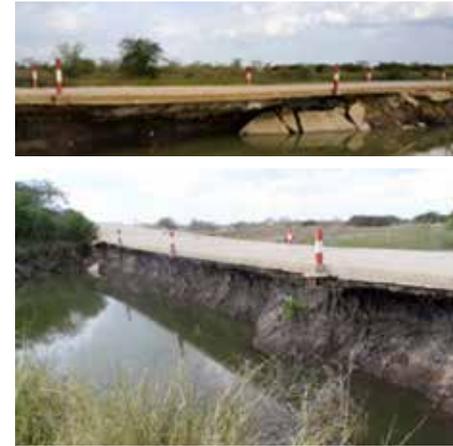
Erosion and undercutting of concrete fords (Figure 3) were observed at two of the new concrete fords. This was mostly restricted to the lake side of the fords and was either the result of over-topping from the downhill side or more likely softening of the support material (black clay in this case) and subsequent wave action as well as alternative wetting/drying of

the clay. Furthermore, the underlying soils (expansive clay) were unsuitable, and susceptible to slaking and collapse when the material moves from a dry to saturated state. Slaking of the dried black cotton soil was demonstrated on site.

**Figure 3** Erosion and undercutting of concrete fords.

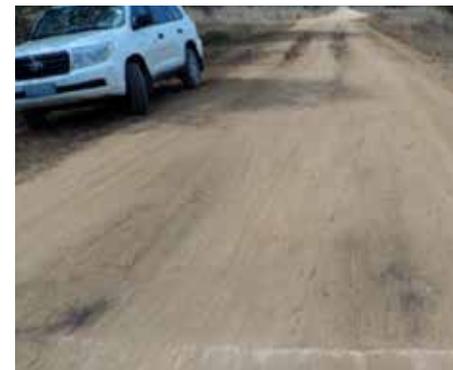
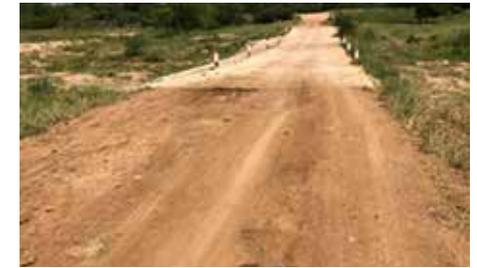
Damage to the approach fill of concrete fords was observed at several locations (Figure 4). The damages were likely to continue to aggravate if the design was not changed. The problem appeared to be exacerbated by braking of vehicles approaching the concrete fords.

**Figure 4** Damage to the road approaching concrete fords.

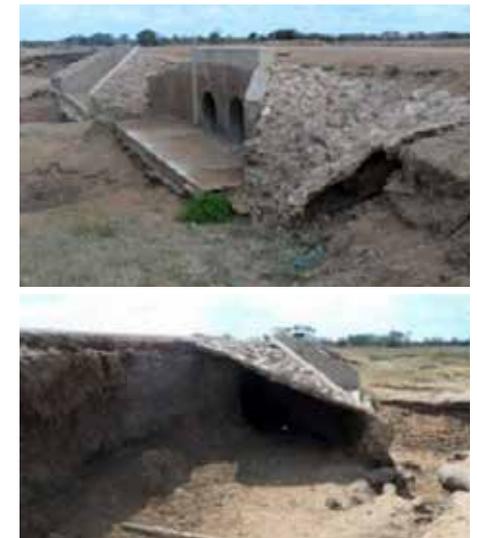
Numerous culverts had been damaged by flooding. Most of the damage was caused by erosion at the exits with undercutting (Figure 5) and cracking. The incidence of undercutting of erosion protection measures (mostly grouted stone pitching) was evident at many of the structures. This was often due to poor compaction of the embankment material allowing access of water behind the structures as well as surface erosion. The main areas affected were the approach fills that were eroded during flooding, protection works that were left unsupported or washed away, and scour of the stream-bed at the outlets.

**Figure 5** Damage to culverts and erosion protection.

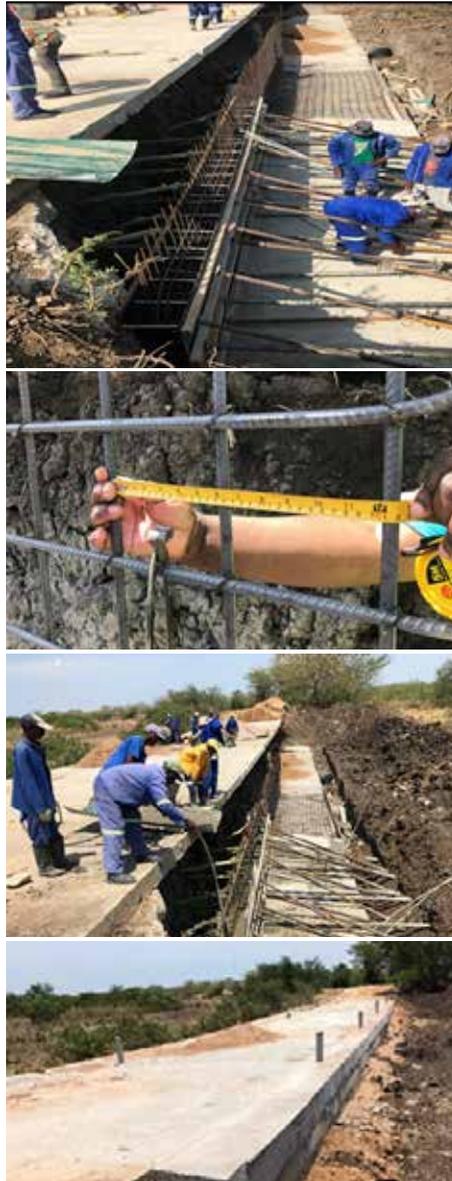
mm steel was used, but at a smaller spacing (i.e., 150 mm). Furthermore, a foundation bed was constructed using low strength concrete, following which the specified foundation was constructed.

Figure 10 Construction of concrete wall.

Concrete compressive strength tests were conducted on various batches. The tests were conducted 7 and 28 days after concrete casting, according to method D1 of the South African Standard Test Method for Highways 1 (TMH 1). Table 1 provides a summary of the test results. It should be noted that the design for the concrete ford protection wall recommended 30 MPa concrete be used for the construction. However, the average 28 days strength of the concrete used ranges from 25 to 27 MPa, which was considered to be satisfactory, despite being slightly lower than the recommended concrete strength. The 30 MPa specified was to be in line with the original upper concrete layer strength, but as the new concrete is only near the edge, the slightly lower strength obtained would be adequate.

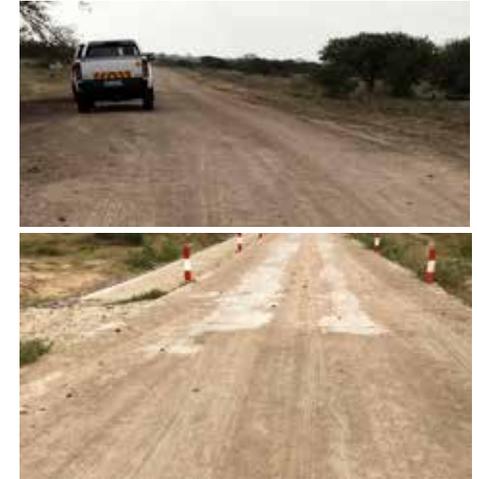
Figure 11 depicts the condition of the approach to the concrete ford after the construction of the improved gravel road. Calcrete material used for the construction of the improved gravel road was sourced from a borrow pit established at km 39. The liquid Limit, plastic limit, plastic index and linear shrinkage of the material were 46.1, 34.5, 11.6, and 4.3 respectively. The CBR of the material at 98 per cent MDD was 40. After completing the construction, in situ density and moisture content tests were carried out to assess the compaction quality of the improved gravel wearing course. The density and in situ moisture content were determined at three chainages 0 (joint of ford and gravel road), 20 and 40 m away from the ford. For each chainage, the tests were carried out on the right wheel path (RWP), the centre of the lane (CL) and the left wheel path (LWP).

Table 2 presents a summary of the compaction results. The specified compaction density for the gravel wearing course was 98 per cent Mod AASHTO. The test results indicate that the compaction density achieved was generally lower than specification, and highly variable. The percentage compaction at the centre of the lane was generally lower than the wheel paths. This was expected as the tests were conducted approximately four months after the construction of

the wearing course; hence, construction and normal traffic may have caused further densification of the gravel wearing course. Furthermore, the compaction densities appeared to decrease with increasing distance away from the concrete ford (i.e., from chainage 0 to 40 m). This could be due to the slow-moving vehicles near the concrete ford.

Figure 11 General view of the approach to concrete ford.

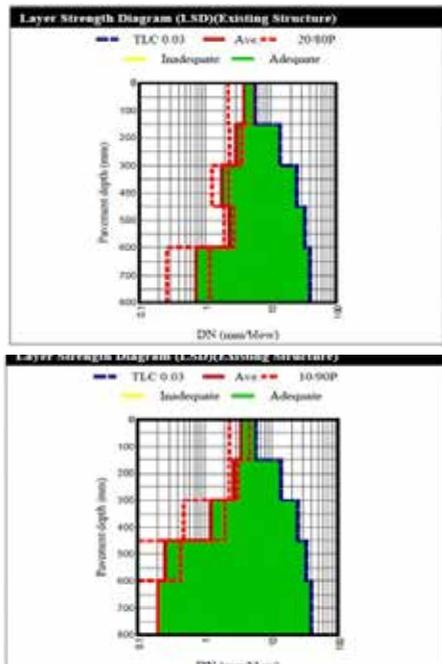
In order to further assess the quality of the gravel wearing course, Dynamic Cone Penetrometer (DCP) tests were carried out at 0, 10 and 20 m away from the concrete ford in the northern direction, and on the left wheel path, the centre of the lane and right wheel path respectively. The DCP results were analysed using ReCAP's Low Volume Road (LVR)-DCP software (De Beer and van Rensburg, 2016). Figure 12 shows layer diagrams of individual DCP tests for the left wheel path and right wheel path. The DCP test results indicate that the structural strength of the gravel road is adequate for TLC 0.03 (i.e., the field DN values are less than TLC 0.03 DN values).

Figure 12 DCP results.

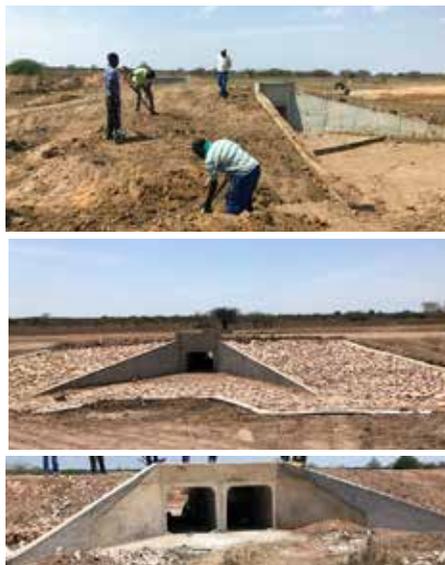
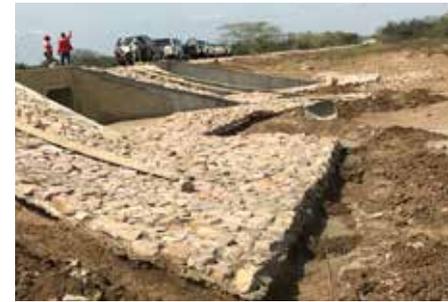
Figure 13 depicts the progression of the culverts and erosion protection construction. It should be pointed out that the design for the culvert protection work recommended that the beam had to be constructed first, followed by the stone pitching to ensure adequate bonding between the stone pitching and the beam. During the implementation, the contractor constructed the stone pitching first, followed by the beam; hence, the performance should be closely monitored during the long-term performance monitoring.

Figure 13 Construction of culverts and erosion protection works.

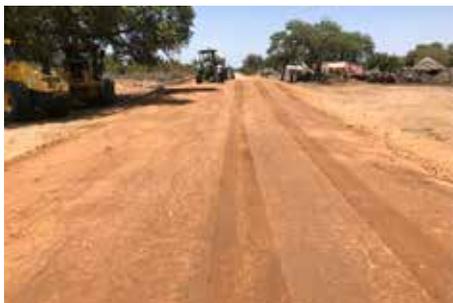
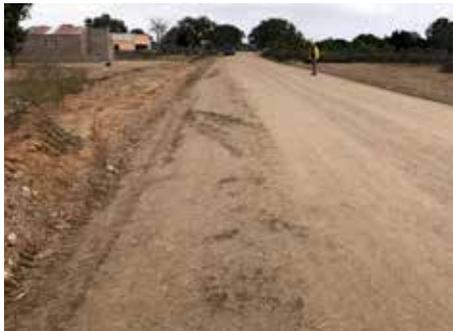
An approximately 200 m long of gravel road section to illustrate that a well-constructed unpaved road can be climate resilient was constructed at km 51. The construction activities involved constructing a 300 mm high fill from the existing ground level, followed by a 150 mm gravel wearing course with 5 per cent camber, using good quality Calcrete material. A new culvert to replace the existing smaller culvert was also constructed. Figure 14 depicts the progression of the construction of the improved gravel road and new culvert. Overall, the gravel wearing course appeared to have been constructed properly.

**Figure 14 Construction of improved gravel road at km 51.**

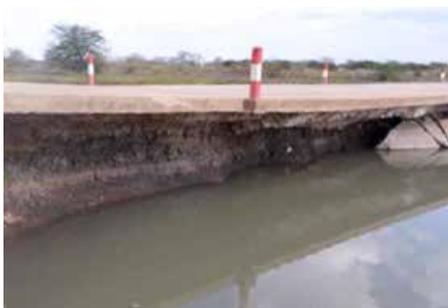
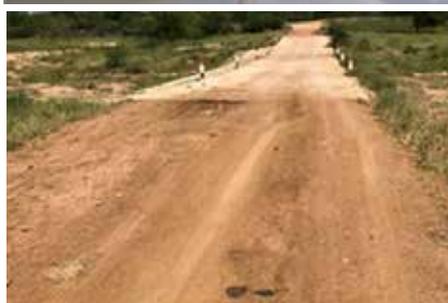
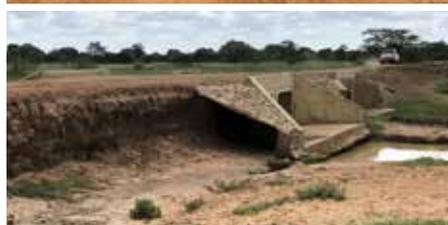
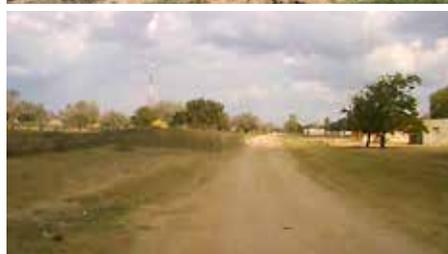
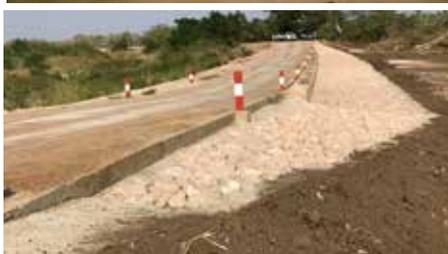
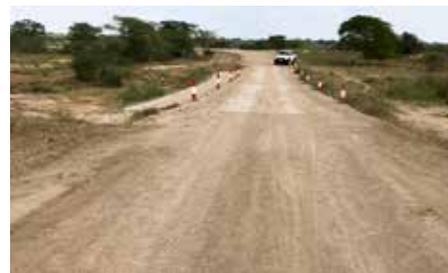
Side slopes of the concrete ford embankments (km 17.6), as well as side slopes of the embankments of the newly constructed approach to the concrete ford at km 36 need to be vegetated to minimise erosion;

Sand was found to have accumulated at the inlet and outlet of the culverts at km 43 as a result of rainfall, necessitating routine inspection and cleaning. Furthermore, side embankments appeared to have been damaged by rain due to inadequate compaction, and required some improvements, and

Some drying cracks were observed on the newly constructed gravel wearing course at km 51. The progression of the cracks should be closely monitored during the planned long term performance monitoring.

**Figure 15 Before and after construction pictures of the demonstration sections.**
