SOME FAILURE ANALYSES OF SOUTH AFRICAN AIR FORCE AIRCRAFT ENGINE AND AIRFRAME COMPONENTS

J. M. BENSON*

Division of Materials Science and Technology, CSIR, P.O. Box 395, Pretoria, Republic of South Africa

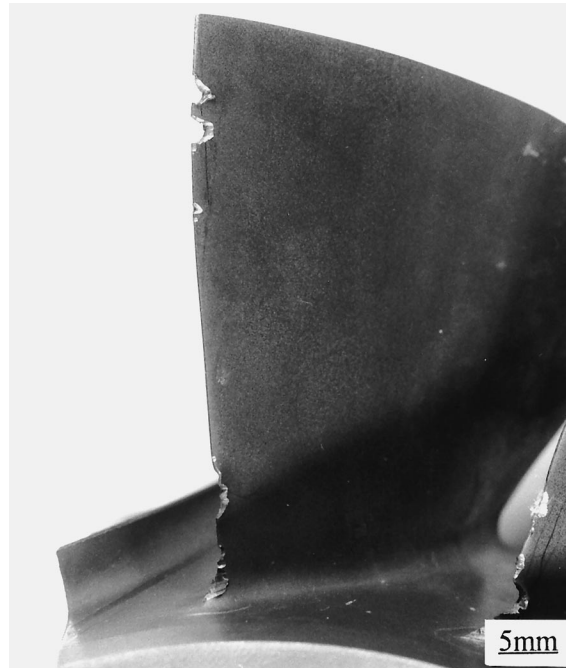
PT6-65AR engines have been fitted to several C47 Dakota aircraft and in several incidences damage to the leading edges of the airfoils in the first stage integrated-blade compressors were observed. In each case this was found to only have occurred in the port engine. Figure 1 shows a view of the typical damage and initial reaction was that it was caused by some metallic object such as loose locking wire or a tool left in the cowling. However, these appeared to be ruled out as no locking wire was seen to be missing and no other damage was observed elsewhere in the engine.

No indication of any metallic object was detected and the only significant difference between the areas was the higher level of silicon in the damaged region.

It was concluded that the likely cause for the foreign object damage was due to ingestion of a

Fig. 1. Foreign object damage to PT6-65AR first stage compressor blades.

stone and this corroborated with the fact that the affected aircraft had been operated from untarred runways.

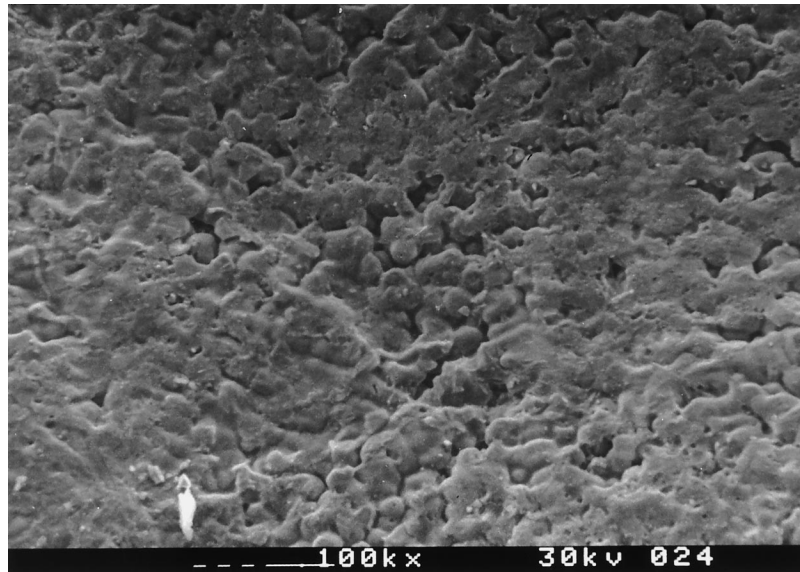
Fig. 2. Fracture surface of failed C47 landing gear strut.

Figure 2 shows a view of the fracture surface and extensive amounts of shrinkage porosity were observed. The cause of the failure however cannot be attributed to the casting porosity as the part had served satisfactorily for several decades and thus some other mechanism was responsible.

The cause of the failure was thus concluded to be due to progressive embrittlement during service as a result of the precipitation of Al_3Mg_2 .

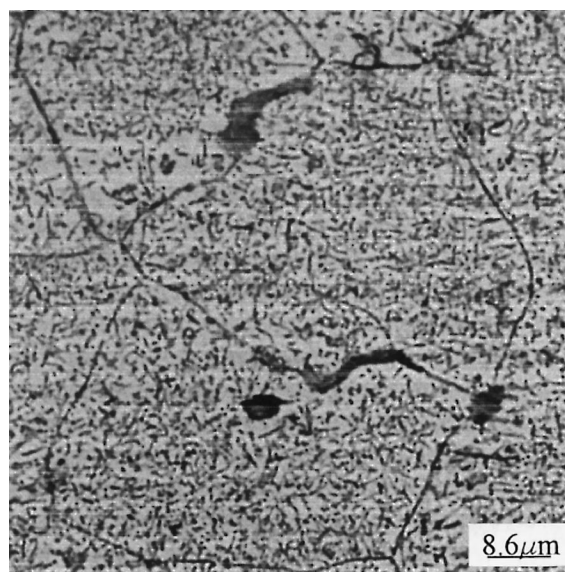
Examination of the microstructure showed an extensive amount of precipitation within the grains and along the boundaries (Fig. 3) which, on reference to the Al–Mg phase diagram [1], was concluded to be Al_3Mg_2 . The precipitation of additional amounts of this phase would occur gradually during service causing an increase in strength but also a decrease in fracture toughness. It has been reported that the elongation to fracture of this alloy can decrease from 16–0.5% over 13 years [2].

Fig. 3. Microstructure of failed C47 landing gear strut.

Removal of this phase can be achieved by solution heat-treating above about $390^\circ C$ followed by fast cooling to prevent re-precipitation and an improvement in the mechanical properties could be expected.

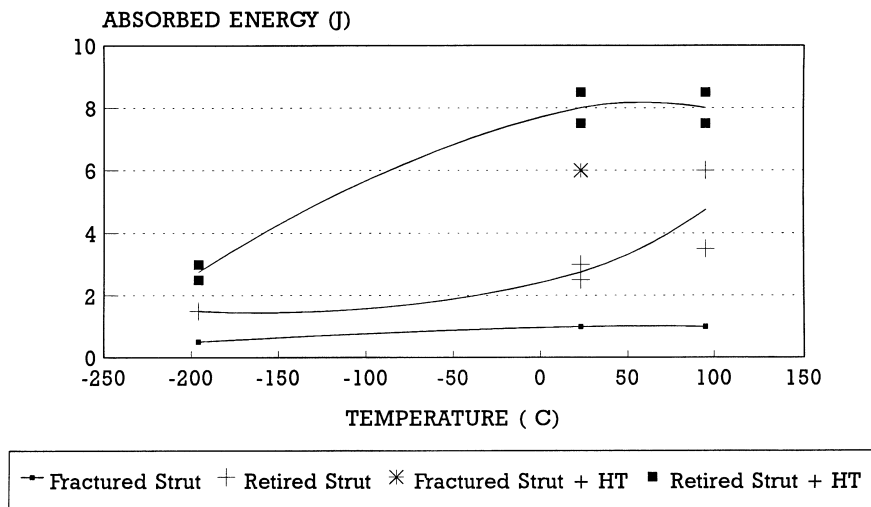
Fig. 4. Charpy impact test results for as-received and heat-treated AA520 material.

these materials in as-received and heat-treated conditions. The heat-treatment used was 425°C for 8 h followed by quenching in hot water (70°C). Figure 4 shows the improvement in impact toughness after removal of the Al_3Mg_2 precipitates. The fracture toughness tests, conducted at room temperature under tension–tension cycling ($R = 0$) at a constant load amplitude and at a frequency of 5 Hz, also showed improvement as indicated in Table 3.

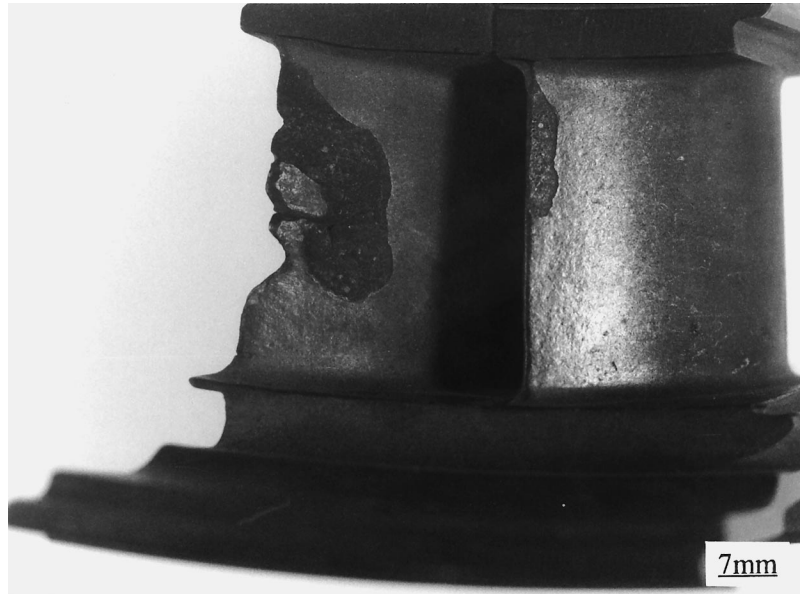
Selective and severe degradation was observed to have occurred to the cobalt vanes (Fig. 5) in a particular engine resulting in premature removal of these from service. The nickel-alloy vanes did not show any obvious external damage.

The reason for these changes was concluded to be over-heating and the cause for this was eventually traced to faulty thermocouples in the engines.

The severe surface damage to the cobalt vanes compared with the IN713 vanes can be explained by the fact that the former rely on Cr_2O_3 to give oxidation protection whereas the nickel vanes form Al_2O_3 . At elevated temperatures above 1000°C the Cr_2O_3 starts to degrade to form the volatile CrO_3 by the following reaction:

Fig. 5. Degraded cobalt alloy (X-40) Allison T56 first stage nozzle guide vane.

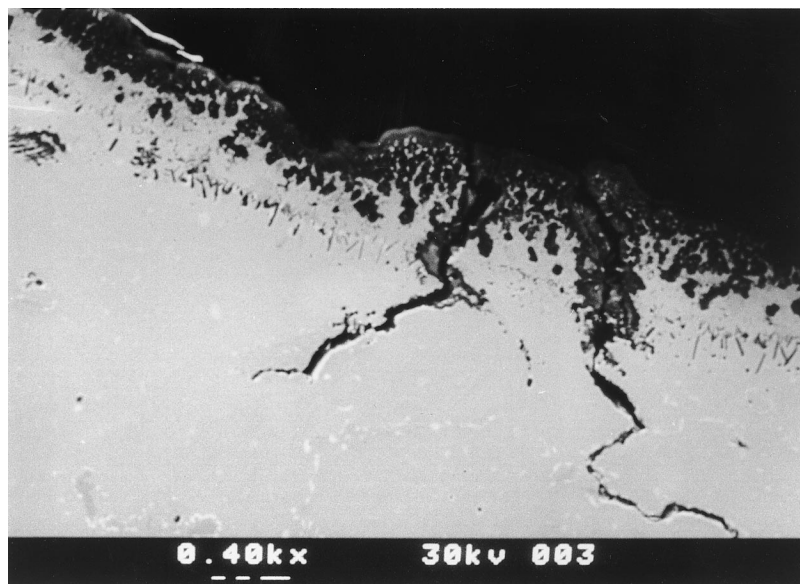
Examination of the microstructures of the X-40 vanes showed a significant increase in carbide precipitation as well as subsurface oxidation and cracking (Fig. 6). In the case of the IN713 vanes the microstructure at the leading edges was seen to have become considerably coarser than elsewhere as shown in Fig. 7.

Fig. 6. Sub-surface oxidation and cracking in X-40 nozzle guide vane.

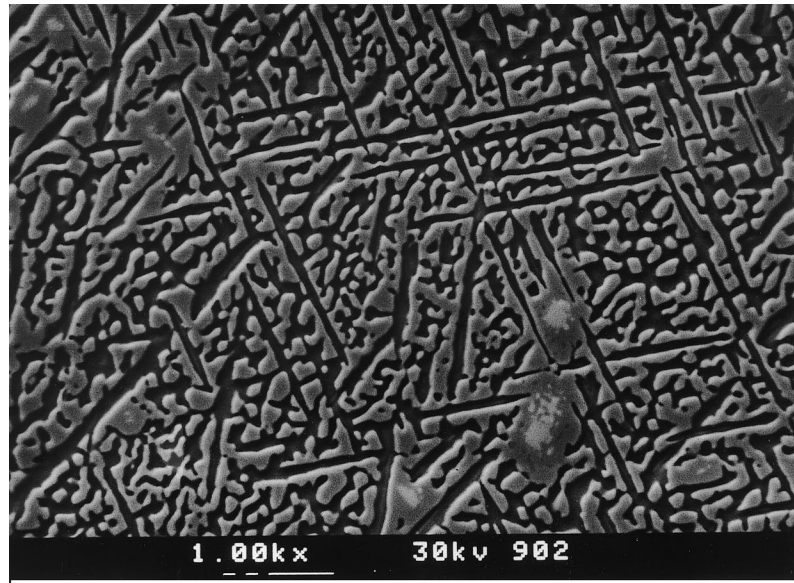
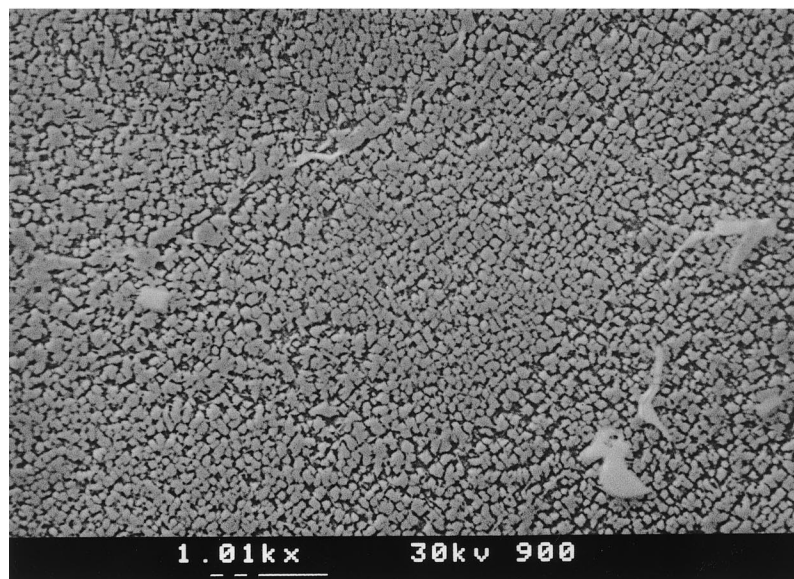
Fig. 7. Microstructure of IN713 vane at (a) leading edge and (b) mid-section.

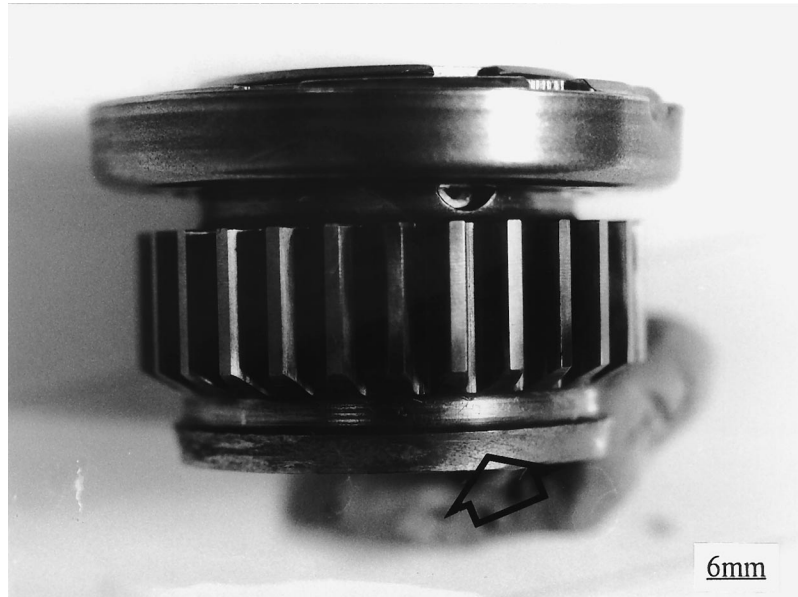
A Casa aircraft crash-landed while attempting an emergency manoeuvre and the subsequent investigation revealed that the first stage reduction carrier assembly had failed. The fracture took place near the junction of the spline and planetary gear assembly (Fig. 8). The engine was apparently

Fig. 8. Fractured PT6A-114 first stage reduction carrier (arrow indicates fracture surface).

occurred during the crash itself, when the propeller hit the ground. The resultant sudden stop in rotation would have created very high loads on the planetary gear and torsional overloading of this would have ensued with fracture occurring at the designed “weak point”.

The failed component was therefore not the cause of the crash.

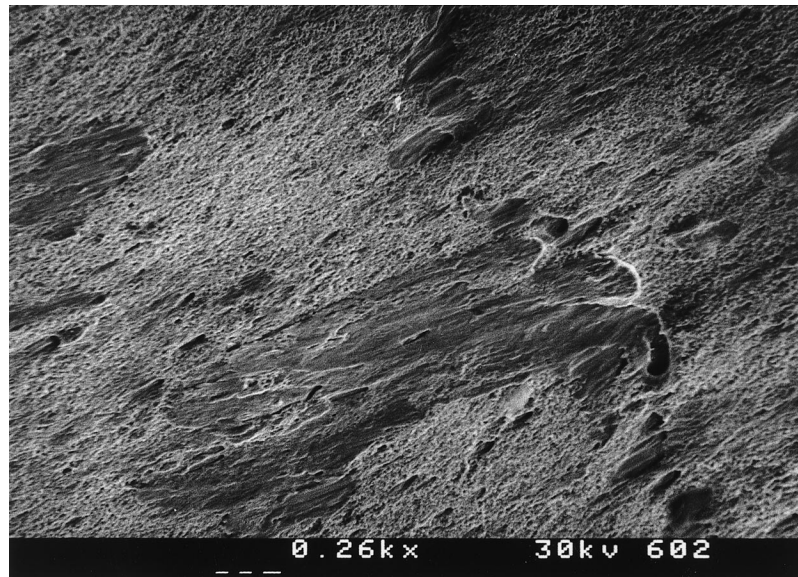
Examination of the fracture surface showed that extensive damage to this had obliterated any evidence of the fracture mechanism due to rubbing of the mating surfaces (Fig. 9). No other indications were observed that would have suggested any material defects or fatigue cracking. Furthermore the position of the fracture did not correspond with a region of high stress concentration. In fact the fracture appearance suggested a torsional overload failure.

Fig. 9. Fracture surface of reduction carrier.
