Neutron radiography and other NDE tests of main rotor helicopter blades

F.C. de Beer^{a,*}, M. Coetzer^b, D. Fendeis^c, A. Da Costa E Silva^d

Abstract

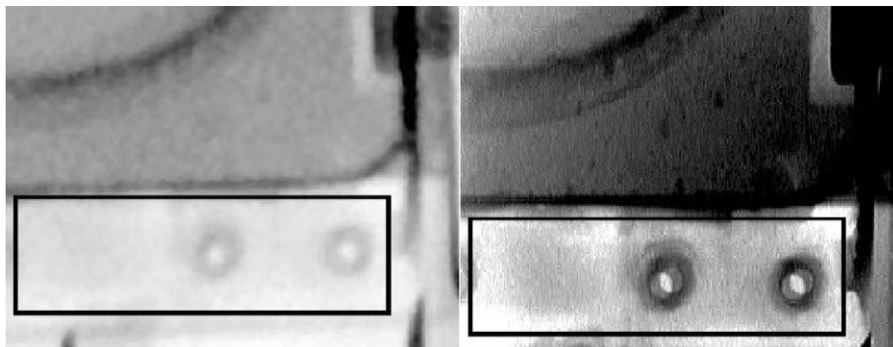
NRad-radiographs (CCD image left and direct film image right) of the same blade area are shown in Fig. 6. The difference in detection capability of the defect due to the higher spatial resolution of the film method versus the CCD imaging method can be clearly seen. On this radiograph, corrosion products are found on the tip area of the blade marked by the rectangle.

Fig. 6. CCD-neutron radiograph (left) and Direct film neutron radiograph (right).

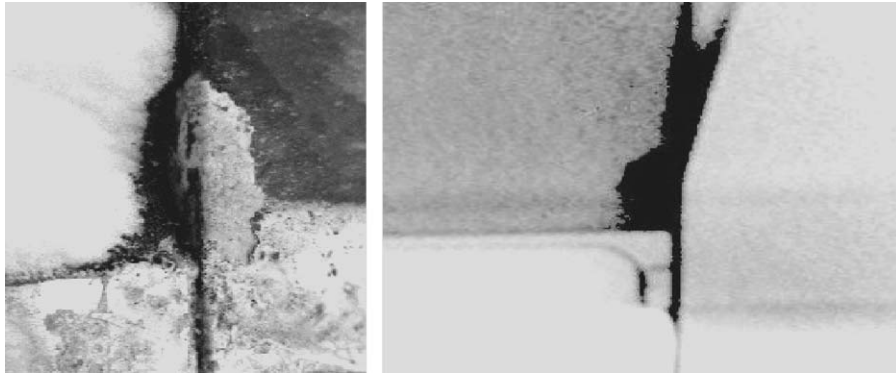
Water and/or oil ingress in the structure of the rotor blades are the most common defect detected by NRad because of the high neutron attenuation ($> 2.0\text{ cm}^{-1}$) of these substances with respect to aluminium (0.098 cm^{-1}). Fig. 7 shows the spar area on the blade with ingress of oil, as anomaly occurred normally in the spar region of the cuff area and is seen as black areas on both the images.

Fig. 7. Photograph (left) and NRad (right) show ingress of oil.

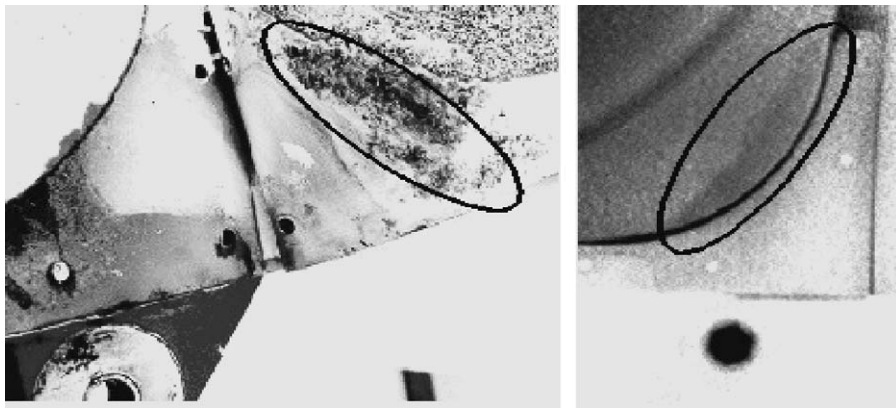
Aluminium corrosion can only be detected with NRad by its corrosion products, if present. In practice, Bayerite constitutes 60–90% of the corrosion products while other organic compounds like various Al-salts, oxides and monohydrates are also present (Rant et al., 1986b). The detect ability of these compositions depends heavily on their thickness and composition. Fig. 8 shows clearly the corrosion products on the blade indicated by the oval.

Fig. 8. Photograph (left) and neutron radiograph (right) shows corrosion products.

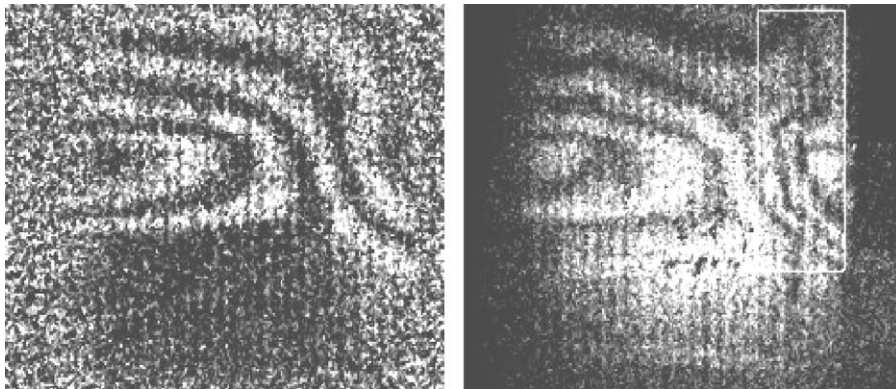
Shearography results. Using Digital Shearography, irregular fringe patterns indicate a deviation from the expected deformations due to heating of the helicopter blade. Fig. 9 (left) is a good fringe representation of a

Fig. 9. Good fringe pattern (left) and irregular fringe pattern (right).

defect-free section from a section of a blade while an irregularity in fringe pattern Fig. 9 (right) indicates an anomaly in the same region of another blade.

White boxes are added to Fig. 9 (right) and Fig. 10 to indicate the area where irregularities exist.

These irregularities indicate a subsurface defect within the structure. The exact type of defect cannot be determined without a “fingerprinting” database, which can be created from a set of known types of defects. Fig. 10 shows a delamination in the cuff area of

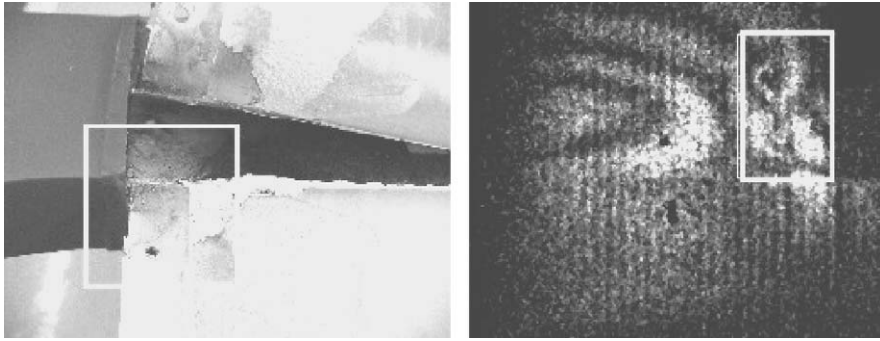
Fig. 10. Photograph (left) and Shearograph (right) of a delamination.

the blade on the photograph (left) which is presented as an irregularity in the fringe pattern on the Shearograph (right).

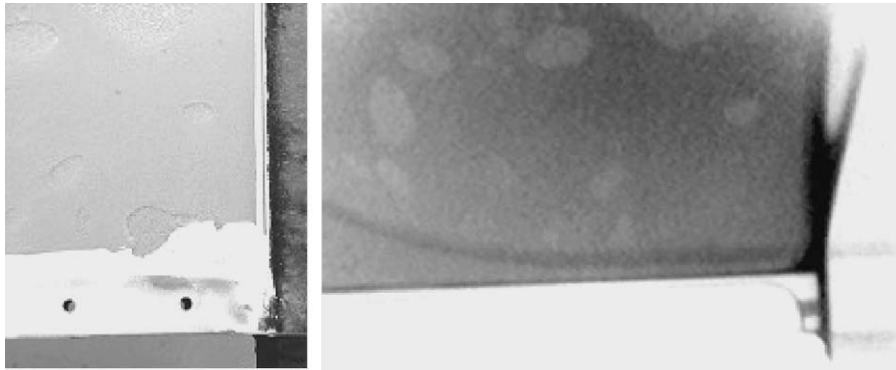
Fig. 11. Photograph (left) and NRad image (right) of delaminations.

anomalies, some other delaminations occur due to improper adhesive or contact. With NRad some delaminations (white on the radiograph) of the outer skin at the foam area on the blade was detected as Fig. 11 shows.

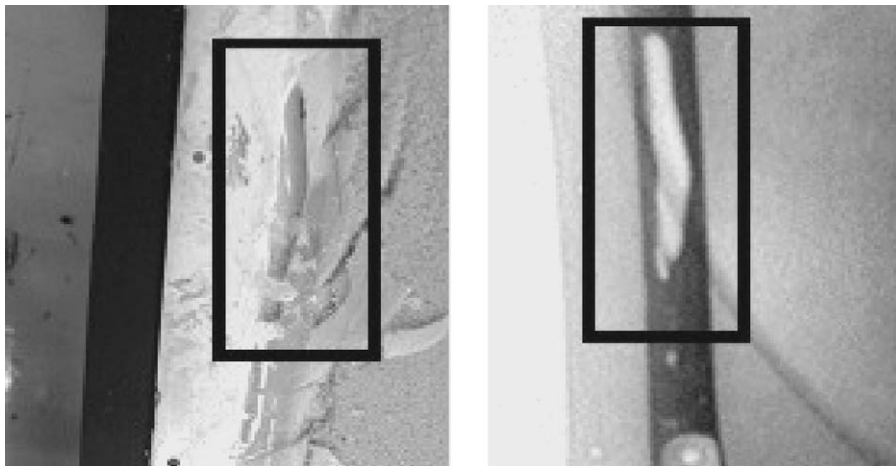
Fig. 12. Photograph (left) and NRad image (right) of lack of resin.

Within the blade, resin helps to bond the relevant parts of the blade together. A lack of resin, which can be described as an abnormality, occurs in a minor number of blades and could be detected by NRad due the high neutron attenuation of resin. An abnormality within the resin is shown white on the neutron radiograph as Fig. 12 indicates.
