CATASTROPHIC FAILURE OF A RAISE BORING MACHINE DURING UNDERGROUND REAMING OPERATIONS

Abstract—This paper describes the investigation of the catastrophic failure of a raise boring machine used for underground reaming operations. The results of the investigation indicate that failure was due to the fracture of the 32 drive head bolts, 30 of which had failed as a result of corrosion-induced fatigue. Metallurgical examination confirmed that the bolts had been manufactured in accordance with the SAE J429 Specification. A number of recommendations have since been implemented by the mine, who have also introduced a quality system specifically for the control of drive head bolt sets. The equipment has now operated without problems for several years. © 1997 Elsevier Science Ltd. All rights reserved.

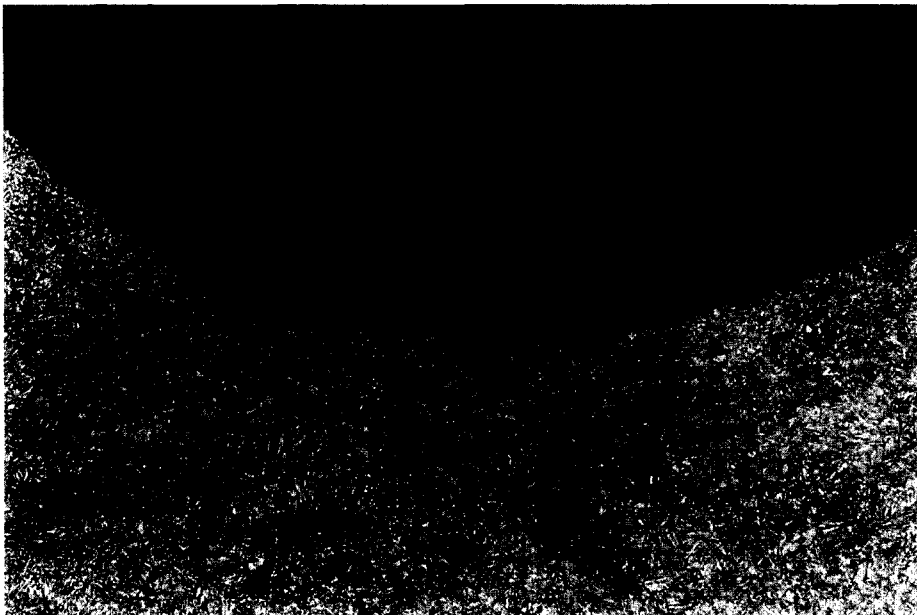
In the unetched condition, the steel from which the bolts were manufactured was relatively free from non-metallic inclusions. Etching in 2% nital revealed a fine, tempered martensite microstructure for each bolt, and no evidence of surface defects such as decarburization (Fig. 10).

Fig. 10. Longitudinal section of a bolt thread root showing fine tempered martensite, and no material or manufacturing defects. Etched in 2% nital. $\times 285$.

The metallurgical examination of the bolts showed that the failure was not associated with any material or manufacturing defects. The bolts conformed to the specification requirements in all respects.
