## USING THE DIRECT CURRENT VOLTAGE GRADIENT TECHNOLOGY AS A QUALITY CONTROL TOOL DURING CONSTRUCTION OF NEW PIPELINES

ZWENI MASILELA\* and JOE PEREIRA

Advance Engineering and Testing Services, CSIR, Private Bag X28, Auckland Park 2006,  
Republic of South Africa

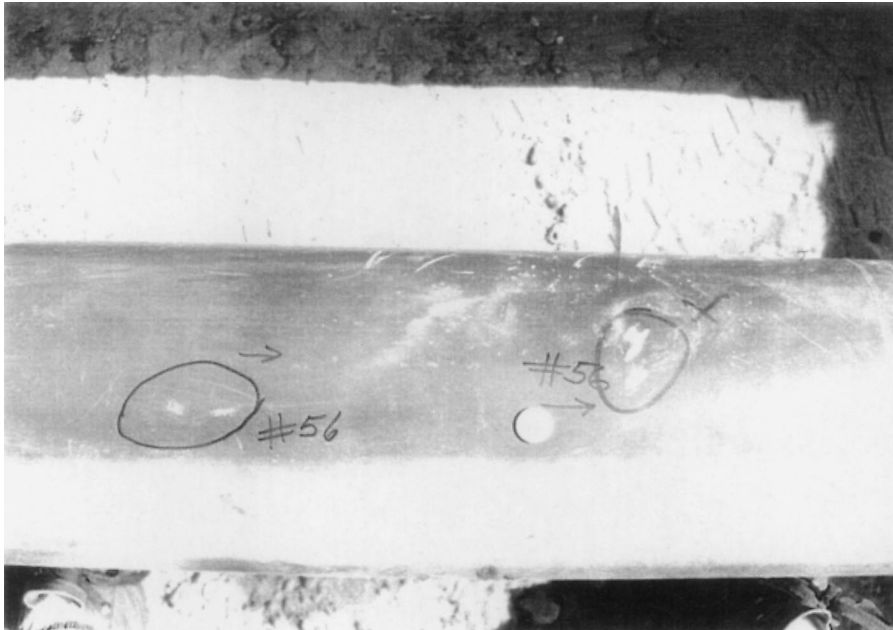
During inspection of these 51 selected defects, it was found that more than 80% of the defects were caused by mechanical damage during construction. The majority of the factory defects were very small and manifested themselves in the form of pimples or pinholes as is often the case with FBE coatings. Photographs of selected defects are shown in Figs 1–4.

Fig. 1. Mechanical damage defects seen on one of the pipes.

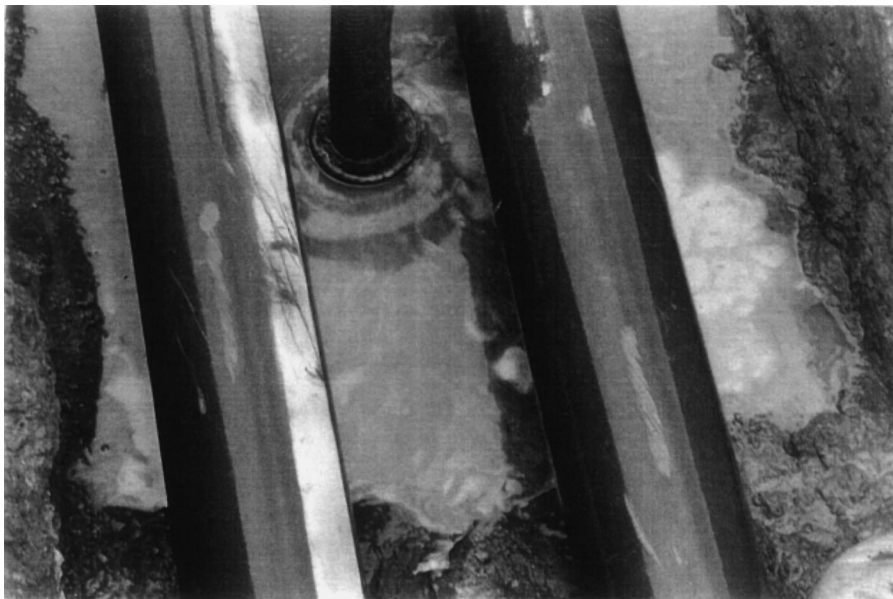
Fig. 2. Mechanical damage defects on both pipes

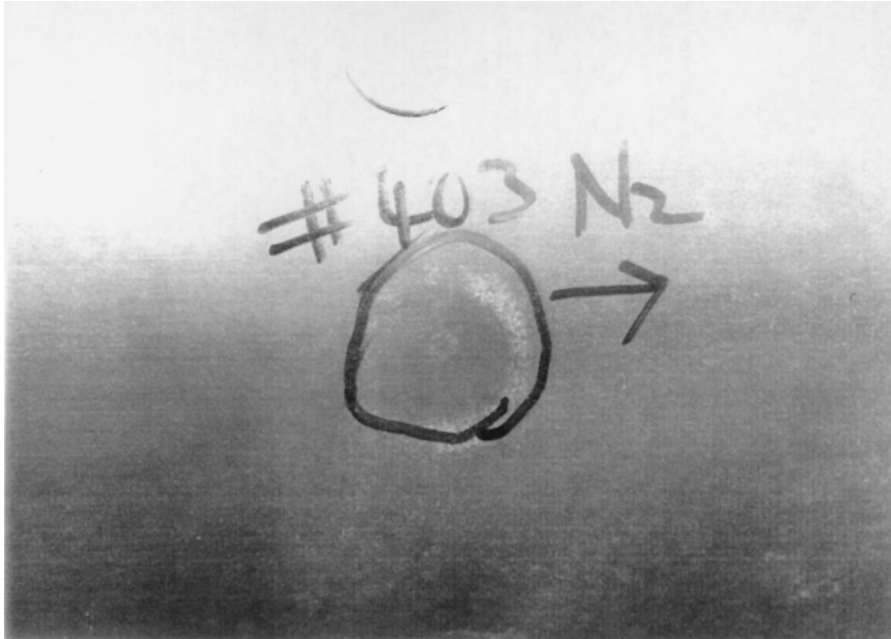
Fig. 3. A pimple defect, marked from factory in white but never repaired before pipelaying.

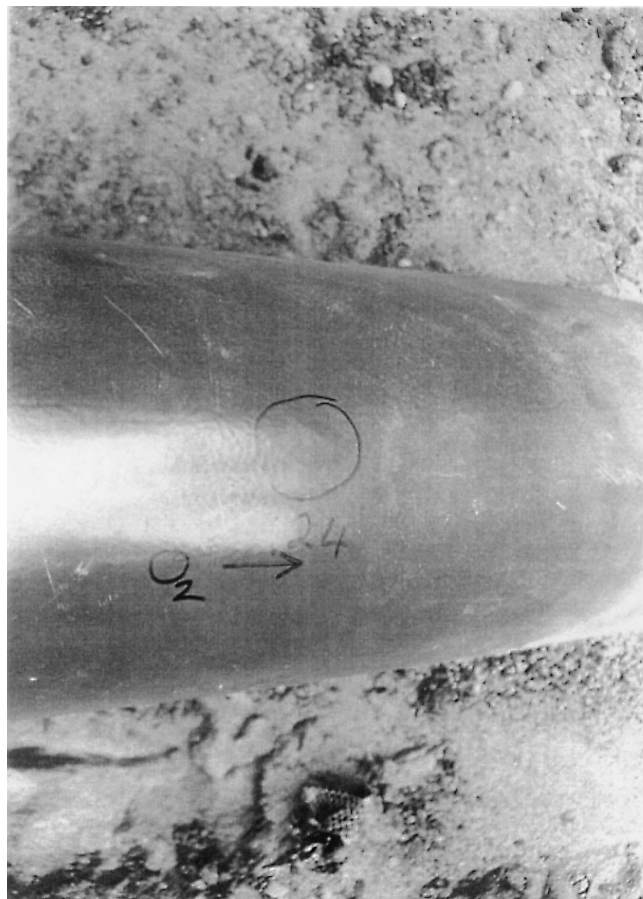
Fig. 4. Pinhole defect confirmed using a holiday detector.
