## AUTOMOTIVE COMPONENT FAILURES

A. M. HEYES

Advanced Engineering and Testing Services, CSIR, Private Bag X28, Auckland Park 2006,  
Republic of South Africa.

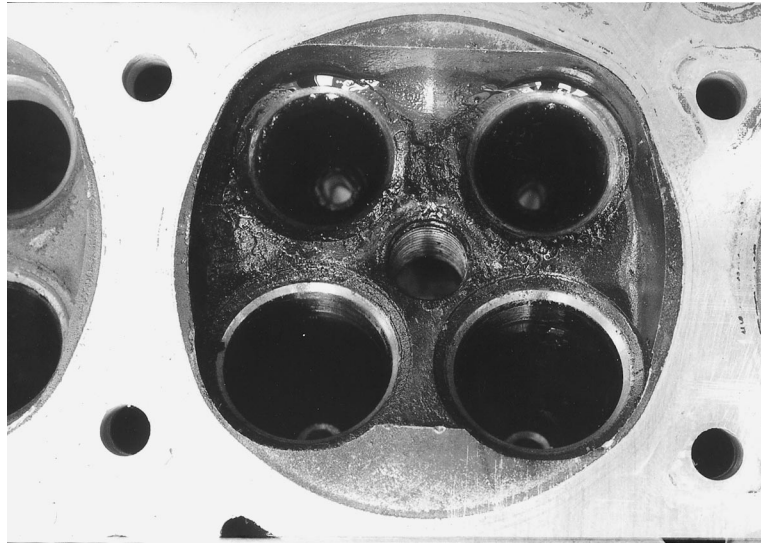
Upon stripping the engine it was found that one of the combustion chambers showed heavy carbonaceous deposits indicative of the burning of oil (Fig. 3) Circumferential black marks were found at differing heights in the bores of three of the cylinders. The visible honing pattern was deemed to be satisfactory. No source of oil ingress was evident at this stage.

Fig. 3. Carbonaceous deposits left in combustion chamber by burnt oil.

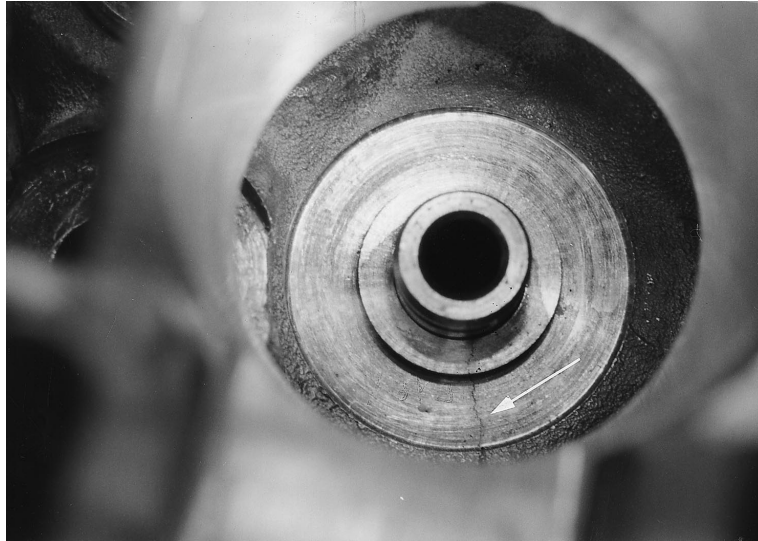
Due to the non-magnetic nature of the cylinder head fluorescent dye penetrant testing was carried out but failed to show any significant defects in the head. An alternate testing procedure involving pressurisation of the inlet ports and immersion of the head in a water bath showed the source of oil ingress to be a crack in the head where the valve guide had been inserted (Fig. 4). Fluorescent dye penetrant testing had failed to show the defect as it had been hidden under a steel spring seat.

This crack led through to the inlet port of the affected cylinder and the engine would draw oil into the engine on every intake stroke. Inspection of the inlet ports of other affected engines showed the same defect. The cause of the defect was related to manufacturing tolerances where the interference fit of the valve guide and the head was too tight, resulting in cracking of the head adjacent to the guide.

Fig. 4. The crack in the cylinder head caused by insertion of the valve guide.

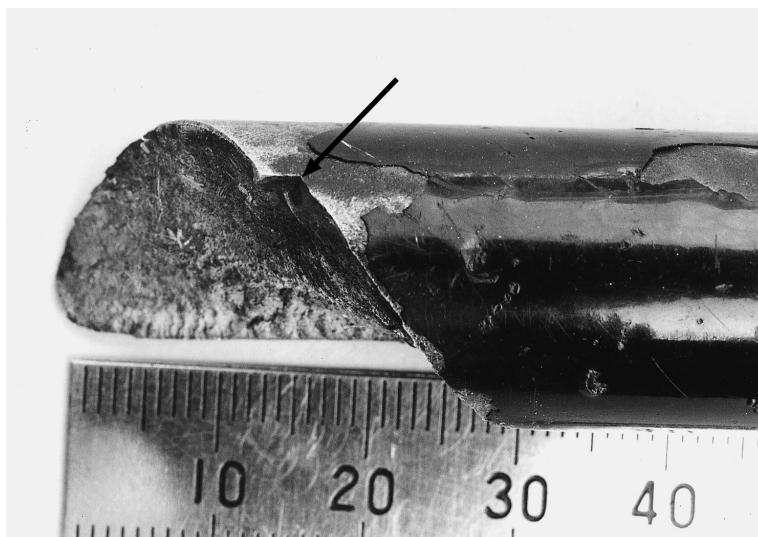
The section of torsion bar submitted for examination was coated with a black paint coating which had flaked off at localised spots, where light rusting had occurred. The fracture surface (Fig. 5) showed the spiral shape typical of a tensile-type torsional failure [1], and the fracture surface appeared brittle in nature. Chevron markings clearly pointed to the fracture origin being some form of longitudinal defect.

Fig. 5. Torsional failure of the bar, showing the likely fracture origin to be a longitudinal defect (arrowed).

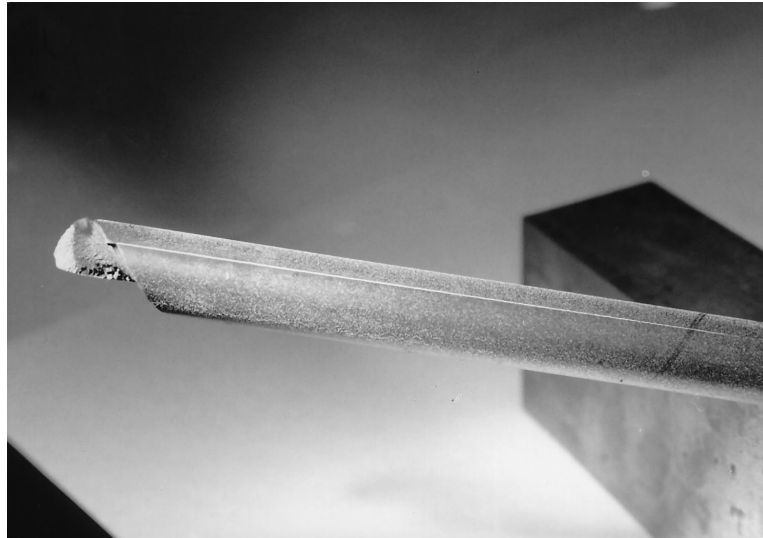
Fig. 6. Seam defect in torsion bar highlighted by fluorescent MPI.

Fluorescent magnetic particle inspection showed that a seam or lap defect existed for a further 200 mm from the fracture site (Fig. 6). Such defects are usually laps formed by incorrect rolling procedures or are seams attributable to steel defects (inclusions). Two further seams were found, but were of a very small size.

As the failure was related to a steelmaking problem it is likely to affect more than one vehicle. It was therefore recommended that the torsion bars of affected vehicles (i.e. manufactured from that particular cast of steel) be replaced. An audit of the non-destructive testing procedures of the component supplier was also recommended, as the defect was easily detectable by standard non-destructive techniques.

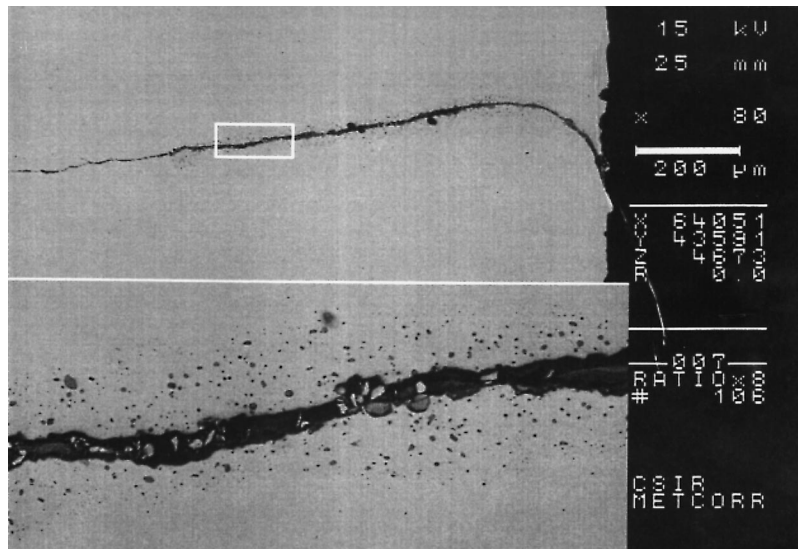
Fig. 9. SEM micrograph of seam (unetched). Note that the inclusions extend only to a depth of 0.84 mm.

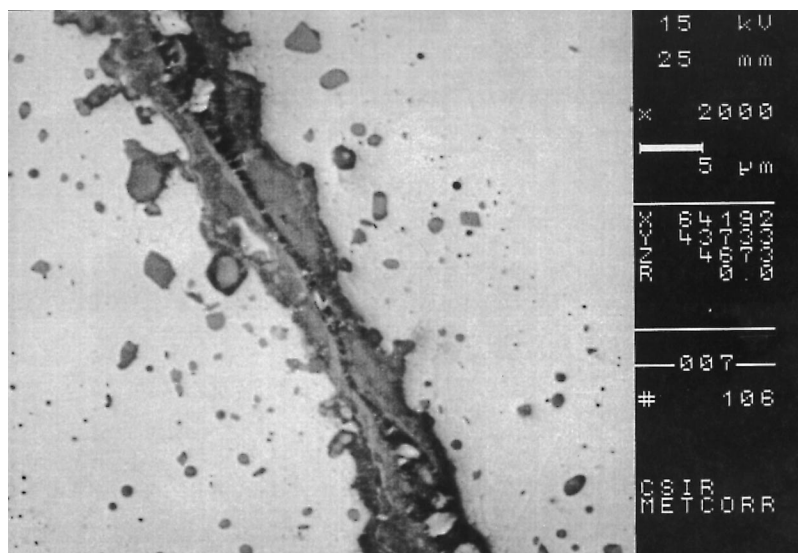
Fig. 10. SEM micrograph of the seam and surrounding inclusions (unetched).

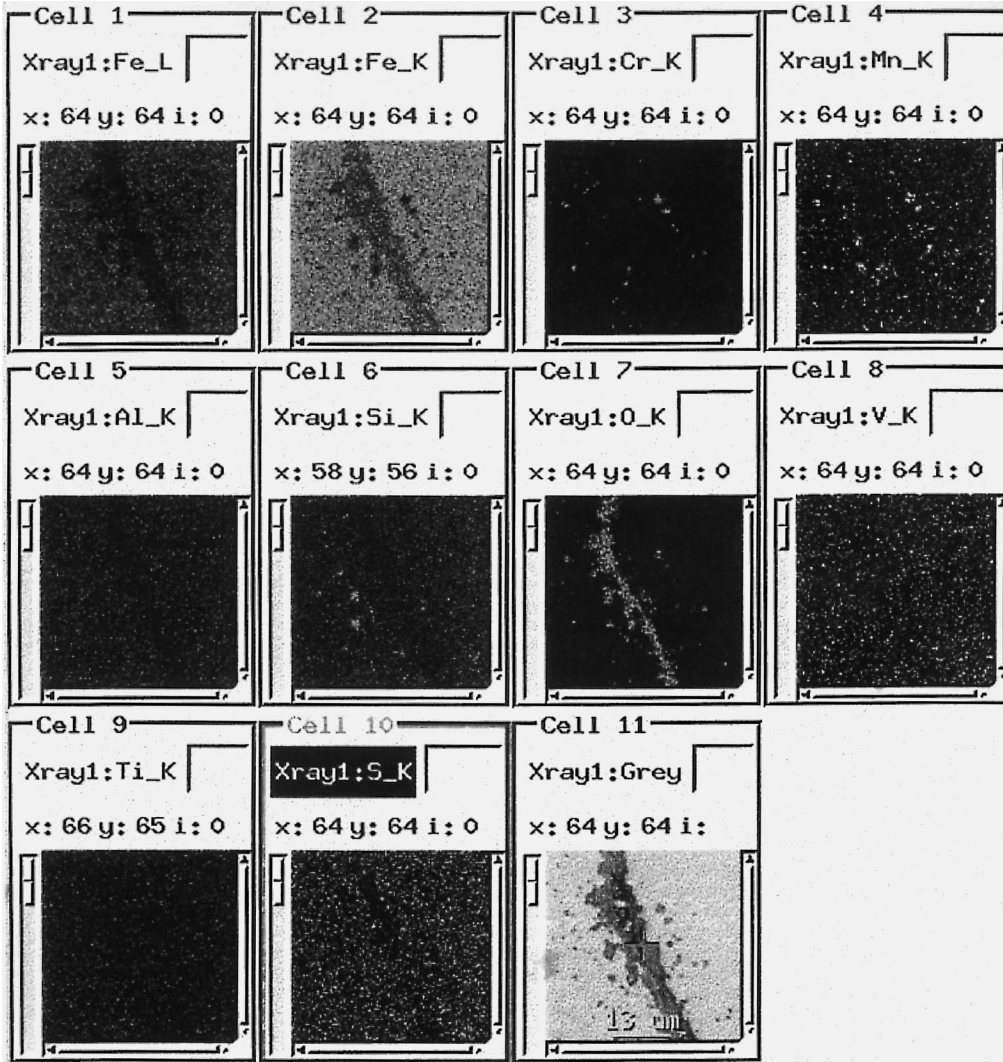
The elements selected for mapping were determined by spot analysis of four random inclusions. The EDS map is shown as Fig. 11, where it can be seen that the seam is filled with iron oxide and that the discrete inclusions contain silicon, oxygen, chromium and manganese. Further EDS spot analysis indicated that the inclusions were probably a mixture of manganese iron silicate and chromite.

Fig. 11. Energy Dispersive Spectroscopy (EDS) map of the area shown in Fig. 9.

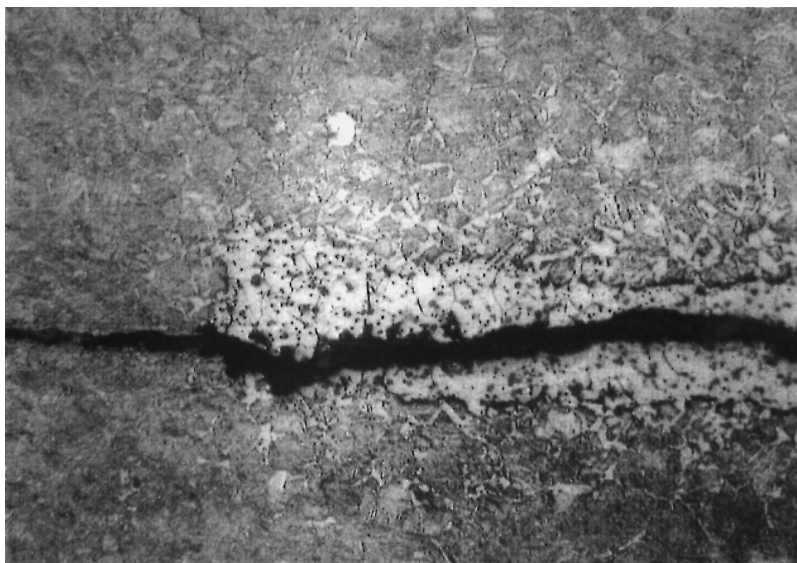
Etching of the microstructure in a 2% Nital etchant showed a decarburized area along the flanks of the seam (Fig. 12). It was noted that this extended to the depth of the inclusions, i.e. 0.84 mm. This implies that the defect was formed during the hot rolling operation of steelmaking. While the bar undoubtedly undergoes a quench and temper heat treatment, the only place for such cracking to occur during heat treatment would be in the quench cycle. This would be followed by tempering at temperatures unlikely to result in the observed decarburization. It should also be noted that high temperature oxidation accounts for the iron oxide (mainly FeO and Fe<sub>3</sub>O<sub>4</sub>) found within the crack. It can also be inferred, from the depth of the decarburization, that the seam defect grew somewhat after its formation.

Fig. 12. Decarburization along the seam flanks, indicating high temperature oxidation (etched in 2% Nital).

It was determined that the seam defect was caused by the presence of a segregated mixture of manganese iron silicate and chromite inclusions, the presence of which is related to a problem in the steelmaking process. These inclusions probably caused the bar to split during hot rolling, as evidenced by the decarburization of the flanks of the seam.

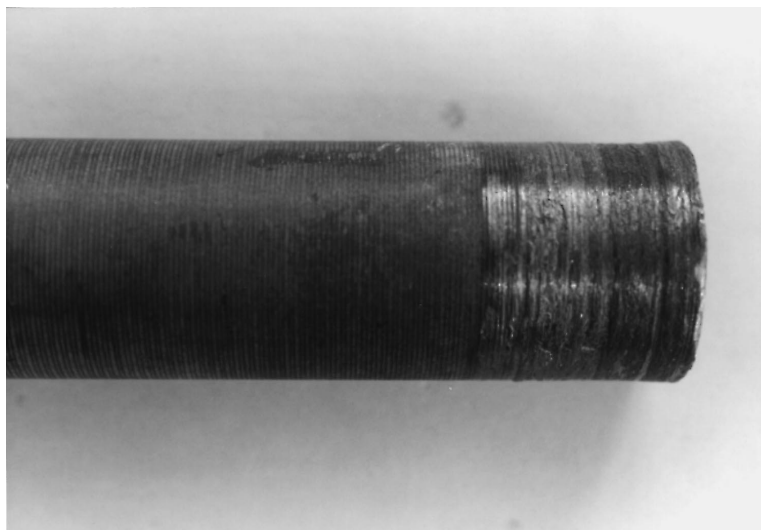
The section of driveshaft received for analysis measured approximately 60 cm in length and had failed just after a gradual change in section. Close examination of the fractured end of the shaft showed evident scoring (Fig. 13), with light blue interference film oxides visible in this region.

Fig. 13. The fractured end of the driveshaft. Note the scoring.

Measurement of the scored regions on both pieces of driveshaft showed the scoring to be approximately 30 mm wide.

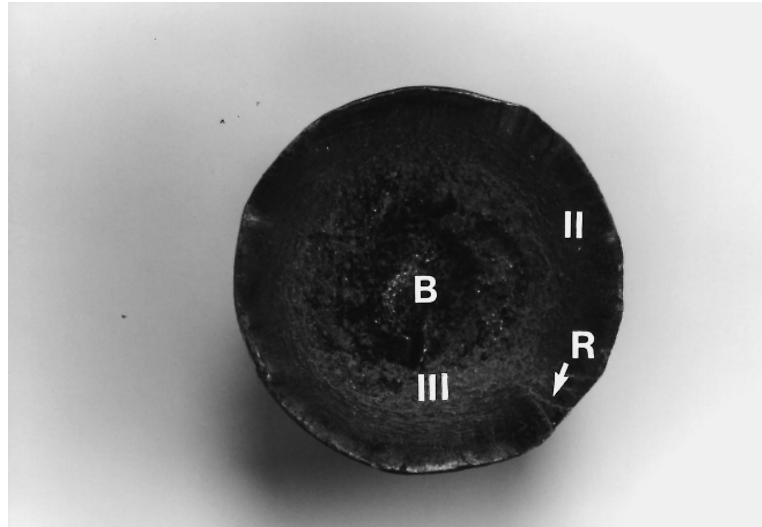
Fig. 14. Fracture surface of the driveshaft, showing a fatigue induced failure. (R—ratchet marks, II—Stage II fatigue growth, III—Stage III fatigue growth, F—fast fracture).

The fracture surface is shown in the as-received condition in Fig. 14, where the failure can be seen to be due to rotating bending fatigue. In such cases, numerous circumferential cracks initiate and grow together to form one circumferential crack front, giving rise to the ratchet markings observed on this fracture surface. As the crack grows (stage II fatigue crack growth) the stress intensity range ( $\Delta K$ ) driving the fatigue crack growth increases. This leads to a transition from stage II to stage III crack growth, evidenced by the increasing roughness of the fatigue fracture surface towards the centre of the driveshaft. At some point the increasing crack length results in a maximum strength intensity ( $K_{max}$ ) greater than the fracture toughness of the material ( $K_c$ ) and fast fracture occurs. It was estimated that only 42% of the cross-sectional area remained when fast fracture occurred, showing that the shaft had a significant safety factor against fast fracture.

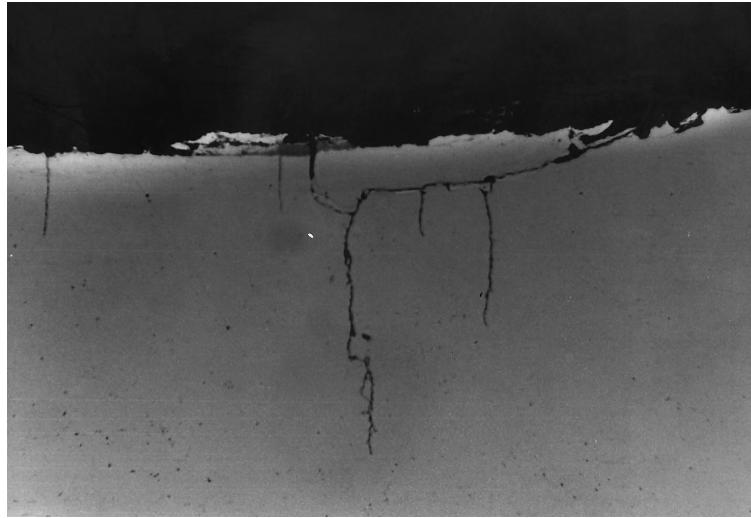
In this case the scoring of the surface of the driveshaft has effectively eliminated the initiation phase of the fatigue cracking process. Figure 15 shows a micrograph of a longitudinal section taken through the scored section of driveshaft. Numerous fatigue cracks can be seen to emanate from the scoring.

The fatigue cracking of the driveshaft was found to have initiated due to scoring of the surface. Upon inspection of the vehicle it was found that there was an indent, of a size corresponding to the diameter of the driveshaft, in the vertical chassis member near the wheel hub. The chassis member was also approximately 30 mm in width, the same width as the scored region on the driveshaft. Evidently, the rotating driveshaft had contacted the chassis at some stage, resulting in the observed scoring.

Fig. 15. Longitudinal micrograph taken through scored region of driveshaft (unetched).

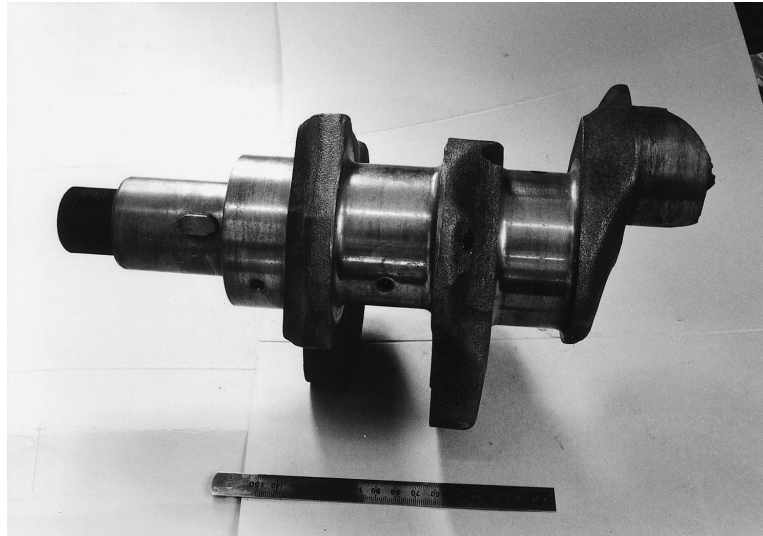
Figure 16 shows the section of crankshaft received for failure analysis. It can be seen that the failure has occurred at the second big end journal.

Fig. 16. The as-received section of crankshaft.

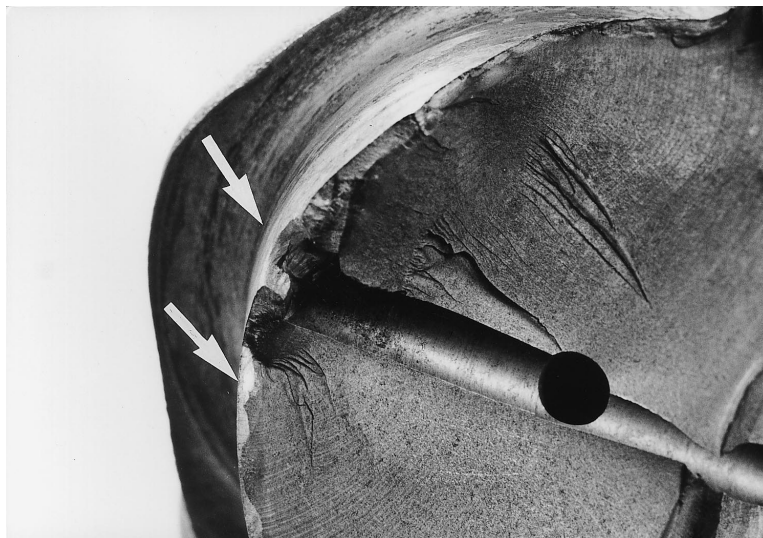
In this case the cause of the failure could be determined with no more than a visual inspection and low power microscopy. The fracture surface of the journal showed evidence of fatigue, with two opposed fatigue cracks and a very small fast fracture area. One of the cracks grew to a depth of 75% of the diameter of the journal. Figure 17 shows a close up view of the large fatigue fracture surface with beach markings clearly evident. Weld build up is also visible, evidenced by its scalloped appearance on the fracture near the journal surface. This showed that the crankshaft had been refurbished.

The origin of the fatigue crack is evidently the oil hole, which can be seen to have been poorly drilled out following weld build up of the journal. Inspection of the other oil holes showed another hole to have been poorly dressed, leaving a sharp notch at the intersection of the oil hole and the journal surface.

Fig. 17. The fracture surface of the journal showing clear beach markings, indicative of fatigue. The fatigue crack initiated at the mismatched oil hole. Note the scalloped appearance of the weld deposit near the surface of the journal.

The failure of the crankshaft was due to poor refurbishment of the journals by welding. The original oil hole and the drilled out hole were grossly mismatched creating a step of weld material. Fatigue cracking, probably initiated by cracking of the weld deposit at the oil hole, caused the crankshaft to fracture.

This case study highlights the need for expert knowledge when it comes to the refurbishment of crankshafts. Factors to be considered in refurbishing a crankshaft include machining tolerances, material of construction of the crankshaft, the process used to build up the journal diameter and the possible presence of surface treatments such as tufftriding, induction hardening or shot peening.
