FAILURES OF CHAIN SYSTEMS

ALAN JAMES

Abstract—Chains are used for various purposes in a wide range of industries. This paper describes three case studies where a failure analysis was carried out on chains used in markedly different applications. The failure mechanisms emphasize the importance of operating the equipment within the original design parameters, and also that material integrity is fundamental to the operational life of a system. © 1997 Elsevier Science Ltd. All rights reserved.

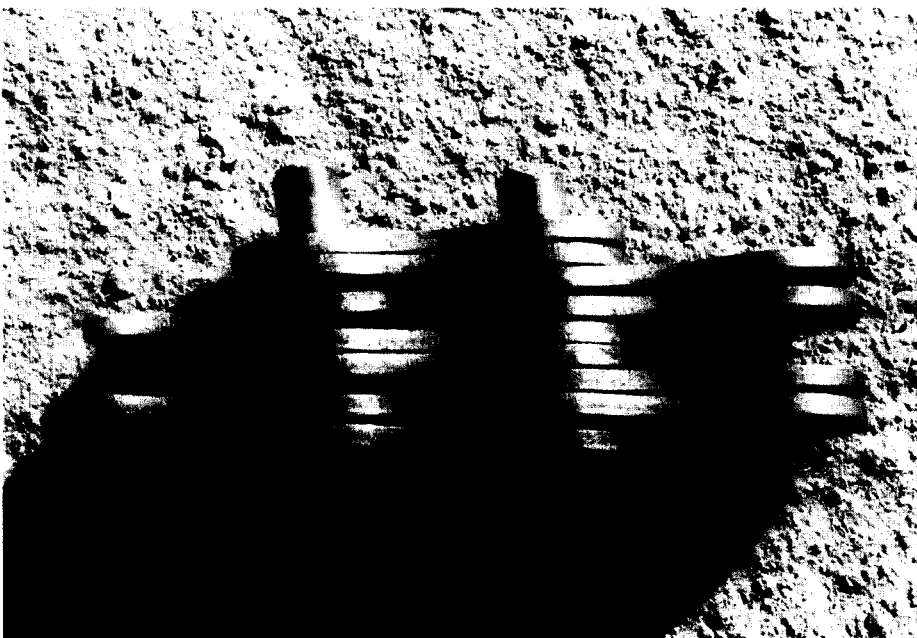
The chain had failed locally, resulting in the fracture of numerous links and one side plate. Only two fractured links remained attached to the sample submitted for examination (Fig. 11). Both locating pins on the sample had been deformed.

Fig. 11. Close-up view of the fractured sample of chain. Note the pin deformation.

The pull-down chain has failed due to fatigue which has originated from the surface of the locating holes and from the hole-side face intersection. The area of fatigue crack propagation is relatively small, compared to the total fracture area, which is indicative of high operational stress. This may have been in the form of very high working loads or a combination of high loads and a sudden event such as dynamic loading. Clearly, the stress necessary to cause deformation of the locating pins would have been appreciable.

- (1) The pull-down chain has failed by fatigue originating from the 14 mm diameter locating holes in the leaf links.
- (2) The failure of the chain is due to excessive operational stresses.
- (3) Consideration should be given to using a higher-strength chain, or at least control or redistribute the operating loads on the system.

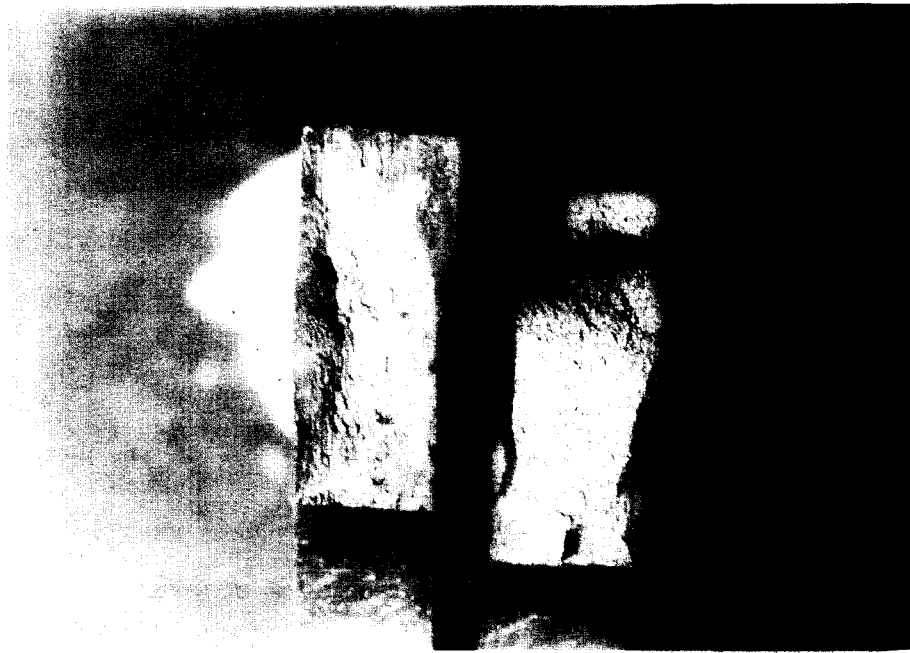
Examination of the fracture surfaces revealed areas of fatigue on both links (Fig. 12). The fatigue cracking had originated from the surface of the locating hole and from the hole-side face intersection on one link, and from the hole surface on the other link. The areas of fatigue, compared to the total fracture areas of the links, were less than 5% on one link and less than 10% on the other, and had a fairly coarse texture.

Fig. 12. Areas of fatigue on both fractured links.
