Service life and sustainable design methods: A case study

Dr Johann Mc Duling Pr Eng ¹
Geoff Abbott Arch²

T 51

11DBMC International Conference on Durability of Building Materials and Components ISTANBUL, Turkey 11-14 May 2008

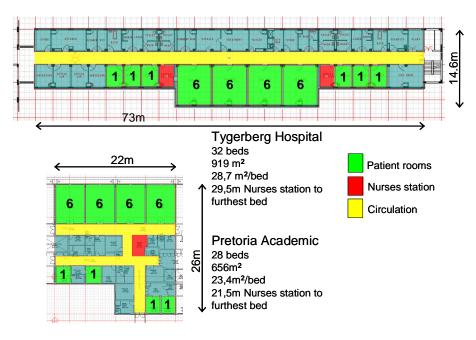
Figure 1: Ward shape comparison

Most new wards in modern hospitals have a far more compact layout than those at Tygerberg, see Figure 1 below. There are significant advantages to a compact design including shorter walking distances between patient beds and key work areas [nurses station, clean and dirty utility, etc], better observation of patients by staff, less overall area, better external wall to area ratios and therefore lower cost. A compact ward with a central nurses' station also allows more effective air-conditioning air flow with supply flow from the nurses' station outwards through patient and service rooms.

The current elongated layout was designed originally for natural ventilation. Air-conditioning was added but is not working. The location of the plant rooms [at the furthest point from the entrance near the escape stair] is problematic as all maintenance and moving of soiled filters have to go along the length of the ward. The elongated ward required the separation and duplication of some support spaces including two nursing stations [ward secretary at entrance, sister's station and nurse's station along the length of the ward], two sluice rooms [including duplication of equipment], two linen rooms, and main kitchen and sub-kitchen. Control of the ward and observation of patients is problematic and security is a concern. Patients in single rooms towards the end of the wards can easily be forgotten. Many of the wards have their escape doors leading to the fire escape stairs locked for security reasons or open but not alarmed.

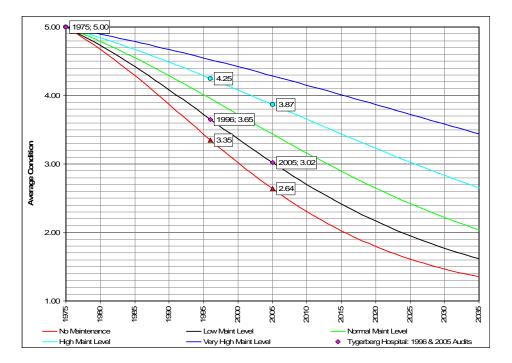
Figure 4: Anticipated Average Condition over Time vs Level of Maintenance [Mc Duling, 2006]

In Figure 4 below, the actual average condition of Tygerberg Hospital as assessed during the NHFA and 2005 CSIR assessment is compared to the anticipated change in average condition over time for various levels of maintenance, ranging from no maintenance to a very high level of maintenance. For a health care facility, such as Tygerberg Hospital, a high level of maintenance [the curve second from

the top] would be appropriate. From the graph it can be seen that the 1996 NHFA and 2005 CSIR Assessment average condition of Tygerberg Hospital falls on the low maintenance curve.

The anticipated average condition of Tygerberg Hospital should have been around 3.87 for a high level of maintenance and 2.64 for no maintenance. The consequences of the inappropriate level of maintenance amount to R428 million more required now than what should have been the case if the facility was properly maintained [high level of maintenance].
