A BRIDGE MANAGEMENT SYSTEM FOR THE WESTERN CAPE PROVINCIAL GOVERNMENT, SOUTH AFRICA: IMPLEMENTATION AND UTILIZATION

AJ NELL

PA NORDENGEN

A NEWMARK

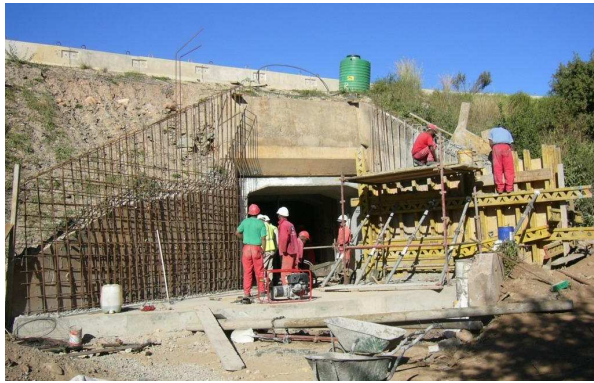
a) Structural repairs to culvert

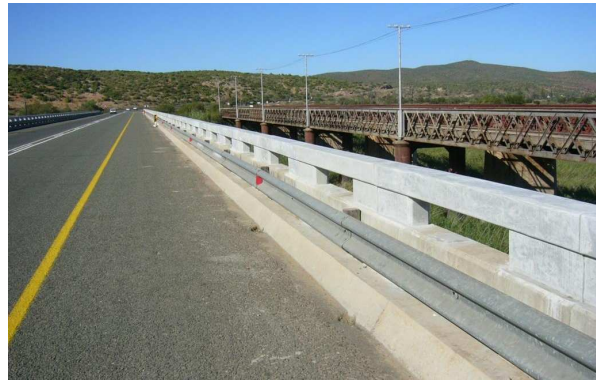
b) Replaced bridge handrails

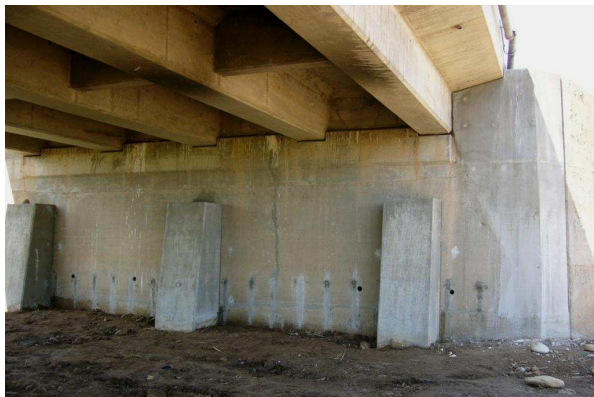
c) Repairs to bridge abutment

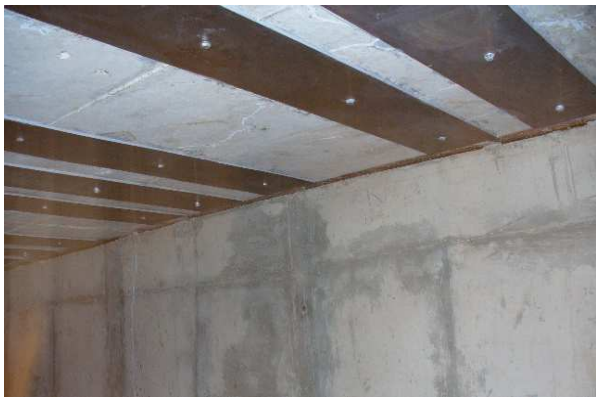
d) Repairs to culvert deck soffit
