MONITORING AND MAINTENANCE OF BREAKWATERS WHICH PROTECT PORT ENTRANCES

Kishan Tulsi and David Phelp

CSIR Built Environment, PO Box 320, Stellenbosch 7599, South Africa

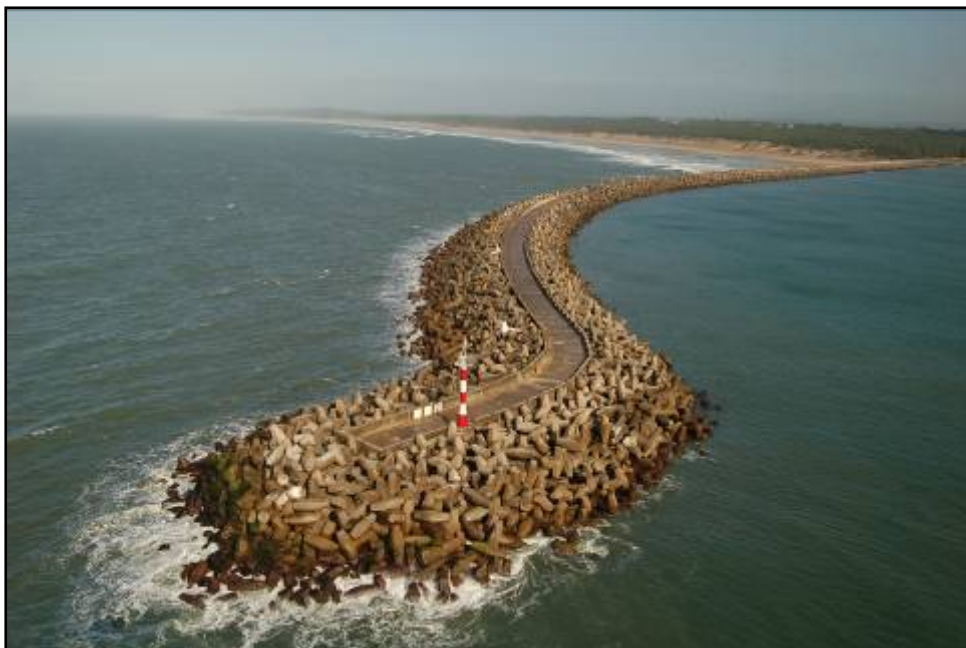
Figure 6: South Breakwater at the Port of Richards Bay

Annual photographic monitoring of the south breakwater has shown a gradual increase in damage to localised areas on the southern side of the trunk, despite spot repairs using 20t dolosse, carried out by Portnet in 1985. A detailed evaluation of the damage was undertaken by Zwamborn in 1988 (CSIR, 1988b) which led Portnet to commission the CSIR in 1991 to carry out investigatory model tests in an existing 3D 1:100 scale model of the entrance to the Port of Richards Bay. These tests were to check different repair options, taking into account the position of a dredged sand-trap along the seaward side of the breakwater. The repairs required the casting of 1 000 additional 30t dolosse. Between 1991 and 1996, additional 2D flume tests were carried out at a 1:40 scale to check the stability of the rock toe of the repair slope. These tests were carried out with a movable (sand) bed to model the effects of toe scour. Before the commencement of the repair work it was found that, due to a gap in the dredging programme, there was a buildup of sand along the breakwater toe. Final model tests were therefor carried out to re-check the toe stability at this shallower depth.

The original breakwater construction used a total of 13 400 20t dolosse on the trunk, and 2200 30t dolosse on the roundhead, which amounts to approximately 10 dolosse per metre of breakwater. The original depth at the head was -18m and -14m along the outer curve of the trunk. The worst damage prior to the repair was located on the trunk with 17% dolosse displaced or broken. Ad-hoc spot repair work was carried out in this area in 1985, when 52 new 20t dolosse were placed. Although this showed a significant improvement in the measured profiles, the photo survey showed that half of these dolosse were broken and/or lost by 1987.

The occurrence of low pressure cyclonic storms (cyclones Demoina and Emboa in 1984) subjected the breakwater to wave heights exceeding the 7,9m 1:50 year design H_{mo}. Storm wave set-up and low atmospheric pressure associated with these storms also had the effect of raising the water level, thereby increasing the depth limited wave heights reaching the breakwater. There have also been a number of lesser, but still powerful storms with wave heights in excess of 6m.

Based on the results of the model tests, only 30t dolosse were to be used for the repair. These dolosse were brought from the casting yard (1 001 new 30t units) and old stockpile (37 old 20t and 88 old 30t units left over from the original breakwater construction) on the south side of the entrance channel directly onto the breakwater. Three double direction trailers were then used to transport the dolosse, but as these trailers could only pass when unloaded, it meant that only one 30t dolos could be brought onto the breakwater at any one time. A portal crane was used to handle the dolosse from the casting yard onto the stockpile and from there onto the trailers.

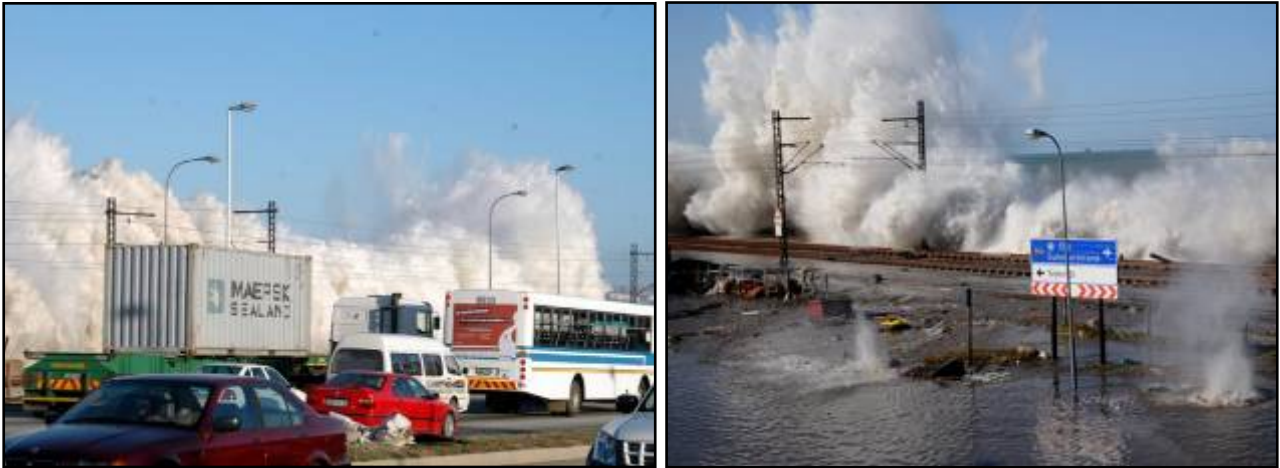
Figure 7 and 8: Severe Wave Overtopping causing Flooding

During a severe storm in August 2008, with wave heights exceeding 4m (recorded off Ngqura), extensive damage was caused to the shore protection along the N2 Freeway in Port Elizabeth. The storm coincided with a spring high tide, which increased the wave overtopping, causing undermining of the railway line and closure of the freeway from flooding and rocks washed onto the tarmac (Figures 7, 8 and 9). Note the water pushing up through the storm water drains (Figure 8). The road was cleared within a day, but the railway took longer to reinstate, with the dumping of additional large rock shore protection.

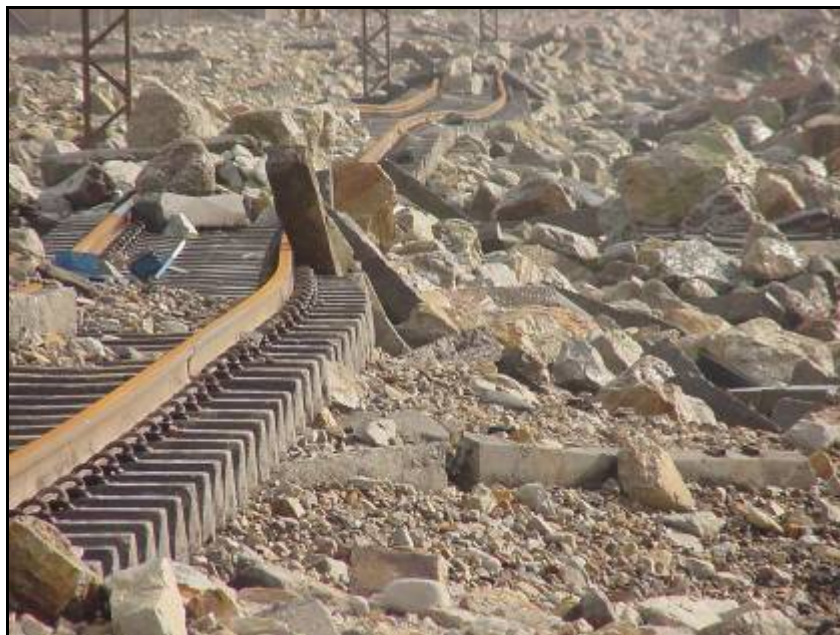
Figure 9: Damage to the Railway Line

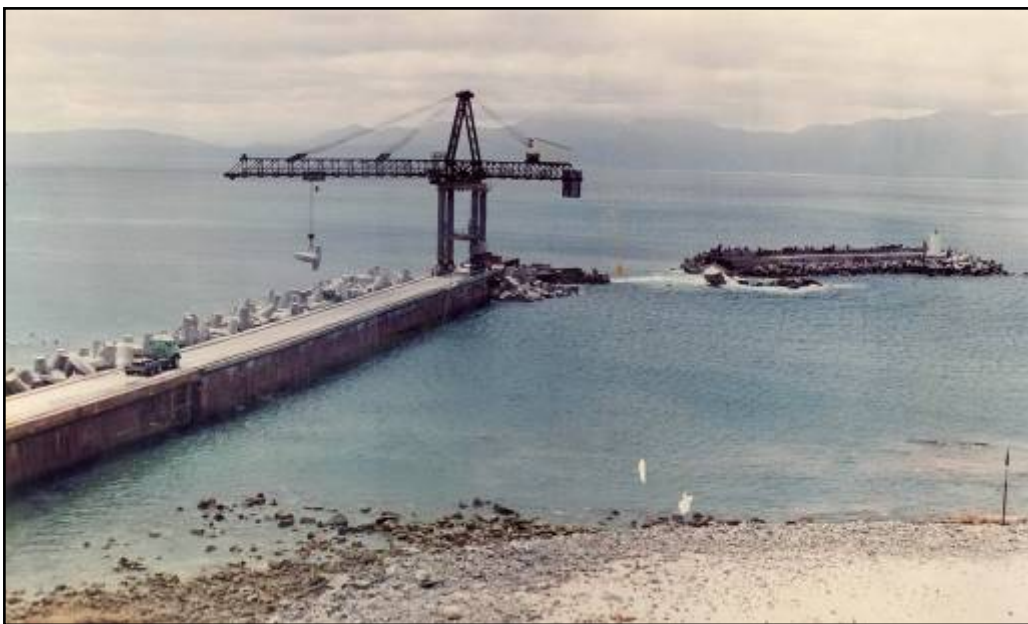
Figure 10: Breakwater Failure due to Focusing of Storm Waves
