# MODIFICATIONS TO 25m<sup>2</sup> TARGET-ALIGNED RESEARCH HELIOSTAT MIRROR PANELS

## Abstract

Several heliostat mirror panels of the CSIR 25m<sup>2</sup> target-aligned heliostat suffered corrosion-related failure, prompting a panel redesign. Two test samples of the new design were subjected to mechanical and thermal cycling tests in an attempt to simulate accelerated life loading, as well as simulated hail testing. While the samples survived all tests without failure, the results are not fully conclusive as the mechanical cycling and hail test sample was manufactured of 4mm instead of the design 3mm mirror sheet. The test results nonetheless suggest that a sample made of 3mm mirror sheet would successfully survive the tests, and preparations for such tests are underway. Conclusive thermal cycling tests require a reduced scale mirror panel to be manufactured and tested in an environmental test chamber.

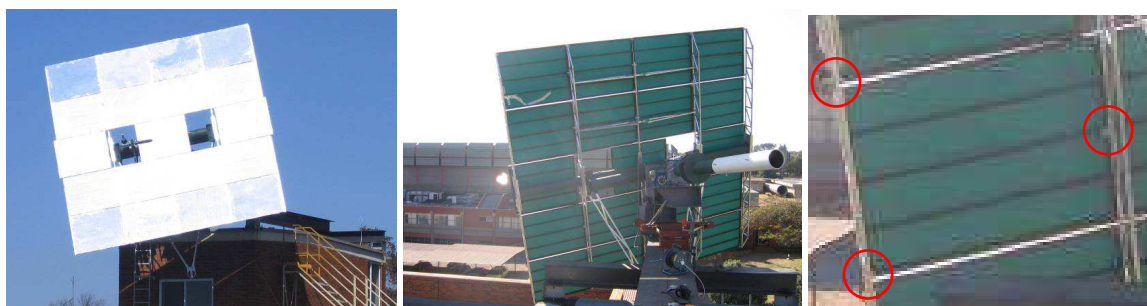
**Figure 1: Front (left) and rear (centre) views of heliostat, close-up of mirror panel showing reinforcing stringers and three attachment studs (right)**

- The 3 support backing stringers on each panel (visible in fig 1) were affixed to the back of the mirror glass but by oversight not to the outer frame, resulting in the weight of these stringers being supported by the mirror glass and not by the frame
- Despite the fact that the mirror frames had been painted (after the mirrors had been bonded to them), corrosion of the frames nonetheless took place. This corrosion propagated under the frame/resin bonding interface, leading to mirror panes separating from the frames.

Since the heliostat is mounted on the roof of a 2-storey building, all the remaining mirror panels were taken down for safety reasons. It was decided to redesign the mirror panels with aluminium frames.

The replacement frame design has the same outer dimensions in length and width, but is noticeably thicker. The short outer sides of the rectangle are made up of 38mm aluminium square tubing, which are welded to the 32mm aluminium square tubing that makes up the long outer sides. The stringer design was changed from rectangular tubing to sections from the construction industry, made from 0.4mm galvanized sheeting folded into 38mm sections. The stringers were riveted to the frame, making the frame and stringers a single rigid structure. Using laser-cut formers, the mirror sheet was deformed to a spherical curvature (of 66m focal length) and bonded to the frame and stringers. The new mirror panel mass is 14kg compared to the old panel mass of 21kg. It was expected that the new mirror panel design would alleviate both the corrosion and the actuator problems, since:

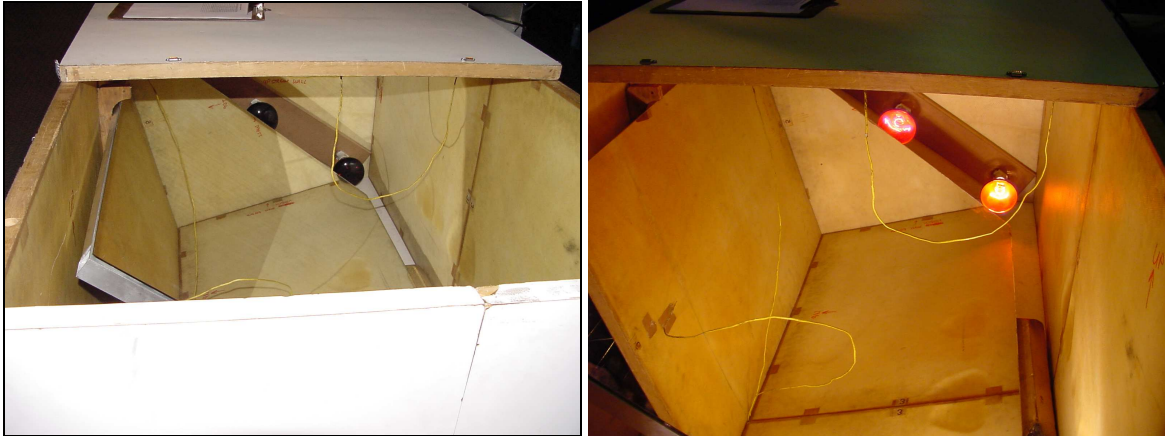
**Figure 2: “Hot box” with one top panel removed showing mirror panel inside, with infrared lamps off (left) and on (right)**

The mirror panel was subjected to 37 thermal cycles in total with no resultant cracks or delamination. All cycles began with the structure at or below  $30^{\circ}\text{C}$  and ended at  $54^{\circ}\text{C}$  (resolution  $1^{\circ}\text{C}$ ).

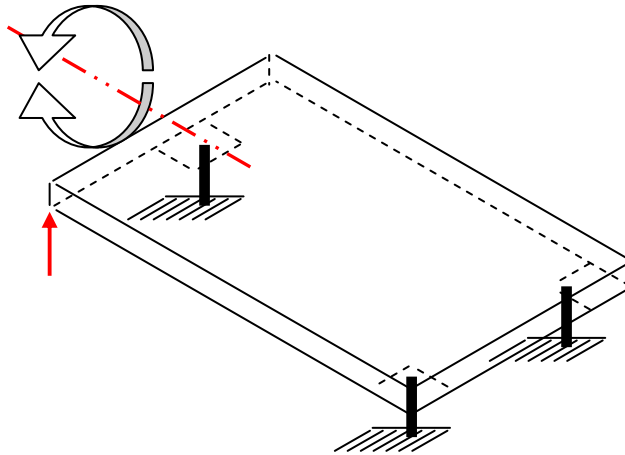
The mirror panel is supported by three studs, to allow control of angular positioning. In high winds, the most likely vibration mode is torsion about the single stud (red axis in Figure 3), rather than simple bending along the long axis of the panel due to the stiffening effect of the stringers.

**Figure 3: Expected mirror panel vibration mode**

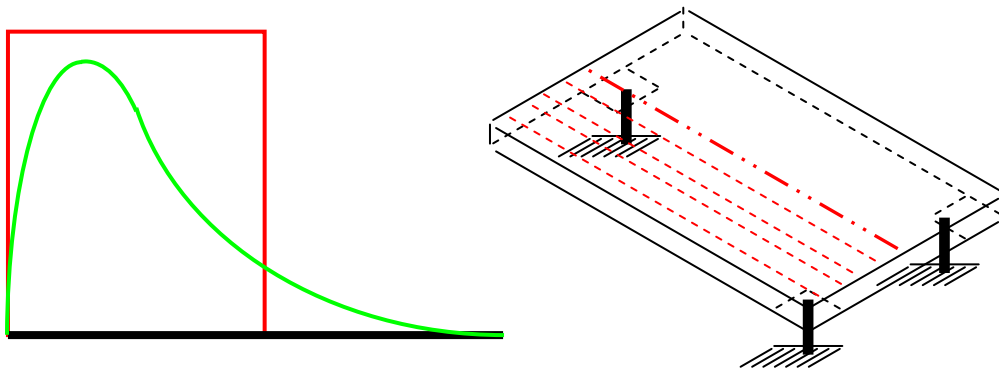
**Figure 4: Wind loading approximation**

- A finite element model of the composite mirror panel was constructed, with a conservative torsional wind loading distribution simulated by a stepwise lift coefficient distribution of 2 over the windward half of the panel and 0 over the leeward half (red distribution in Figure 4). This was done since an aerofoil near stall (worst load case) has a near-triangular lift distribution, with a peak lift coefficient of 1.8 at about  $\frac{1}{4}$  to  $\frac{1}{3}$  chord length downstream of the leading edge (green distribution in Figure 4).

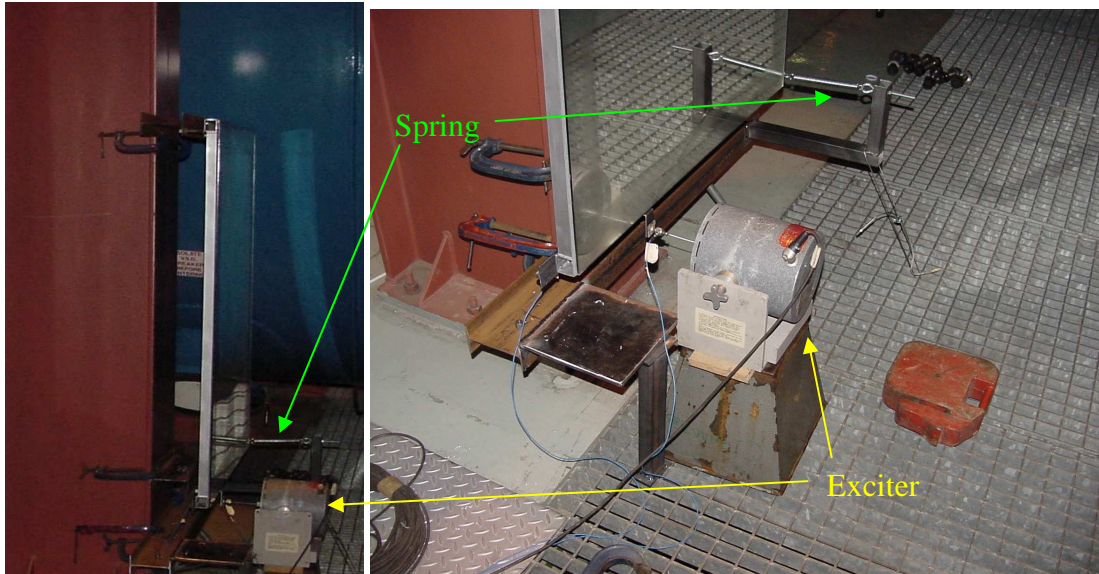
**Figure 5: Mirror mounted on test frame (left), close-up of mechanical exciter installation (right)**

The first natural torsion frequency of the mirror panel was experimentally determined to be 17.13Hz. The mirror panel was vibrated at this torsional frequency, controlling displacement (maximum corner displacement of 4.6 mm) rather than force as the input variable. The panel successfully survived 1 000 000 cycles. The natural frequency varied only in a tight range of 17.122Hz to 17.150Hz (0.16% of nominal value), and the starting and frequencies differ only in the 3<sup>rd</sup> decimal place, so no damage is expected.. A visual inspection of the mirror, mounting frame, and interface bond did not show any signs of vibration damage or de-lamination and cracking.

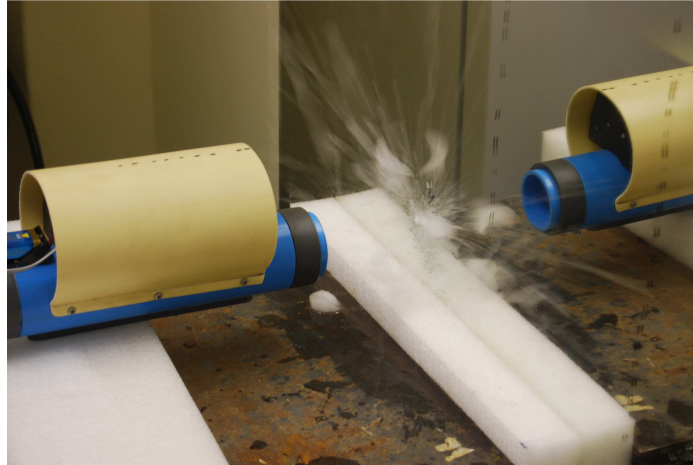
As shown in Table 1, a range of hailstone sizes and velocities were tested on the mirror panel. The final test made use of a 45mm diameter hailstone at 78m/s. The mirror panel withstood the 243J impact without any damage to the surface (as illustrated in figure 7), as it had survived all the previous hailstones. For comparison, the hailstone density implied by the true mass and nominal diameter is given, as well as the implied diameter for the true mass and ice density of 916.8 kg/m<sup>3</sup>.

**Figure 7: Impact of 45 mm hail stone at 78 m/s**
