# ROCKBURST DAMAGE MECHANISM AT IMPALA PLATINUM MINE

# L S Ledwaba and J Scheepers Impala Platinum Holdings Limited

The Southern African Institute of Mining and Metallurgy Southern Hemisphere International Rock Mechanics Symposium SHIRMS 2012							
L S Ledwaba, J Scheepers, R J Durrheim & S M Spottiswoode

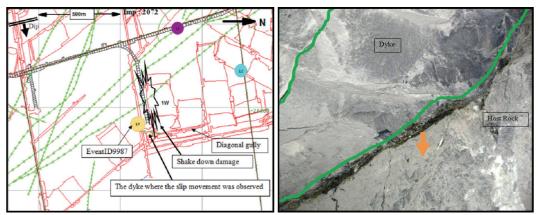
A seismic event with  $M_L = 1.9$  was recorded at No. 10 Shaft on the 26/04/2007 at 18h02 (henceforth referred to EventID9987) and was located near panel 1W, which was in the midst of negotiating a dyke intersections. **Figure 8** shows the locations of the seismic events and the distribution of damage. The panels in the proximity were mined up-dip. The right side of **Figure 8** depicts a photograph of shear movement of approximately 4 cm between the dyke and the host rock. The yielding pillar within panel 1W sustained damage, and also rock fragments fell from the hangingwall as part of the shake out.

**Figure 8.** Locations of seismic event and the associated damage. On the right, view upwards towards the hangingwall; the dyke is contained within the green lines. The host rock moved about 4 cm in a downward direction indicated by the arrow.

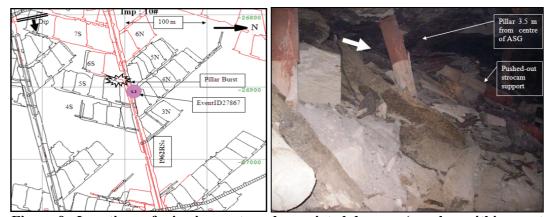
**Figure 9.** Locations of seismic events and associated damage (number within event represent the local magnitude). On the right figure, view south-westerly within the ASG towards panel 6S ASG face, pillar burst observed within panel 1962 6S. The damaged pillar is on the left side behind the support. Rock fragments were ejected from first pillar (4.1 m × 10 m) from 1962 RSE between panels 1962 5S and 6S. Ejected rock fragments rolled out of the siding into the ASG, indicated with a white arrow. Some of the support units along the 1962 4S ASG were pushed-out and not broken.

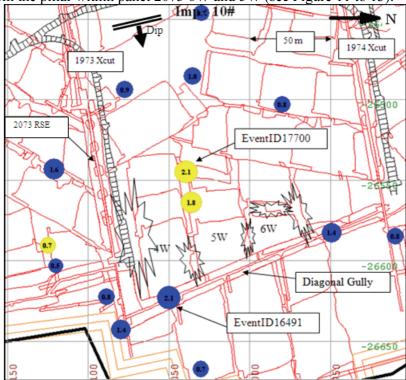
(**Figure 10**). A complete collapse of 1973 crosscut and scattered damage in the nearby panels was observed. Two months later, two seismic events with  $M_L = 2.1$  (henceforth referred to as EventID17700) and a  $M_L = 1.8$  occurred on 08/09/2008 (**Figure 10**) and contributed to the total collapse and complete sealing off of 1973 crosscut.

**Figure 10. Locations of seismic events and associated damage.** Black spheres represent seismic events recorded on the 03 July 2008 and the light shaded spheres represent events recorded on 08 September 2008.

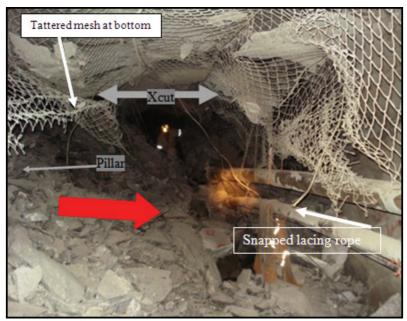
The sidewall of the 1973 Xcut was shattered into small fragments. The support that had been installed ( $2 \text{ m} \times 2 \text{ m}$  diamond mesh and lace, with 1.9 m tendons) was ineffective in supporting the sidewall. The observed damage was interpreted to be the result of a pillar bursts which led to a number of falls of ground in the nearby panels. Rocks were ejected from the pillar within panel 2073 6W and 5W (see Figure 11 to 13).

Figure 11. Rock fragments ejected from the pillar between 1973 Xcut and 2073 panel 4W into the Xcut. View easterly towards the end of the Xcut. Red arrow illustrates the direction in which rocks were ejected. The tunnel wall on left side is intensely fragmented and has suffered severe dilation. Tendons on the hanging wall appear not to have failed. Lacing rope has snapped and meshing was torn by ejected rocks. Slabs are caught up in the overhead mesh.

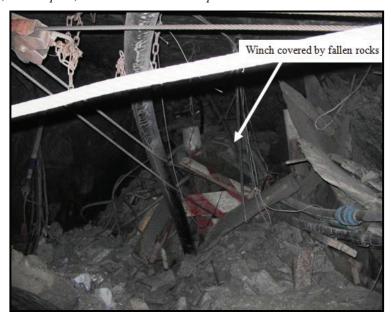
Figure 12. FOG next to the tip area within 2073 RSE

View westerly towards the 2073 gully and 1973 Xcut intersection. The pipes and cables that run across the centre gully are damaged. The winch is completely covered by fragmented rocks that fell from the hanging wall and were ejected from the nearby pillar. The pipes and cables that lead towards the face are damaged.

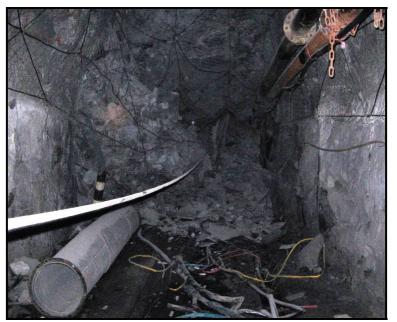
Figure 13. Extensive damage at the 1973 X/Cut due to EventID17700

View easterly towards the end of the Xcut. The tunnel wall on left side is intensely fragmented and has suffered severe dilation. Tendons and meshing on the hangingwall appear too loosened. Cables and pipes are completely destroyed. When comparing with Figure 11, it should be noted that this photo was taken ±3 m away from damage, and the damage is more extensive (complete closure of the Xcut).

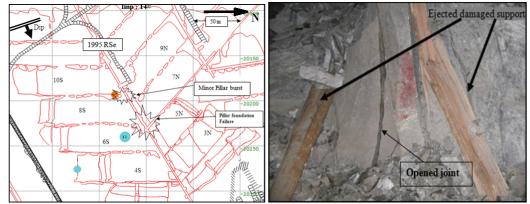
Rockburst damage resulted from a seismic event with  $M_L = 1.2$  on 22/12/2006 at 03h24 at No.14 Shaft 1995 South area, hence forth referred to as EventID8762 (**Figure 14**). It caused footwall uplift between the 5N and 6S pillars (right side of **Figure 14**).

**Figure 14. Locations of seismic events and associated damage.** On the right, viewing south towards the entry of panel 6S, footwall damage observed on the pillar at the entry to panel 6S. 3-Sticks cluster pack pushed out by fragmented and jointed rocks from the pillar footwall. Open joints on the pillar footwall.
