CHAMBER OF MINES OF SOUTH AFRICA
RESEARCH ORGANIZATION

CAUSES OF FALLS OF HANGINGWALL OVER GULLIES ADJACENT
TO STABILIZING STRIKE PILLARS

P.A. TURNER

RESEARCH REPORT NO. 37/87 (Amended)
PROJECT NO. GR2P
AUGUST 1987

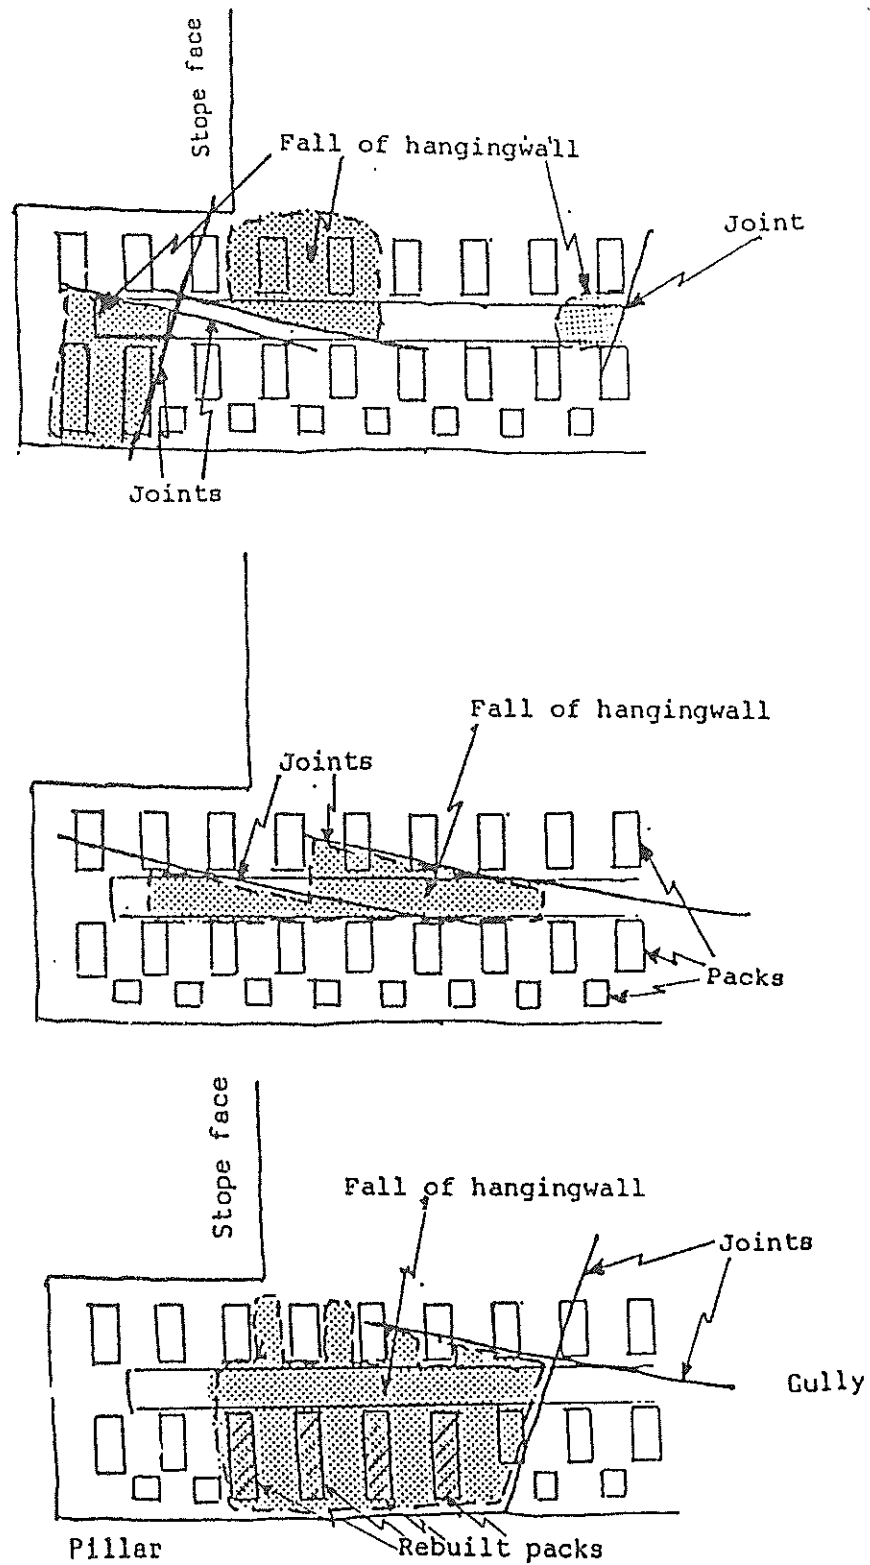
The smaller falls had usually fallen out to a height of a metre or less above the initial hangingwall. Larger falls had commonly fallen out to the base of the Green Bar (1,5 to 2 m up). Occasionally the falls extended up into or through the Green Bar (3,5 or 4 m up) to expose the hangingwall of Green Bar quartzite. Along a 40 m stretch of 104-38 W1 gully on Western Deep Levels, 100 per cent of the gully hangingwall had fallen to a height of between 2 and 4 m (Figure 4) and from 2 to 4 m up-dip of the gully down to the pillar abutment.

Figure 3 COMMON FALL OF GROUND GEOMETRIES AND DISTRIBUTIONS, WITH RESPECT TO GULLIES AND WIDE HEADINGS ADJACENT TO STABILIZING PILLARS

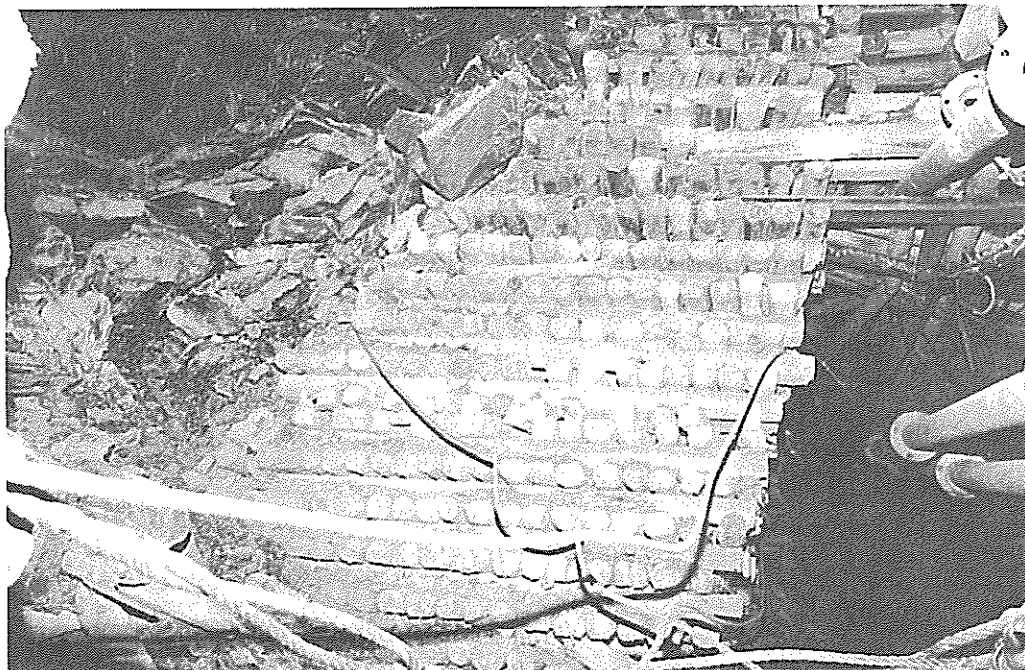
Figure 4 PART OF THE 40 m LONG FALL OF HANGINGWALL ALONG THE 104-38 W1 GULLY ON WESTERN DEEP LEVELS

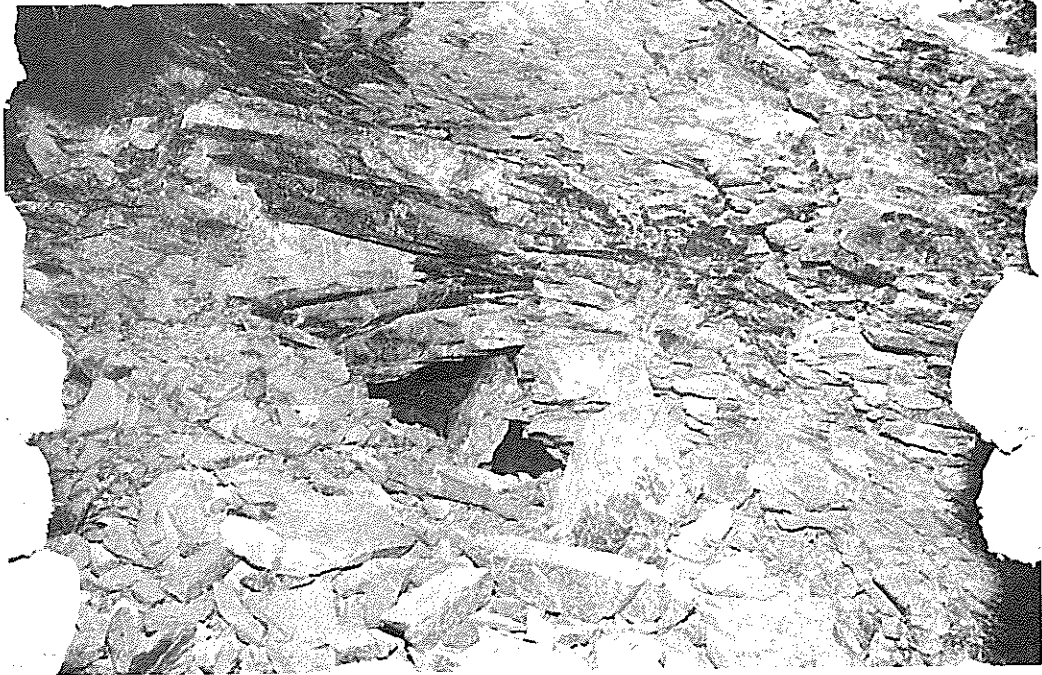
Figure 5 PART OF A MAJOR FAIL DUE TO A ROCKBURST AFFECTING THE HANGINGWALL OF THE 1024 - 58 W1 GULLY ON WESTERN DEEP LEVELS

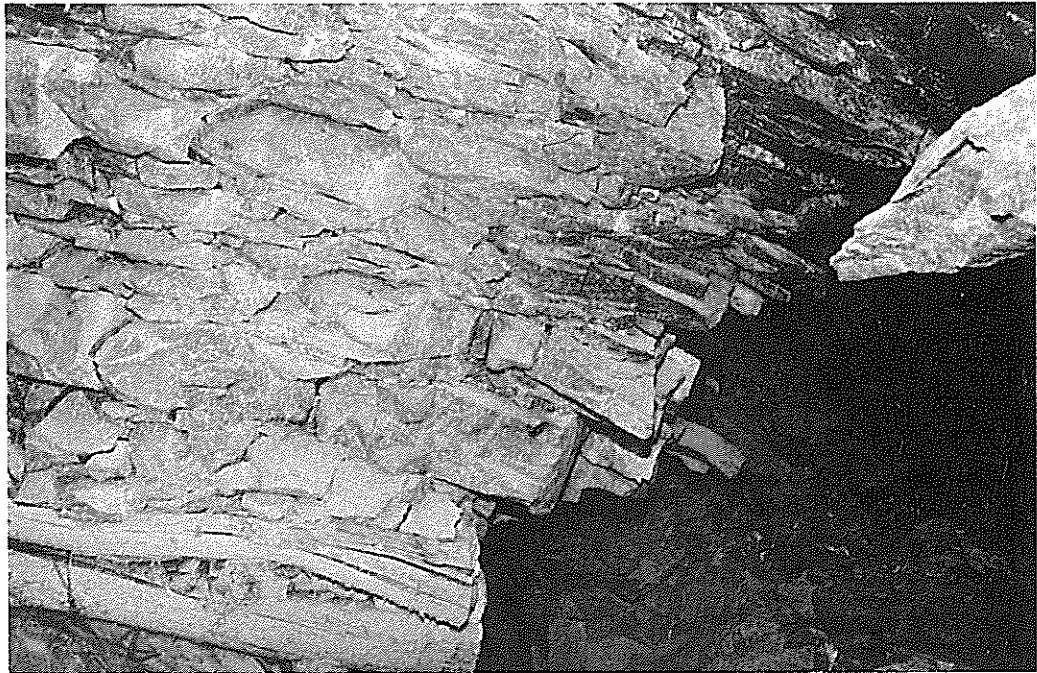
Figure 6 A VIEW SHOWING THE INCIDENCE OF HANGINGWALL-PARALLEL FRACTURING IN THE FAIL ILLUSTRATED IN FIGURE 5

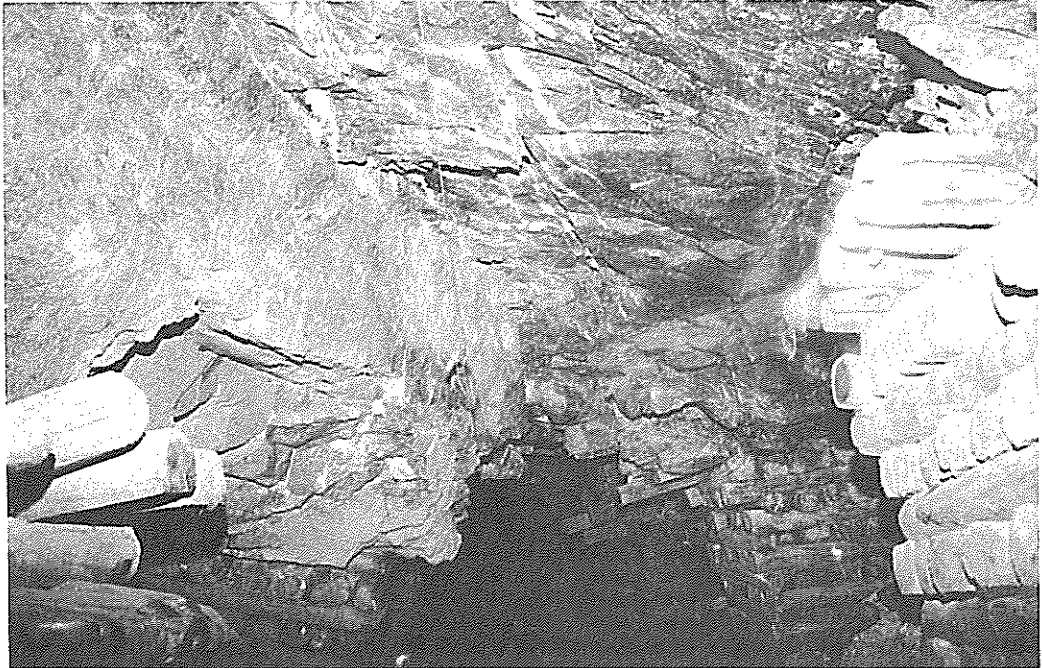
Figure 7 A MAJOR FALL, ATTRIBUTABLE TO THE PRESENCE OF NUMEROUS POORLY COHESIVE PARTINGS AND TO THE PRESENCE OF JOINTING
 The joint is to the left. The yellow parting surfaces can be seen on the hangingwall (11 W gully, B4 longwall, Blyvooruitzicht)

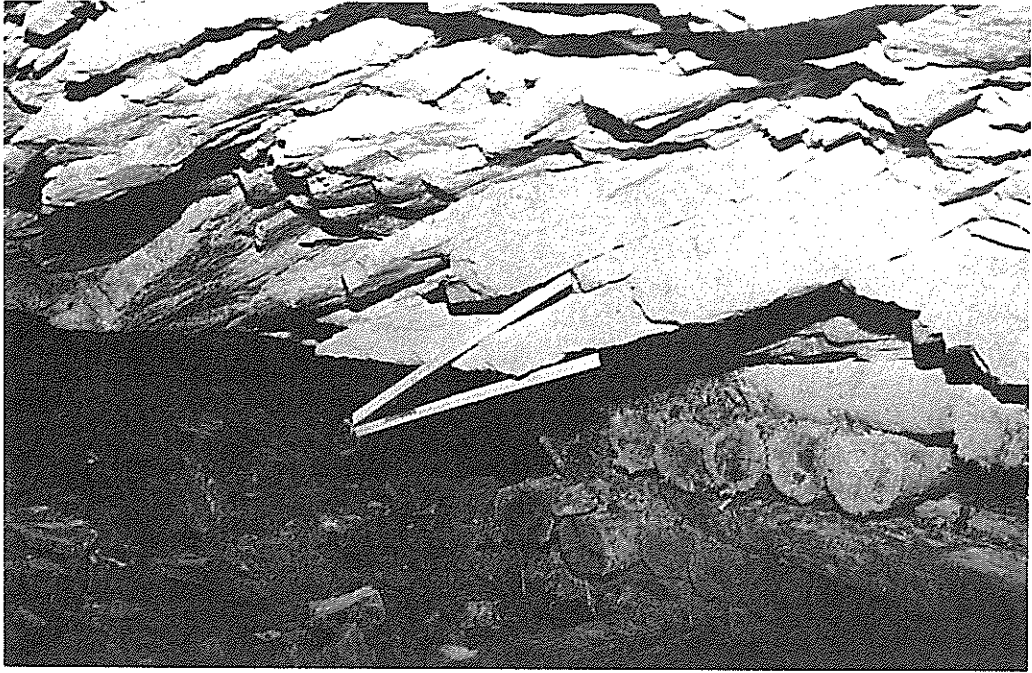
It can be seen from the geometry of these hangingwall-parallel fractures (Figure 8), and in particular the way that they arch shallowly over the 8 to 10 m wide heading, that they form over the headings. These headings are carried up to 10 m ahead of the stope face (Figure 9). The fractures, which are commonly 50 mm or less apart, are extension fractures and are inferred to be the result of stress almost parallel to the hangingwall. This stress is believed to be due to the combined effect of high vertical stresses on either side of the heading which, as a result of the Poisson's effect and dilatation, act together to result in sufficient stresses in the heading hangingwall to fracture the rock. Examination of the surfaces of these hangingwall-parallel fractures reveals that the stress which formed them was parallel to the face-parallel slabs as well as parallel to the hangingwall.

Figure 8 DOWNWARD-CURVING, HANGINGWALL-PARALLEL FRACTURES ON THE NORTH SIDE OF A WIDE ADVANCE HEADING
Base of rule is horizontal and the stope dips to the right.

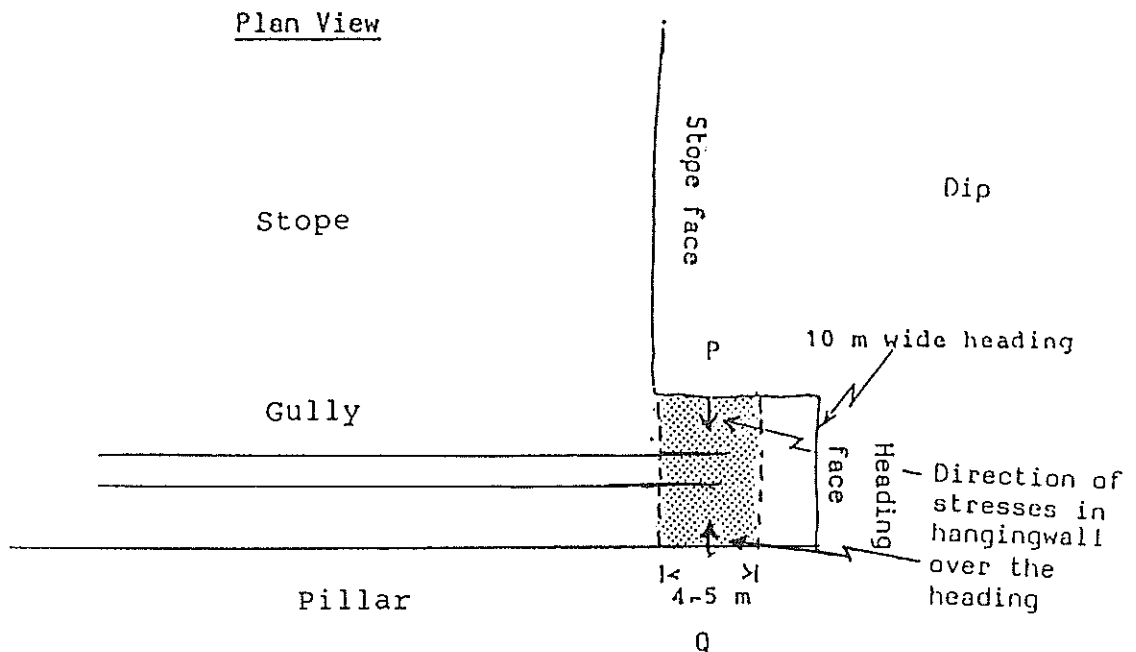
Figure 9 REGION IN WHICH HANGINGWALL-PARALLEL FRACTURES HAVE BEEN SEEN TO DEVELOP MOST ABUNDANTLY
High vertical stresses at P and Q result in stresses acting toward each other over the heading.

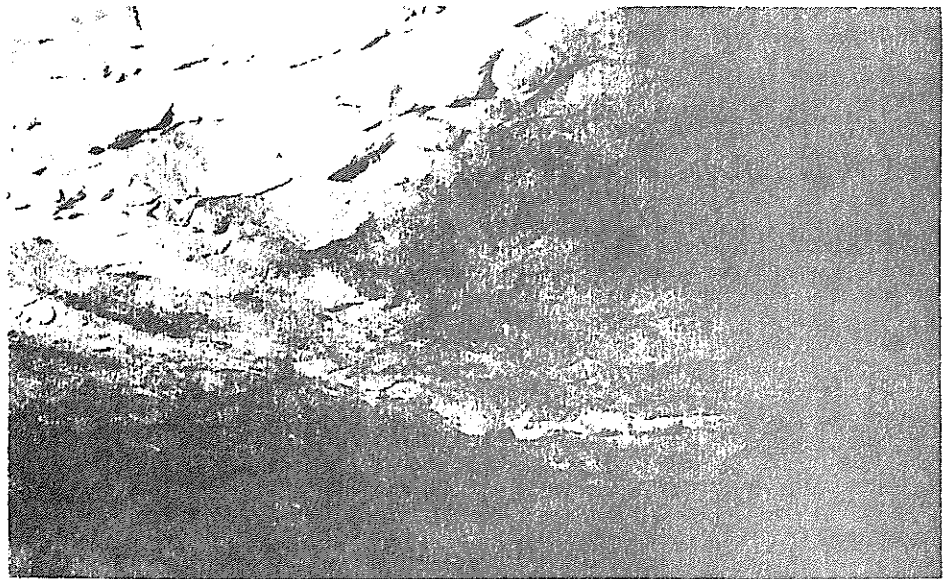
The hangingwall along all three gullies exhibited well developed cross-bed partings dipping across the gullies in a down-dip direction (Figure 10). It is inferred that in the presence of several of these surfaces, which are inclined at a low angle to the hangingwall, slip on the argillaceous cross-bed surfaces would relieve the hangingwall-parallel stress component. This

Figure 10 VIEW ALONG A STRIKE GULLY ON ERPM SHOWING THE ABUNDANT CROSS-BEDDING DIPPING ACROSS THE GULLY
This cross-bedding will prevent hangingwall-parallel fracture.

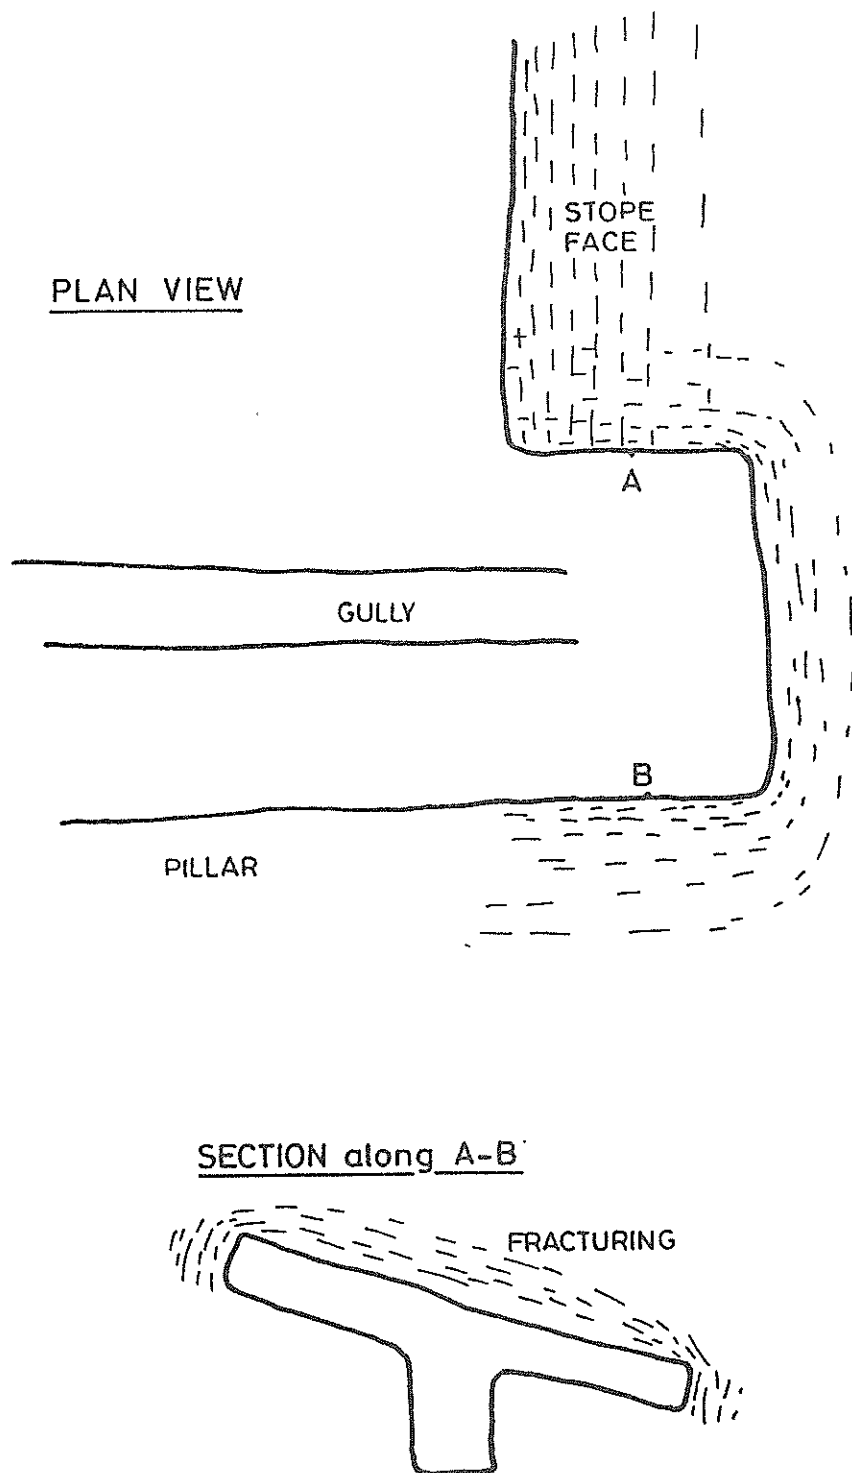
The development of intense hangingwall-parallel fractures has been found to be related to the presence of a wide advance heading (Figure 12) and so the obvious approach to reducing such fracture development lies in modifying the stope geometry to dispense with these wide headings.

Figure 12 THE LAYOUT AND RESULTING FRACTURE PATTERN FOR MINING WITH A 10 m WIDE ADVANCED HEADING, 5-10 m AHEAD OF THE FACE

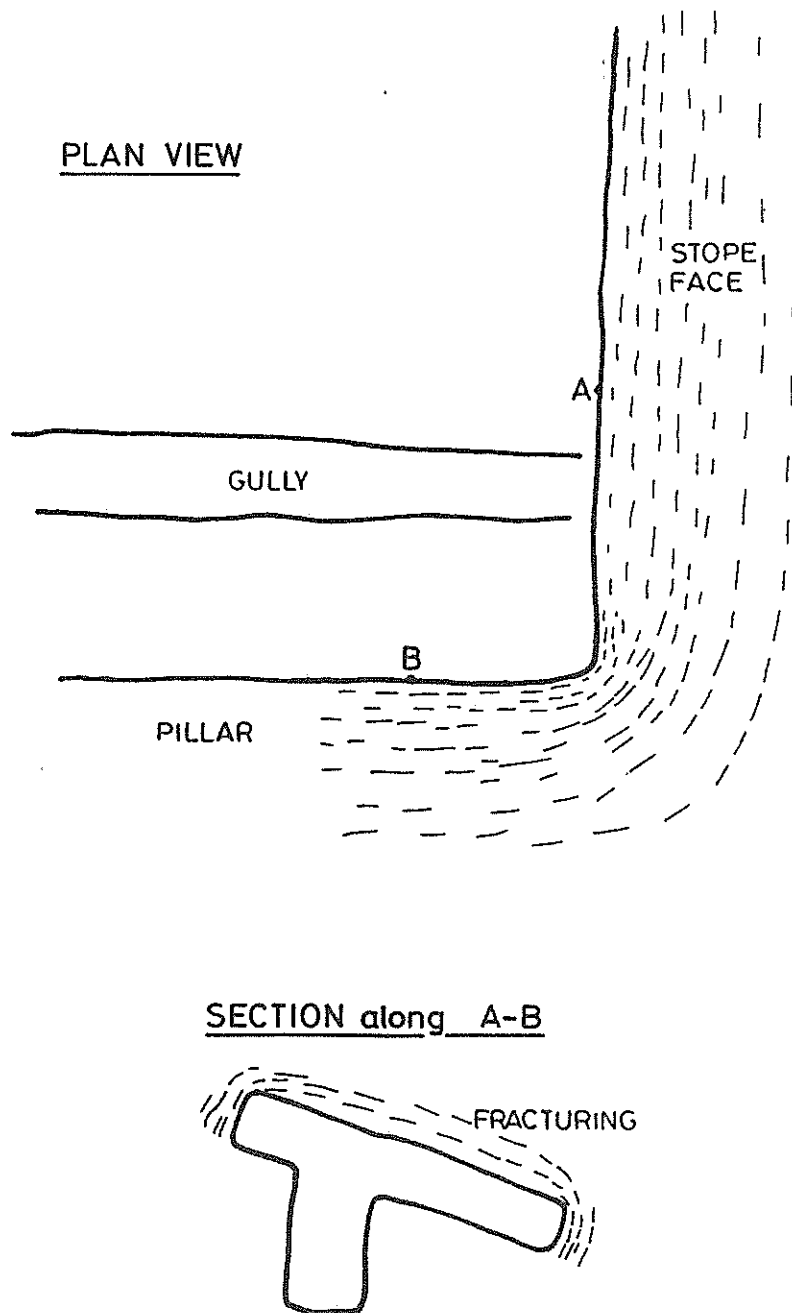
This mining geometry (Figure 13) would create cleaning problems due to the lack of over-run for the scraper. An alternative scraper system might overcome the problem but would require technical development. Moreover, as a probable result of stress across the corner of the stope (A-B) some shallowly arched, hangingwall-parallel fractures also occur with this geometry. These were seen at the top of the 107-47 mini-longwall in the 107-47 E3 escape gully at Western Deep Levels, where several falls had occurred. Being at the top of a mini-longwall, this gully did not have an advance heading and therefore had a geometry analogous to that in Figure 13.

Figure 13 THE LAYOUT FOR MINING WITH NO ADVANCED GULLY HEADING AND THE RESULTANT FRACTURE PATTERN

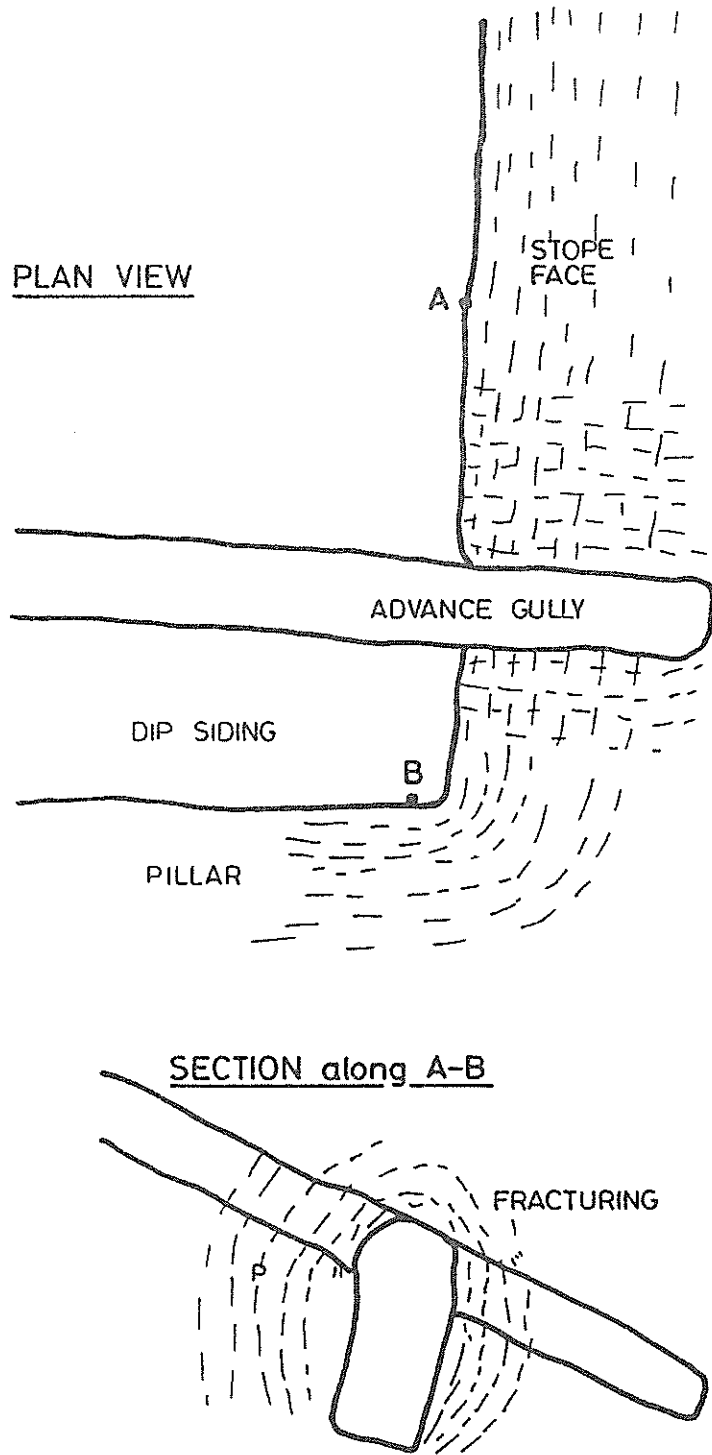
This technique (Figure 14) has been tested fairly successfully in the 104/38 W1 gully at Western Deep Levels. A down-dip siding was carried level with the stope face. The fracture pattern was modified as shown (Figures 14 and 15) and the minor falls that did occur fell to a stable arch only slightly wider than the gully (Figure 15). (In Figure 15, the clinorule is horizontal and the dip is to the right.) As a result of the height of the excavation at the gully face, it was possible to drill holes steeply into the relatively unfractured rock at the face and grout in shepherds-crook bars. This further stabilized the hangingwall. Stope-face-parallel fracture could be seen in the gully up to five or six metres ahead of the face, and it is probable that the rock within this distance of the face had been partially de-stressed. However it is advisable to keep the length of gully ahead of the face as short as possible.

Figure 14 THE LAYOUT USED IN 104/38 W1 CARRYING ONLY THE GULLY AHEAD OF THE FACE AS AN ADVANCED HEADING AND THE RESULTANT FRACTURE PATTERN

- (i) several gully headings adjacent to stabilizing pillars should be modified along the lines described above and illustrated in Figures 14 and 16, to confirm the influence of gully-width headings in reducing hangingwall-parallel fracture development; these gullies should not protrude more than is necessary (3 m) ahead of the stope face.

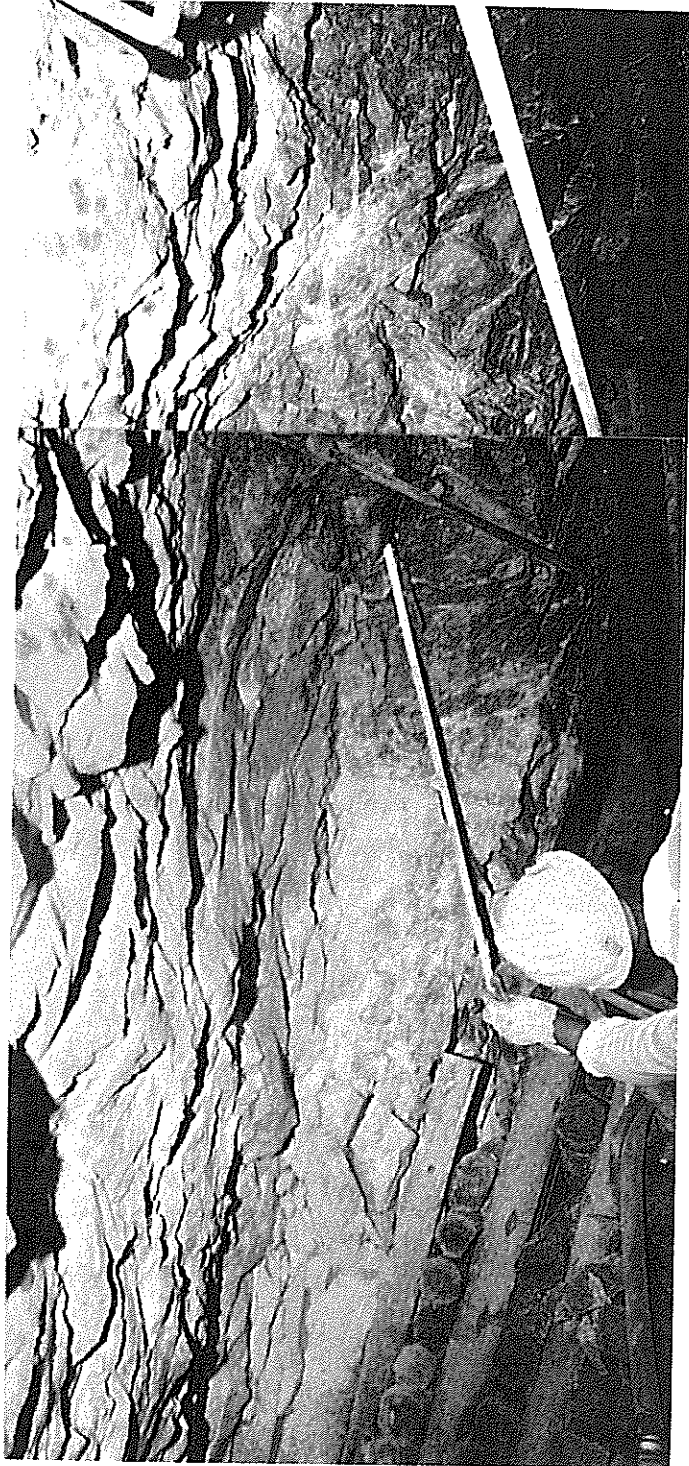
Figure 15 THE STABLE ARCH REMAINING AFTER A MINOR FALL OVER A GULLY
MINED AS AN ADVANCED HEADING (104/38 W1 gully on Western
Deep Levels)
Clinorule is horizontal and dip is to the right.

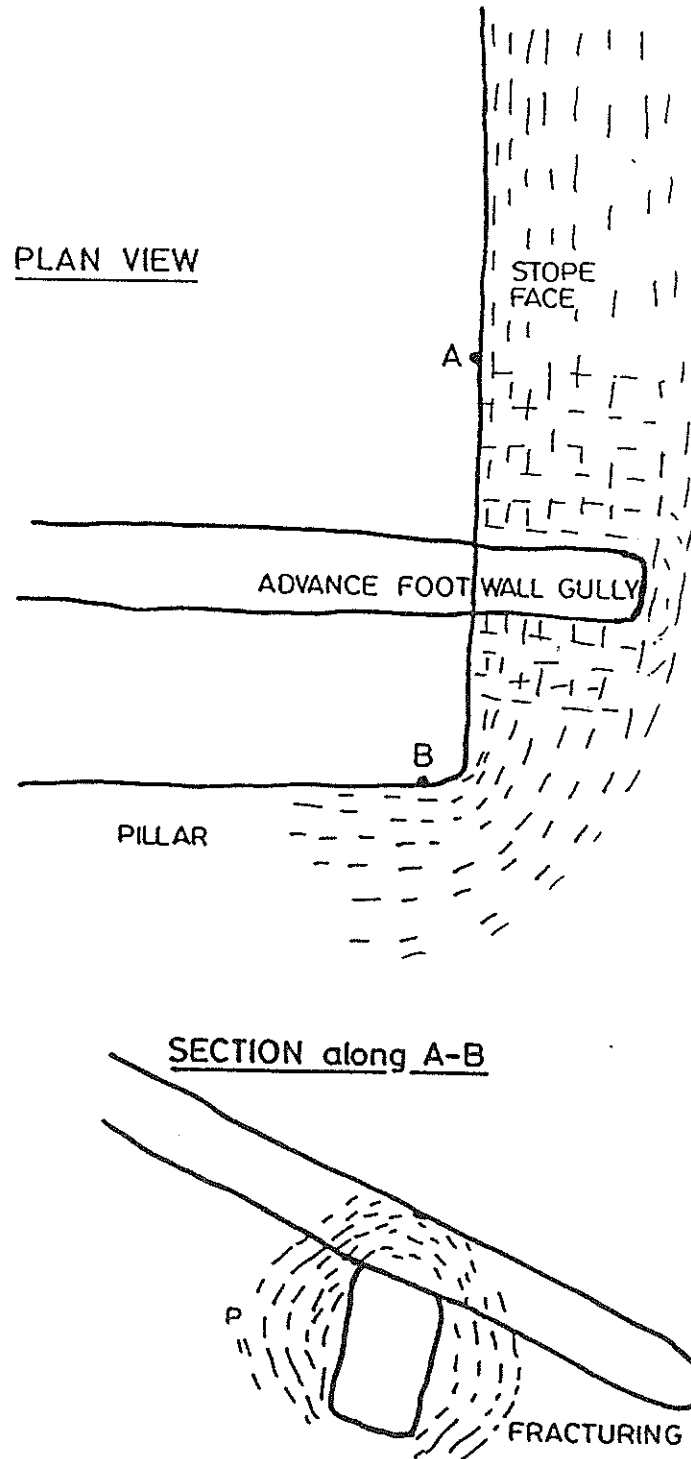
By carrying the advance gully development with its hangingwall level with the footwall of the stope (Figure 16), the inflection (point P) of the gully-parallel fracturing could possibly be moved down sufficiently to stabilize the gully sidewall. This would have the added advantage that much of the arch of fractured gully hangingwall would be within the stope and would therefore be mined out.

Figure 16 THE LIKELY FRACTURING AROUND A GULLY-WIDTH ADVANCE HEADING DEVELOPED IN THE FOOTWALL OF THE STOPE

- (ii) at least one of these gullies should be mined with the advanced gully development beneath the plane of the stope, as shown in Figure 16;
- (iii) if possible, in both the full height advance-gully stope and the footwall-height advance-gully stope, a four or five metre long dip gully should be developed. This dip gully should be excavated up-dip, behind the swept area of the stope, to expose the footwall fracture-geometry and thus enable the likely stability of the footwall beneath up-dip gully-side packs to be assessed;

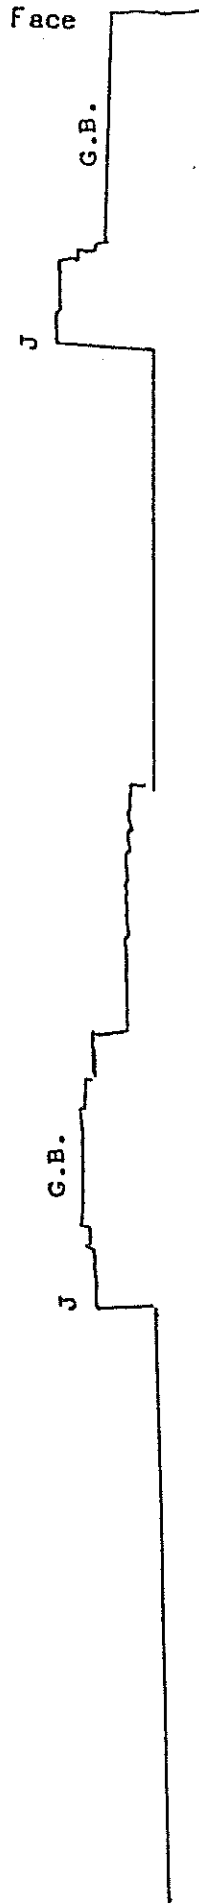
106/47 E1 gully, Western Deep Levels

Figure II.1 PROFILE ALONG 106/47 E1 GULLY, WESTERN DEEP LEVELS

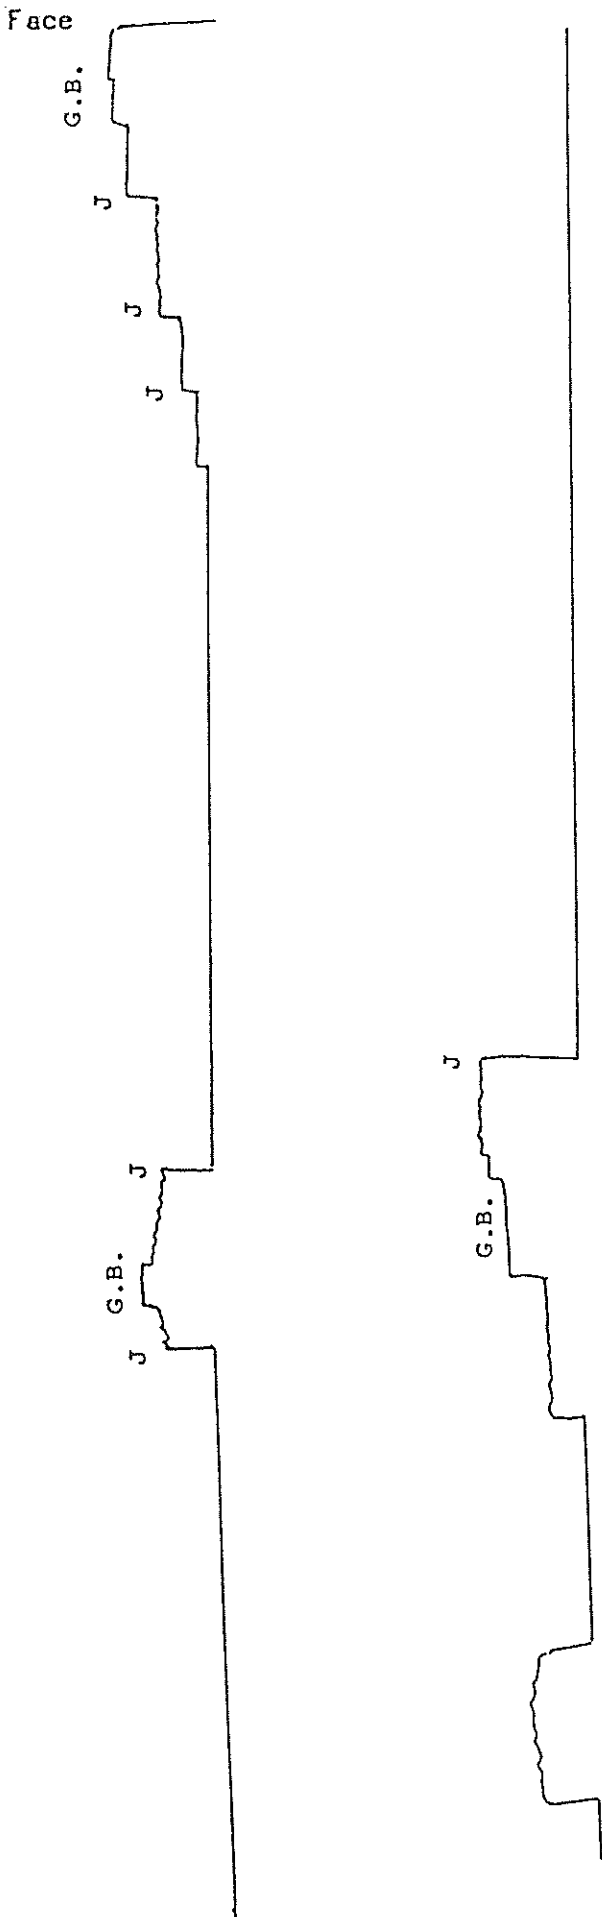
107/47 E1 gully, Western Deep Levels

Figure II.2 PROFILE ALONG 107/47 E1 GULLY, WESTERN DEEP LEVELS

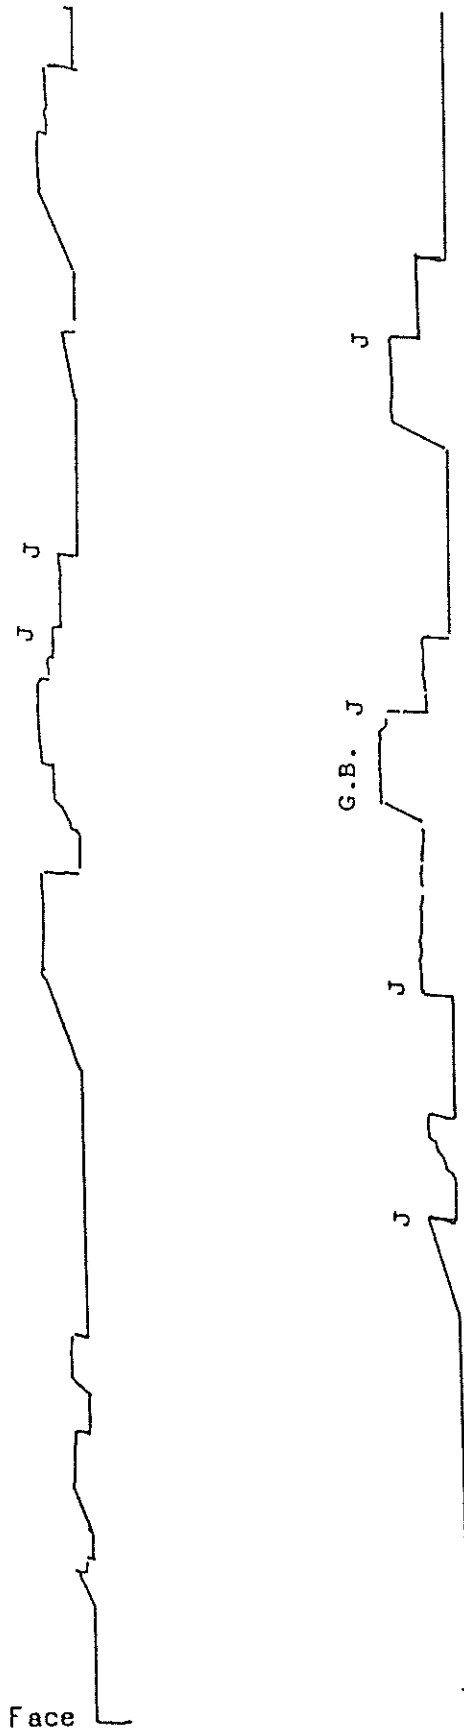
28 W gully, B4 L.W., Blyvooruitzicht

Figure II.3 PROFILE ALONG 28 W GULLY, B4 LW. BLYVOORUITZICHT
