1
2 **USE OF GRID REINFORCEMENT IN HMA OVERLAYS -**
3 **A TEXAS FIELD CASE STUDY OF HIGHWAY US 59 IN ATLANTA DISTRICT**
4

10 **Abstract:** One of the common methods to mitigate reflective cracking, in existing cracked pavements, is
11 the use of interlayer grid reinforcements in hot-mix asphalt (HMA) overlay construction during
12 maintenance and/or rehabilitation projects. As a means of sharing the practical experience, lessons learned,
13 and demonstrating the performance benefits of using interlayer grid-reinforcements, this paper presents a
14 field case study where different types of grid reinforcements (namely geosynthetic paving mats) were used
15 in HMA overlay construction to mitigate reflective cracking and thereafter, field performance was
16 monitored and evaluated periodically. Two HMA overlay test sections (denoted as Sec13 and Sec14),
17 reinforced with different geosynthetic materials were constructed in 2011 over an existing cracked HMA
18 pavement (with transverse cracks) on an in-service highway US 59 in the Atlanta District of Texas. Field

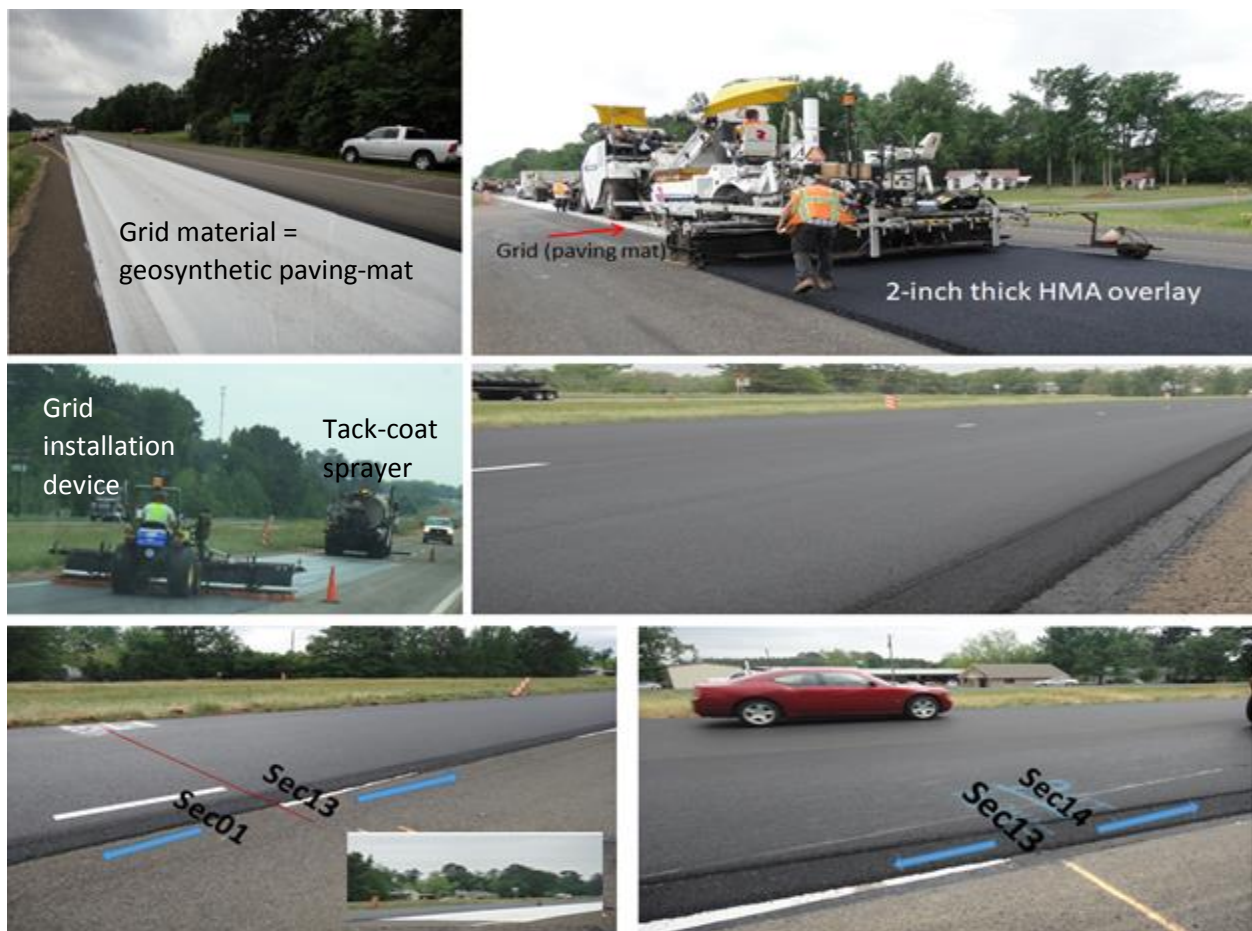
15
 16 **Fig. 4. Geosynthetic Installation and HMA Overlay Construction.**

7
 8 As shown in Fig. 4, the construction process comprised of tack-coat application, geosynthetic installation
 9 (in the case of test sections Sec13 and Sec14), HMA overlay placement, and compaction thereafter, which
 10 was monitored, recorded, and documented for cataloguing in the DSS [9]. The HMA overlay mix is a
 11 standard Texas 12.5-mm nominal maximum aggregate size (NMAS) fine-graded Type D surfacing mix
 12 comprising of 5.1% PG 64-22 asphalt-binder with quartzite aggregates and 20.1% recycled asphalt
 13 pavement (RAP) material – compacted to a 2-inch thickness at a target density of 97%.
 14

17
 18 The construction operation, in a line-sequence, comprised of a tack-coat sprayer (0.085 gal/sy PG 64-22
 19 application rate), a grid installation equipment, dump trucks, material transfer device (Roadtec), a paver,
 20 and compactors. The compaction pattern comprised of 4 to 6 vibratory passes (2 rollers, 12.15 ton each)
 21 with a 200 lb joint roller. As catalogued in the DSS, QA/QC testing during and just after construction
 22 included the following: material sampling, temperatures, infrared thermal imaging (mat temperature),
 23 density (nuclear density gauge), compaction thickness and density (GPR), field coring for density
 24 measurements and extraction tests (asphalt-binder and aggregates), smoothness (surface profiles), and

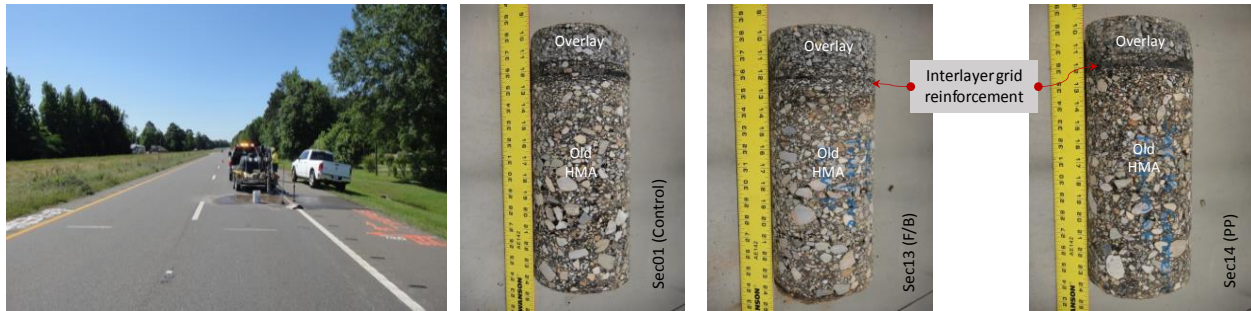
8
 9 **Fig. 10. Intact and Fully Bonded Cores.**

1 Field cores were extracted from both the inside and outside wheel paths after over 5 years of service life.
 2 As evident in Fig. 10, it was visually observed that all Control and grid-reinforced cores were intact and
 3 fully bonded at the layer interface. In the laboratory, the measured interlayer shear-bond strengths,
 4 conducted in the shear-bond test at room temperature under a monotonic shear loading rate of 0.2 in/min
 5 [15], for all the cores (both Control and grid-reinforced) were all well above 100 psi, averaging 115 psi.
 6 The measured interlayer shear-bond strengths were 117 psi (Sec01), 113 psi (Sec13), and 115 psi (Sec14).
 7

10
 11 Assuming a tentative threshold of 40 psi as proposed by Wilson et al., the measured shear-bond bond
 12 strength values (averaging 115 psi) are satisfactory [15,17]. However, even if a tighter threshold value of
 13 100 psi, as proposed by Johnson et al. and Mohammad et al., was considered, all the cores would still pass
 14 [18,20]. Furthermore, the measured core shear-bond strength values are indifferent to the reviewed
 15 literature range of 15 psi to 217 psi, mostly for un-reinforced HMA [15-29]. Overall, these visual core
 16 observations (Fig. 10) and shear-bond strength results suggest that with good construction practices and
 17 QA/QC monitoring/testing, there is hardly any adverse effect on the interlayer bond strength due to grid
 18 reinforcement.

13
14 As previously shown in Fig. 10, cores extracted from both the Control and grid-reinforced test sections
15 were all in an intact condition. The laboratory measured interlay shear-bond strength on the cores averaged
16 over 100 psi, well above the 40 psi tentative threshold criterion and satisfactorily comparable to the
17 reviewed literature range of 15-217 psi [15-29]. Overall, these findings suggest that with good construction
18 practices and stringent QA/QC protocols, an equivalent level of interlayer bonding similar to traditional
19 un-reinforced HMA is attainable with grid-reinforced HMA overlays – as is the case with the grid materials
20 used in this study.

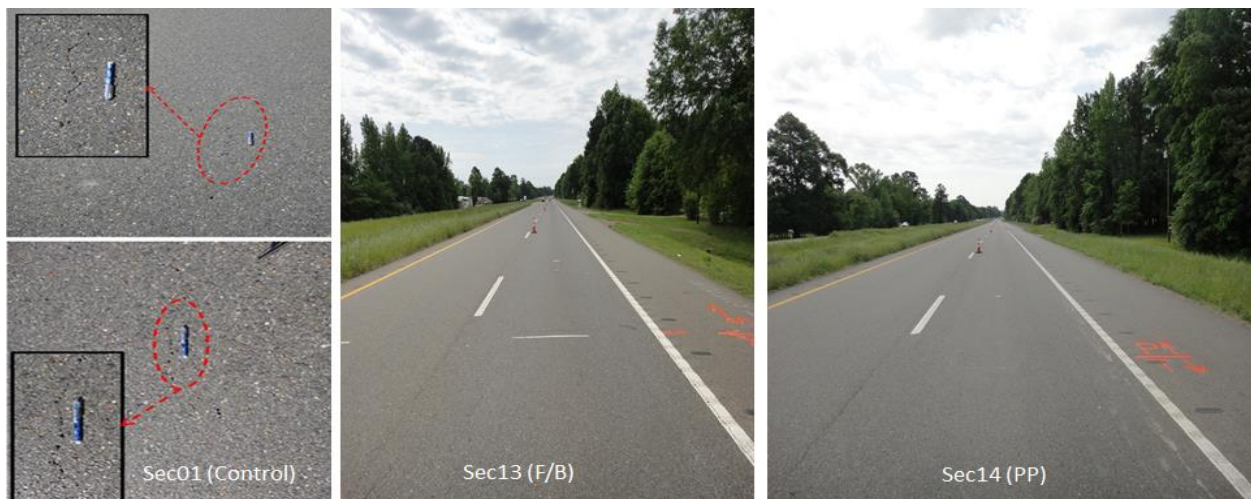
26
 27 **Fig. 11. Pictorial Surface View of the US 59 Test Sections.**

21
 22 The pictures in Fig. 11 visually shows surface cracking on Sec01 (Control) with little to none on the
 23 grid-reinforced test sections as of April 25, 2018. This is in agreement with Fig. 7 that showed 17% cracking
 24 for Sec01 and 4% on Sec13 and Sec14.
 25

28 As seen in Fig. 11, no other defects are visible on the test sections except for the cracking on Sec01. From
 29 both coring (Fig. 10) and GPR measurements, no subsurface or forensic defects such as moisture intrusion
