Coastal Engineering 53 (2006) 1045-1058

Shoreline accretion and sand transport at groynes inside the Port of Richards Bay

J.S. Schoonees ^{a,*}, A.K. Theron ^b, D. Bevis ^c

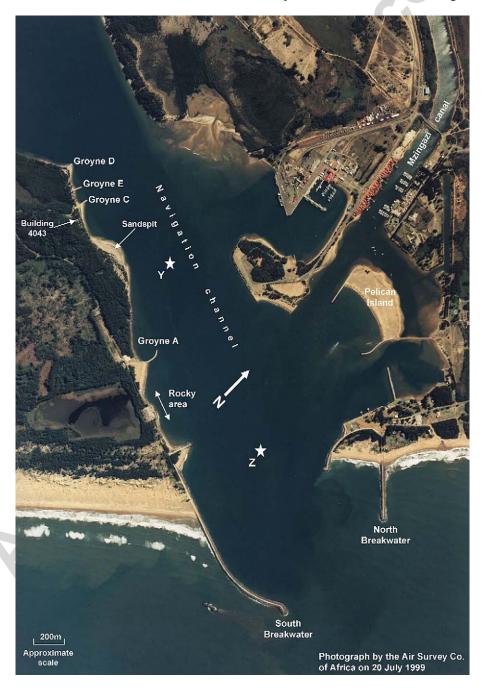
Fig. 1. Locality map.

The Port of Richards Bay (Fig. 1), situated on the east coast of South Africa, was constructed mainly as a coal export harbour and was opened for shipping in 1978 by the National Ports Authority of South Africa (NPA). The south-western shoreline along the navigation (or entrance) channel inside the Port of Richards Bay (Fig. 1) has experienced continued erosion. This erosion endangered the road leading to the south breakwater, as well as Building 4043 (Fig. 1). Coastal processes were studied to determine the causes of the erosion and different solutions were investigated to protect this shoreline against the erosion (CSIR, 1997; Schoonees et al., 1999).

Four groynes (Fig. 1) were constructed to stabilise the shoreline along the navigation channel (Schoonees et al., 1999). These groynes successfully withstood a major storm without suffering significant damage. Sand trapped by the groynes provided sufficient protection and has continued to halt localised erosion. The shoreline evolution in the vicinity of the groynes has been monitored on an ongoing basis, providing valuable data on the accretion adjacent to the groynes, the orientation of the shoreline, and the rate of accretion. At the same time, the environmental conditions at the site are well-known. This case study therefore provides valuable information on the shoreline accretion and longshore sediment transport at both a "protected" and a "moderately protected" site.

Swell heights and periods were derived at two positions (Points Y and Z; Fig. 1) along the centreline of the navigation channel. Results from previous physical model studies (CSIR, 1990) were used. Exceedance curves were plotted for Points Y and Z. These curves were then used to predict the swell wave heights in the study area (Table 1).

Fig. 1 shows the locations of the four existing groynes, namely: Groyne A (the L groyne), Groyne C (near Building 4043), Groyne D at Spinach Point and Groyne E between Groynes C and D. (Groyne B, planned to be between Groynes A

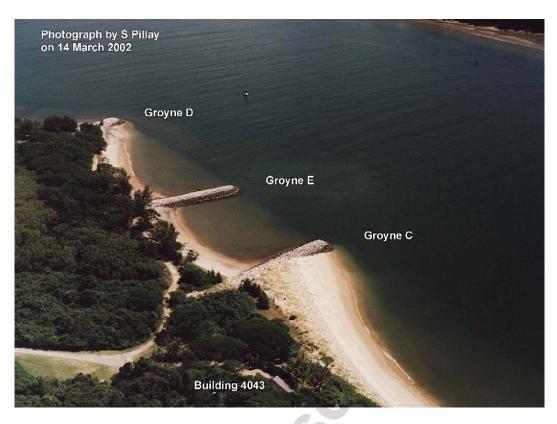
Fig. 9. Equilibrium shoreline at Groyne C.

surf zone width is typically less than 5 m because of the small waves (for example, see Figs. 9 and 10). Observations during site visits confirmed this result. In Fig. 1, the surf zone is very

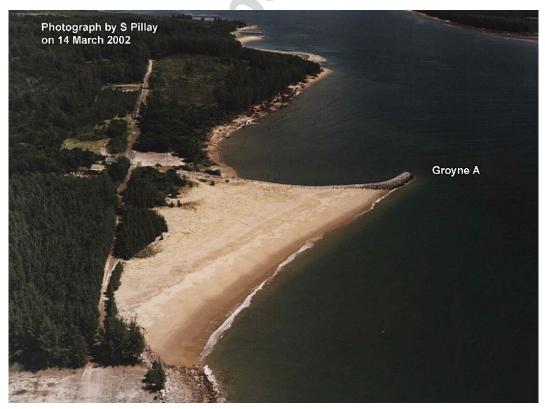
Fig. 10. Equilibrium shoreline at Groyne A.
