APPLICATION OF DRONES AND IMAGE PROCESSING FOR BRIDGE INSPECTIONS IN SOUTH AFRICA

L KEMP, MP ROUX*, M KEMP AND R KOCK*****

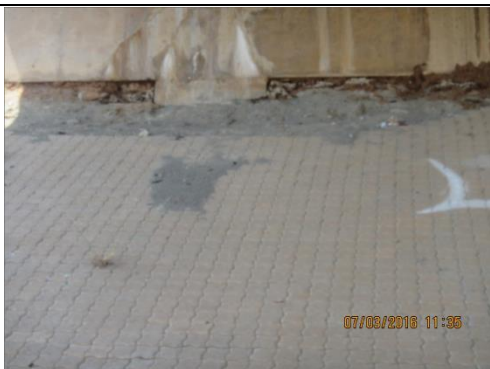
Interlocking blocks missing

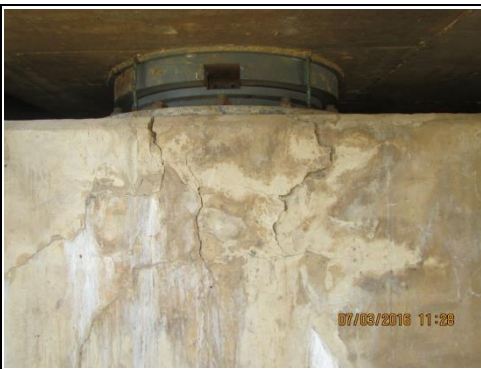
The defects recorded for the two bridges during the 2016 inspection are shown in Table 4-22. The railway bridge is in a fair condition, mainly as a result of the abutment seating cracks.

Abutment seating cracks

Illumination underneath the bridge was limited and the images captured were too dark to identify the abutment-seating crack below the bearing. It appears as if herbicide has been applied to the abutment protection works since 2016, as only slight vegetation growth is visible.

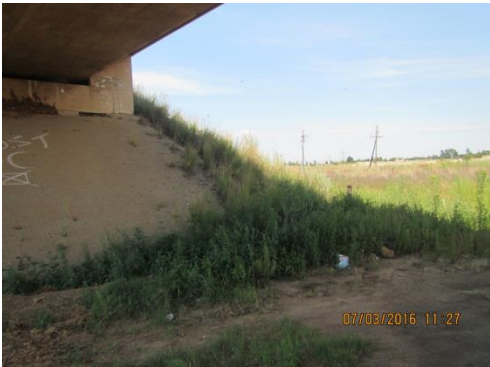
Vegetation growing through the interlocking paving on the abutment
