MONITORING FOR CRACKS IN METAL L-PBF USING GAS-BORNE ACOUSTIC EMISSION

Presented at the 24th Annual International Conference of the Rapid Product Development Association of South Africa (RAPDASA) Institute for Industrial Engineering, held from 30 October to 2 November 2023 in Pretoria, South Africa

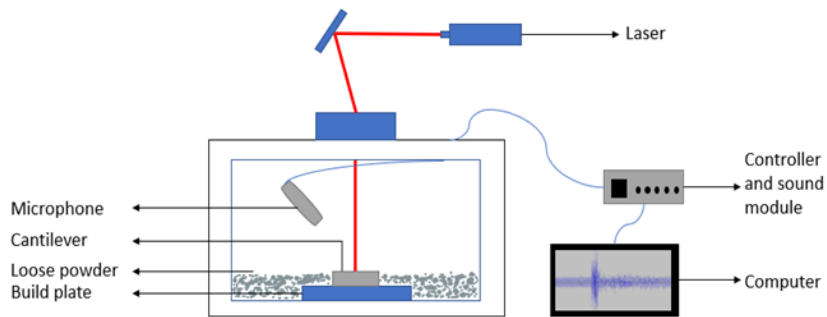
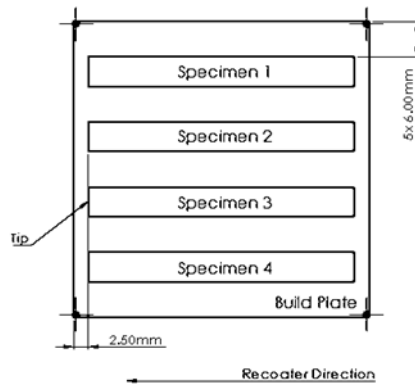
Figure 1 Schematic of experimental setup (a), cantilever design (b), and location of cantilevers on the build plate (c).

The experiments were carried out using the EOSINT M280 L-PBF machine with pre-assigned EOS Ti6Al4V extra low interstitial (ELI) powder process parameters and a layer thickness of 30 μm . A model 378B02 ICP microphone with an optimal frequency range of 3.75 - 20 000 Hz ($\pm 2\text{dB}$) was placed 240 mm above the substrate in the building chamber, directed at the centre of the build plate (Figure 1a). A NI9250 DAQ soundcard and LabVIEW 2022 software were used to record and analyse the gas-borne AE signals during the build process of the cantilevers that were designed to fail *in situ* [10] (Figure 1b). The cantilevers were built on a reduced grade 5 Ti build plate with dimensions of length and width 50 x 50 mm. A sampling frequency of 102.4 kHz was used to acquire AE data, as this frequency was indicated to be in accordance with the Nyquist criterion [5]. To test the capabilities of the AE equipment to detect cracking during the build process, four cantilevers were placed at the centre of the build plate, as shown in Figure 1c. The expected failure tip (Figure 1b) of the cantilever specimen was placed facing opposite the recoater arm direction to avoid damage to the recoater when the specimen failed with the build plate. The entire construction process was recorded until all four specimens had failed with the construction plate, which was indicated by the dispersion of the powder at the tip of the specimen; this failure height was then noted. The cool-down process of the cantilever specimen was also recorded after the build process had stopped. Only two cracks per cantilever specimen were considered: the crack that had occurred during the construction stages of the cantilever when the laser was scanning and the recirculating fan was operating, and the crack that had occurred when the construction process had been stopped, in the cool-down phase of the cantilevers when the laser was not scanning and the recirculating fan was not operating.

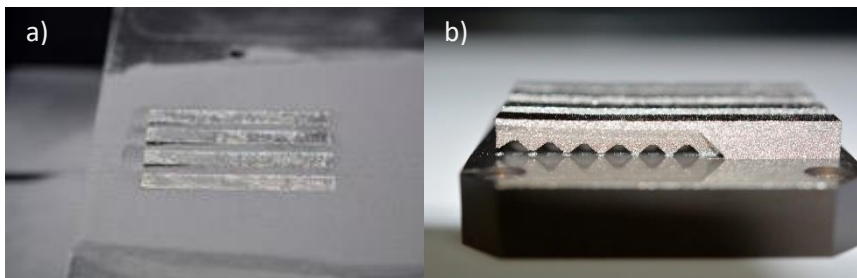
Figure 2 Dispersed powder after cantilever failure (a), view of cantilever after deflection (b)

The failure of the cantilever(s) with the build plate was observed by the powder being dispersed owing to the progression of the cracks that were caused by the residual stresses induced during the build process (Figure 2). The cantilevers were seen to fail twice with the build plate: once during the build process, and again when the build had been stopped in the cool-down phase of the cantilevers.

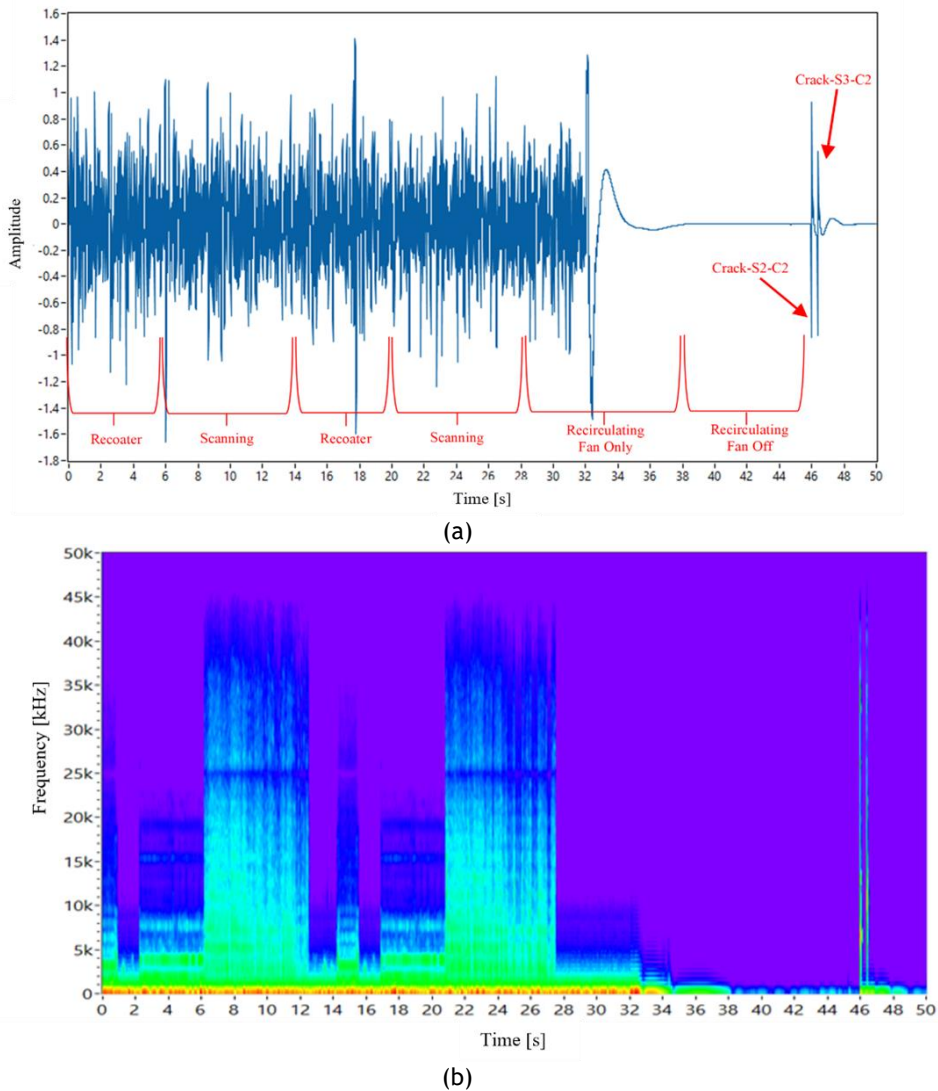
Figure 3 Amplitude-time graph (a) and frequency-time graph (b) of the recorded AE signal

The segment extracted for the last two layers of the AE signal in the time domain is shown in Figure 3a. The corresponding STFT can be seen in Figure 3b. In the signal, the recoater arm movement, the laser scanning, the recirculating fan running, and the two cracks that occurred when the recirculating fan was off because the build process was stopped are shown and labelled. Looking at the amplitudes of the signal in the time domain, the machine-related noise such as the laser scanning, the recoater arm movement, and the recirculating fan running was seen to be difficult to identify and differentiate. The only noticeable AE signals in this domain were those of the recirculating fan turning off and the cantilever cracks of crack-S2-C2 and crack-S3-C2. The aforementioned cracks occurred when the laser was not scanning in the cool-

When looking at the STFT of the extracted segment of the AE signals in Figure 3b, the duration and frequency content of the recoater arm movement, the laser scanning, the recirculating fan on/off, and the two cracks can be clearly seen and differentiated from one another in detail. The second last layer can be seen being initiated by the recoater arm movement, with frequencies ranging up to 35 kHz lasting for a period of six seconds, followed by the laser scanning with slightly higher frequencies ranging up to 45kHz, and the process repeated for the last layer. The recirculating fan could be seen to be constant throughout the entire build process until it switched off at about 33 seconds. Towards the end of the extracted segment of the signal at about 46 s, the two cracks could be seen to have frequencies ranging up to 47 kHz.

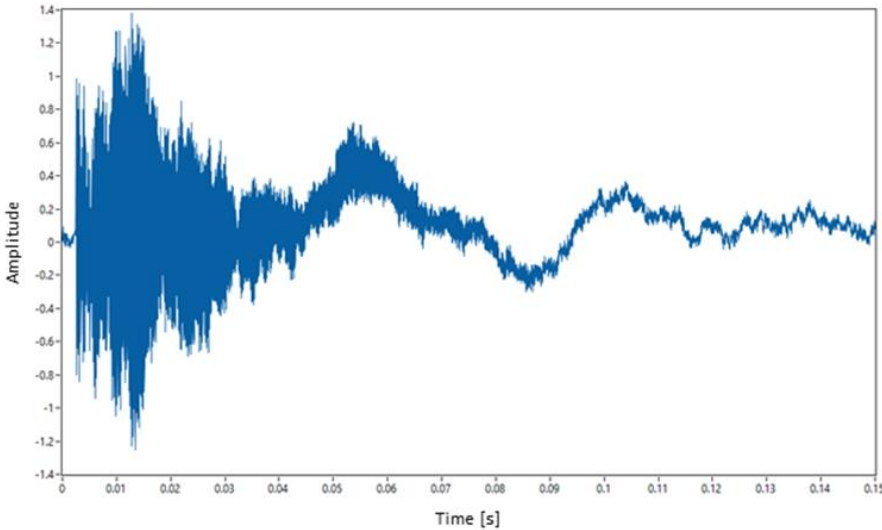
(a)

Figure 4 Unfiltered time-domain signal for crack with laser scanning (a), and signal from crack without laser scanning (b)

Using the STFT of the AE signal to categorise and differentiate the signals in the time domain, two cracks are shown below where crack-S2-C1 in Figure 4a occurred when the laser was scanning and the recirculating fan was running, and crack-S2-C2 in Figure 4b occurred when the laser was not scanning and the recirculating fan was off. Since the latter crack occurred when the build process had stopped and there was no machine noise, the duration of this crack was used as the sampling window for FFT and STFT. Both AE crack signals in Figure 4 could be seen having similarities in the crack signal profile, containing a burst of the amplitude intensity initially that gradually decreases with time. The only difference could be seen

in the gradual decrease of the crack that occurred when the laser was scanning, possibly owing to the presence of the laser and recirculating fan noise. The peak amplitude of the crack in Figure 4a was also seen to be 1.38 (about 1.4), which was 0.5 greater than the amplitude intensity of the crack that occurred when the machine was not scanning. This could be a result of the reduction of residual stresses in the crack that occurred while the laser was not scanning, as it was observed to be the second crack to form on the same cantilever that caused failure with the baseplate. In both of the above cases, the crack signals could be detected and identified by using the time-domain features of the AE signal.

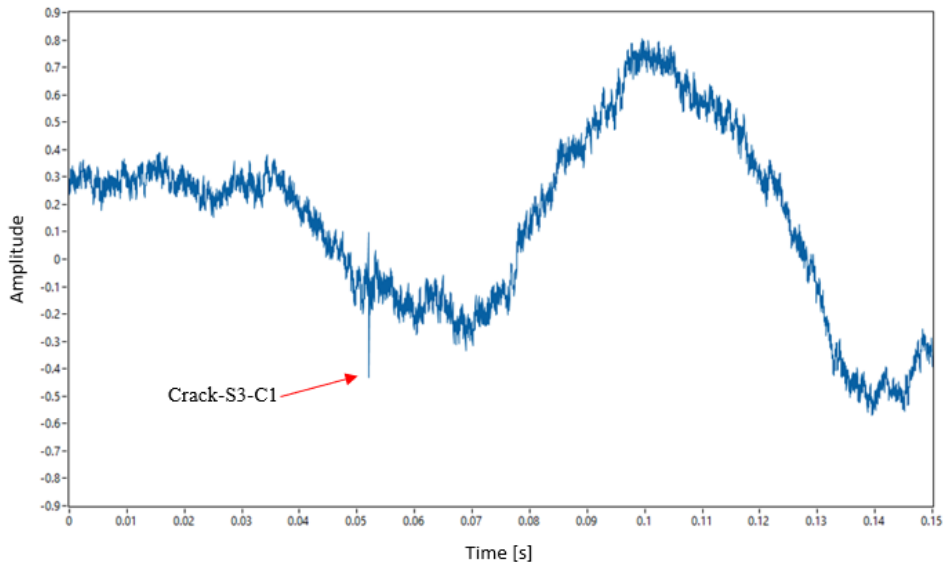
Figure 5 Time domain-AE signal of small crack with laser scanning

At about 0.052s in the time domain, the AE signal in Figure 5, a small spike in the amplitude could be observed. This spike in amplitude could be attributed to crack-S3-C1, which had occurred in the region while the laser was scanning and the recirculating fan was running. Unlike the crack signal that occurred previously in Figure 4a when the laser was scanning, these type of crack signals were difficult to detect in the time domain and even in the frequency-time domain because of the machine-related noise present in the signal.

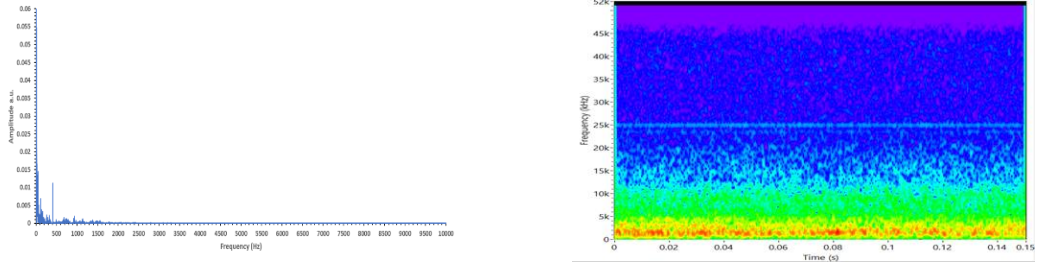
a) Recirculating fan

Figure 6 FFT (left) and filtered STFT (right) for recirculating fan (a), recoater movement (b), laser scanning (c), laser scanning with crack-S2-C1 (d), crack-S2-C2 without scanning (e)

In Figure 6 below, the FFT and STFT of various machine-related AE signals - (a) the recirculating fan, (b) the recoater arm movement, (b) the laser scanning and AE crack signals; (c) crack-S2-C1, which occurred when the laser was scanning and the recirculating fan was running, and (d) crack-S2-C2, which occurred when the laser was not scanning and the recirculating fan was off is shown. Analysing the frequency content of the recorded AE signal provided great insight into the occurrence of different events in the signal. Focusing only on the FFT of the machine-related noise in Figure 6a, Figure 6b, and Figure 6c, the recirculating fan was seen to have a frequency range below around 400 Hz, with the other noise in the signal being very low and not exceeding 2 kHz. The recoater arm movement had a frequency peak of about 1.9 kHz, with its possible harmonic at about 3.8 kHz, while the laser scanning frequencies ranged from 0-20kHz. In the aforementioned machine-related noise, the respective frequencies observed in the FFT could also be seen to be constant throughout the considered duration of the STFT. The other higher frequencies present in all these signals, namely (a) the recirculating fan, (b) the recoater movement, and (c) the laser scanning, could possibly be related to other machine or external noise that was not categorised in this paper, and that would require further investigation.
