Engineering Failure Analysis 8 (2001) 135–144

Pump shaft failures — a compendium of case studies

This paper presents a collection of pump shaft failures that have been encountered during the consulting activities at the University of the Witwatersrand and the Plant Infrastructure and Pipelines Centre at the Council for Scientific and Industrial Research (CSIR). © 2001 Published by Elsevier Science Ltd.

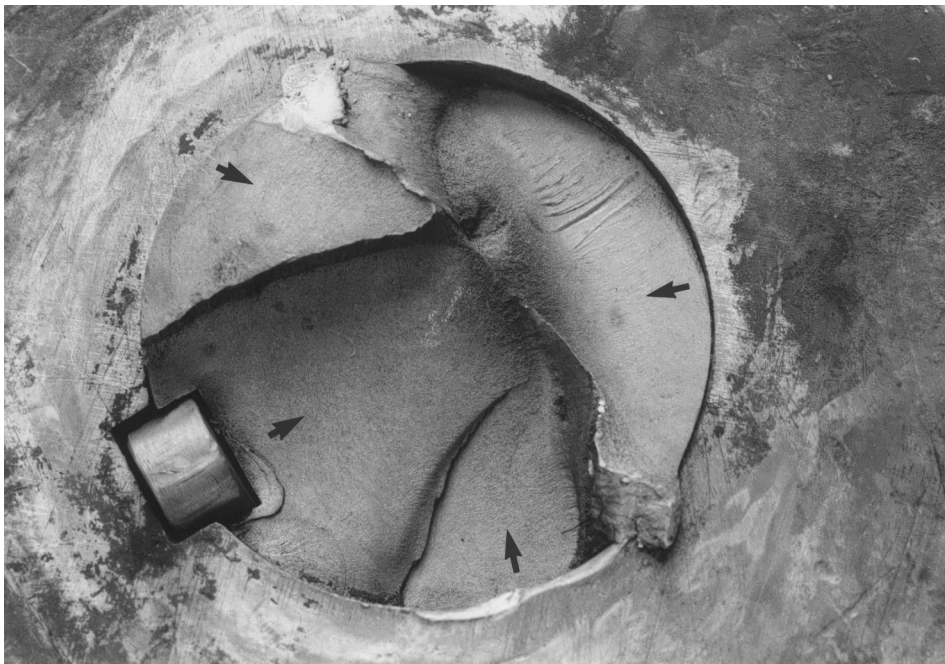
Fig. 7 shows a section of a multistage pump shaft embedded in the hub of a flexible coupling. The pump was used in a mine dewatering application and failed after approximately 600 h in service. Failure occurred at the face of the coupling between the pump shaft and the motor shaft. Multiple fatigue crack planes are visible (arrowed) indicating rotating bending fatigue with multiple crack initiation sites. The teeth of the flexible coupling hub showed significant eccentric wear indicating angular misalignment between the pump shaft and the motor shaft at the flexible coupling. It was concluded that fatigue cracks initiated at the keyway root and at various points along the shaft circumference and propagated under a cyclic bending stress occurring as a result of misalignment.

Fig. 7. Fatigue failure with multiple initiation. The arrows point to fatigue crack planes.

Bearing failures due to ingress of water or dirt are common and will result in severe shaft vibration if not maintained. High levels of vibration can exaggerate fatigue and vibration should be monitored regularly. Misalignment of shafts occurs primarily during the installation process and can be avoided if

the correct procedures are followed. By preventing corrosion of the shaft, the stress concentration factor associated with pitting can be eliminated. Corrosion on shafts can be prevented by either sealing the shaft by means of o-rings on the sleeves or by selecting high alloy steels, such as stainless steels, depending on the application. Galvanic corrosion can be prevented by selecting similar shaft and sleeve materials. Increasing the keyway root radii and shoulder radii at changes in section will also serve to decrease the stress concentration factors at these sites. Elimination of keyways would be the ideal solution, but this is not always possible. Fatigue life can also be improved by selecting materials with higher fatigue limits.

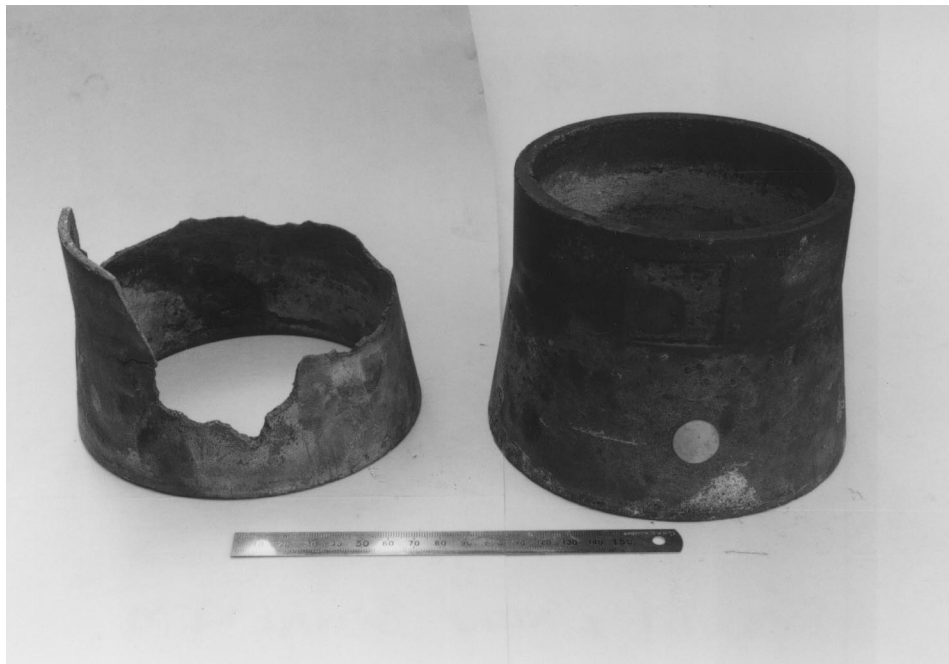
Sleeves protect the shaft against corrosion, erosion and wear and are mainly found on large hydraulic pumps [4]. However, inadequate sealing of the sleeves will allow ingress of water, resulting in under-sleeve corrosion of both sleeve and shaft as mentioned previously. Common materials for sleeves are cast-iron or bronze. If exposed to water, grey cast irons are likely to corrode fairly rapidly. Liquid ingress under a poorly machined or installed sleeve or shaft will result in a loose fit between sleeve and shaft, with the result that the components will wear against each other. One such example is illustrated in Fig. 8 and shows two sleeves from a horizontal split-casing pump. The sleeve on the left shows severe corrosion and wear when compared with the sleeve on the right. Both sleeves are located on opposite sides of the impeller shaft and were manufactured from cast iron. It is suspected that corrosion occurred due to water ingress under the sleeve, possibly as a result of the sleeve being slightly loose to start with. The sleeve corroded to the extent that it was loose on the shaft, resulting in eccentric wear and

Fig. 8. Cast-iron sleeves showing severe corrosion and wear (left-hand side).

subsequent thinning of the sleeve walls. This type of failure can be prevented by sealing the shaft by means of o-rings or by selecting a more corrosion-resistant material for the shaft sleeves.
