SIMRAC

Final Project Report

Title: DEVELOP GUIDELINES FOR THE DESIGN OF PILLAR SYSTEMS FOR SHALLOW AND INTERMEDIATE DEPTH, TABULAR, HARD ROCK MINES AND PROVIDE A METHODOLOGY FOR ASSESSING HANGINGWALL STABILITY AND SUPPORT REQUIREMENTS FOR THE PANELS BETWEEN PILLARS

Part 2: Appendices D - E (E1 and E2)

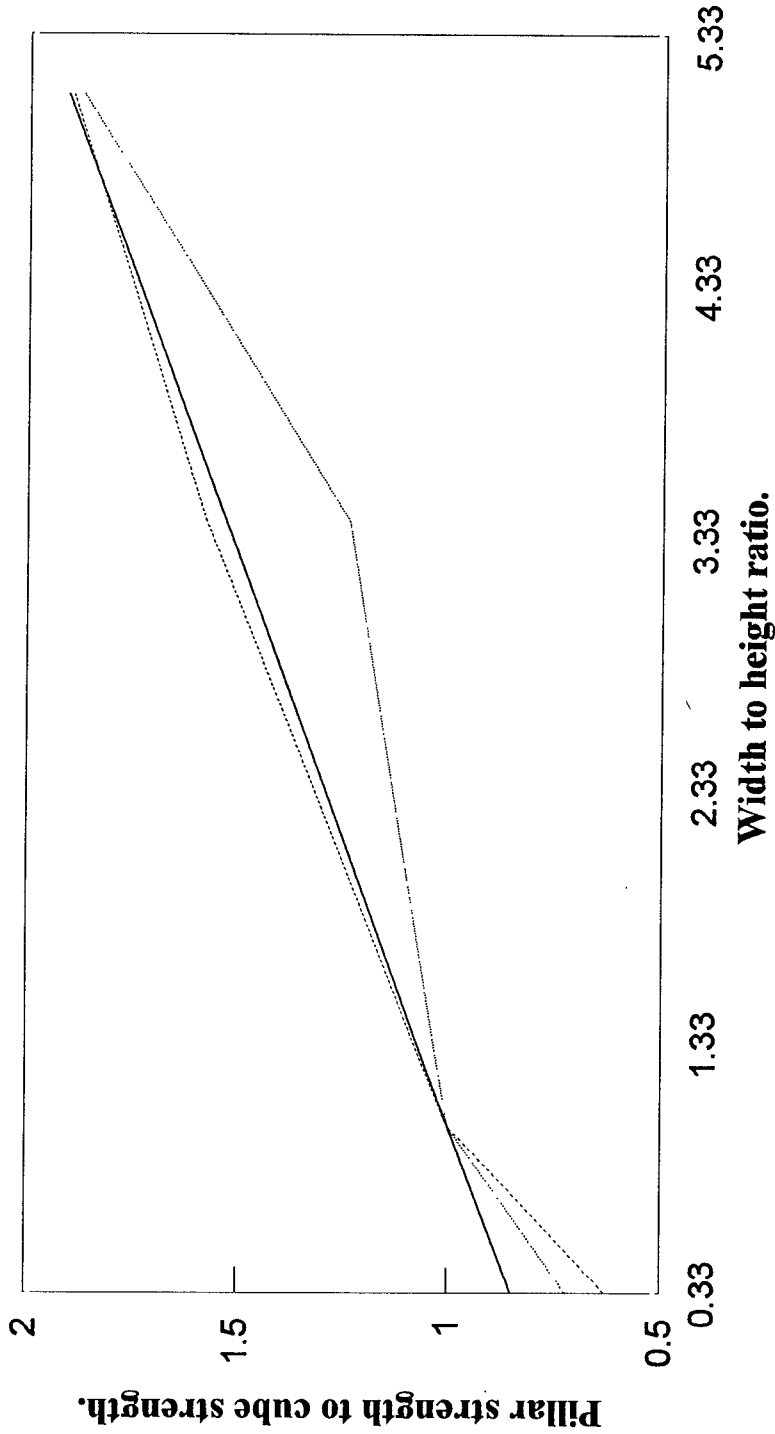
EFFECT OF WIDTH TO HEIGHT RATIO ON PILLAR STRENGTH.

$$P_s = C_s \{ 0.778 + 0.222 (w/h) \}$$

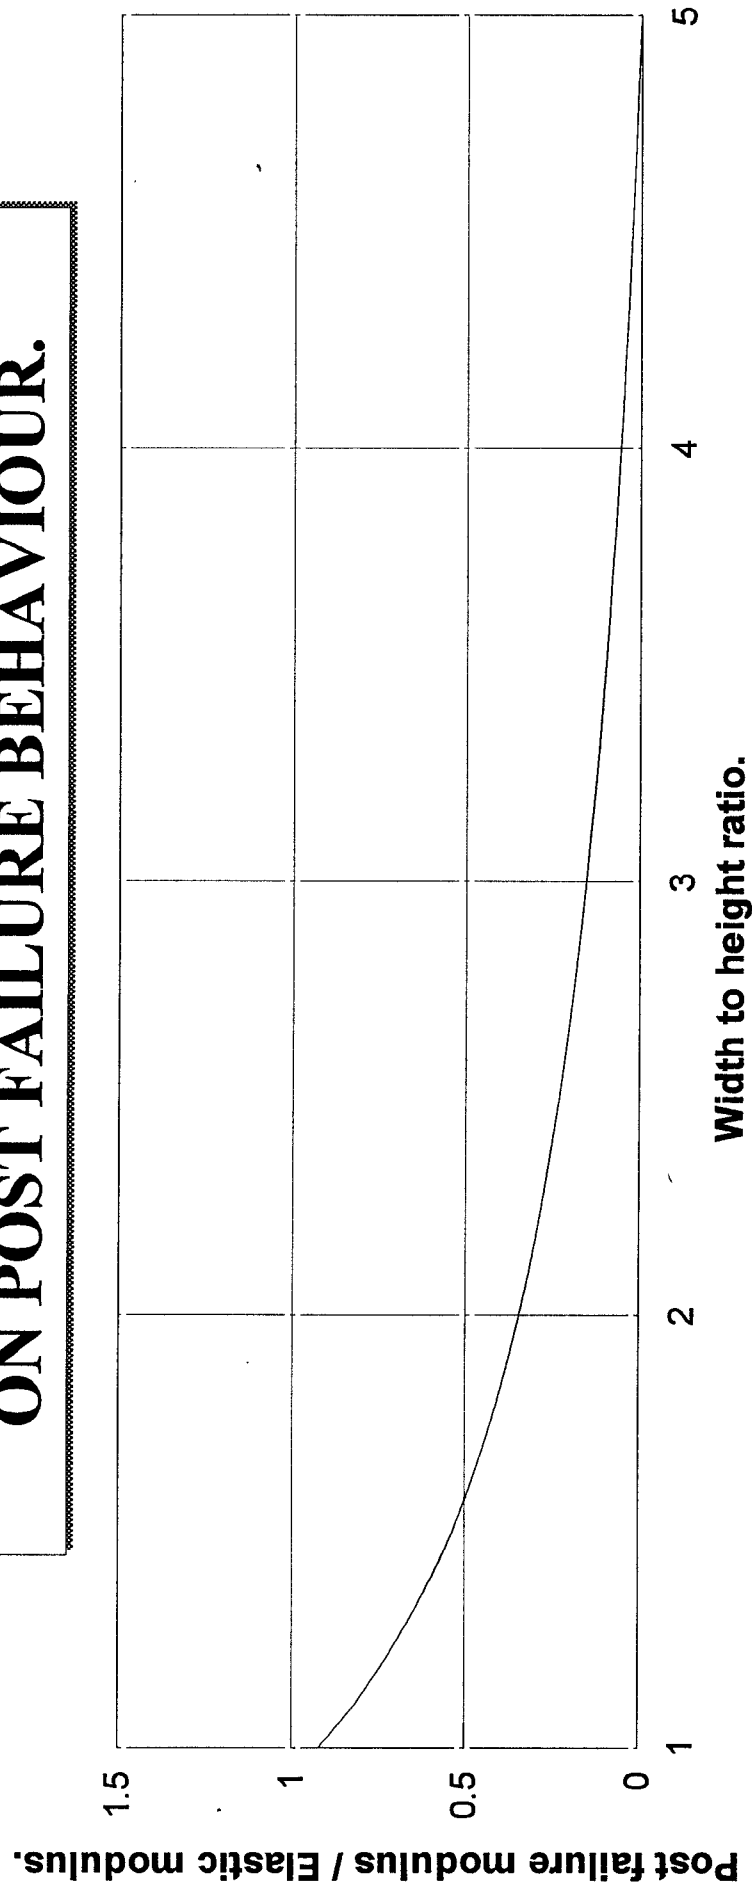
EFFECT OF WIDTH TO HEIGHT RATIO ON POST FAILURE BEHAVIOUR.

Figure (25) in Appendix (4) illustrates the effect of width to height ratio on post failure behaviour. The curved line suggests that at a width to height ratio of 5:1, the post failure curve is flat. In other words there is no load shedding. The results of the punch tests on the footwalls 1 and 3 rock types indicate two points :

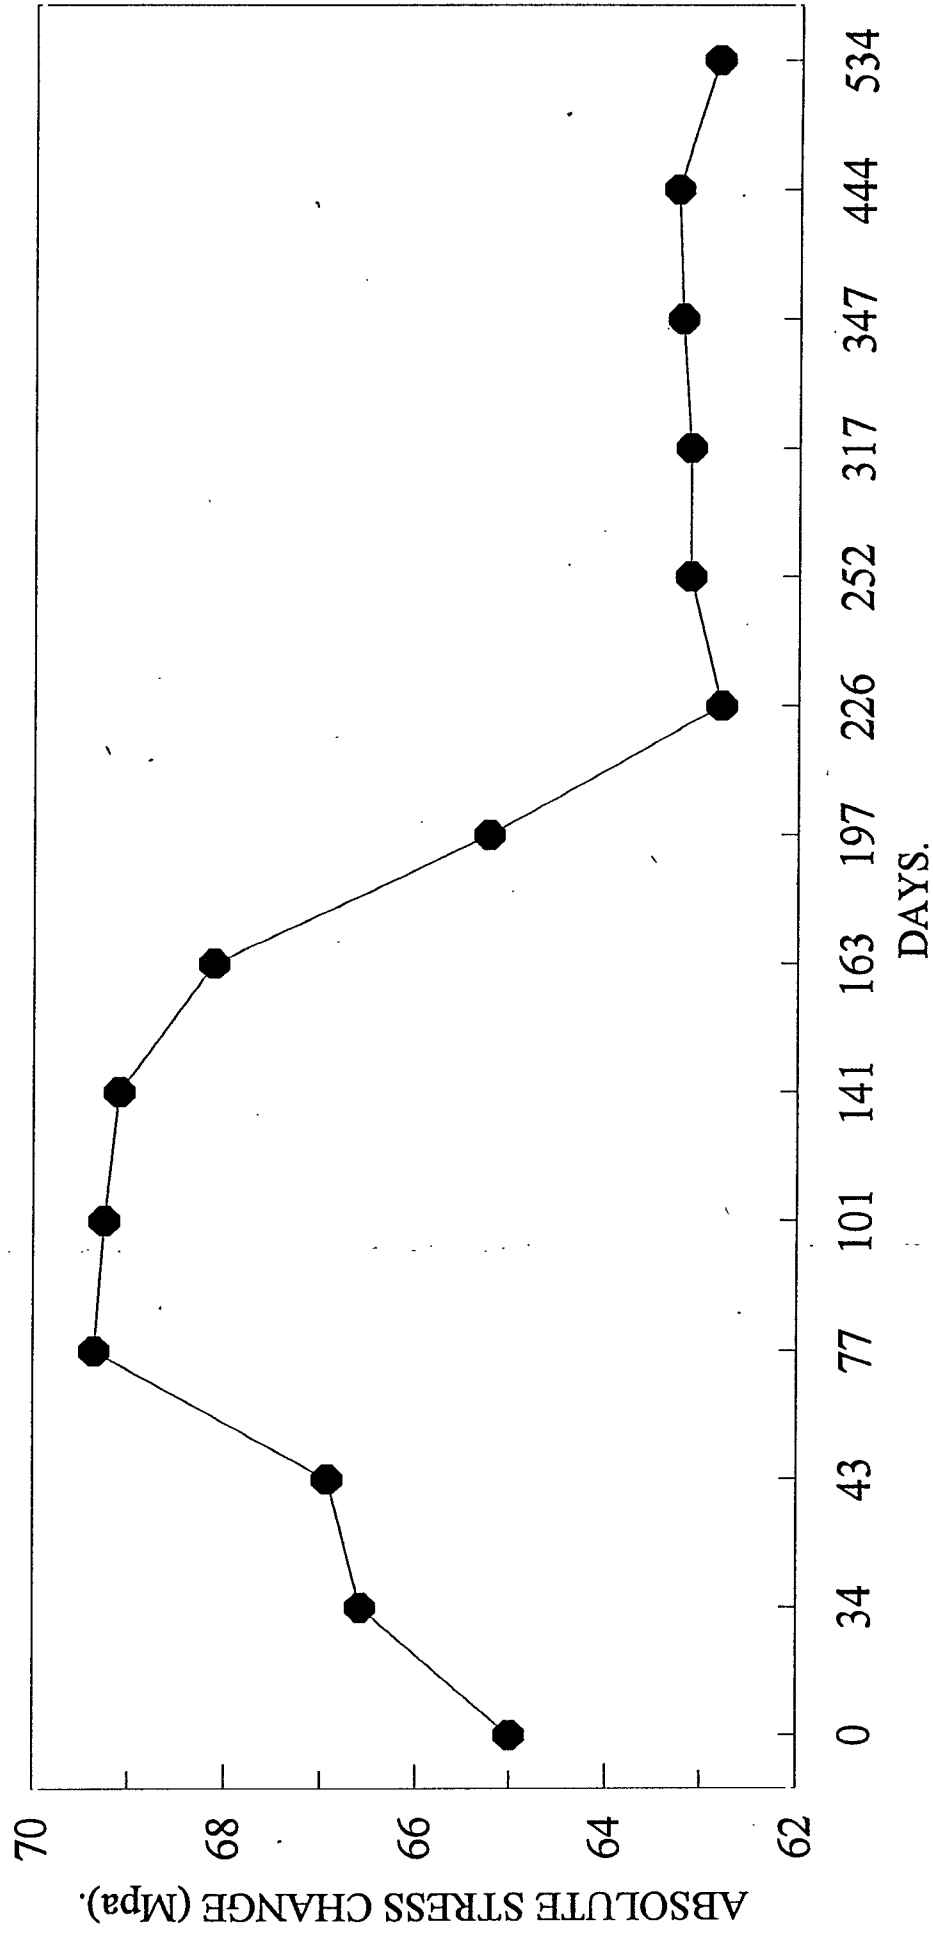
**VERTICAL STRESS CHANGE VERSUS TIME.
16 - 109 STOPE, PILLAR "A".**

METER LOCATED 1.5m FROM PILLAR EDGE.

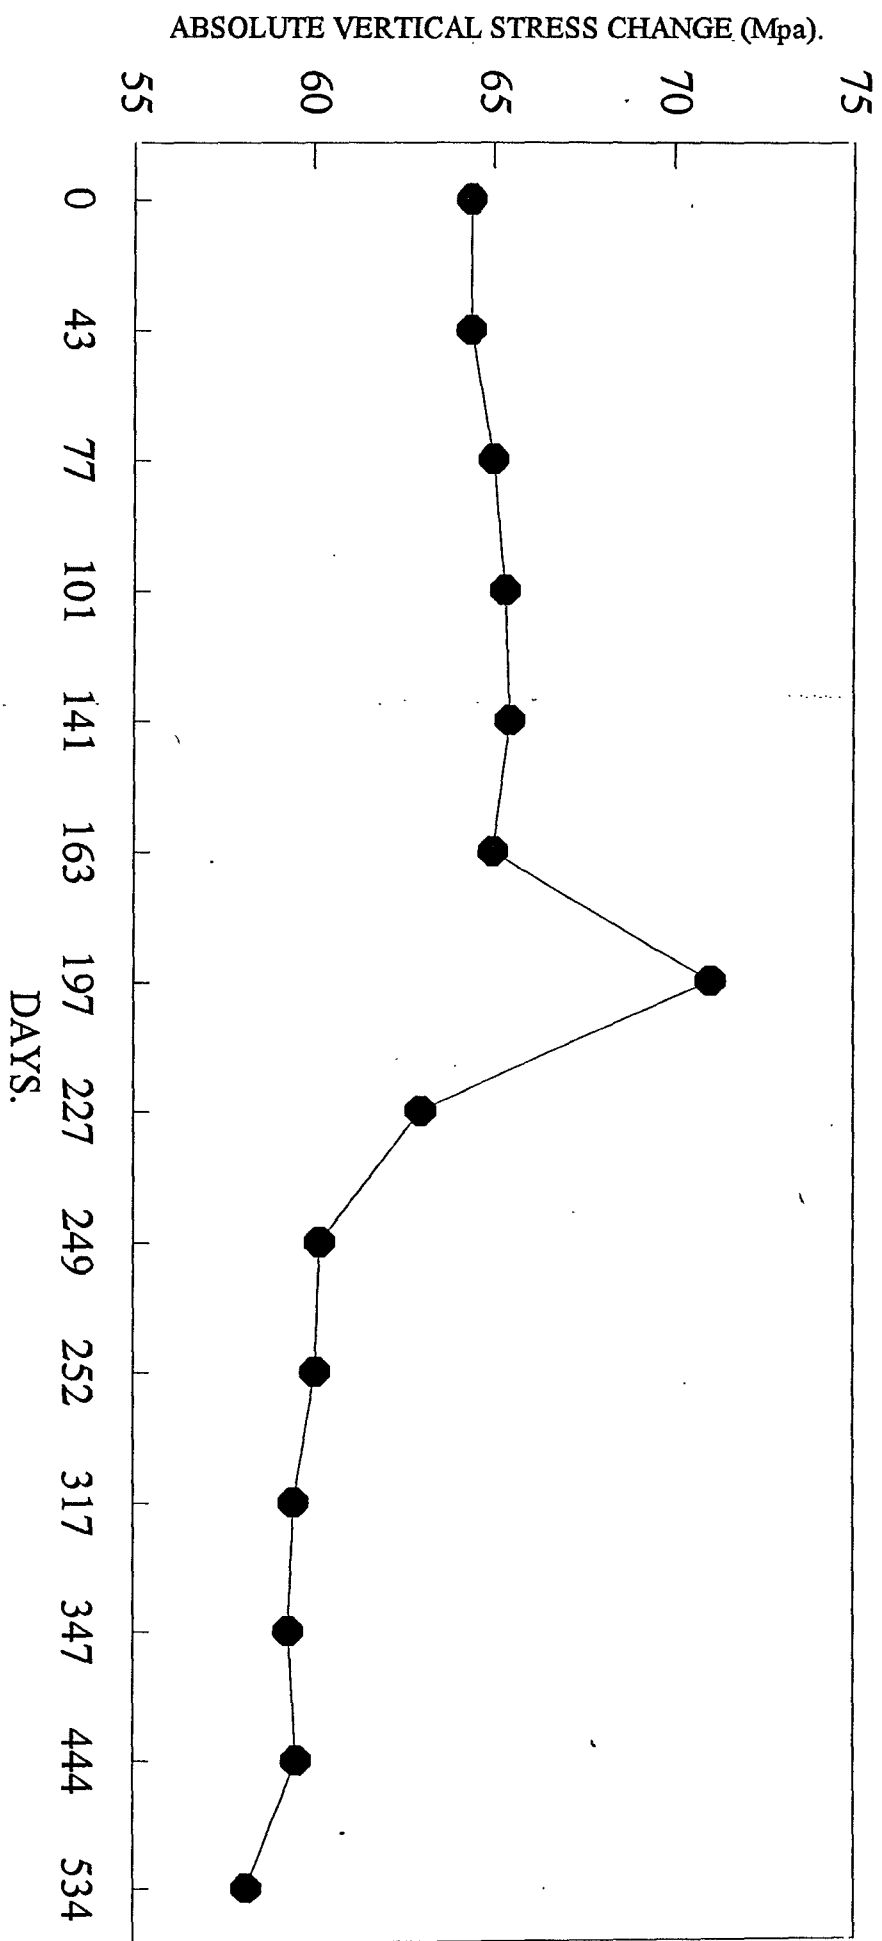
**ABSOLUTE VERTICAL STRESS CHANGE VERSUS TIME.
16 - 109 STOPE, PILLAR "B".**

METER LOCATED 1.5m FROM PILLAR EDGE.

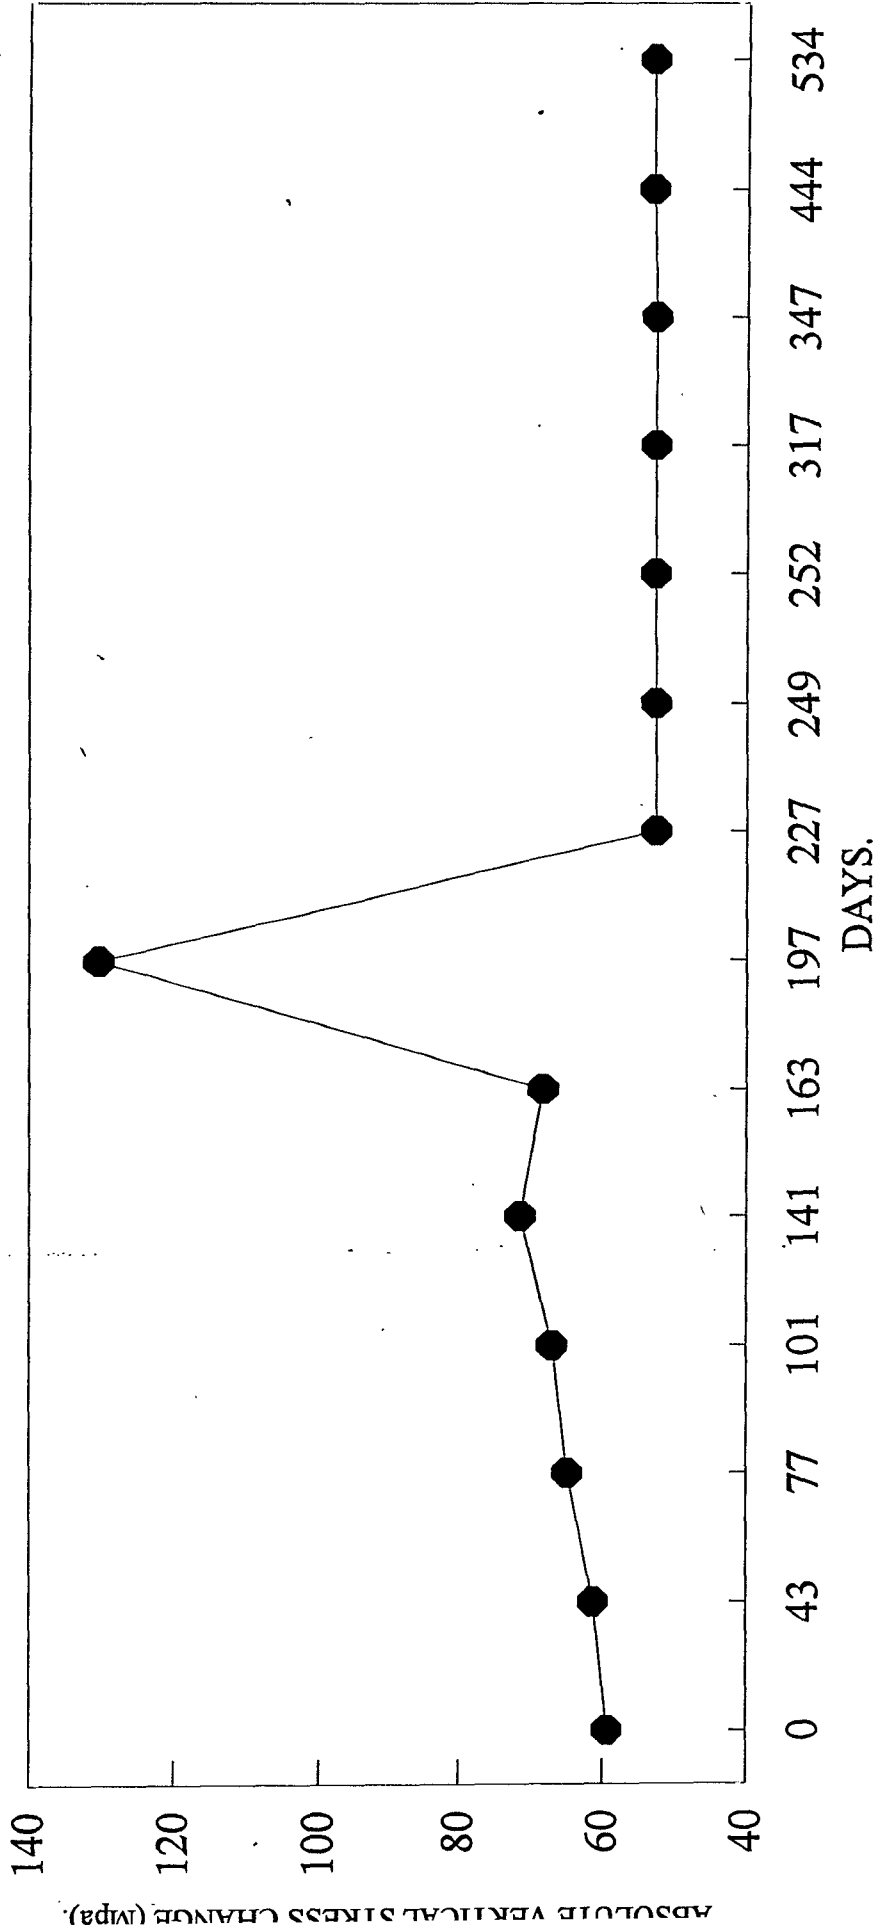
Figure (42).

**ABSOLUTE VERTICAL STRESS CHANGE VERSUS TIME.
16 - 109 STOPE, PILLAR "B".**

METER LOCATED 0.5m FROM PILLAR EDGE.

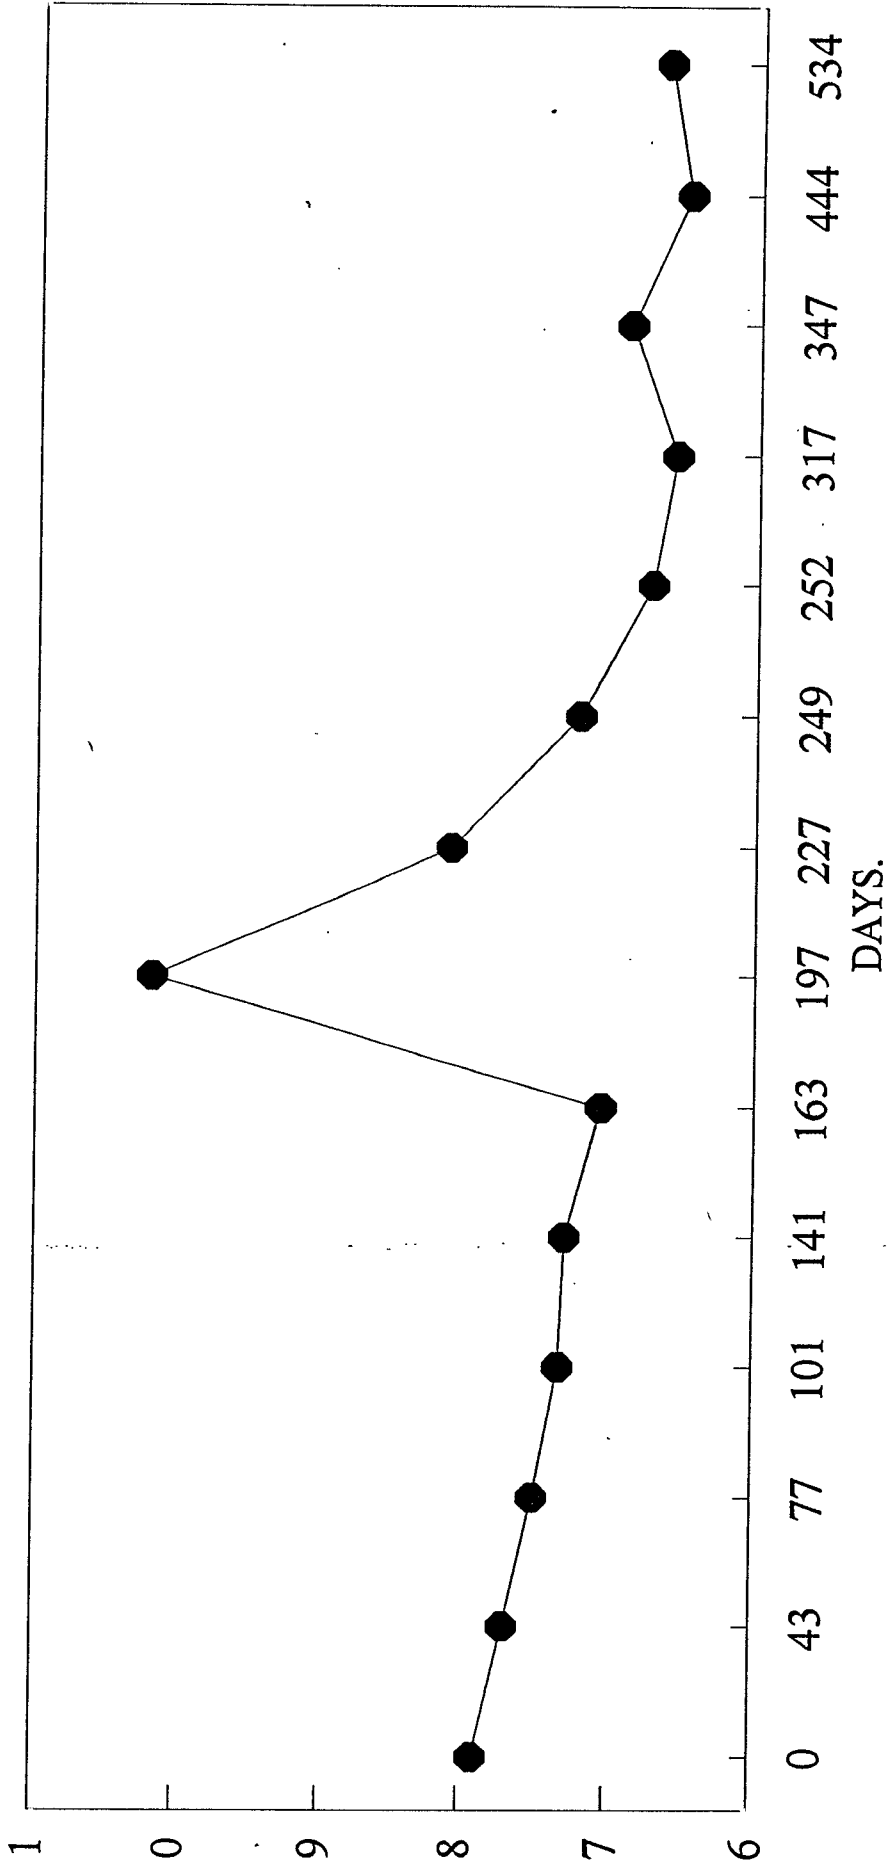
**ABSOLUTE HORIZONTAL STRESS CHANGE VERSUS TIME.
16 - 109 STOPE, PILLAR "B".**

METER LOCATED 1.3m FROM PILLAR EDGE.

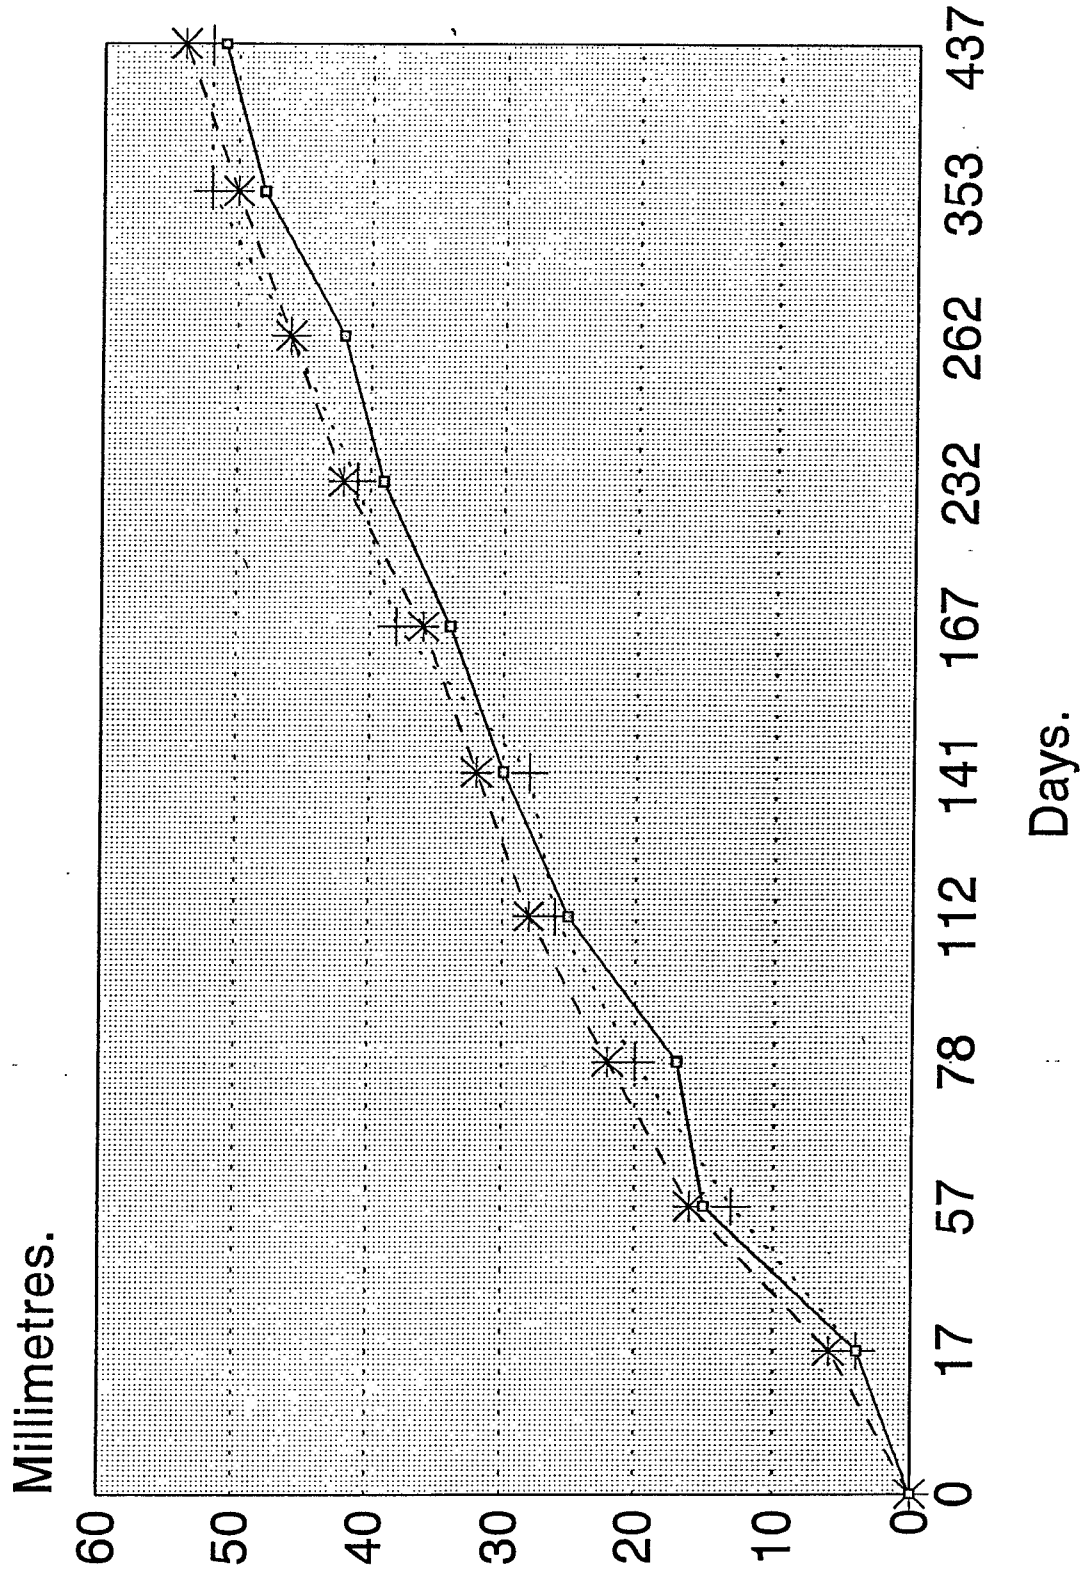
PROGRESSIVE CLOSURE OF METERS ADJACENT TO PILLAR "E".

-□- Meter E3. + Meter E4. * Meter E5.

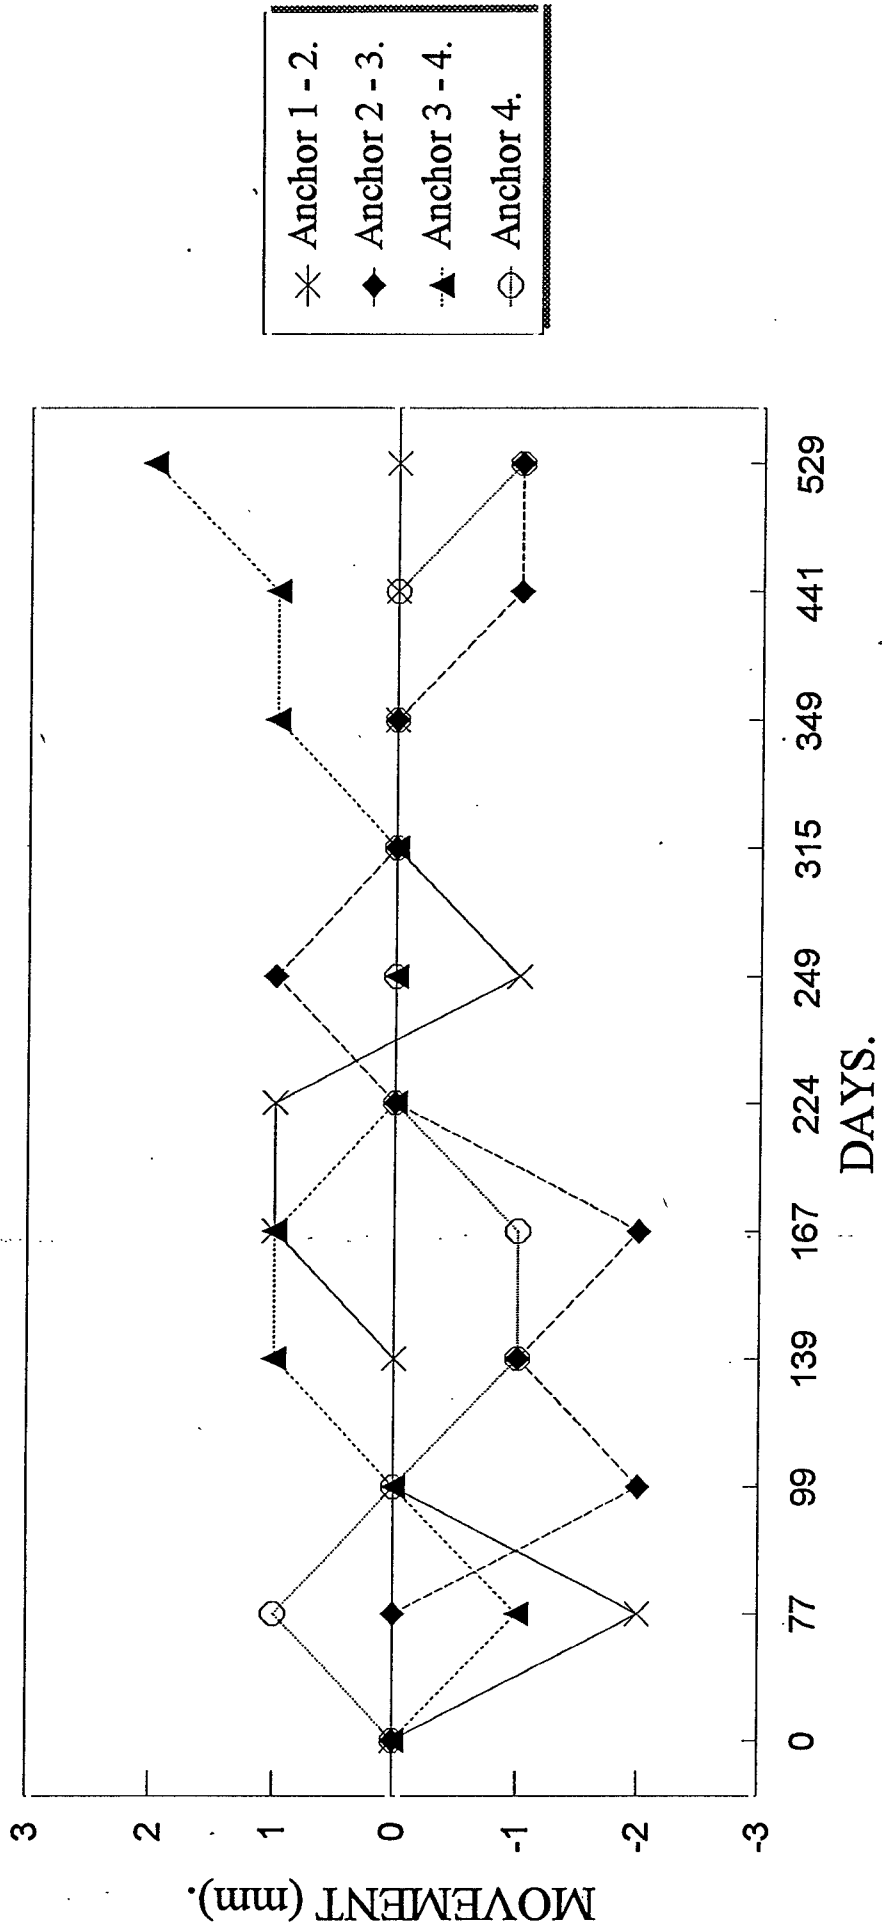
**HANGINGWALL EXTENSOMETER ADJACENT TO PILLAR "B".
(MOVEMENT BETWEEN ANCHORS).**

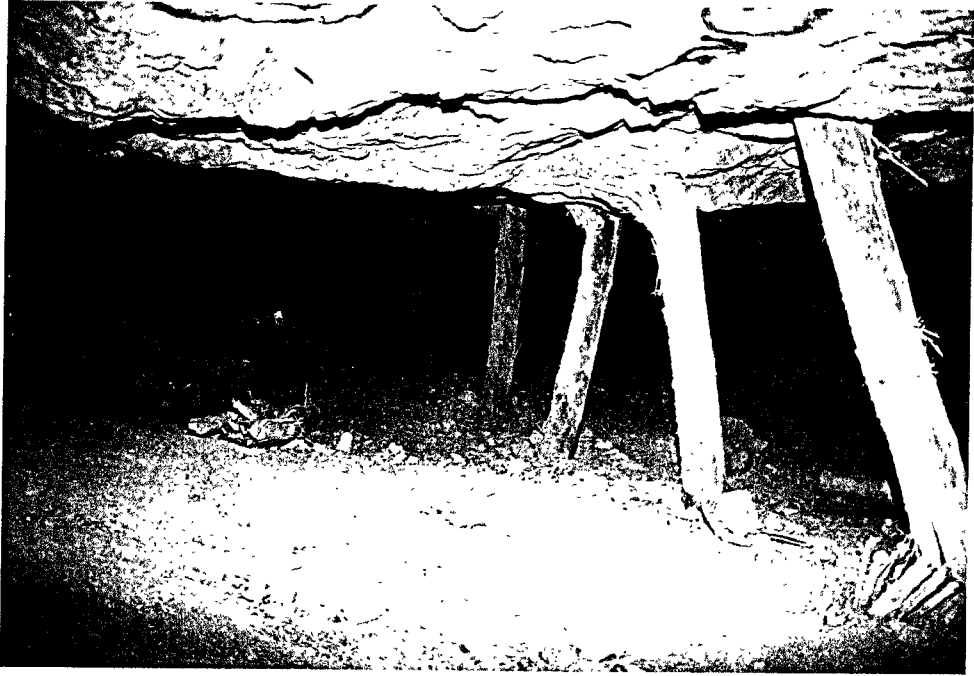
Photograph 12 : Damage to the downdip side of pillar B following a seismic event on 09/11/94.

Photographs (11) and (12) in Appendix (7) illustrate the degree of damage. The difference between the slabbing on the downdip side and the more fragmented nature of the updip side is interesting to note. The most likely explanation for this difference is that the updip side of the pillar is more confined as the siding was cut in horizontally. Hence the height of the updip side of the pillar is less than that on the downdip side.

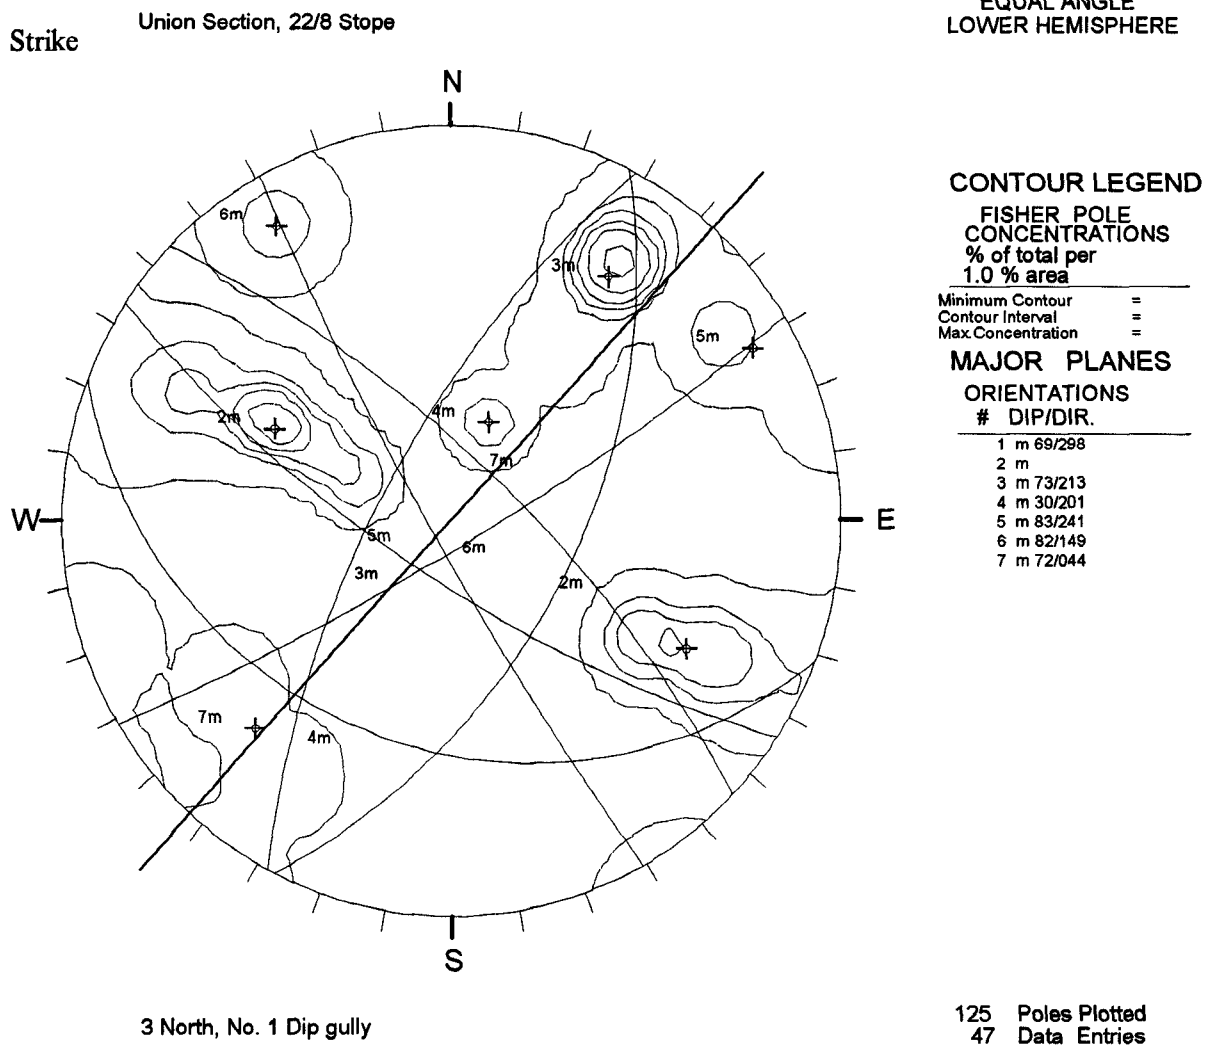
Figure 1. Typical stereographic plot of the joint poles

The grouping of the poles of the strike set as two and sometimes three sub-sets can be seen in any joint stereogram of the site (Figure 1 is a typical stereographic plot of the joint poles encountered in a typical raise). The frequency maxima of these sub-set poles are about 40° apart, i.e. their dips converge at about 40°. That numbers of adjacent and semi-adjacent (close enough to be linked by patches of bedding-parallel joints/ oikocryst cleavage/fracture) joints do in fact converge upward at such angles is illustrated in Figures 2a and 2b. The upward convergence between joints, whose strikes are not parallel but semi-

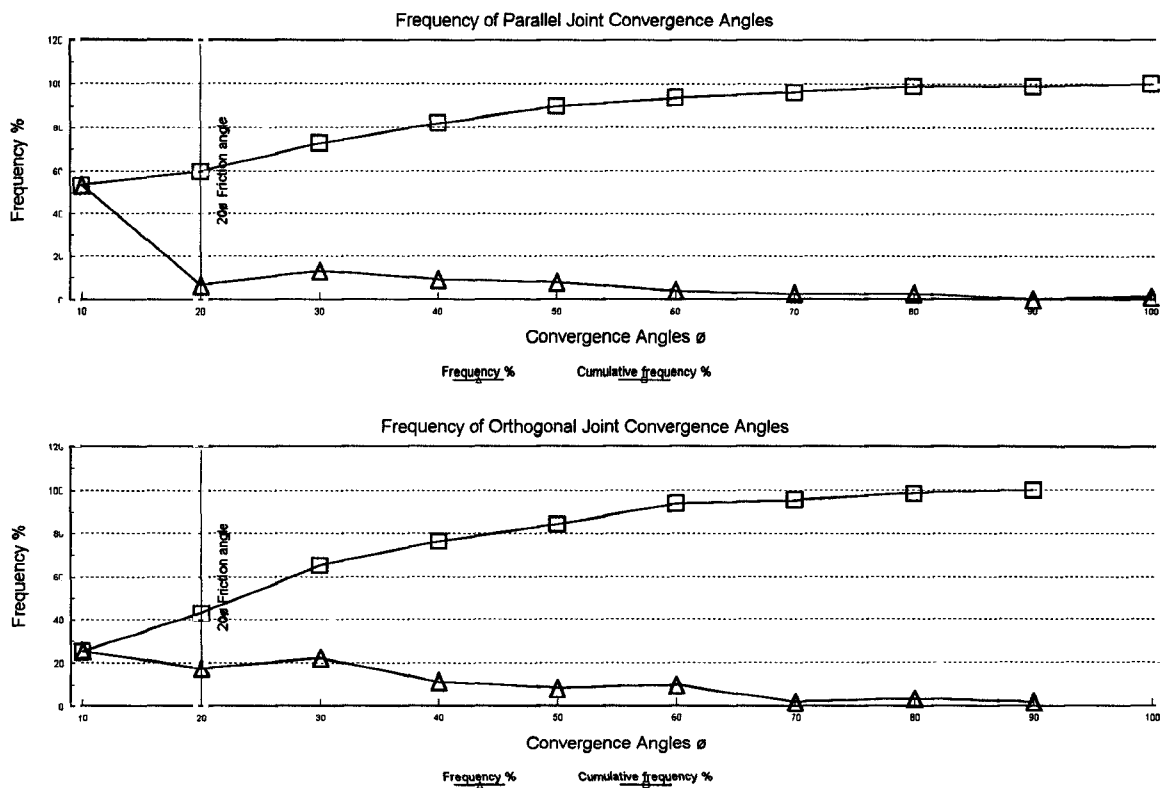
Figure 2a. The frequency of upward convergence between joints whose strikes parallel and whose strikes are semi-orthogonal or oblique

orthogonal or oblique, also contributes significantly to the instability of blocks in the hangingwall. The incidence of upward-convergence angles of such joints is illustrated in Figures 2a and 2c.

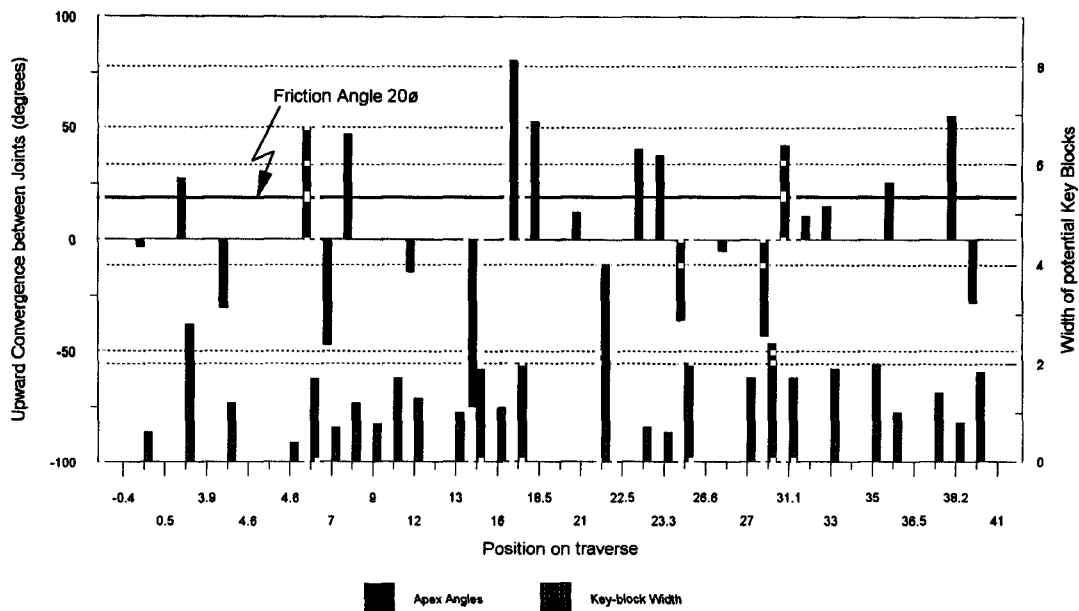
Figure 2b. The upward convergence between joints whose strikes are parallel

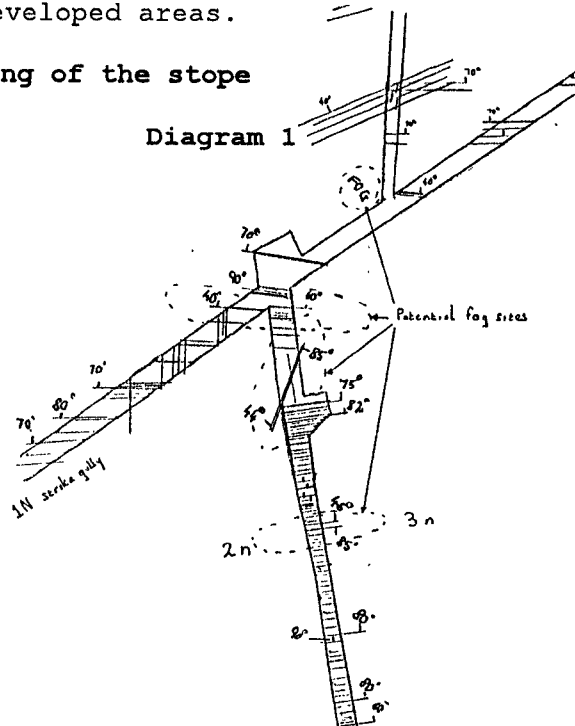
As 22/8 stope was pre-developed, joint mapping of the hangingwall was undertaken in the dip and strike gullies prior to stoping commencing. Particular attention was given to mapping the frequency dip and direction of the joints, but also smoothness, the amount of fill and the continuity was carefully noted. This information was then captured on a spread sheet, mapped on a plan and stereo plotted. It was thus possible to identify potentially unstable joint patterns in the hangingwall at this stage. As strike

Jointing in 1N strike & 2n dip gullies showing potential fog configurations

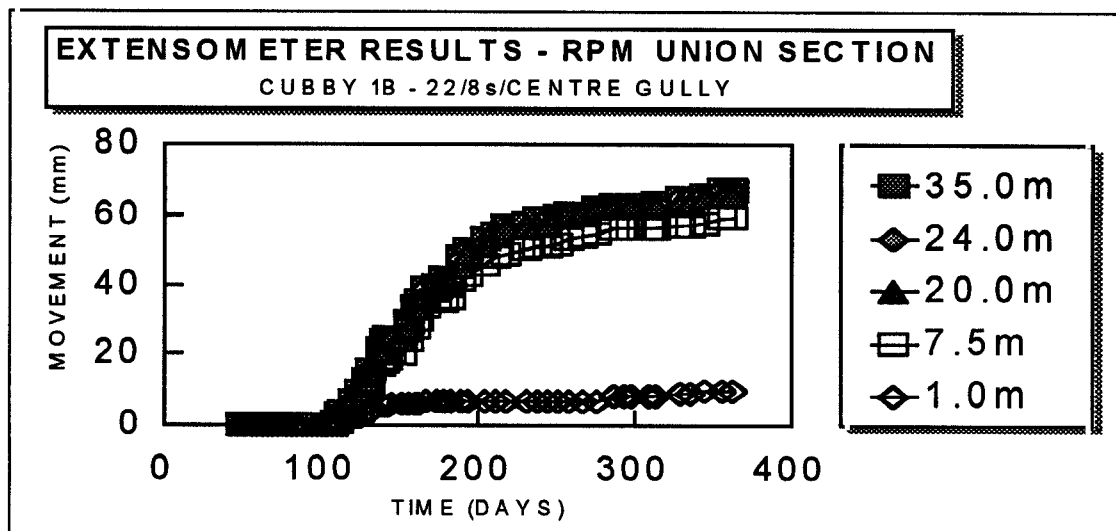
Ext 1b

The total movement measured in the shorter hole is more than in the longer hole because of blast damage to EXT 1a, thus the initial movement was not recorded in that hole. However the results of EXT 1b were unaffected.

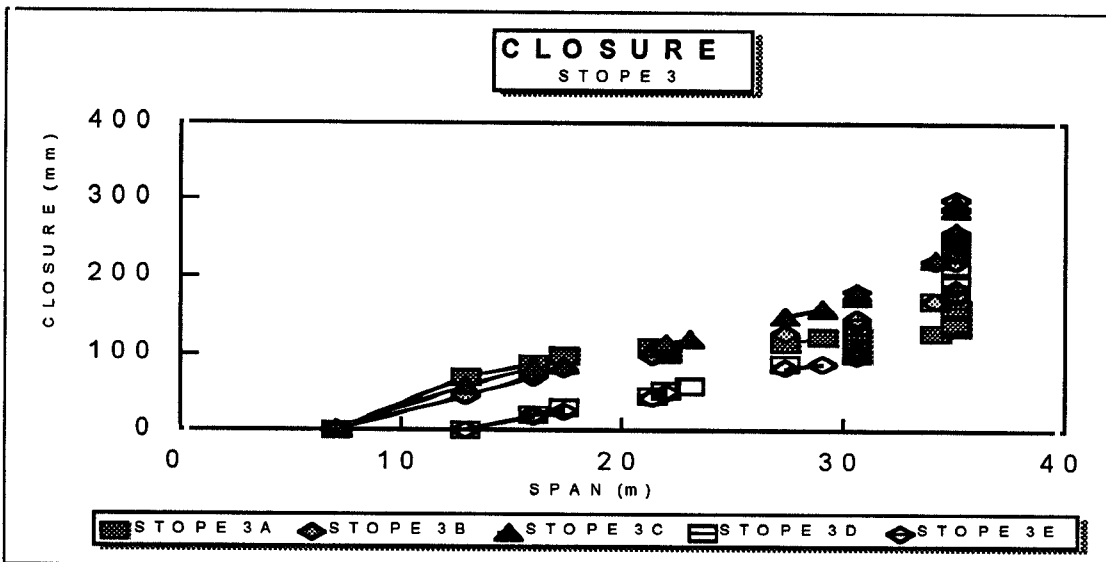
Closure/span data is depicted below for stations 3A which was located at the top of Stope 3, to 3E towards the bottom of the panel. 3E did not show the same trends as 3A because down-dip mining of the panel below (Stope 5) started before the completion of Stope 4 (see figure A1).

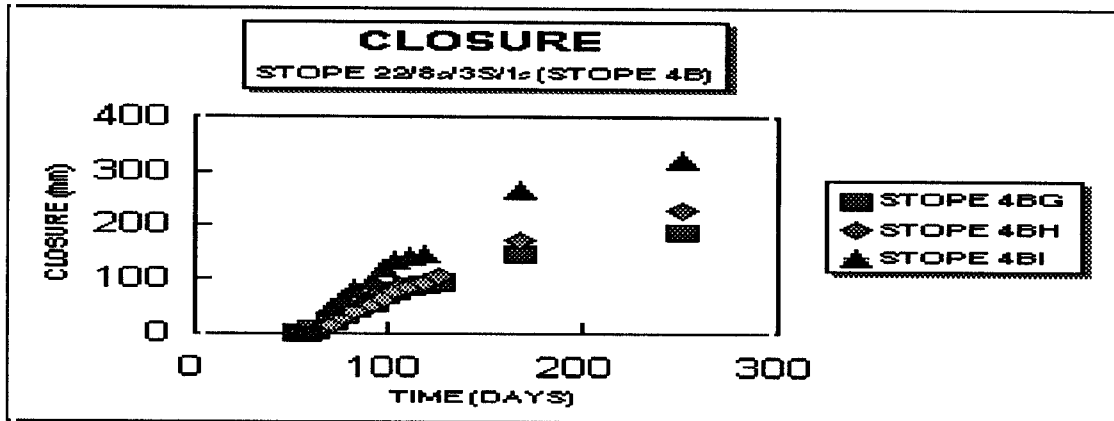
Prior to mining, several discontinuities were identified as being “problematic” due to their dip and strike orientations and fillings. One such discontinuity was traced from Stope 1 & 2 and cut through Stopes 5 & 4 and through Cubby 3. The trace of this discontinuity can be seen on the plan in figure A4 (appendix) indicated by the red line ending in Cubby 3. Large fallout’s were associated in Stope 5 and Cubby 3. In Stope 4 however, where breast mining took place, it was possible to install support before a fallout. Closuremeter stations were also installed across this discontinuity in Stope 4, some results of which are displayed in the graph below. The relative positions of these stations are highlighted on the plan in figure A4 (appendix).

Closuremeter station 4BI was located below the discontinuity and the other two stations up-dip. Note that the closure rate on 4BI was greater throughout the measured period, although similar trends occurred. Since the support resistance closure relationship was the same on either side of the discontinuity, it can be supposed that a greater force was involved on support elements immediately down-dip of the discontinuity. The extensometer installed in Cubby 3 however, did not show a greater depth of hangingwall movement. It is therefore assumed that the “extra” closure measured was associated with footwall movements. Since the joint persisted into the footwall, its trace was observed carefully once the panel was cleaned. Clear evidence of heave could be seen in Stope 4 but there was also an effect of tearing apart. Greater evidence of heave was observed in Stope 5, see observations below.

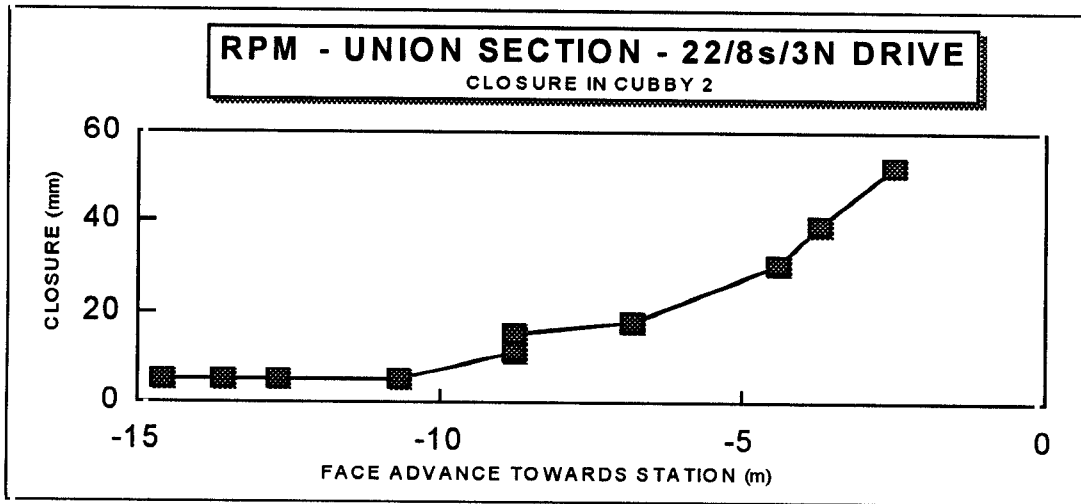
The results of Cubby 2, shown below, tend to confirm the pillar punching theory. As the mining face of Stope 3 advanced towards the station, closure was first observed when the face was about 10 m behind the station.

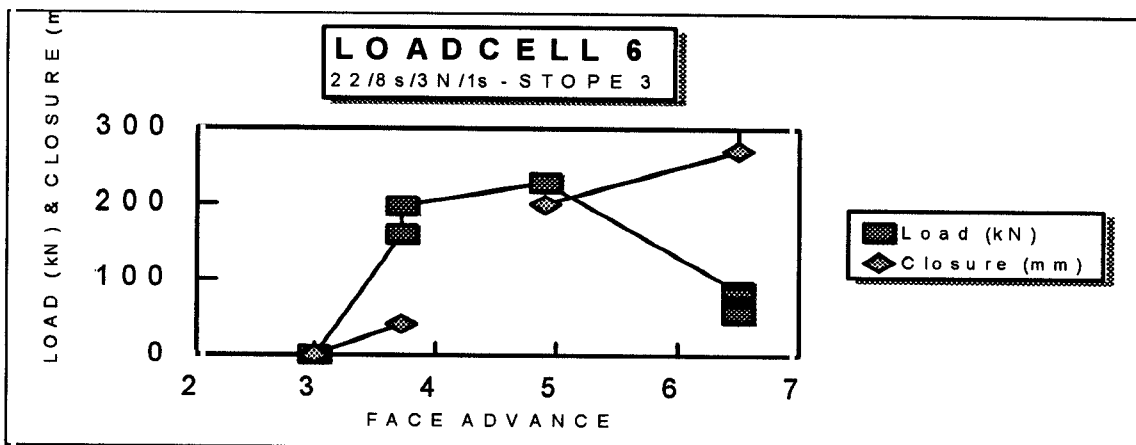
The graph below is a typical example of most of the stations. Permanent support was usually installed 3 m from the face. Failure of the 200 mm diameter sticks generally took place after a 2 m face advance i.e. the face was 5 m from the stick. At this position the next row of permanent support was installed and the failed sticks replaced. Closure measured at the load-cell positions indicated about 25 mm deformation at failure i.e. 12 mm of closure per metre of face advance. This fast closure rate can be explained by pillar punching.

Deviations from the typical curve shown above were caused by the way in which the support elements were installed i.e. at an angle to the footwall or hangingwall where slipping or brushing occurred. One stick which had obviously not been turned in a lathe, was very much stronger than the typical stick.

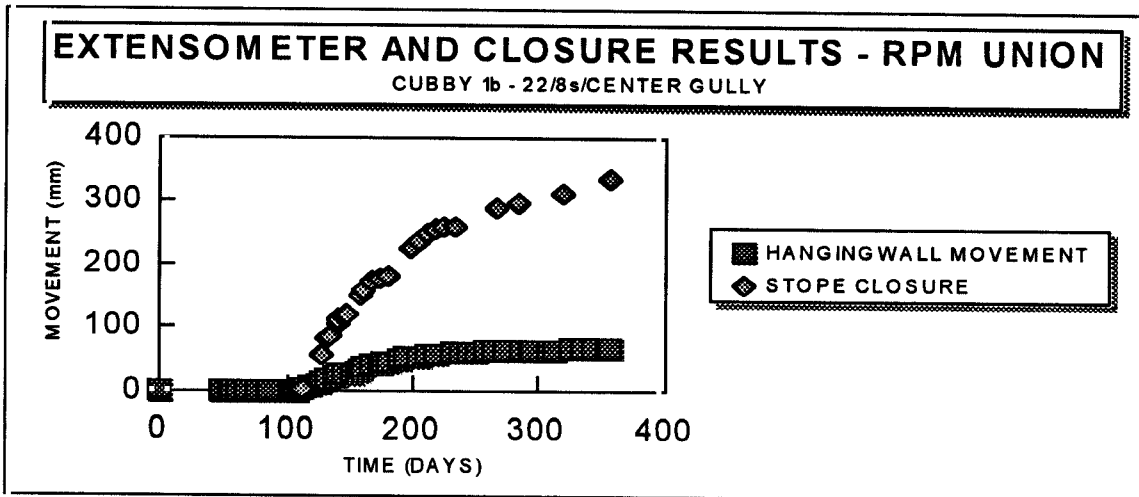
Comparing the extensometer results of Cubby 1 to the results of a closure ride meter station located immediately beneath (see graph below) the hangingwall openings constituted about a quarter of the total stope closure.
