SIMRAC

Final Project Report

Title: DEVELOP GUIDELINES FOR THE DESIGN OF PILLAR SYSTEMS FOR SHALLOW AND INTERMEDIATE DEPTH, TABULAR, HARD ROCK MINES AND PROVIDE A METHODOLOGY FOR ASSESSING HANGINGWALL STABILITY AND SUPPORT REQUIREMENTS FOR THE PANELS BETWEEN PILLARS

Part 2: Appendices D - E (E1 and E2)

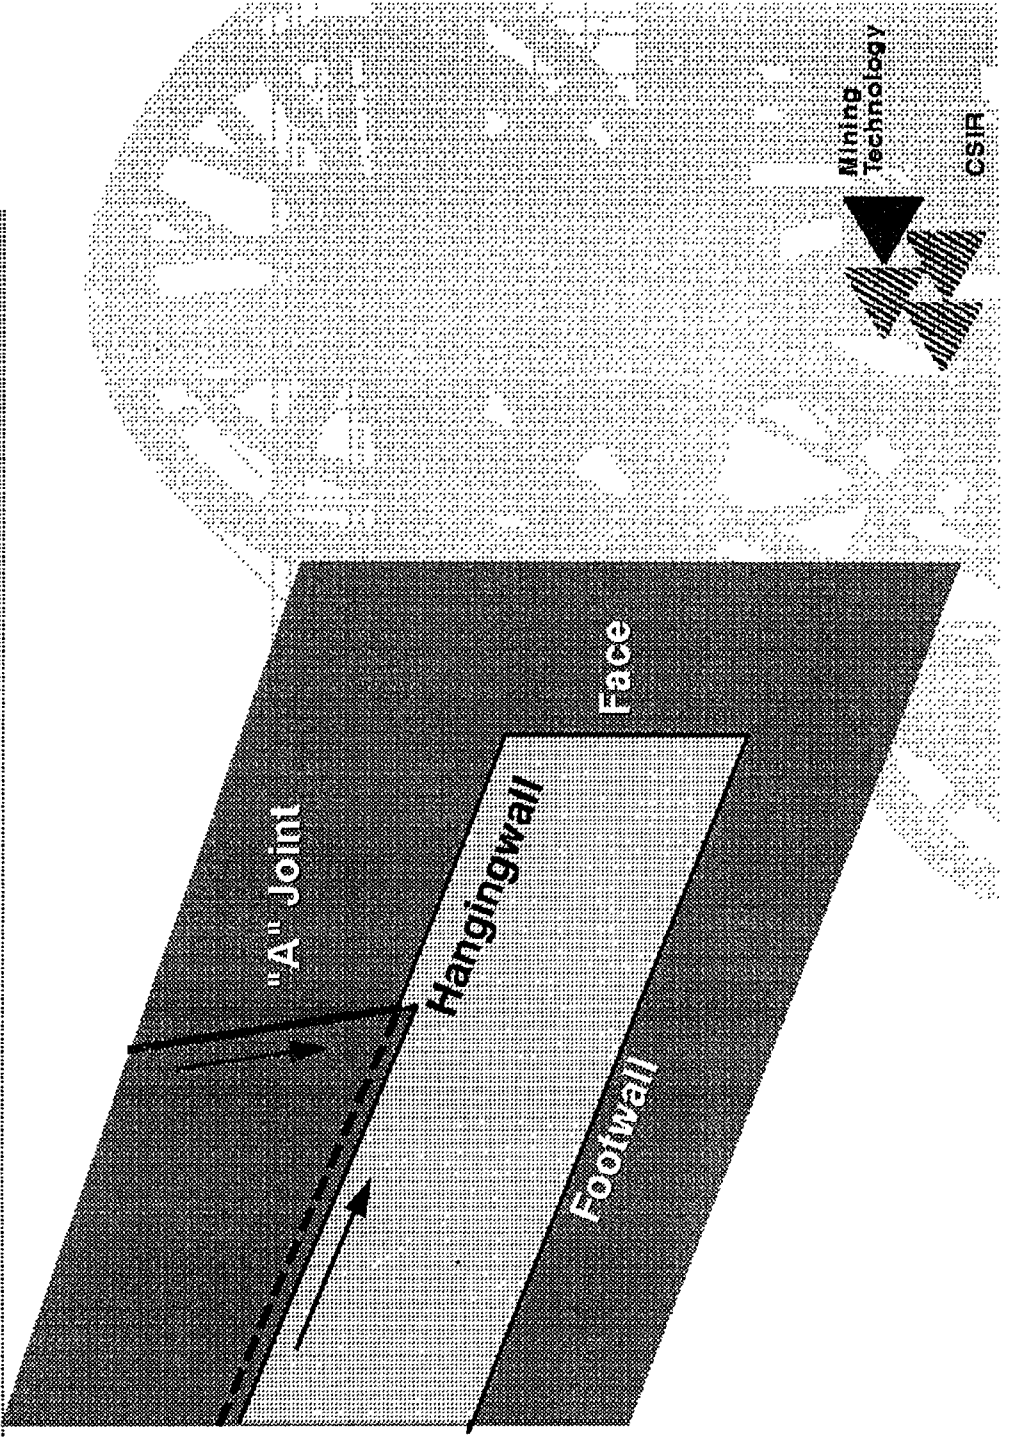
FIGURE A11

Diagram of hangingwall movement along some “strike” joints, based on Crack-meter information.
Figure A11

**SIDE-VIEW OF DOWN-DIP STOPE OF 3N DRIVE
SHOWING HANGINGWALL MOVEMENT ALONG
THE "A" JOINTS**
