Title: THE SAFE USE OF MINE WINDING ROPES

Volume 3: Rope Terminations

Project No: GAP 054

**LABORATORY EVALUATION OF  
WHITE METAL AND RESIN CAPPINGS  
FOR USE AS WINDER ROPE  
TERMINATIONS**

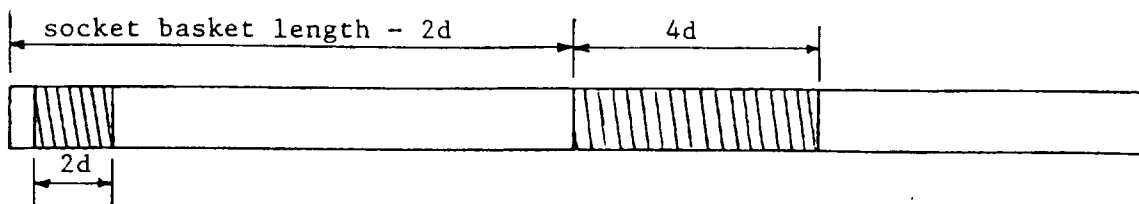
In order to prevent loosening of the wires or strands, each end of the specimen was served before abrasive cutting. Once cut, the outside of the rope was washed in dieselene from the point where it was cut up to a point 1 m from each end. The specimen end was then dried thoroughly. Serving wire was then placed on the specimen over a distance of 4 rope diameters ( $4d$ ) starting from a point equal to the length of the socket basket minus  $2d$  from the end of the specimen, as illustrated in Figure 2.

**Figure 2:** Serving of the rope specimen.

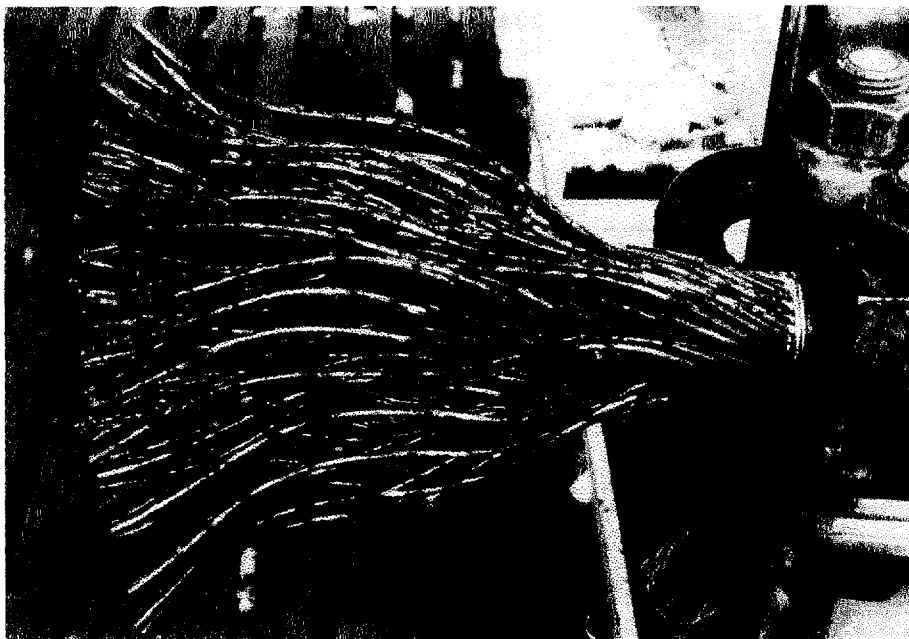
In order to prepare a brush, the two-bolt clamp and the clamp was fastened in a vice or to a rigid structure as shown in Figure 4. When the ends were brushed out, the six strands were first separated from each other. Once that procedure was completed the fibre core was cut out as close to the two-bolt clamp as possible. Each strand was then opened up individually to form a brush leaving the plaited strand cores intact. During the opening of the rope and strands, **care was taken to avoid bending of the wires too sharply at the two-bolt clamp as this could caused individual wire failures at the neck of the socket during the test.** The appearance of the brush at this stage in the process is shown in Figure 4 below.

**Figure 4:** A photograph of the uncleaned, brushed end of the test specimen.

As previously mentioned in the section describing the test programme, the effect of not properly cleaning the brush on termination efficiency was investigated. In one set of tests the brush was wiped clean as described directly above. In the worst case described here the rope samples used were first completely opened after which they the brush was pulled into the socket as described below, and cast. The condition of the brush at the time of casting was the same as that shown in Figure 4.

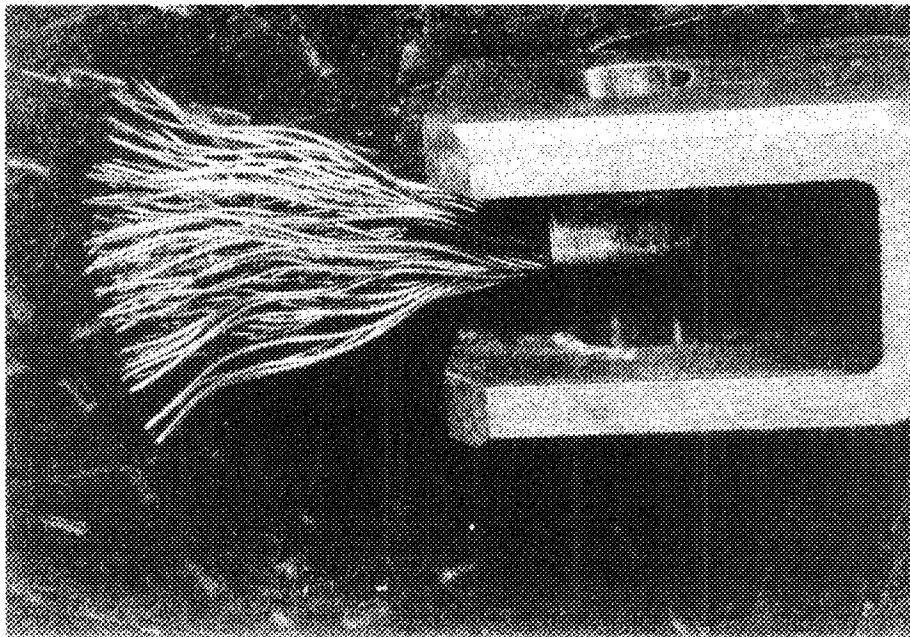
After degreasing (where applicable) the two-bolt clamp was removed from the neck of the brush and the socket was pulled onto the brush so that the ends of the wires were approximately 5 mm above the top of the socket basket. This left a length of 2 rope diameters of serving contained within the mouth of the socket. Figure 6 shows the clean brush after the two-bolt clamp had been removed and prior to the socket being pulled over the brush.

**Figure 6:** Photograph of the brush prior to being pulled into the socket.

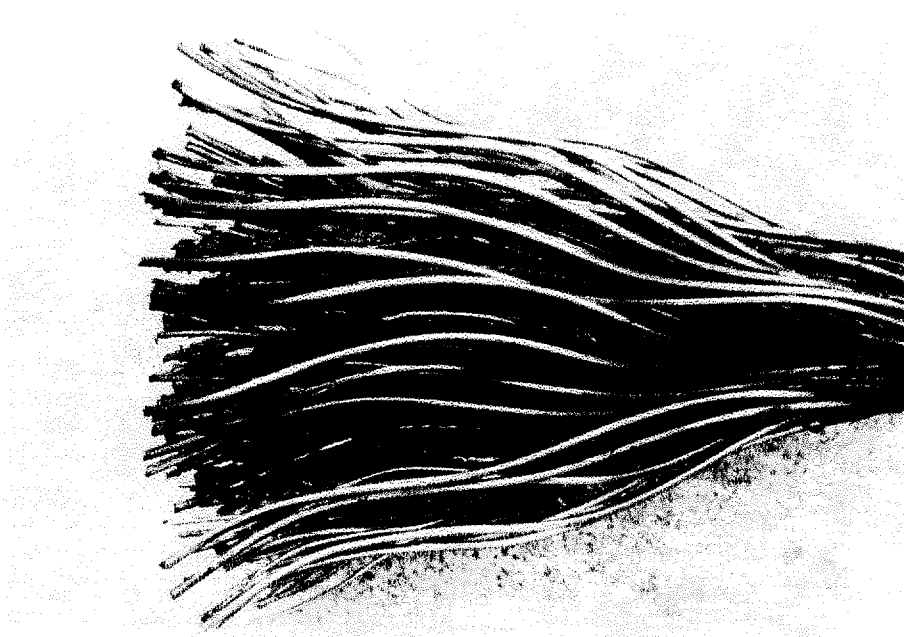
A total of eight resin capped sockets where the wires of the brush had only been wiped were tested. Figure 15 shows the condition of the brush after the wires had been wiped prior to casting. The results of the tensile tests on the unfatigued specimens are summarised in Table 4.

**Figure 15:** The appearance of the wire brush after the wires had been wiped.

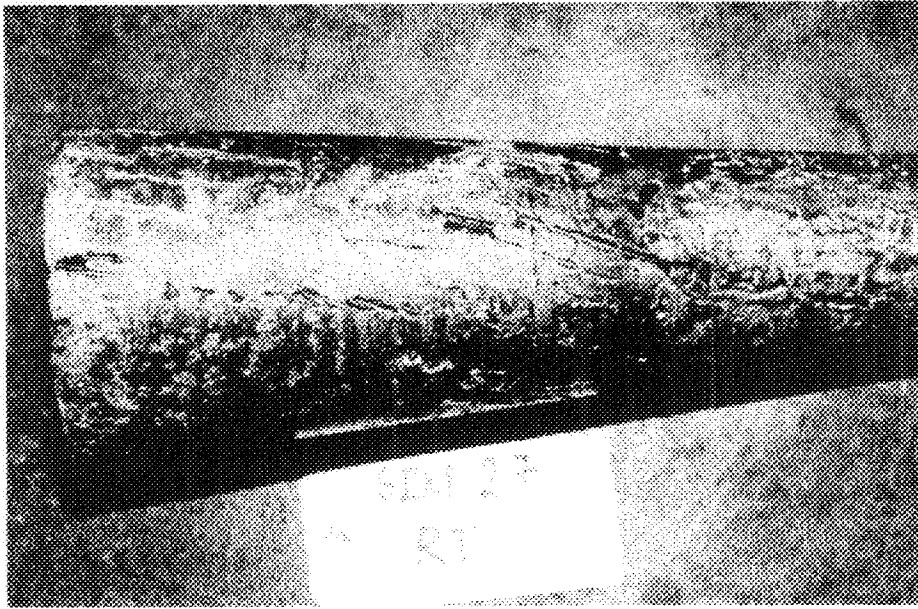
**Figure 17:** White metal capping cast with the socket at a temperature of 25° C.

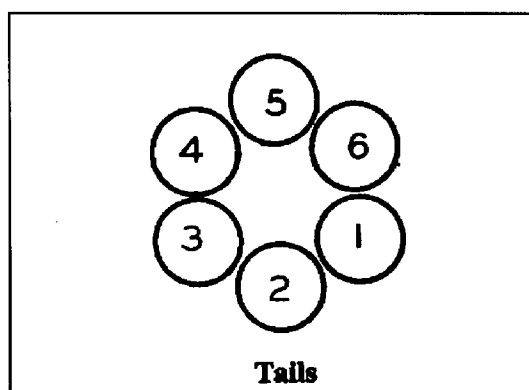
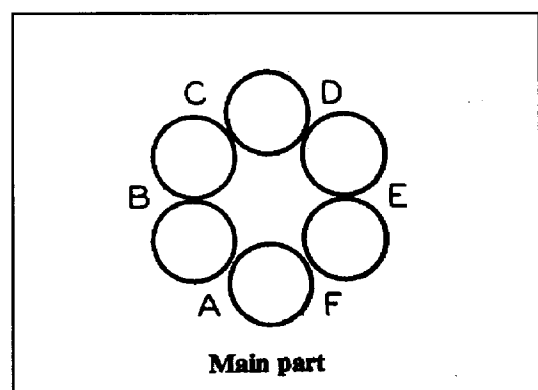
**Figure 9:** The figures show how the tails and main part of the rope have been labelled

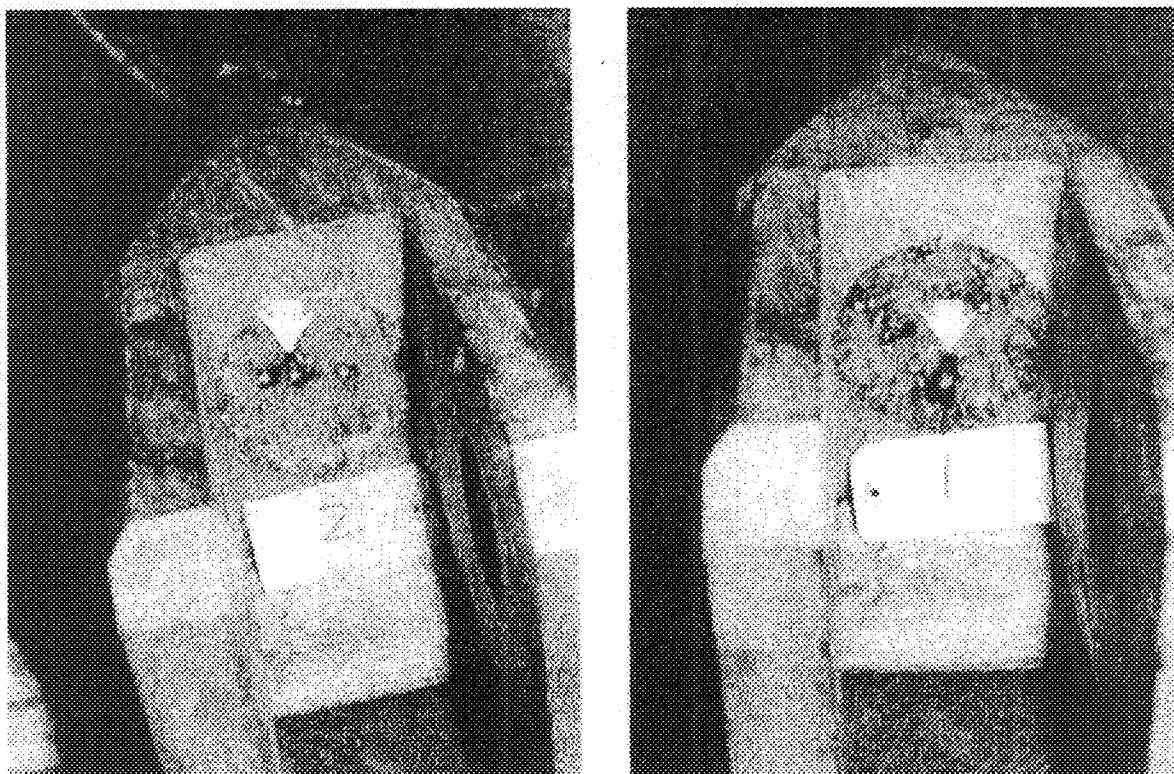
Figure A1 The figure shows the open end of two sockets (No's 1 and 2) with traces of rope dressing which was emitted (arrowed).

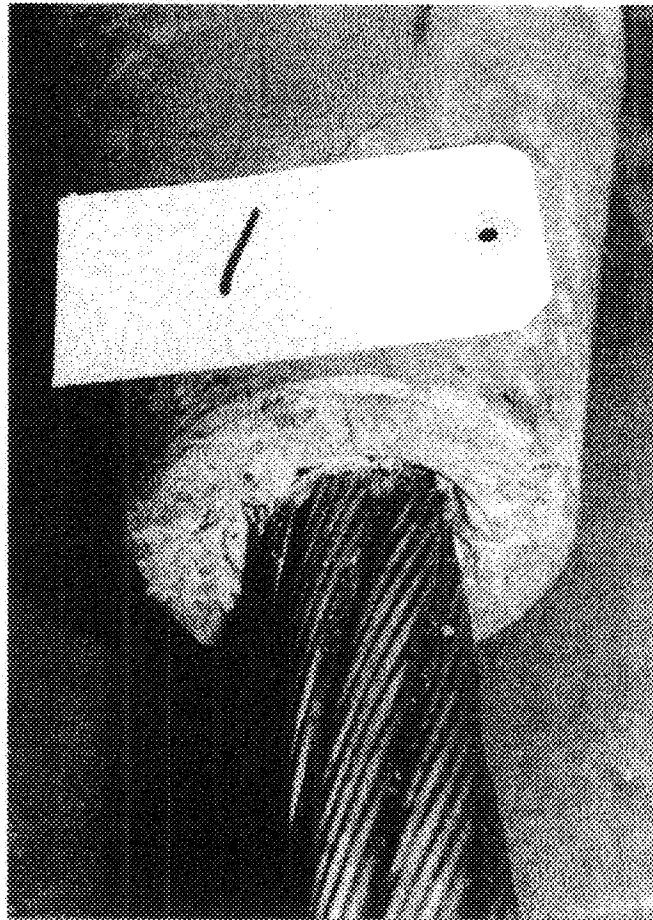
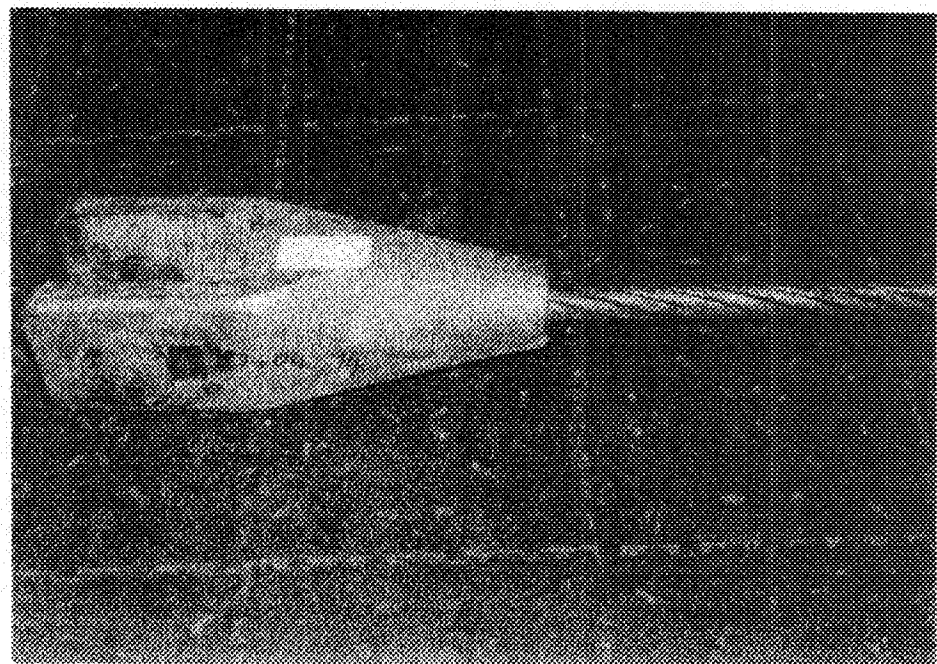
Figure A2 The figure shows the general condition of socket No 1 after it had been prepared.

The preparation of these two sockets was not witnessed by CSIR personnel. It should however be noted that the staff members of this mine had witnessed the CSIR preparing resin sockets on an earlier occasion. When the sockets were brought to the laboratory they were inspected. There was evidence that the strand cores were not very well degreased. This is evident by the rope dressing which was discharged during the resin curing process shown in Figure A1. Besides this the sockets were very well prepared (See Figure A2).

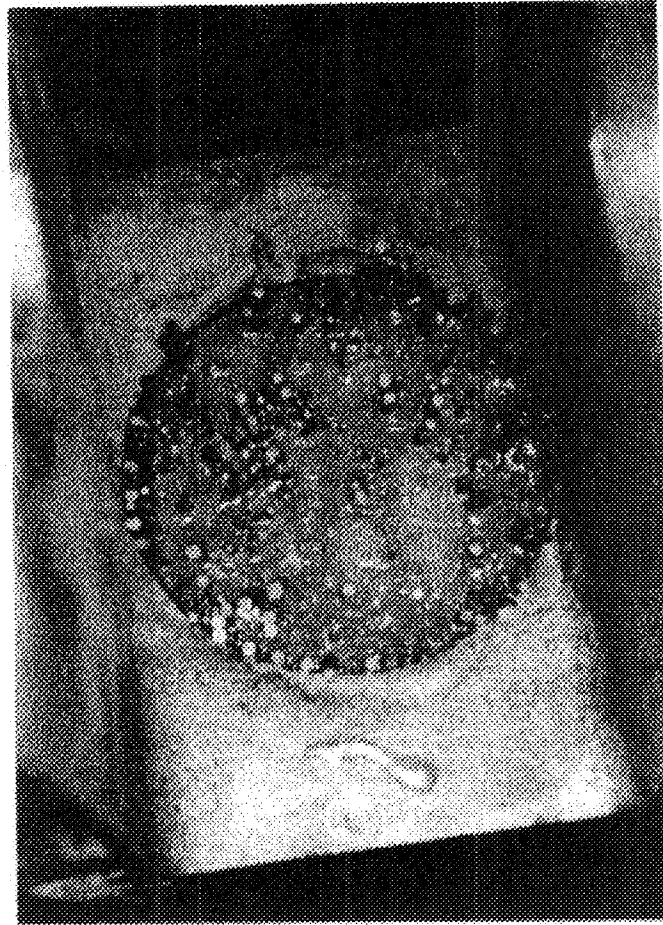
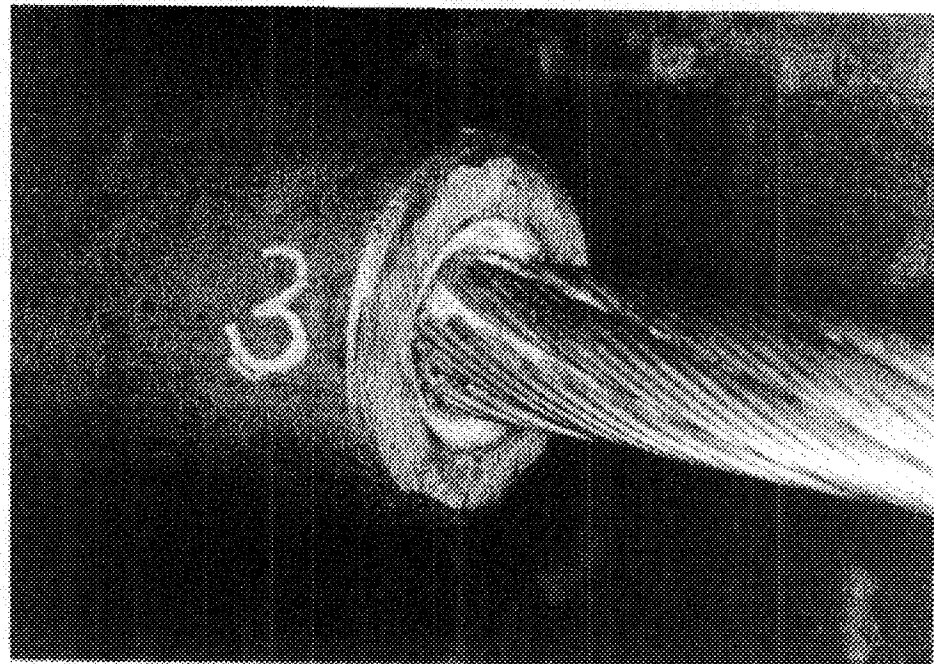
Figure A3 The figure shows the general condition of socket No 3 after it had been prepared.

**With the guidance of the CSIR staff member** the preparation of the first socket went fairly well and the quality of the termination was very good (See Figure A3). During the preparation of the second socket the mine personnel were left to complete the entire exercise by themselves. The quality of the second socket was very good. It was evident from this exercise that although a person learns how to make a socket in a very short time, the notes and video are not as easily understood as we had anticipated. Practical training backed up by written notes (which can be referred to) is required for the correct preparation of resin sockets for winder ropes.

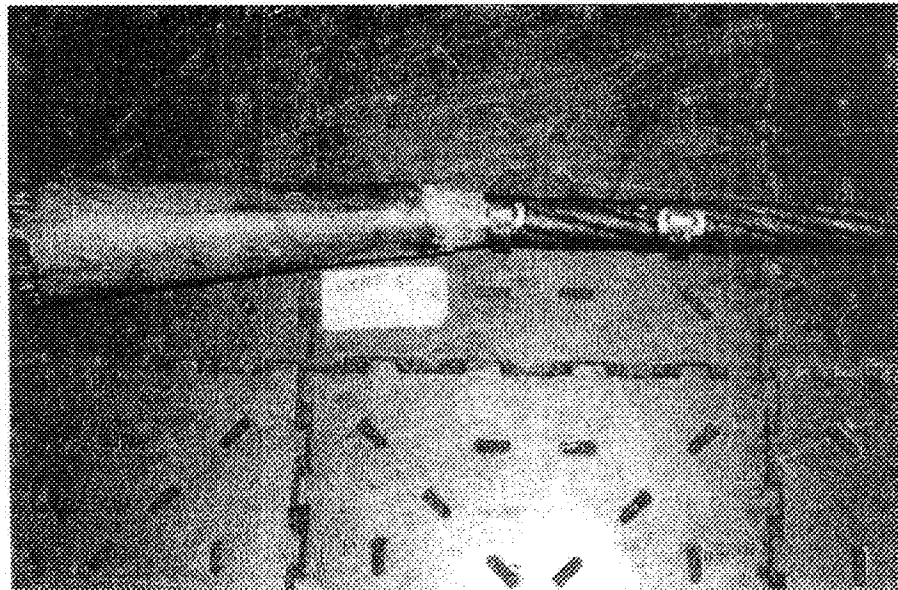
Figure A4 The figure shows the resin capping which was pushed out of the socket for inspection prior to testing. Notice the two metal straps on the rope and how the capping is not aligned with the rope.

The socket preparation was contrary to what the rigger had claimed. It appeared that the rigger had not watched the video, nor had he studied the relevant literature. Firstly, instead of fastening the rope with serving wire, two metal straps approximately 150 mm apart, were used (See Figure A4). The length of the brush was also incorrect. The basket length of the socket was measured and this was used as the brush length. In effect, the brushes started at the neck of the sockets (See Figure A5). This was a direct violation of the prescribed procedure. The unravelling of the wires to form a brush was also incorrect. The bending back of the strands and wires exceeded the prescribed angle. Lastly, the socket was not aligned with the rope prior to casting (See Figure A6).

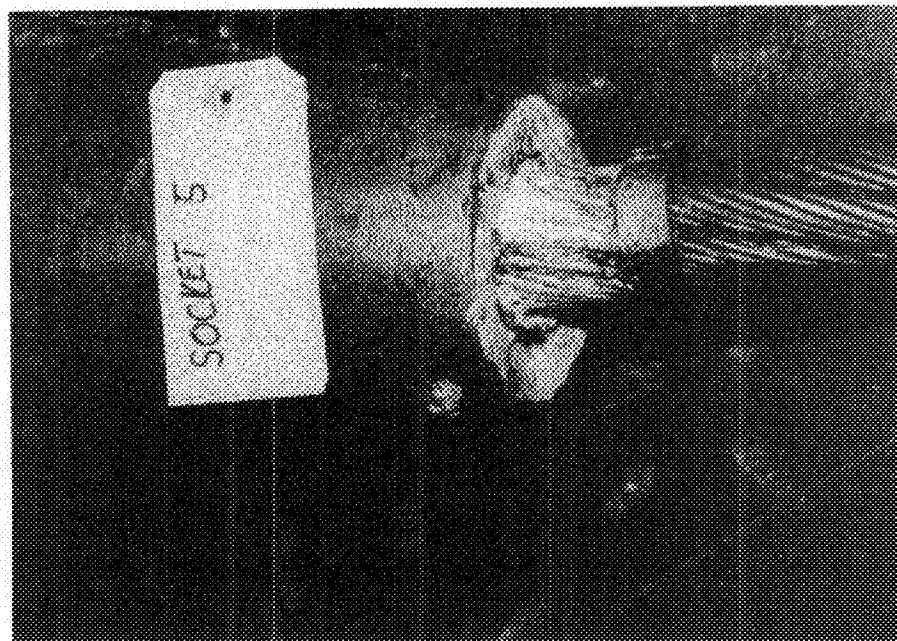
Figure A5 The figure shows the general condition of socket No 5 after it had been prepared. The length of the brush was incorrect and it protruded outside the neck of the socket.

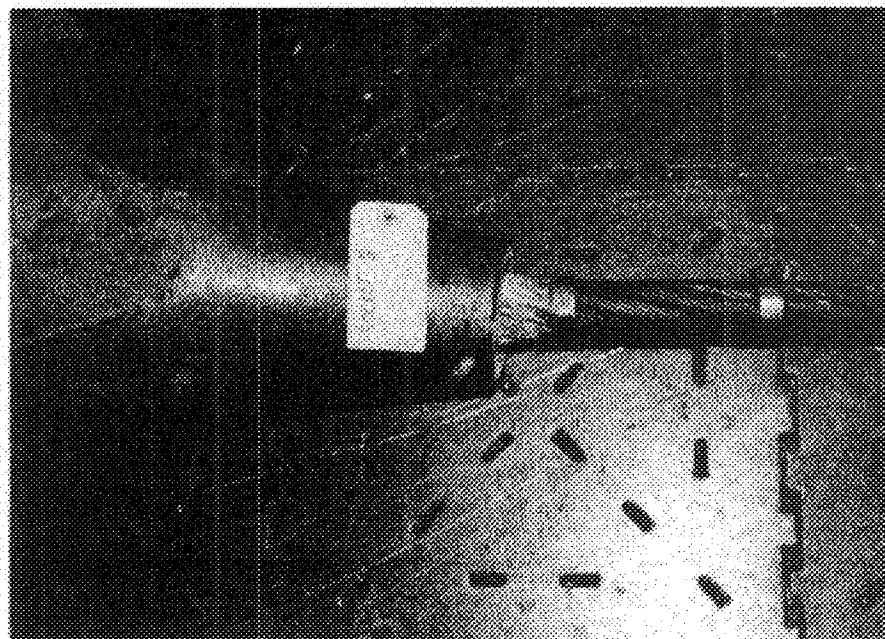
Figure A6 The figure shows the general condition of socket No 5 after it had been prepared. Apart from the length of the brush being incorrect the socket is also not aligned with the rope.

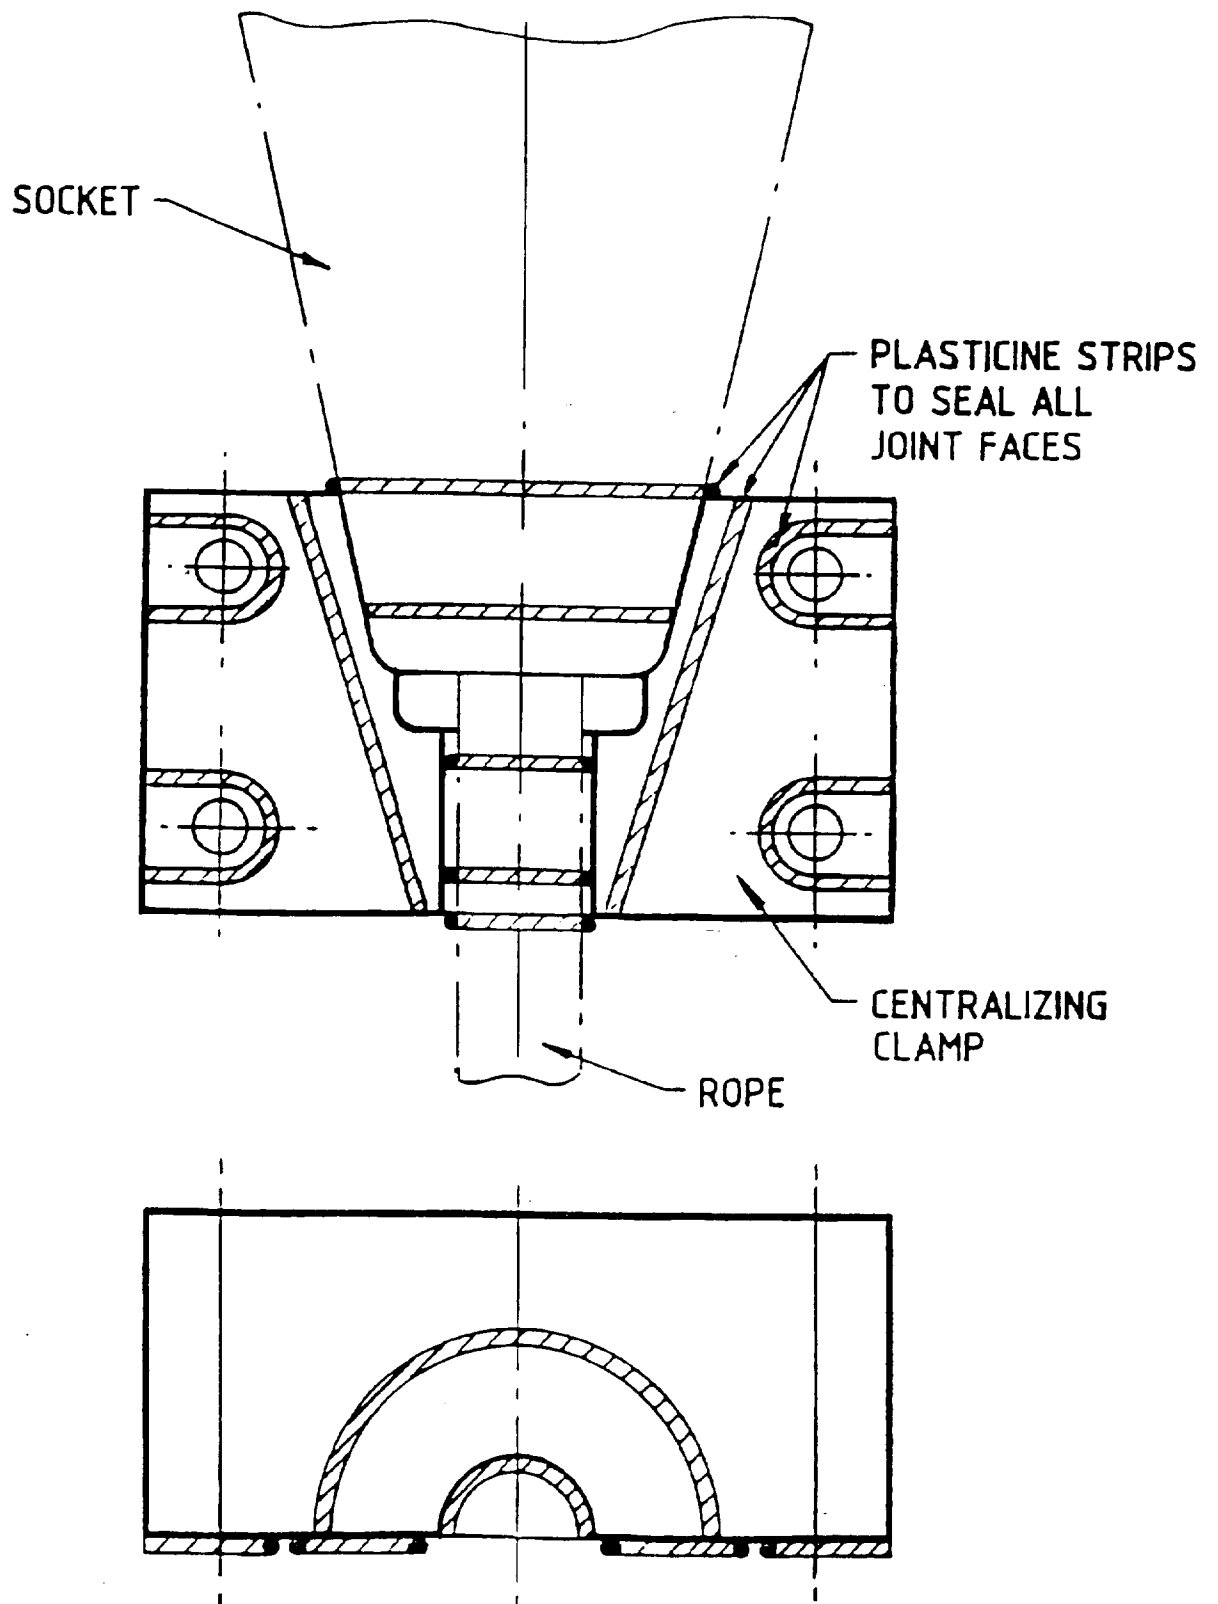
FIGURE 1. TYPICAL SEALING ARRANGEMENT OF CENTRALIZING CLAMP

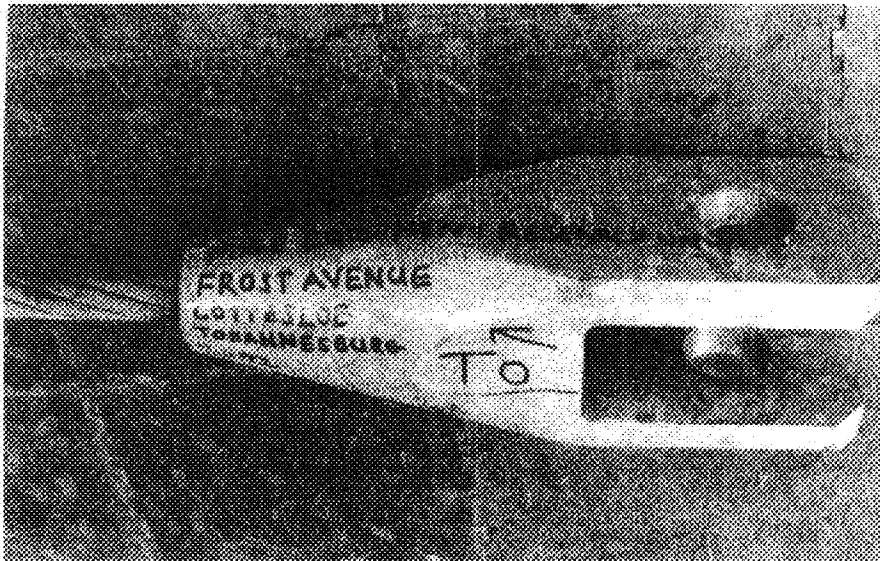
**Figure 1:** The photograph shows the No 1 socket on the laboratory floor after it had been in service for six months

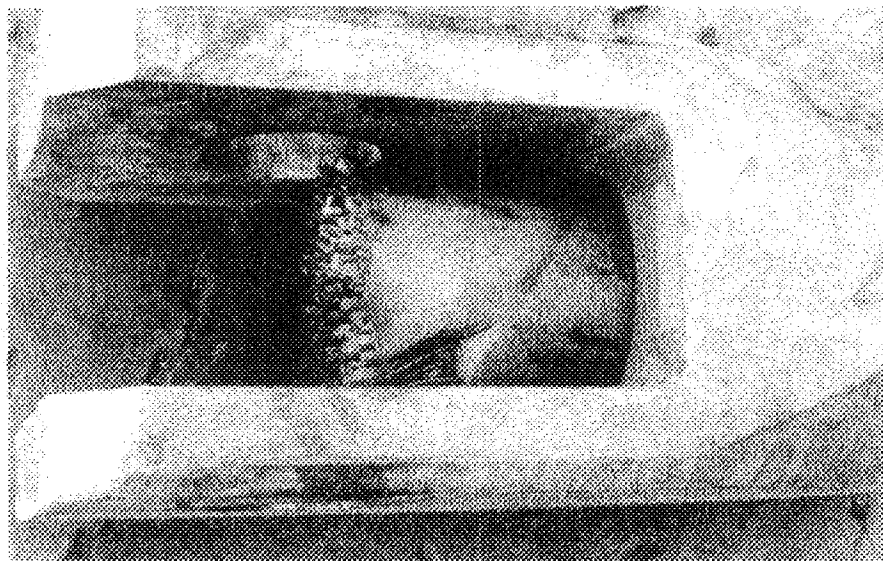
**Figure 3:** The photograph shows the No 2 socket on the laboratory floor after, damage to the resin capping and the steel socket is visible

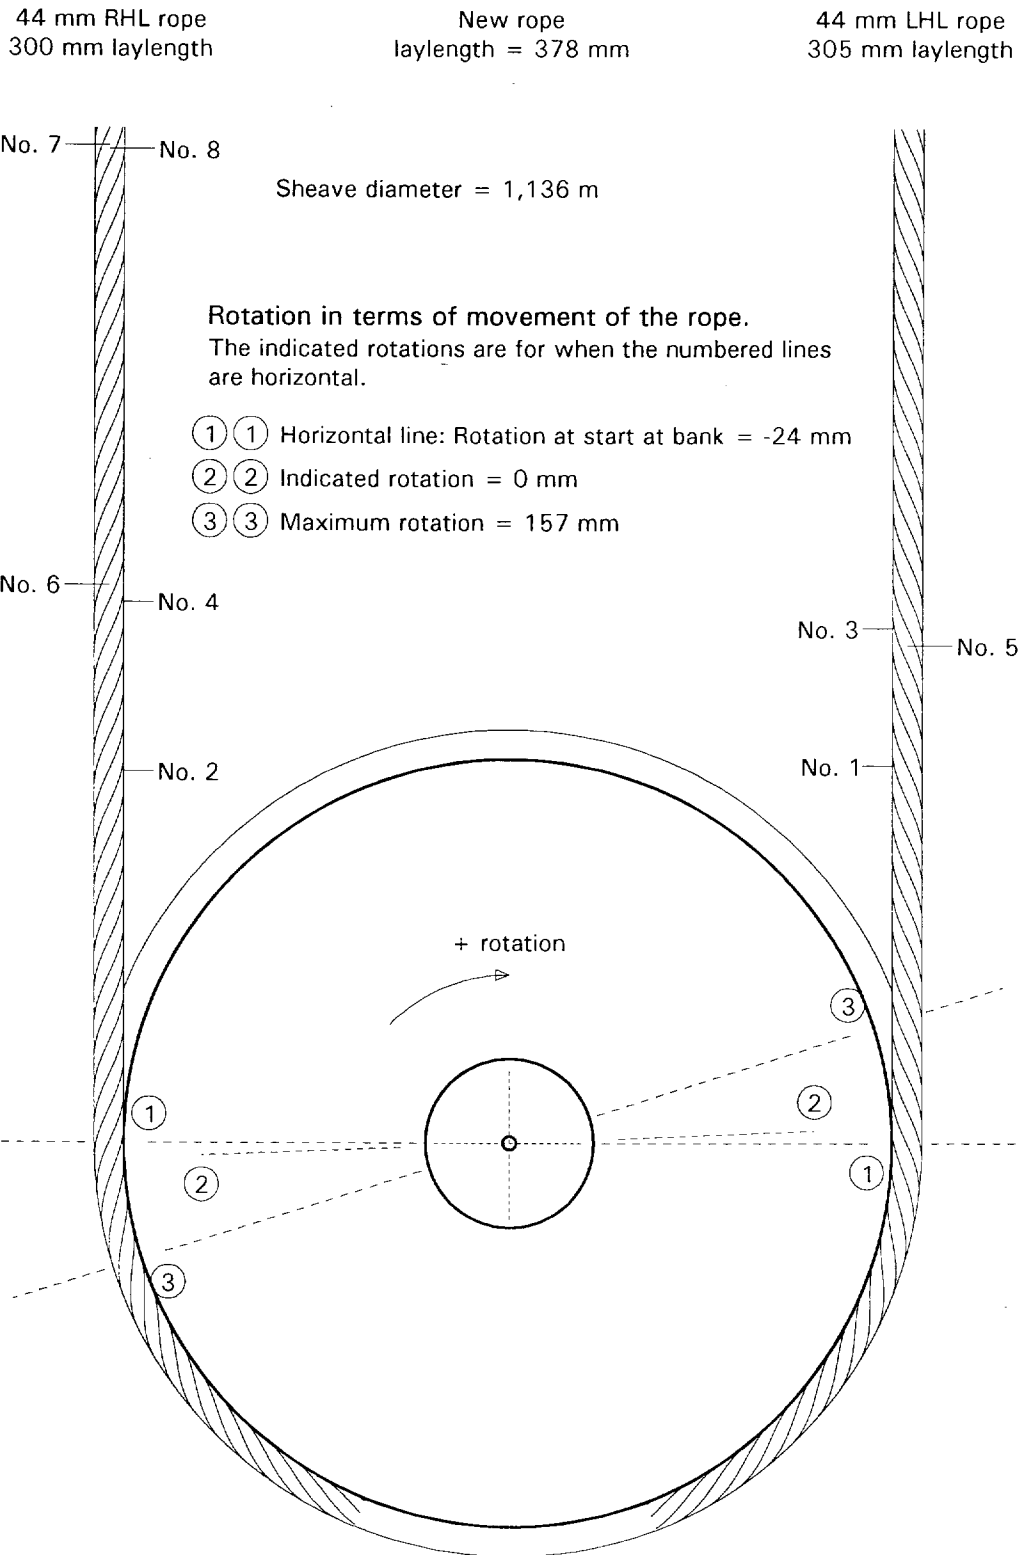
Figure 4: Winder BB: Compensating sheave layout, rope information, rotation direction and strain gauge positions.

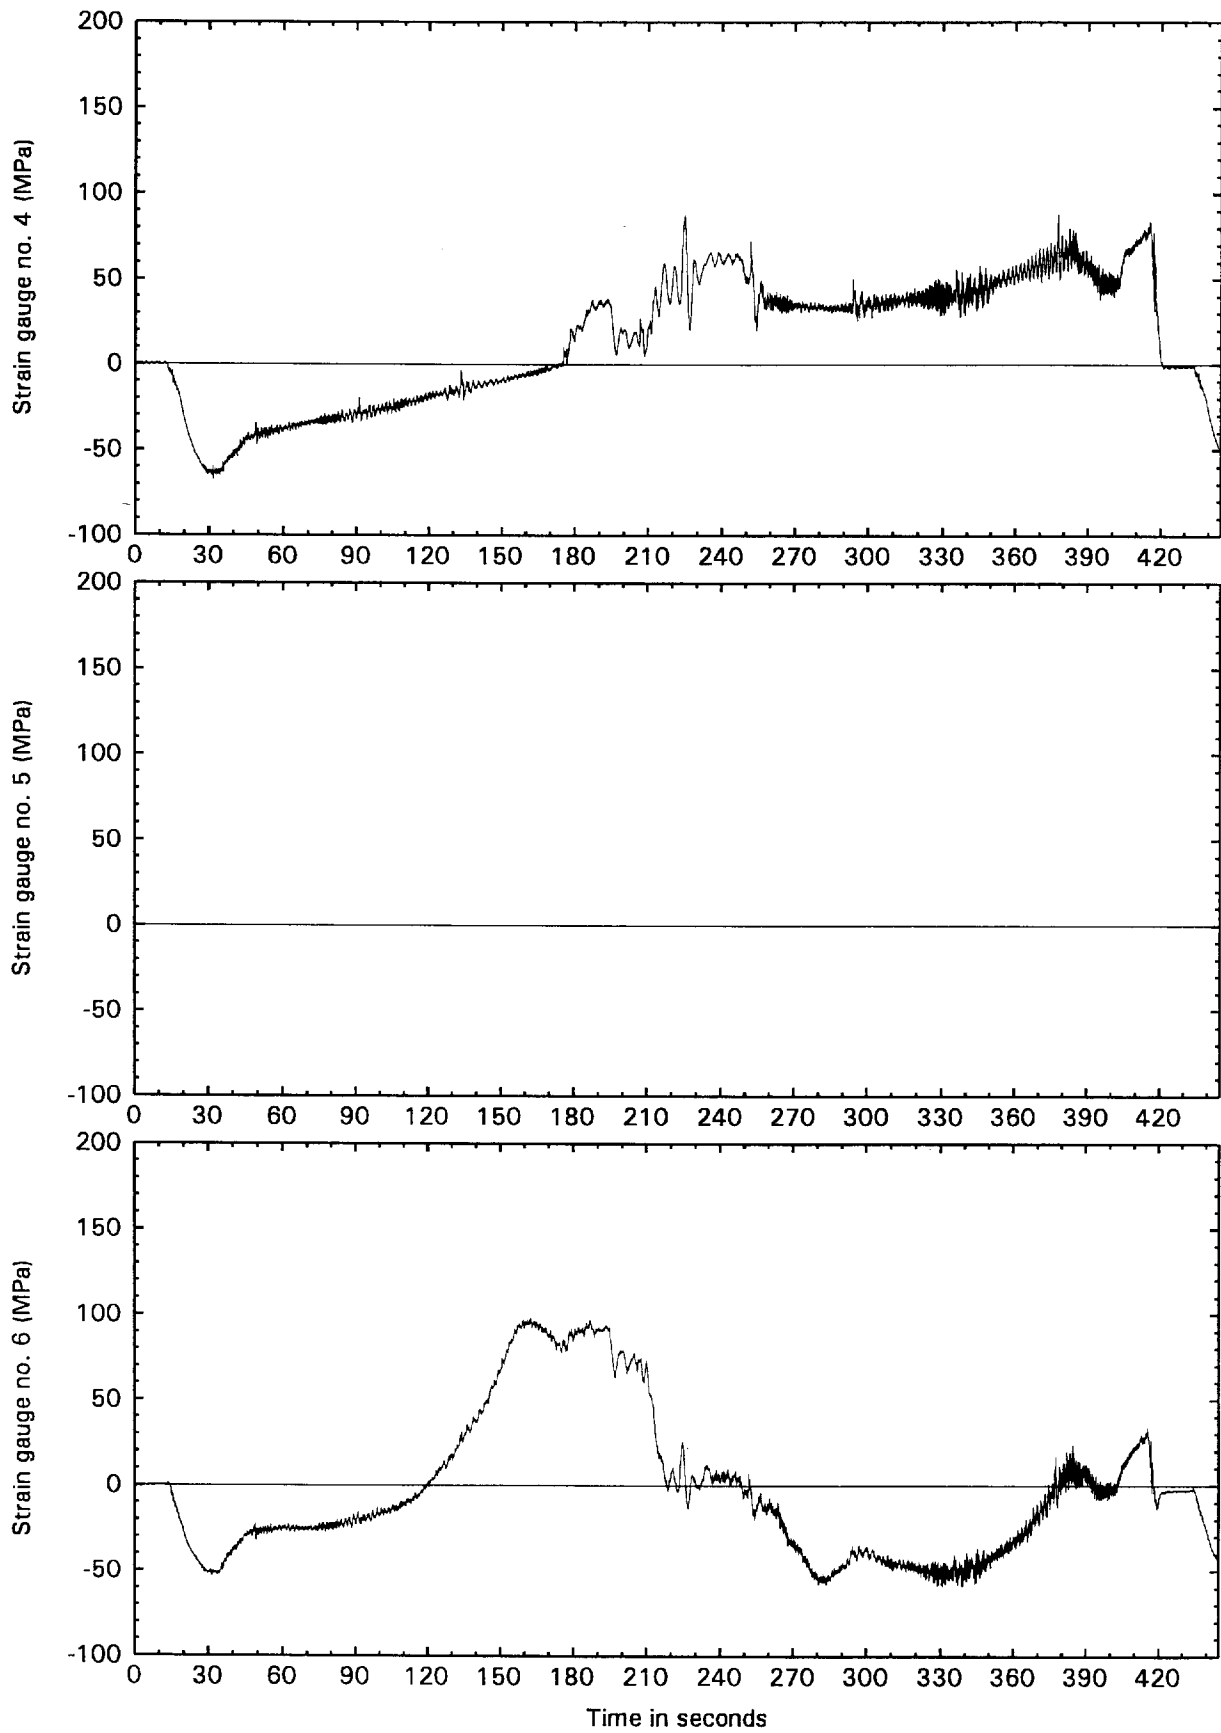
Figure 7: Winder AA: Stress measurements during a single winding cycle.

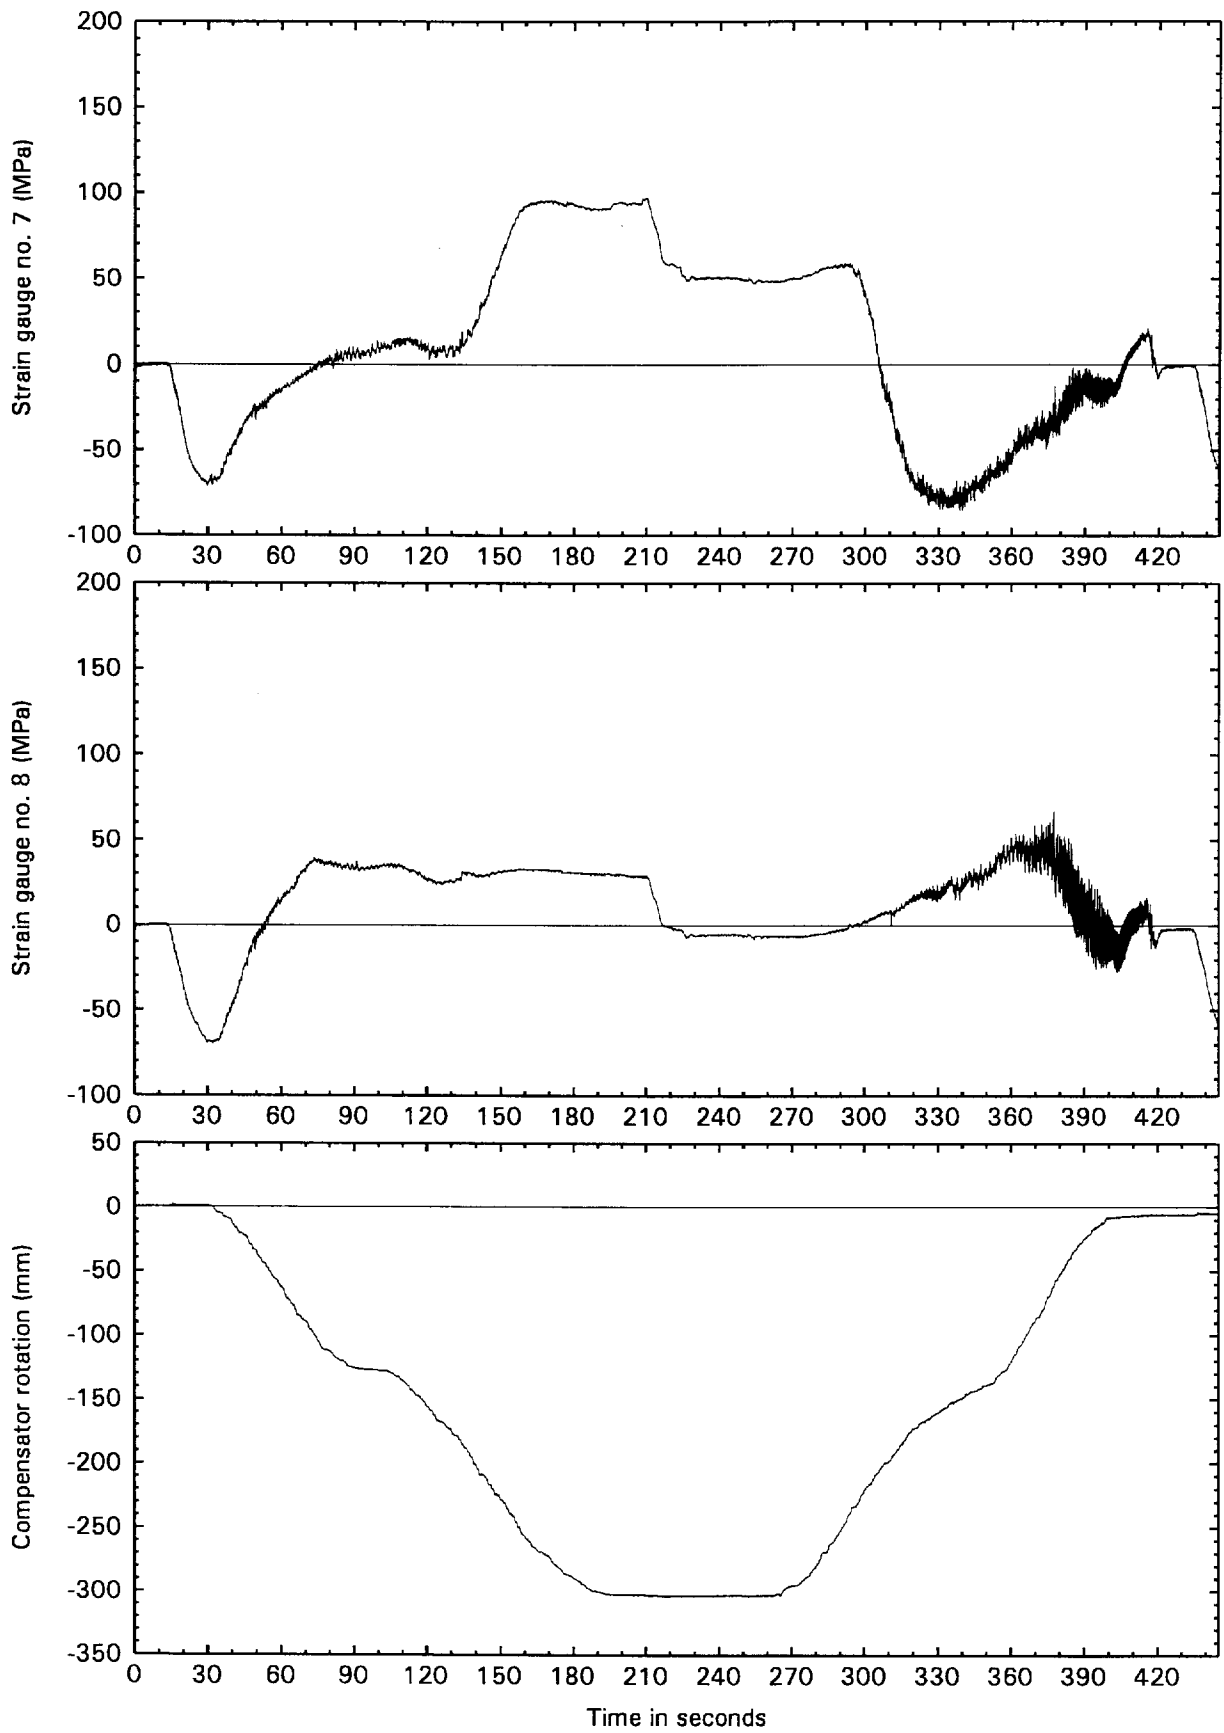
Figure 8: Winder AA: Stress measurement and compensating sheave rotation during a single winding cycle.

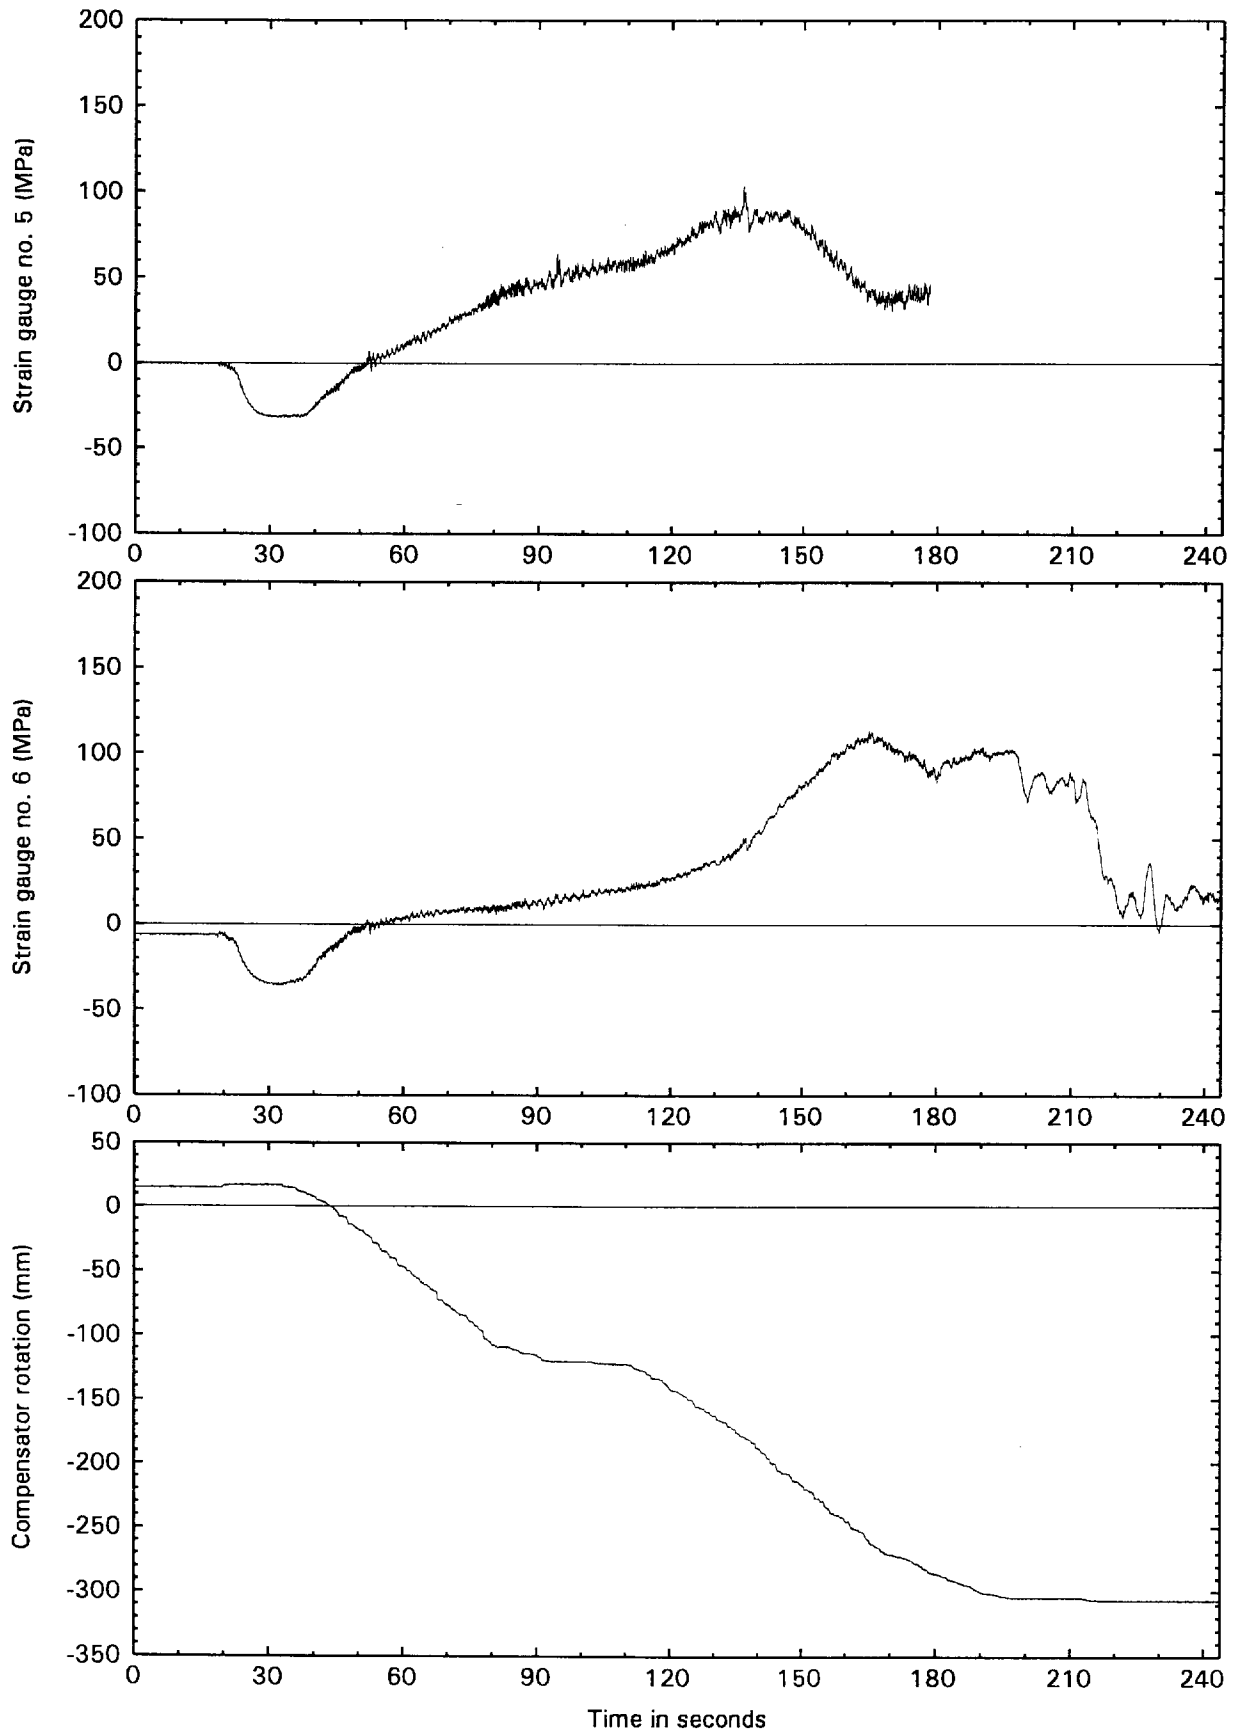
Figure 9: Winder AA: Stress measurement and compensating sheave rotation during part of a winding cycle.

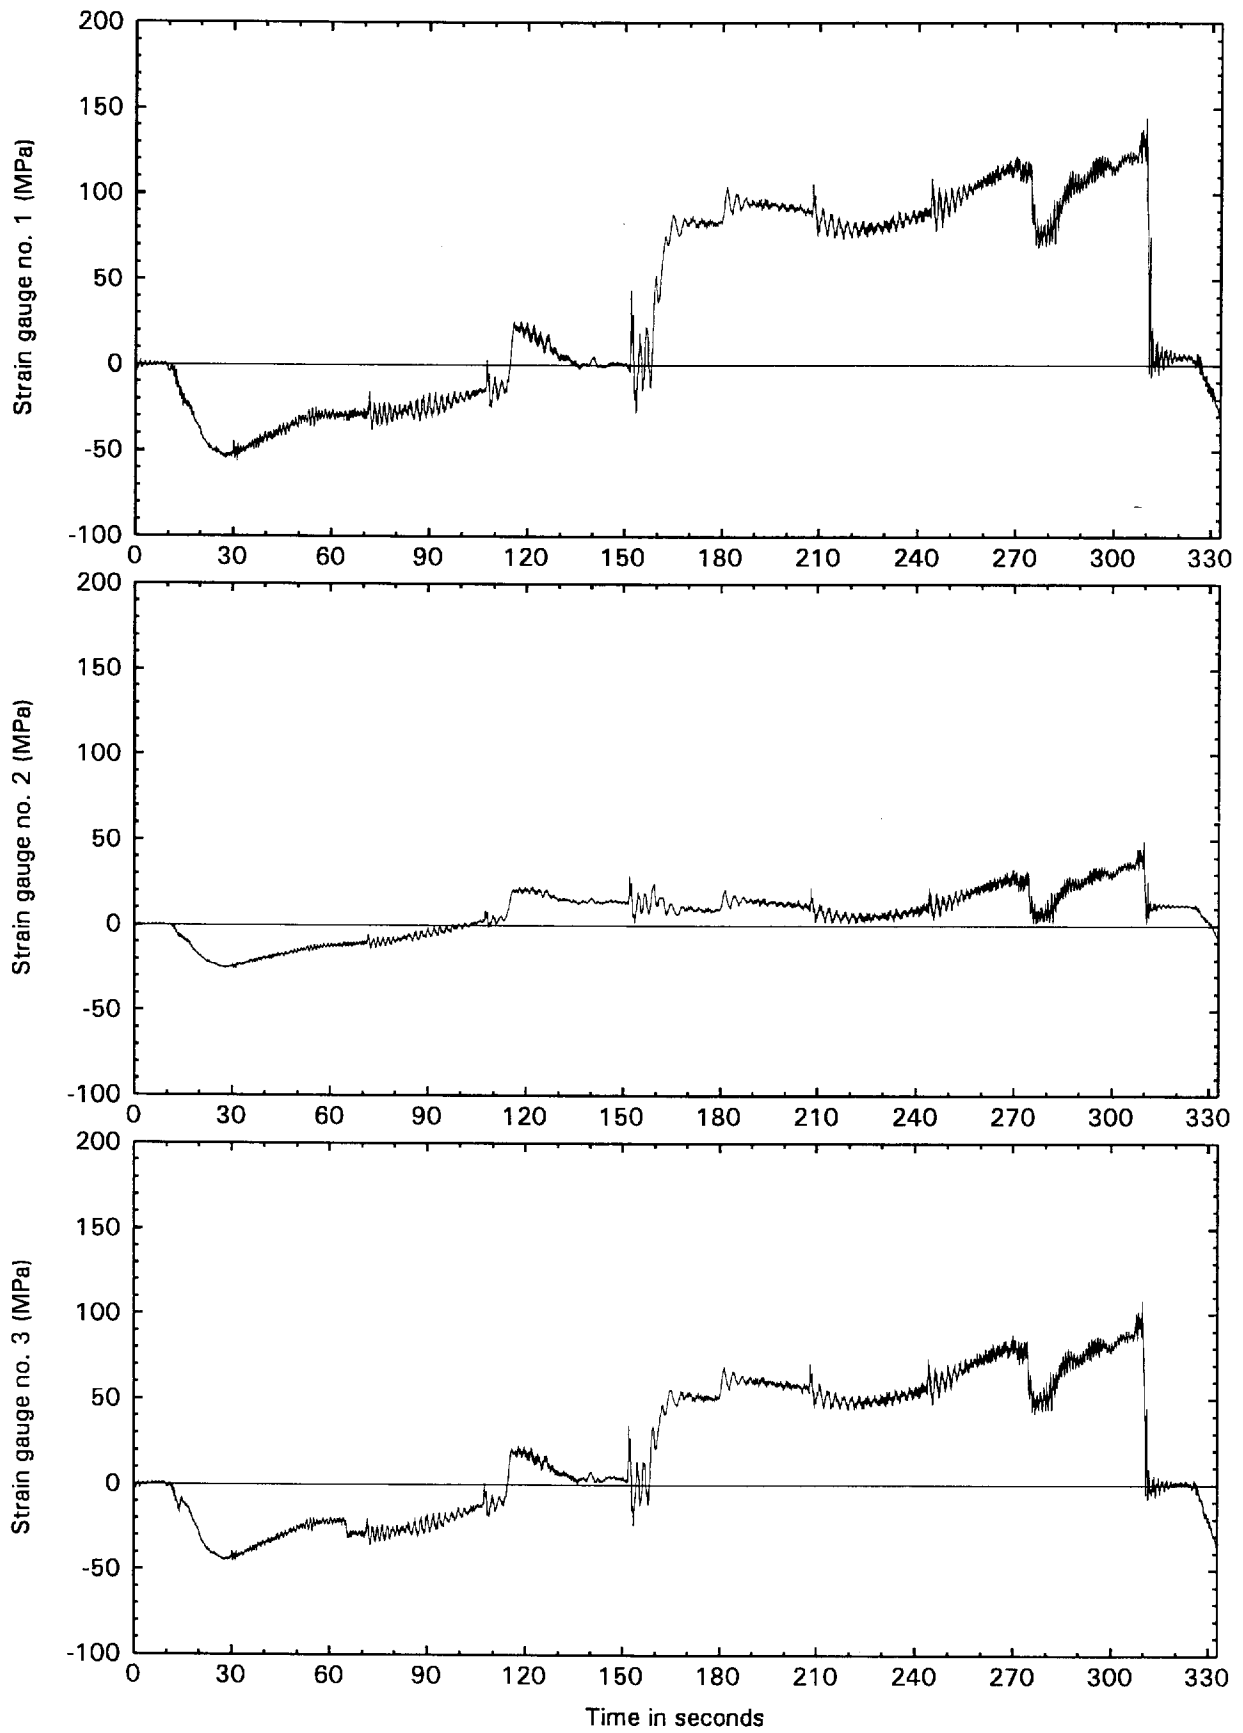
Figure 13: Winder CC: Stress measurements during a single winding cycle.
