Title: THE SAFE USE OF MINE WINDING ROPES

Volume 3: Rope Terminations

Project No: GAP 054

**LABORATORY EVALUATION OF  
WHITE METAL AND RESIN CAPPINGS  
FOR USE AS WINDER ROPE  
TERMINATIONS**

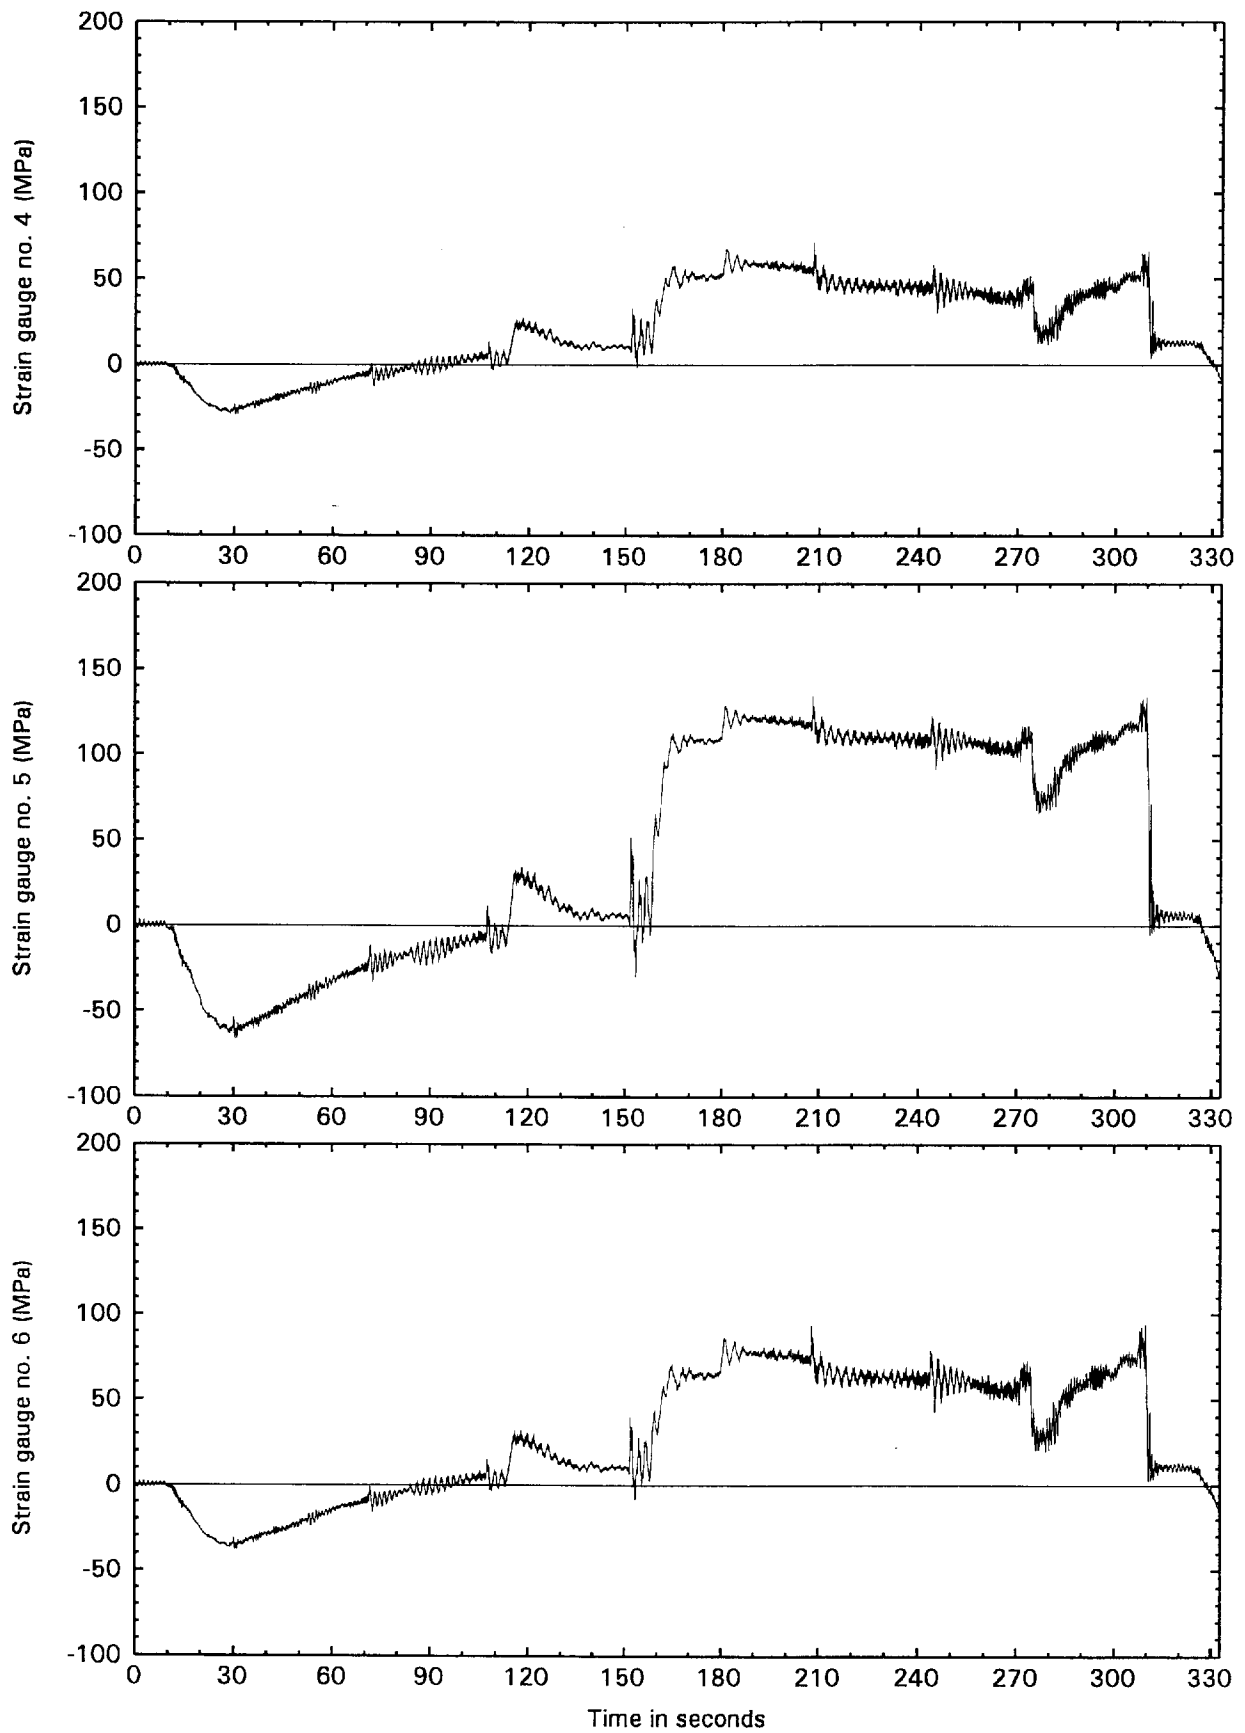
Figure 14: Winder CC: Stress measurements during a single winding cycle.

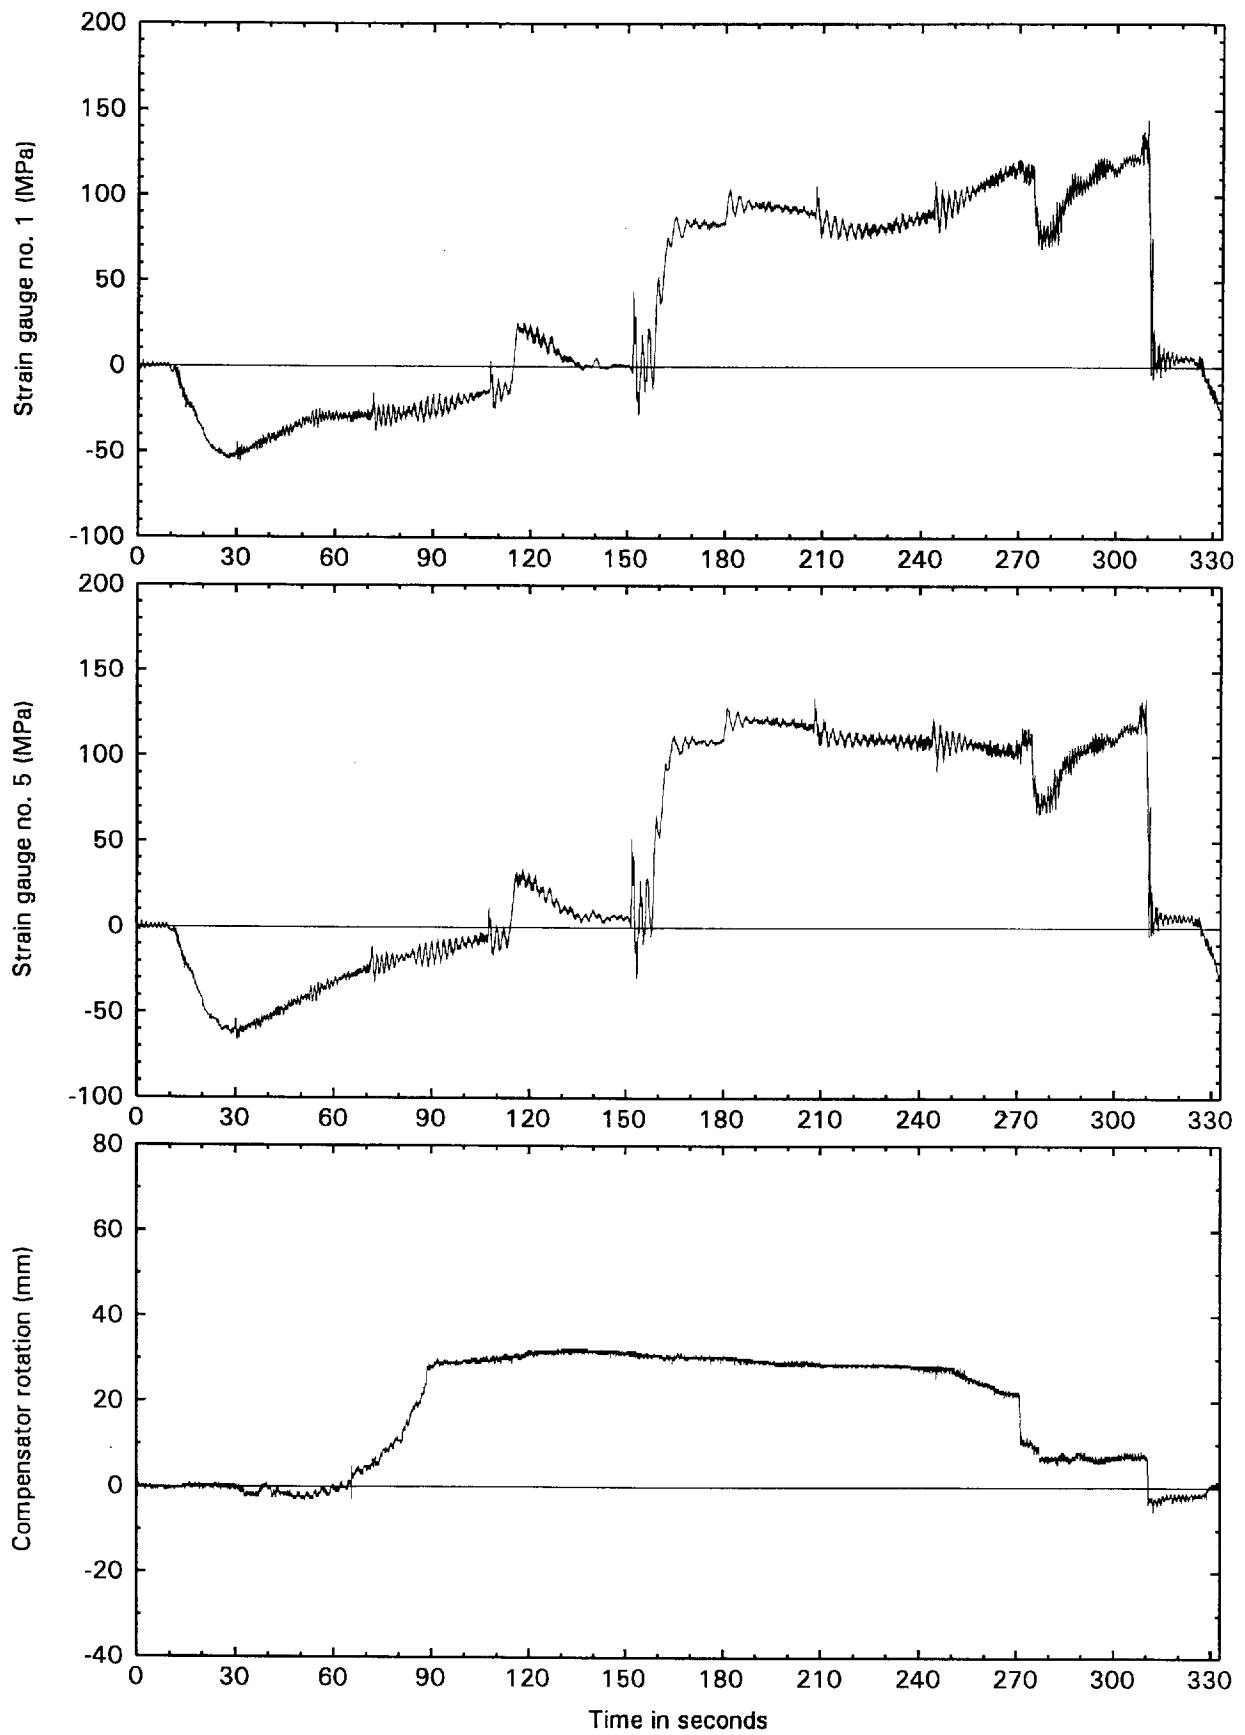
Figure 15: Winder CC: Stress measurement and compensating sheave rotation during a single winding cycle.

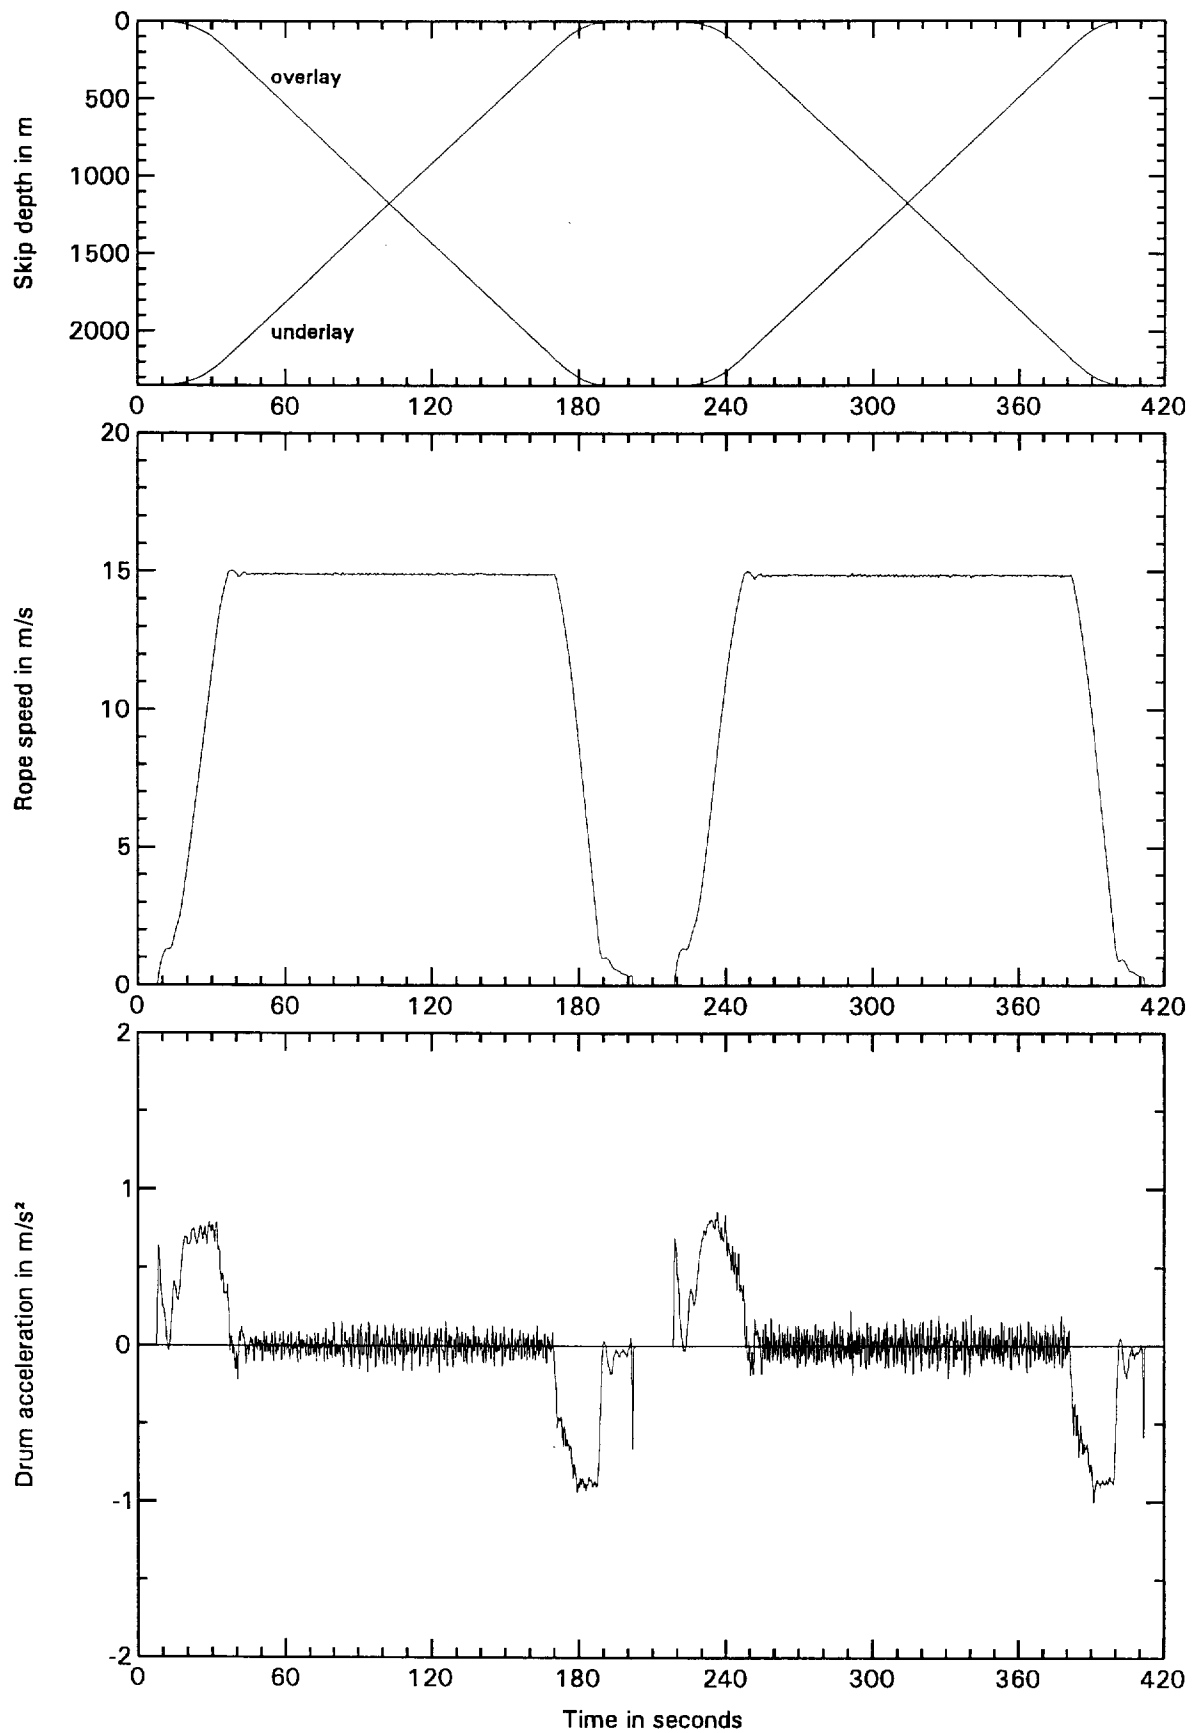
Figure A1: Winder AA: Skip position, rope speed, and drum acceleration.

There is nothing abnormal or out of the ordinary in the accelerations measured on the three winders.

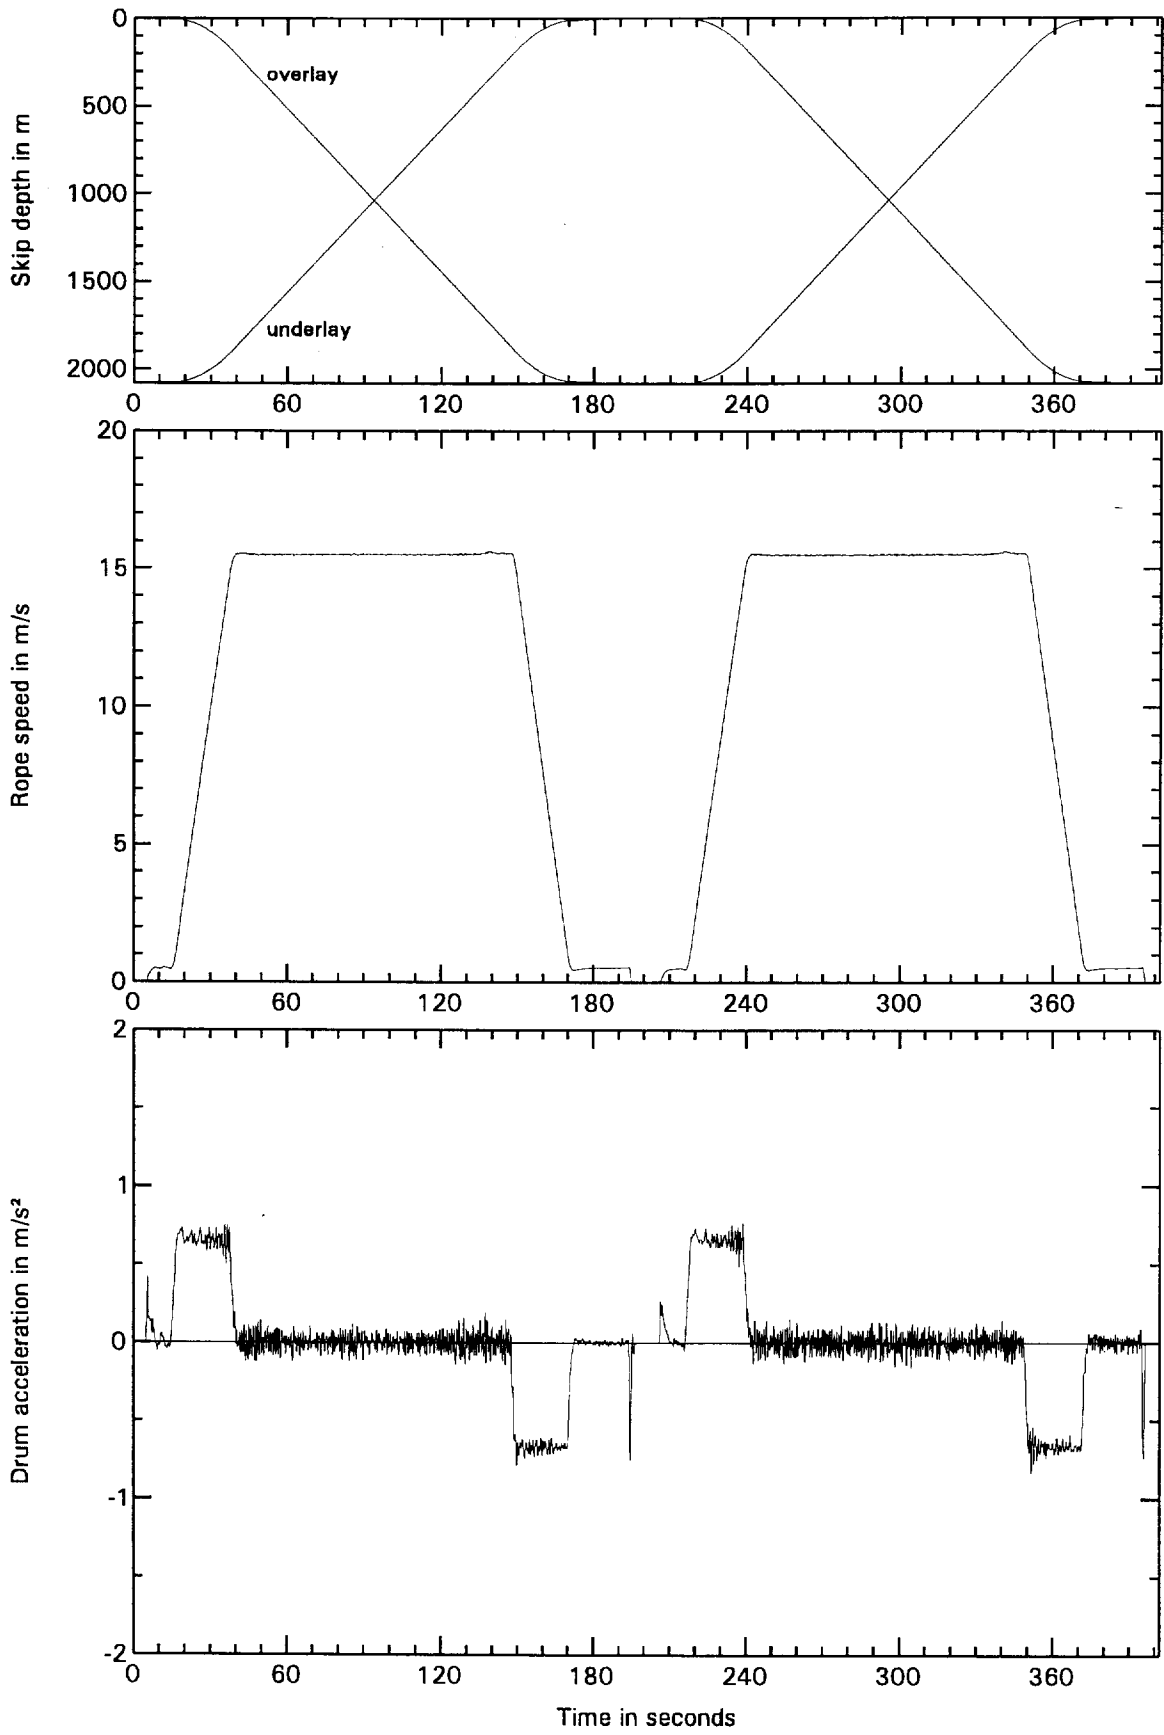
Figure A2: Winder BB: Skip position, rope speed, and drum acceleration.

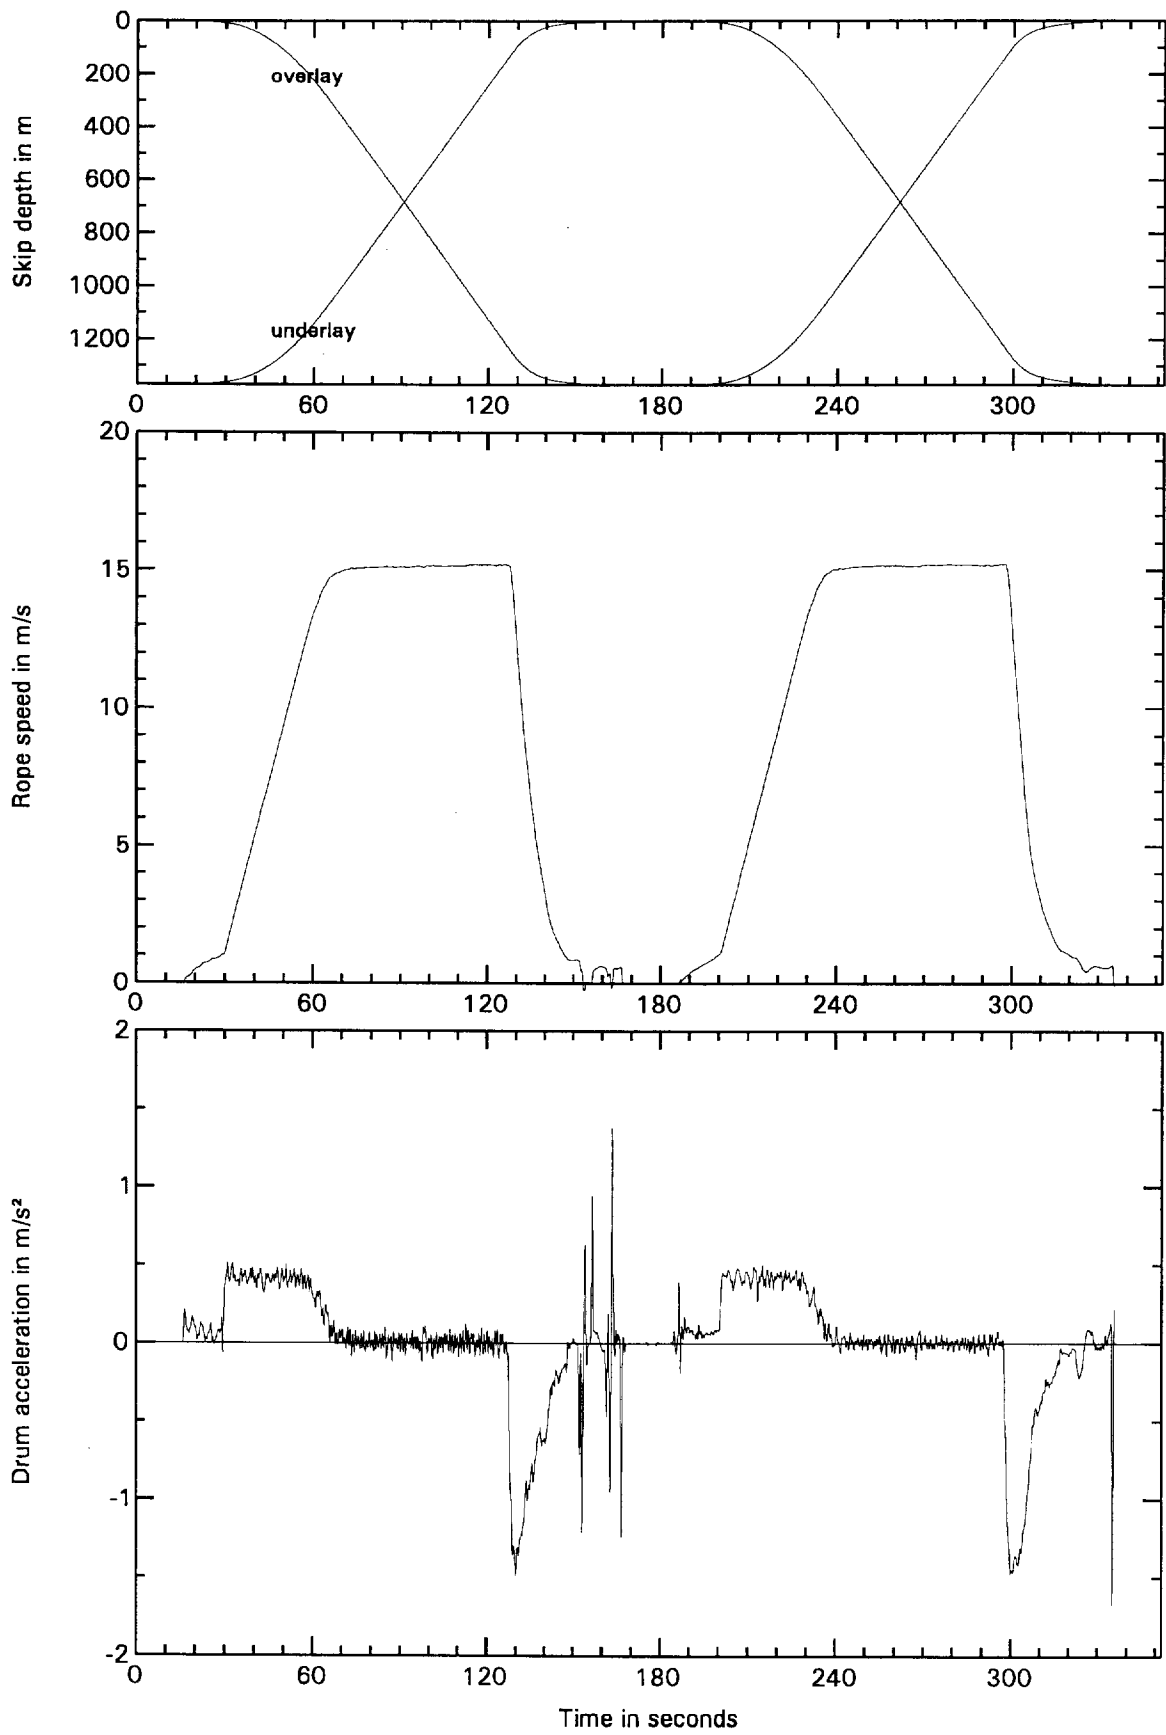
Figure A4: Winder CC: Skip position, rope speed, and drum acceleration for a cold winder drive.

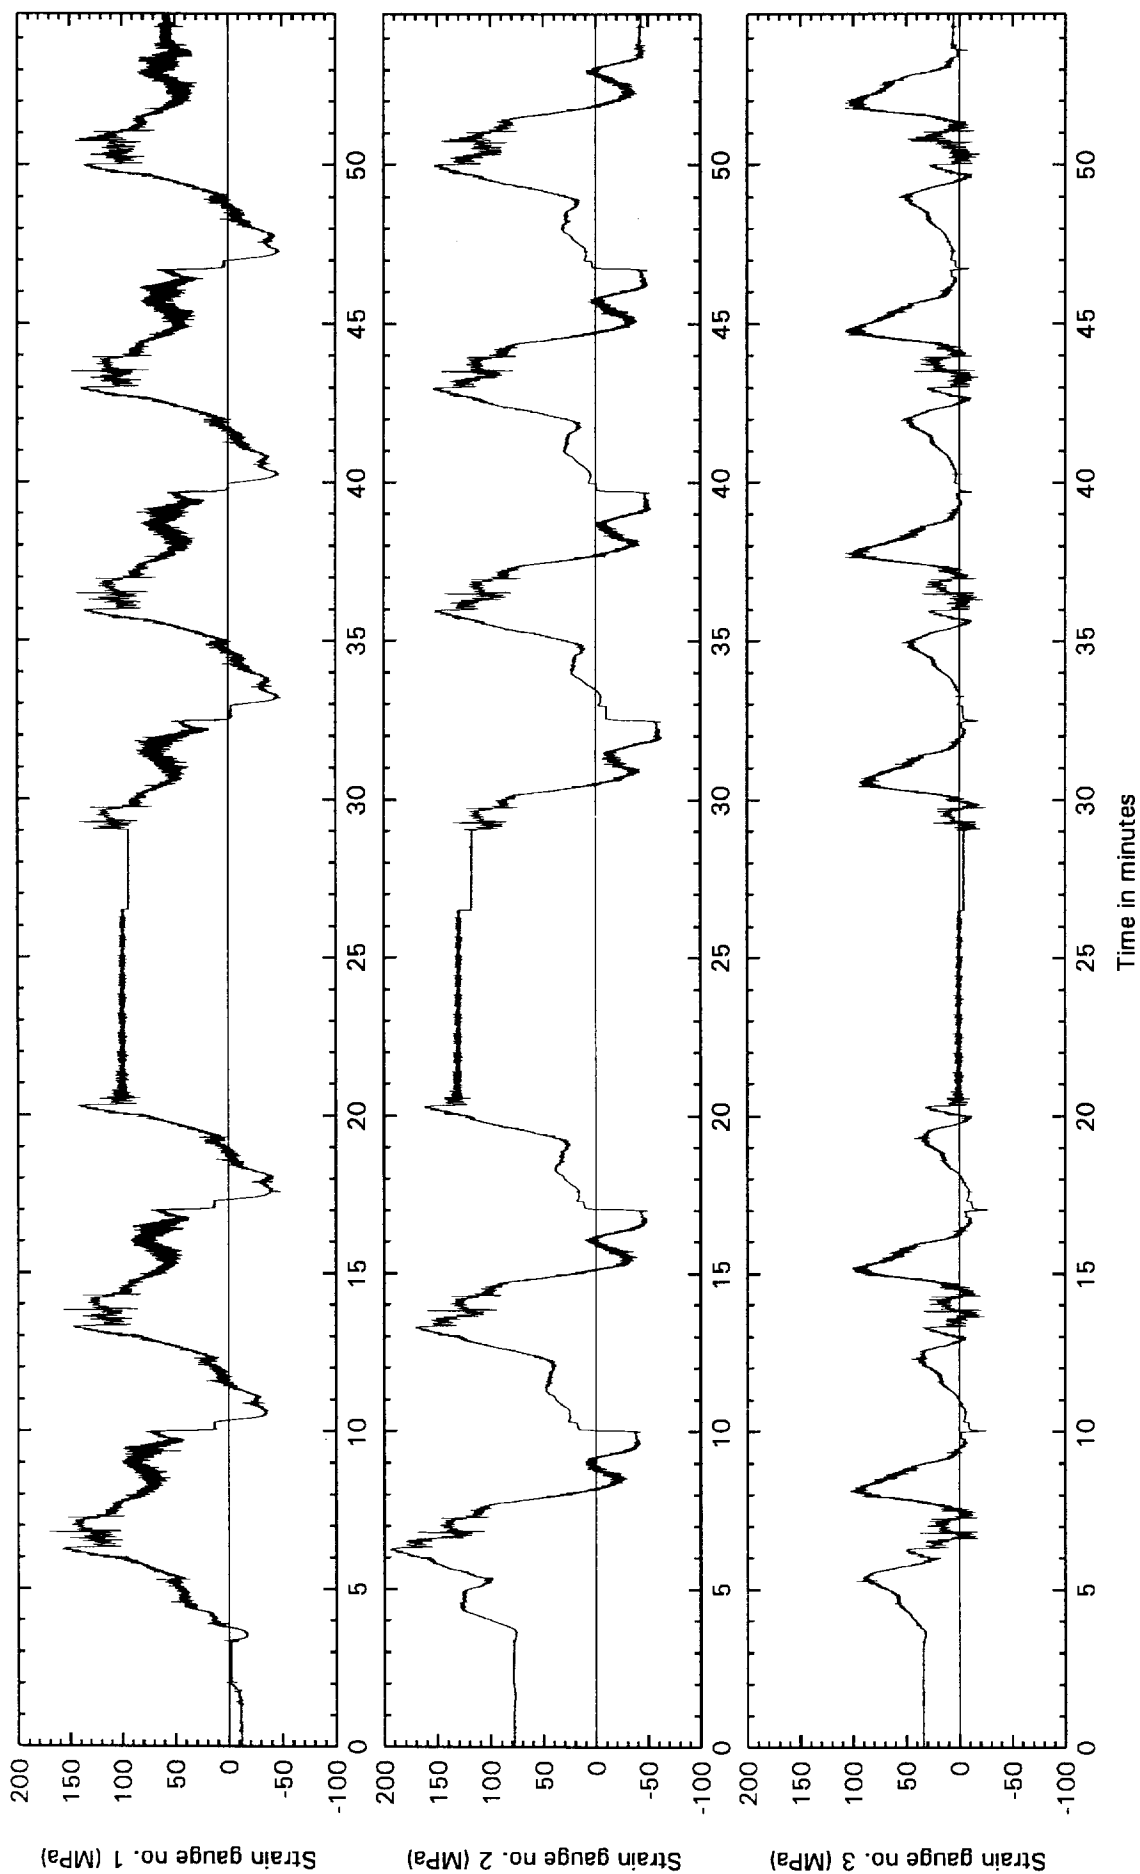
Figure B1: Winder AA: Stress measurements.

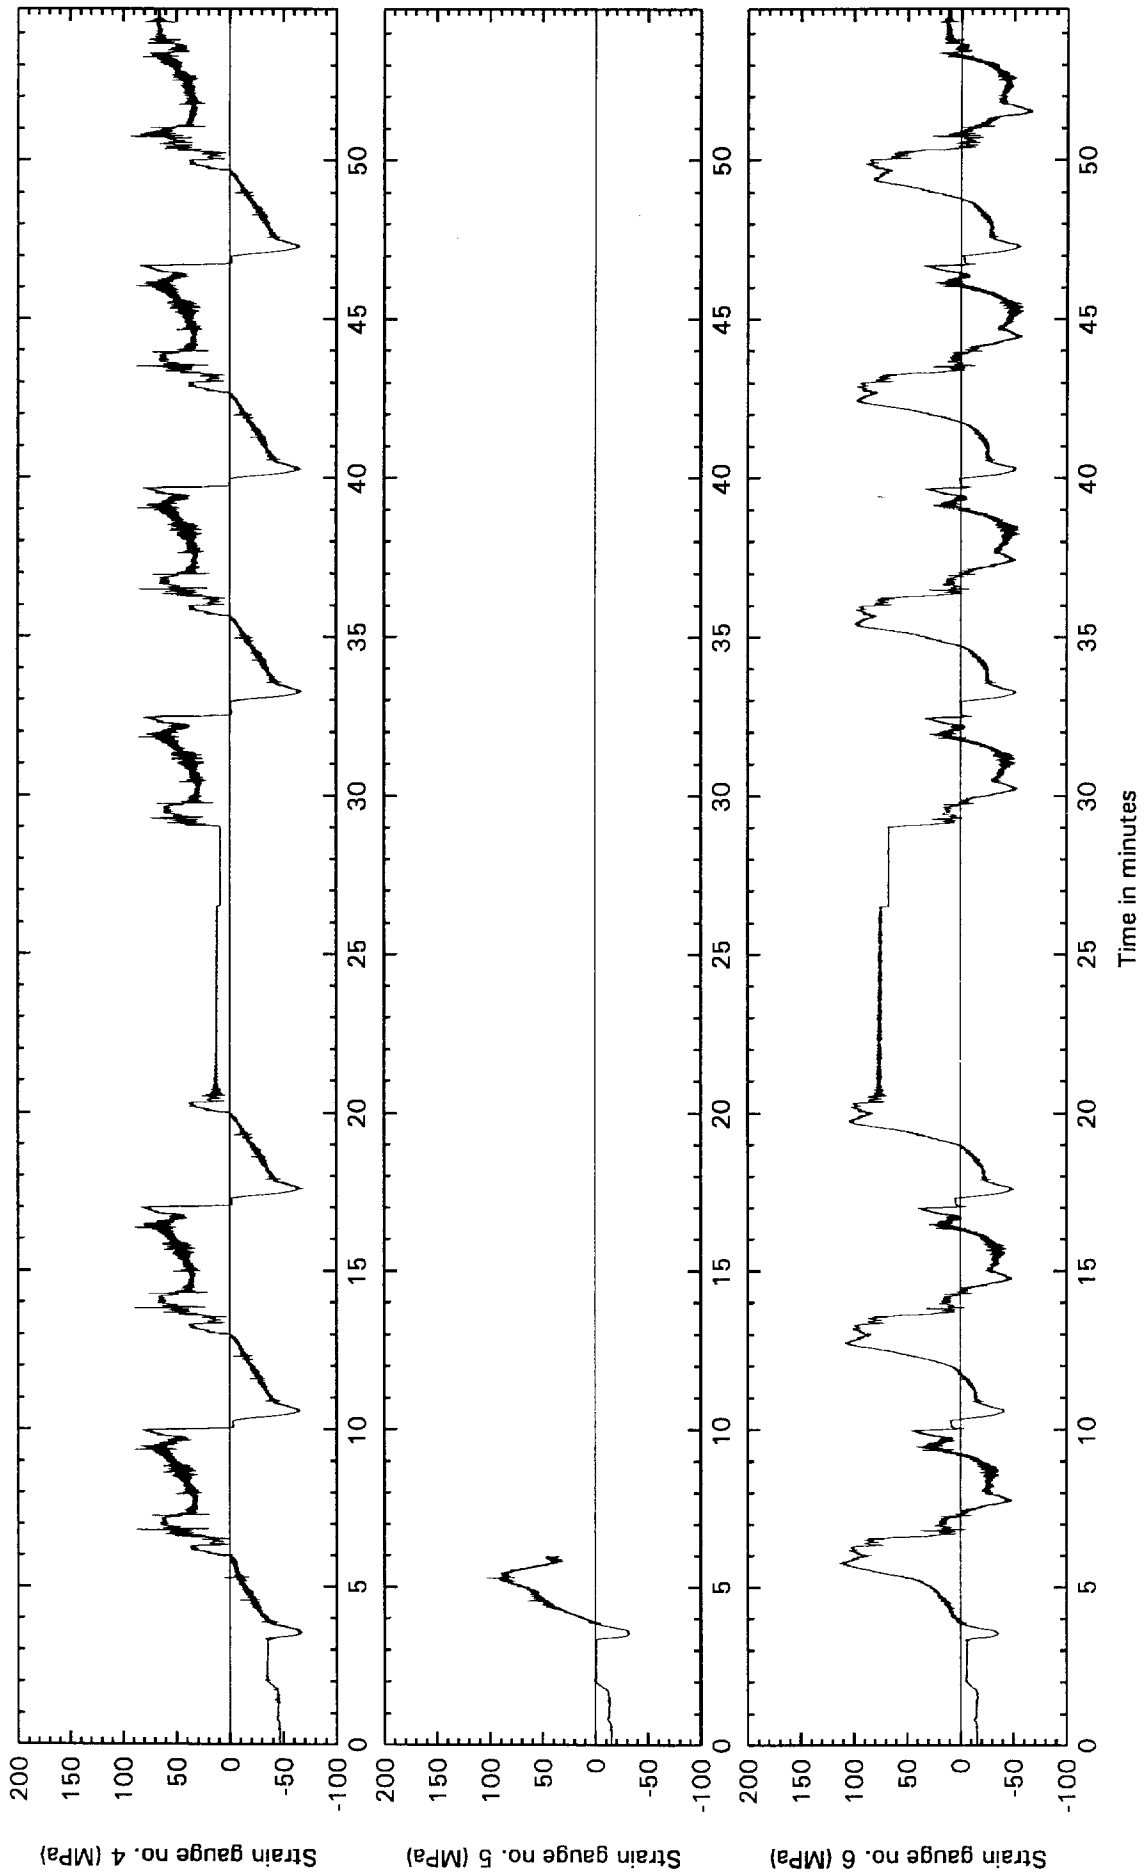
Figure B2: Winder AA: Stress measurements.

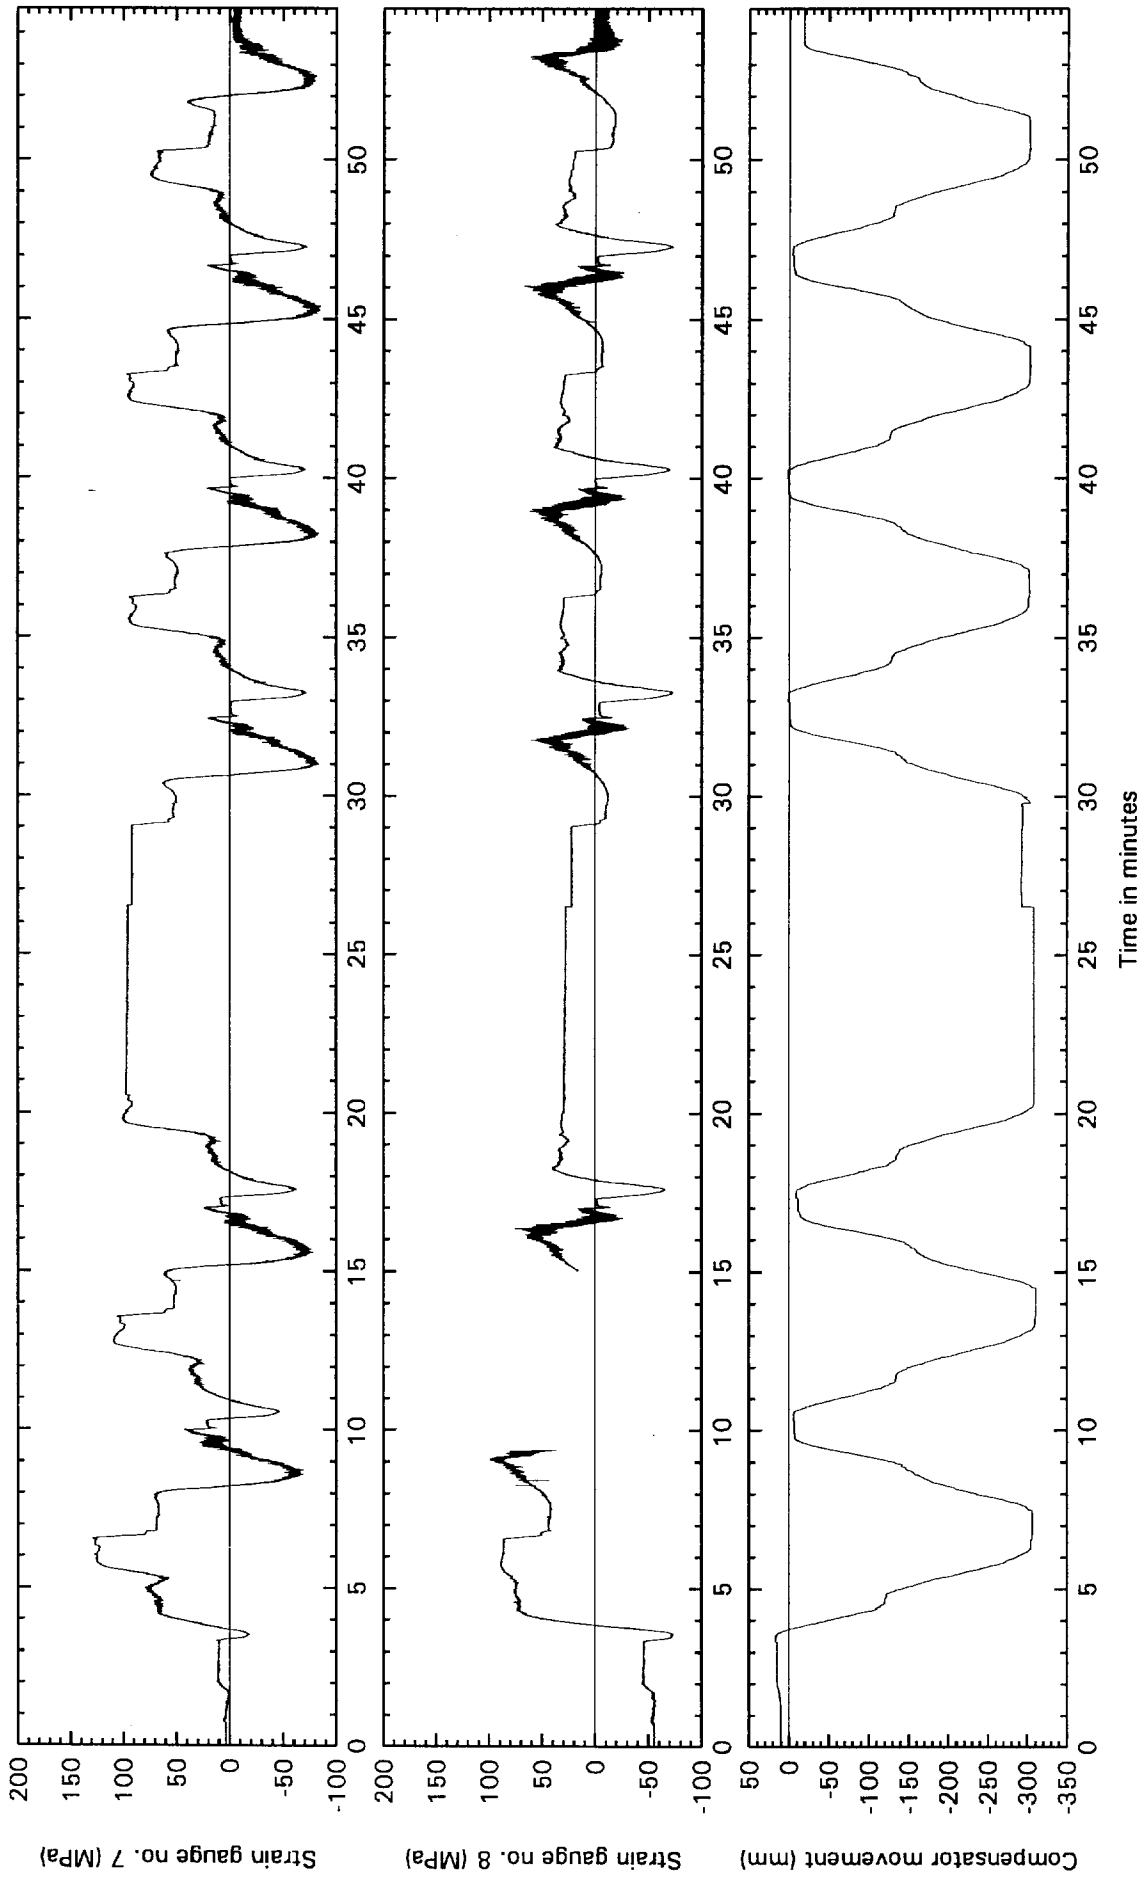
Figure B3: Winder AA: Stress measurements and compensating sheave rotation.

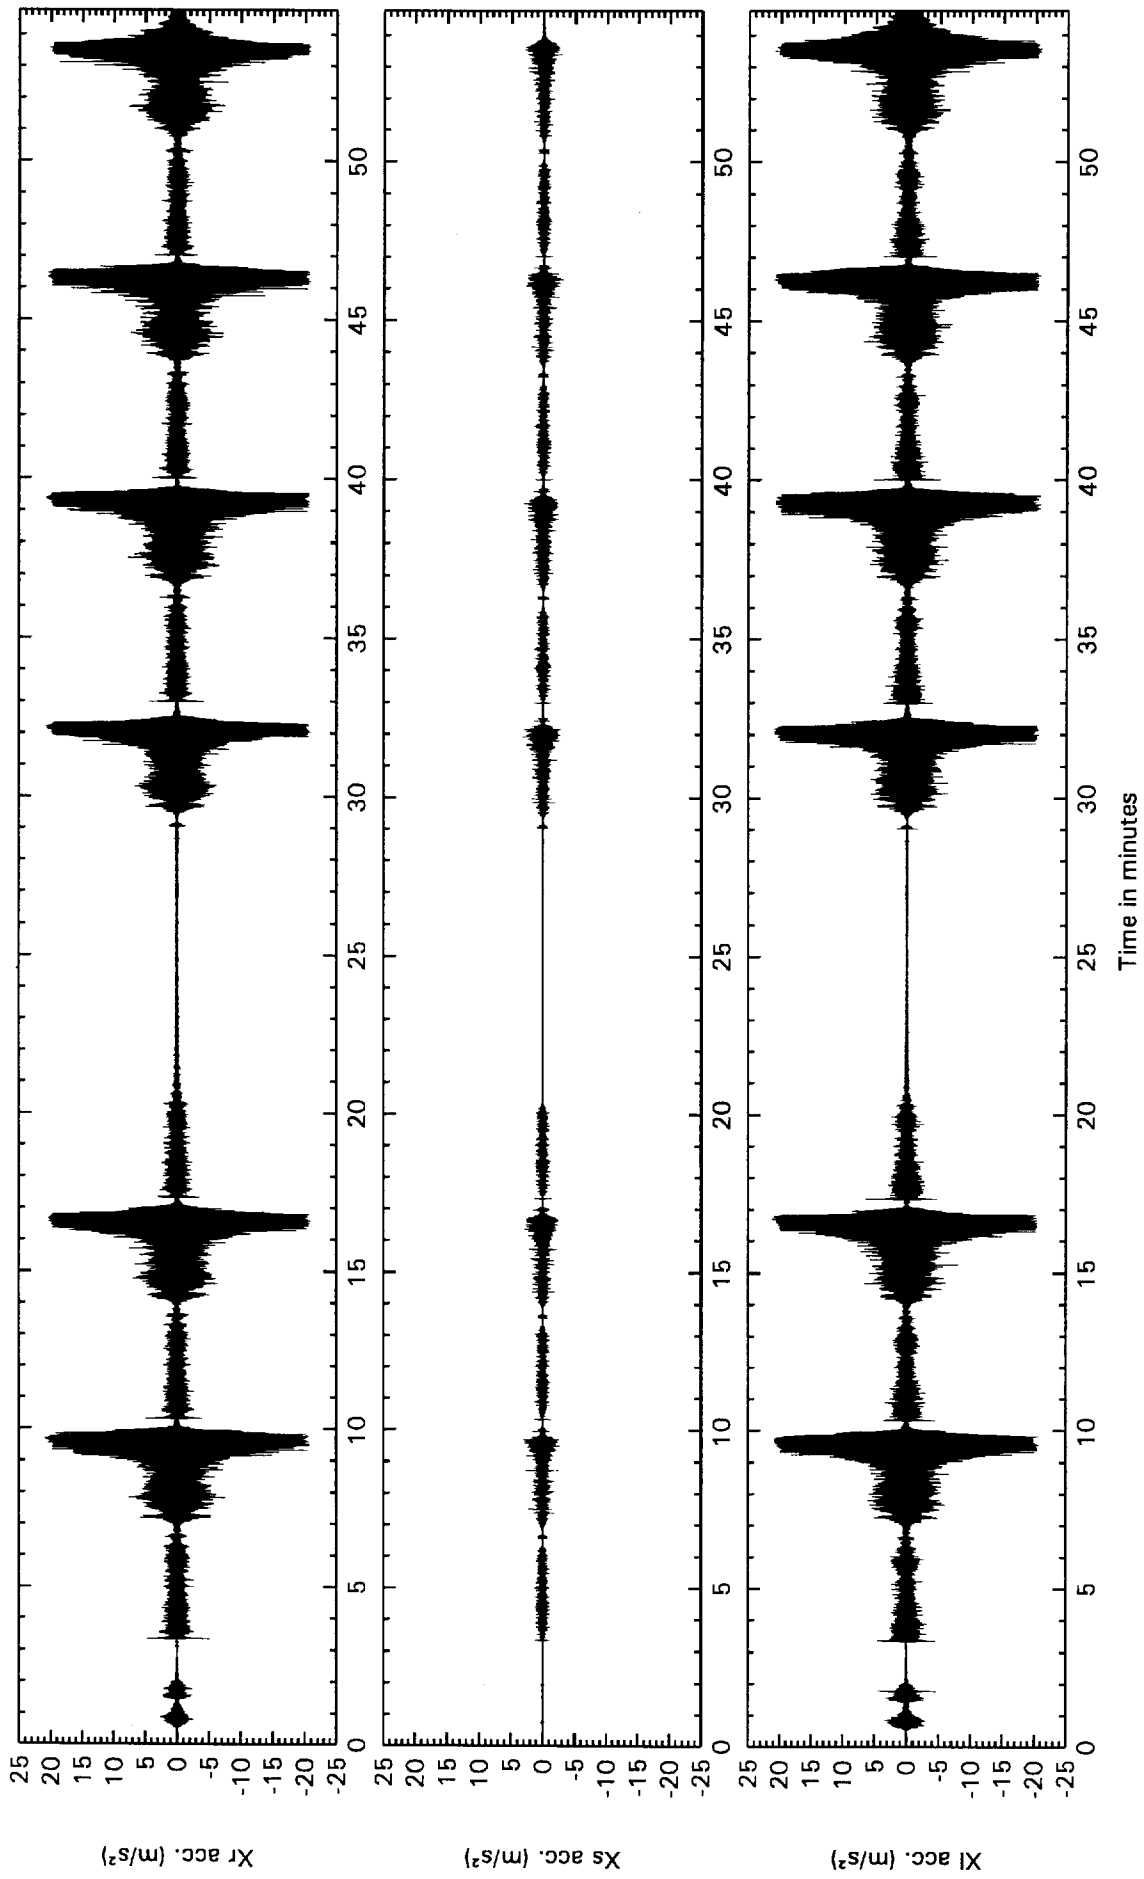
Figure B4: Winder AA: Rope acceleration measurements in the X-direction.

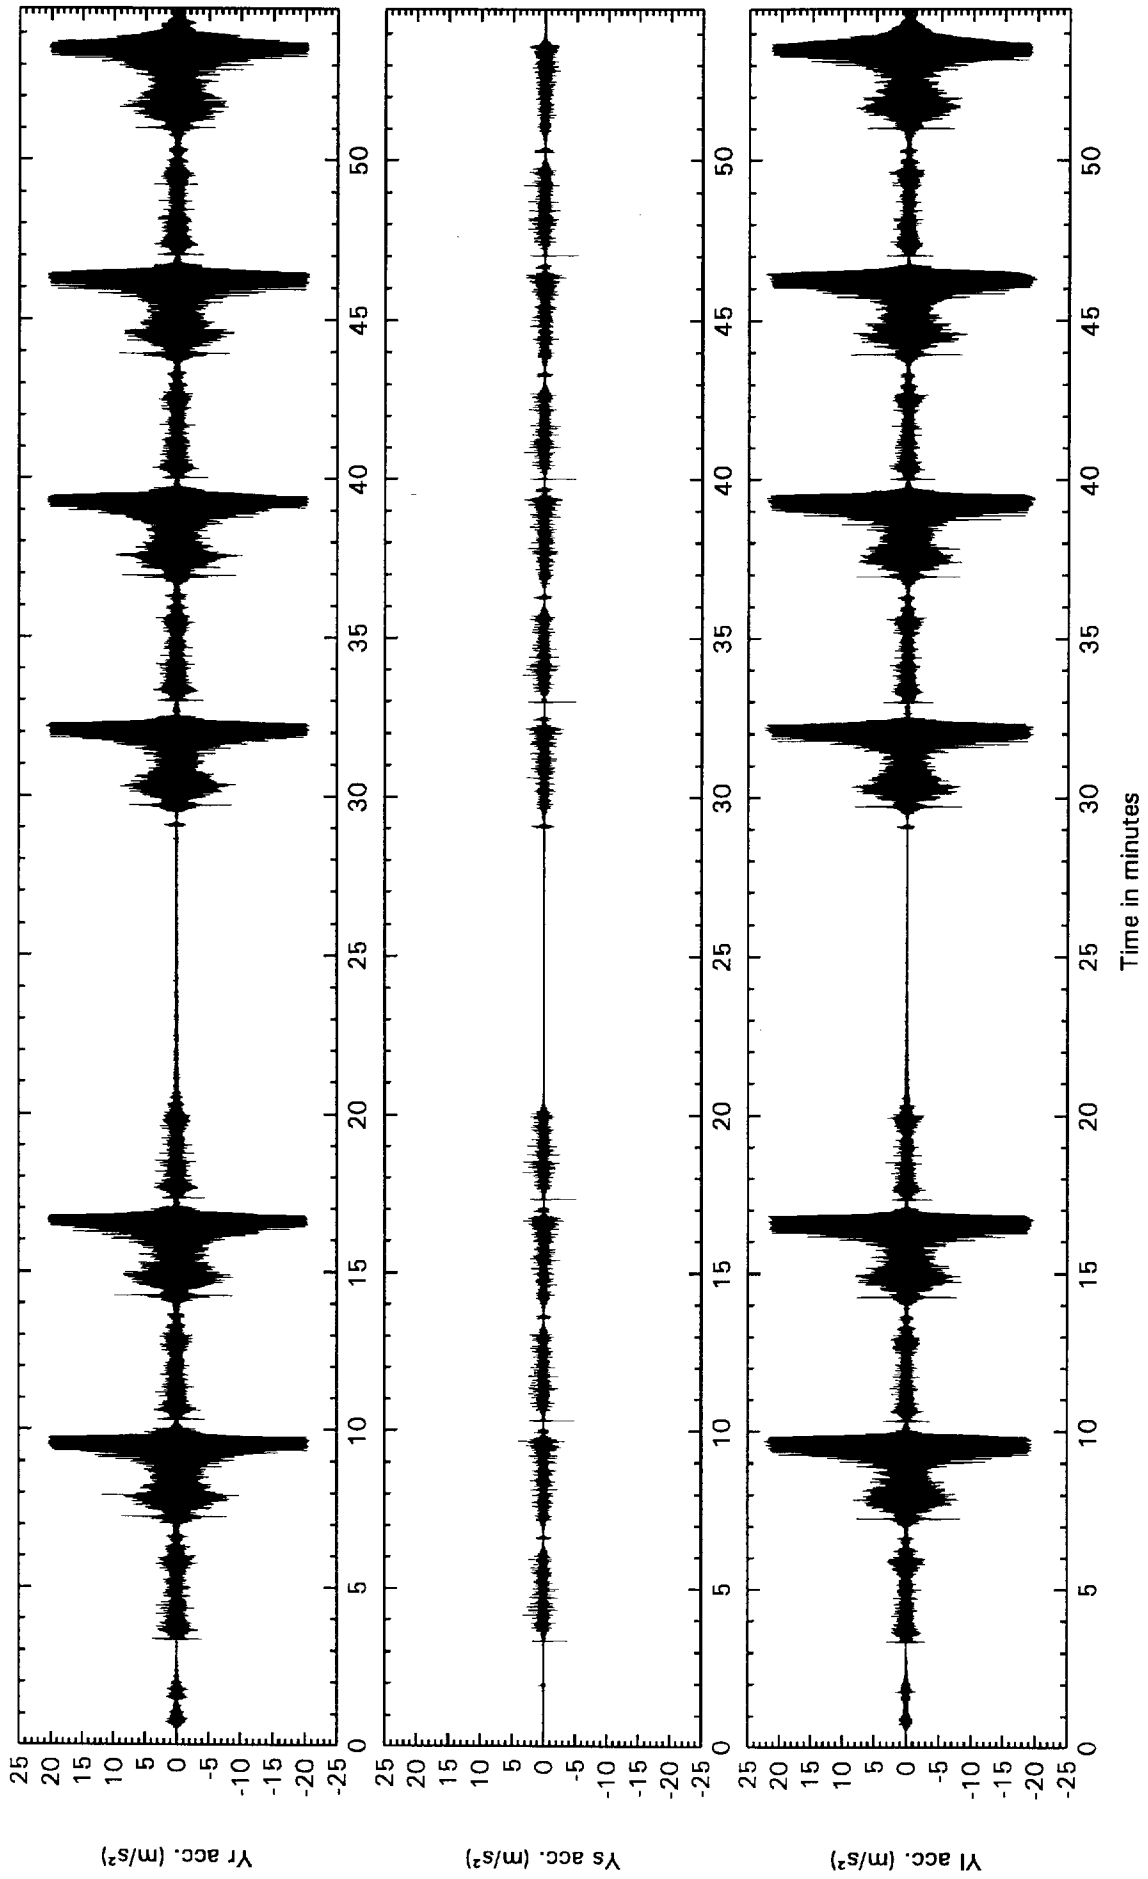
Figure B5: Winder AA: Rope acceleration measurements in the Y-direction.
