Title: THE SAFE USE OF MINE WINDING ROPES

Volume 3: Rope Terminations

Project No: GAP 054

**LABORATORY EVALUATION OF  
WHITE METAL AND RESIN CAPPINGS  
FOR USE AS WINDER ROPE  
TERMINATIONS**

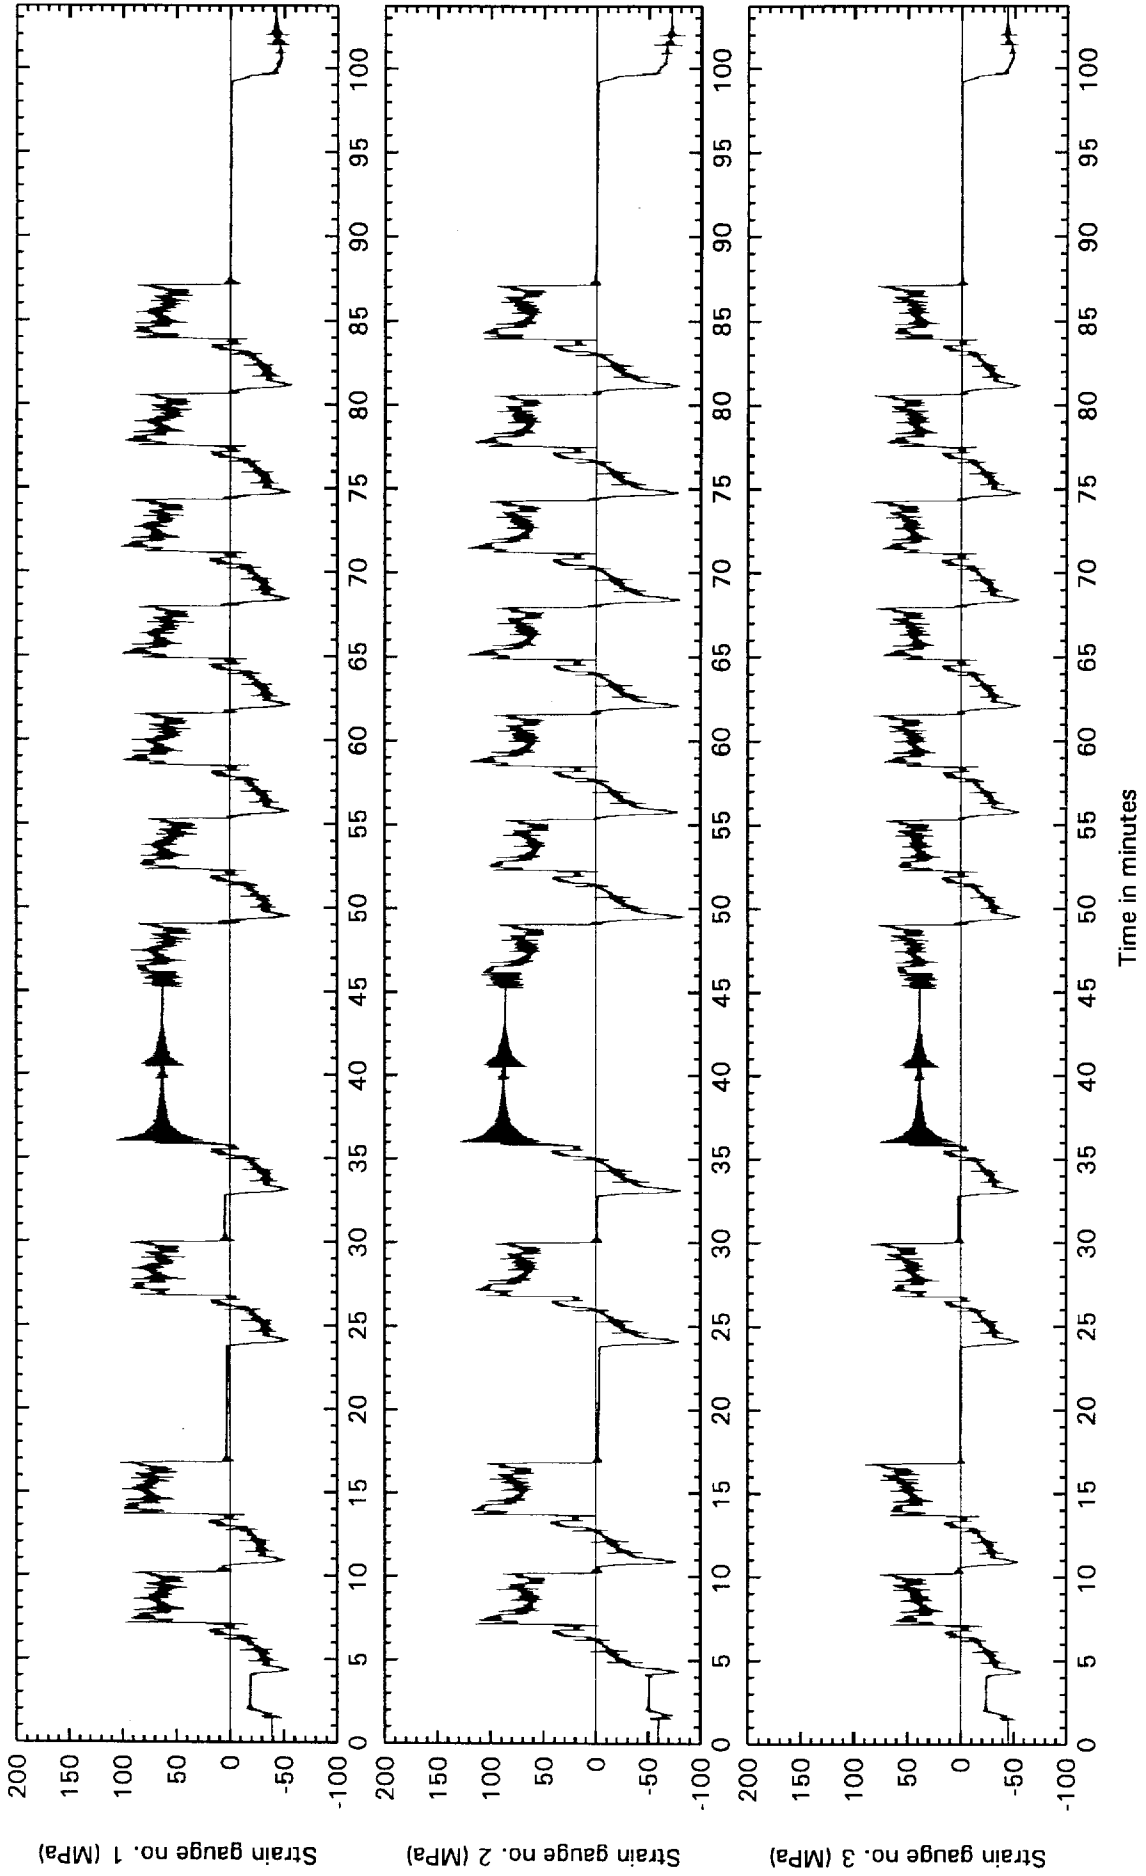
Figure B6: Winder BB: Stress measurements.

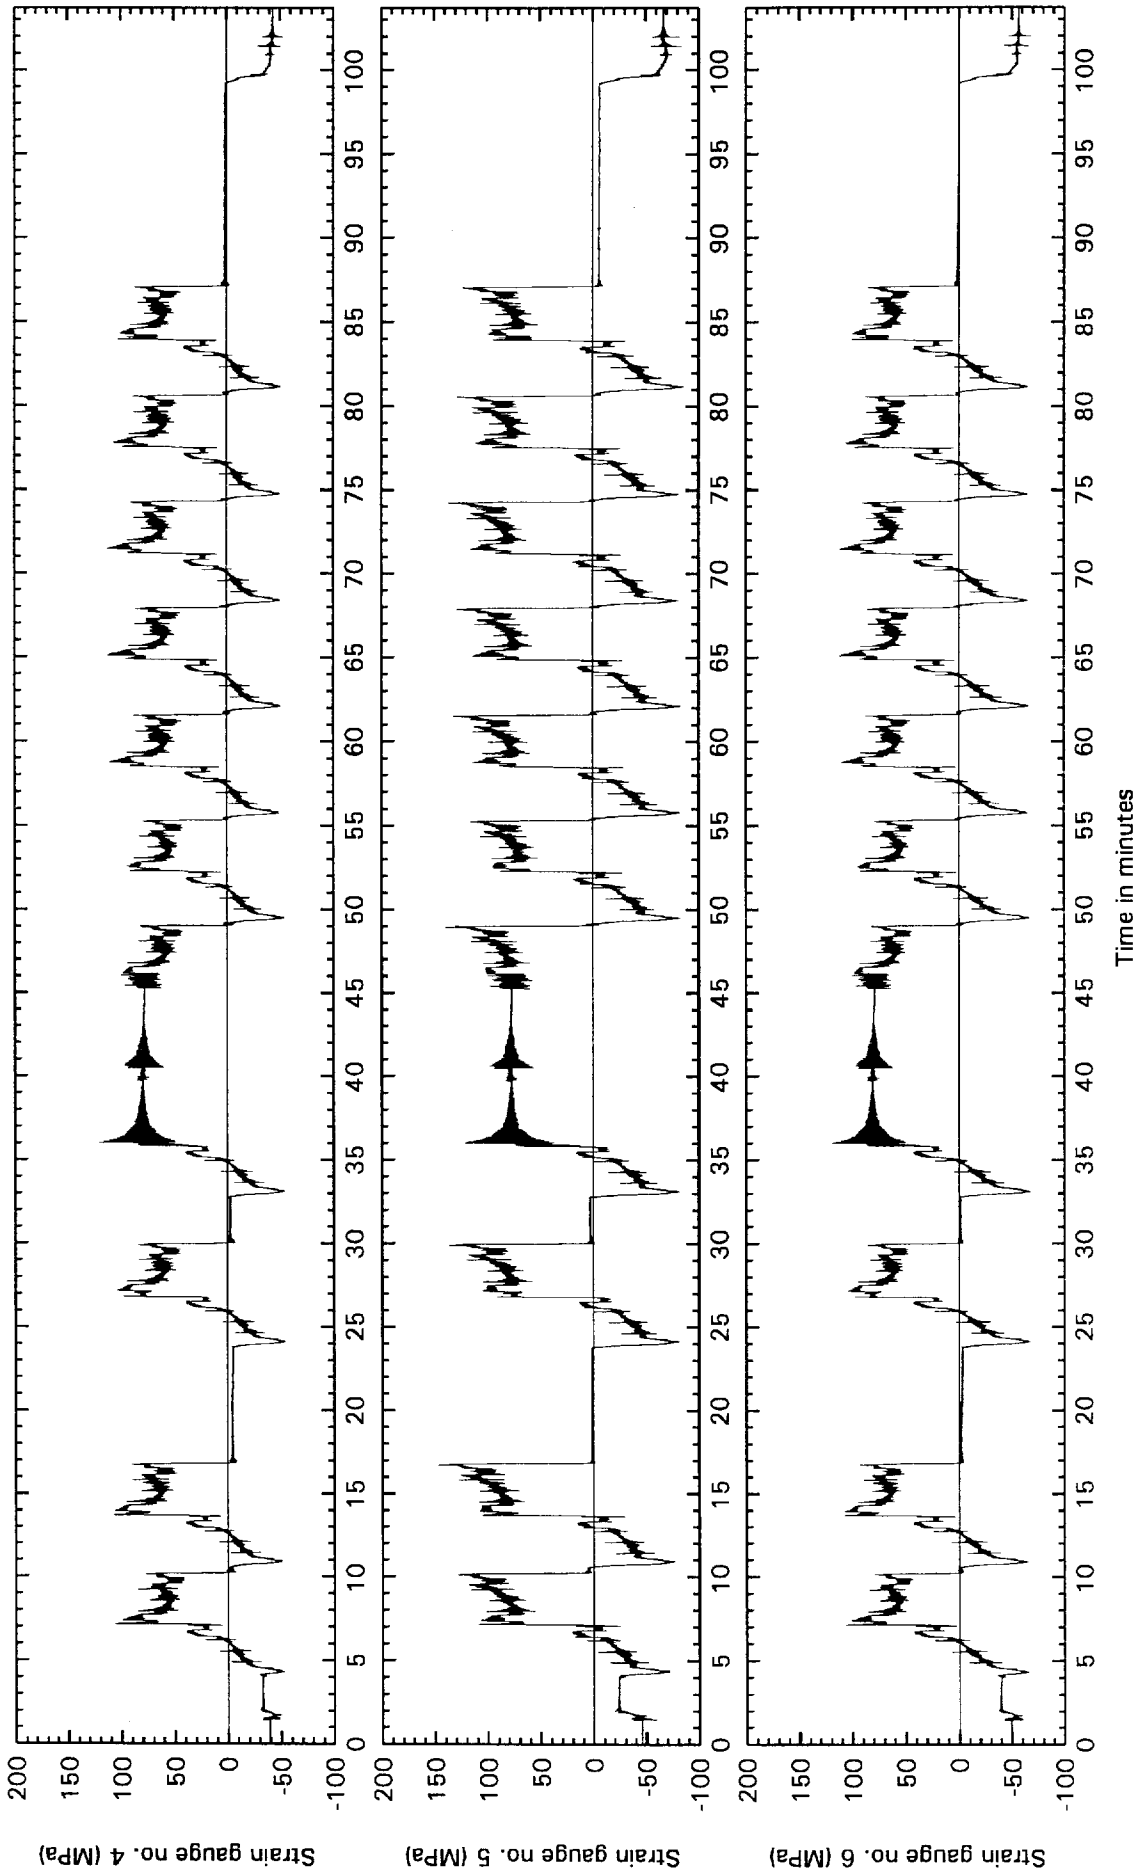
Figure B7: Winder BB: Stress measurements.

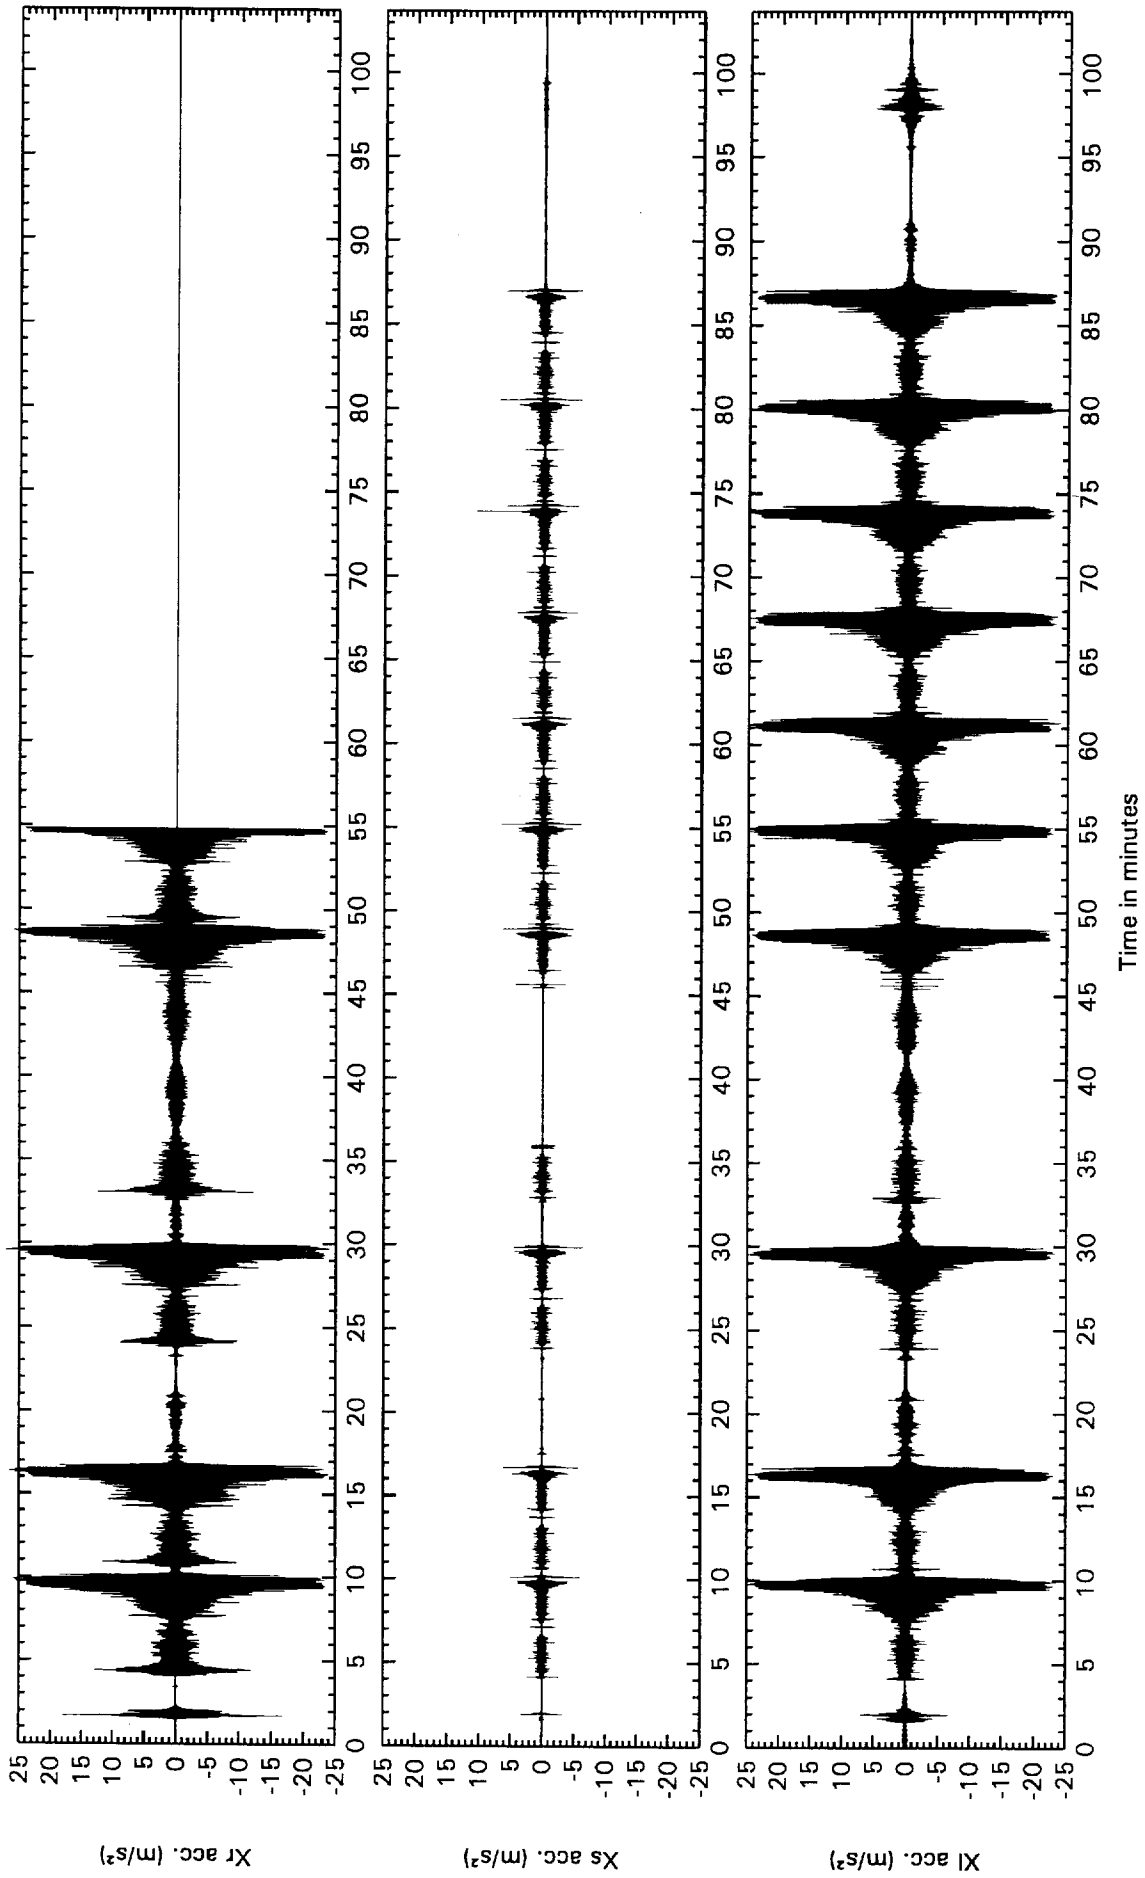
Figure B9: Winder BB: Rope acceleration measurements in the X-direction.

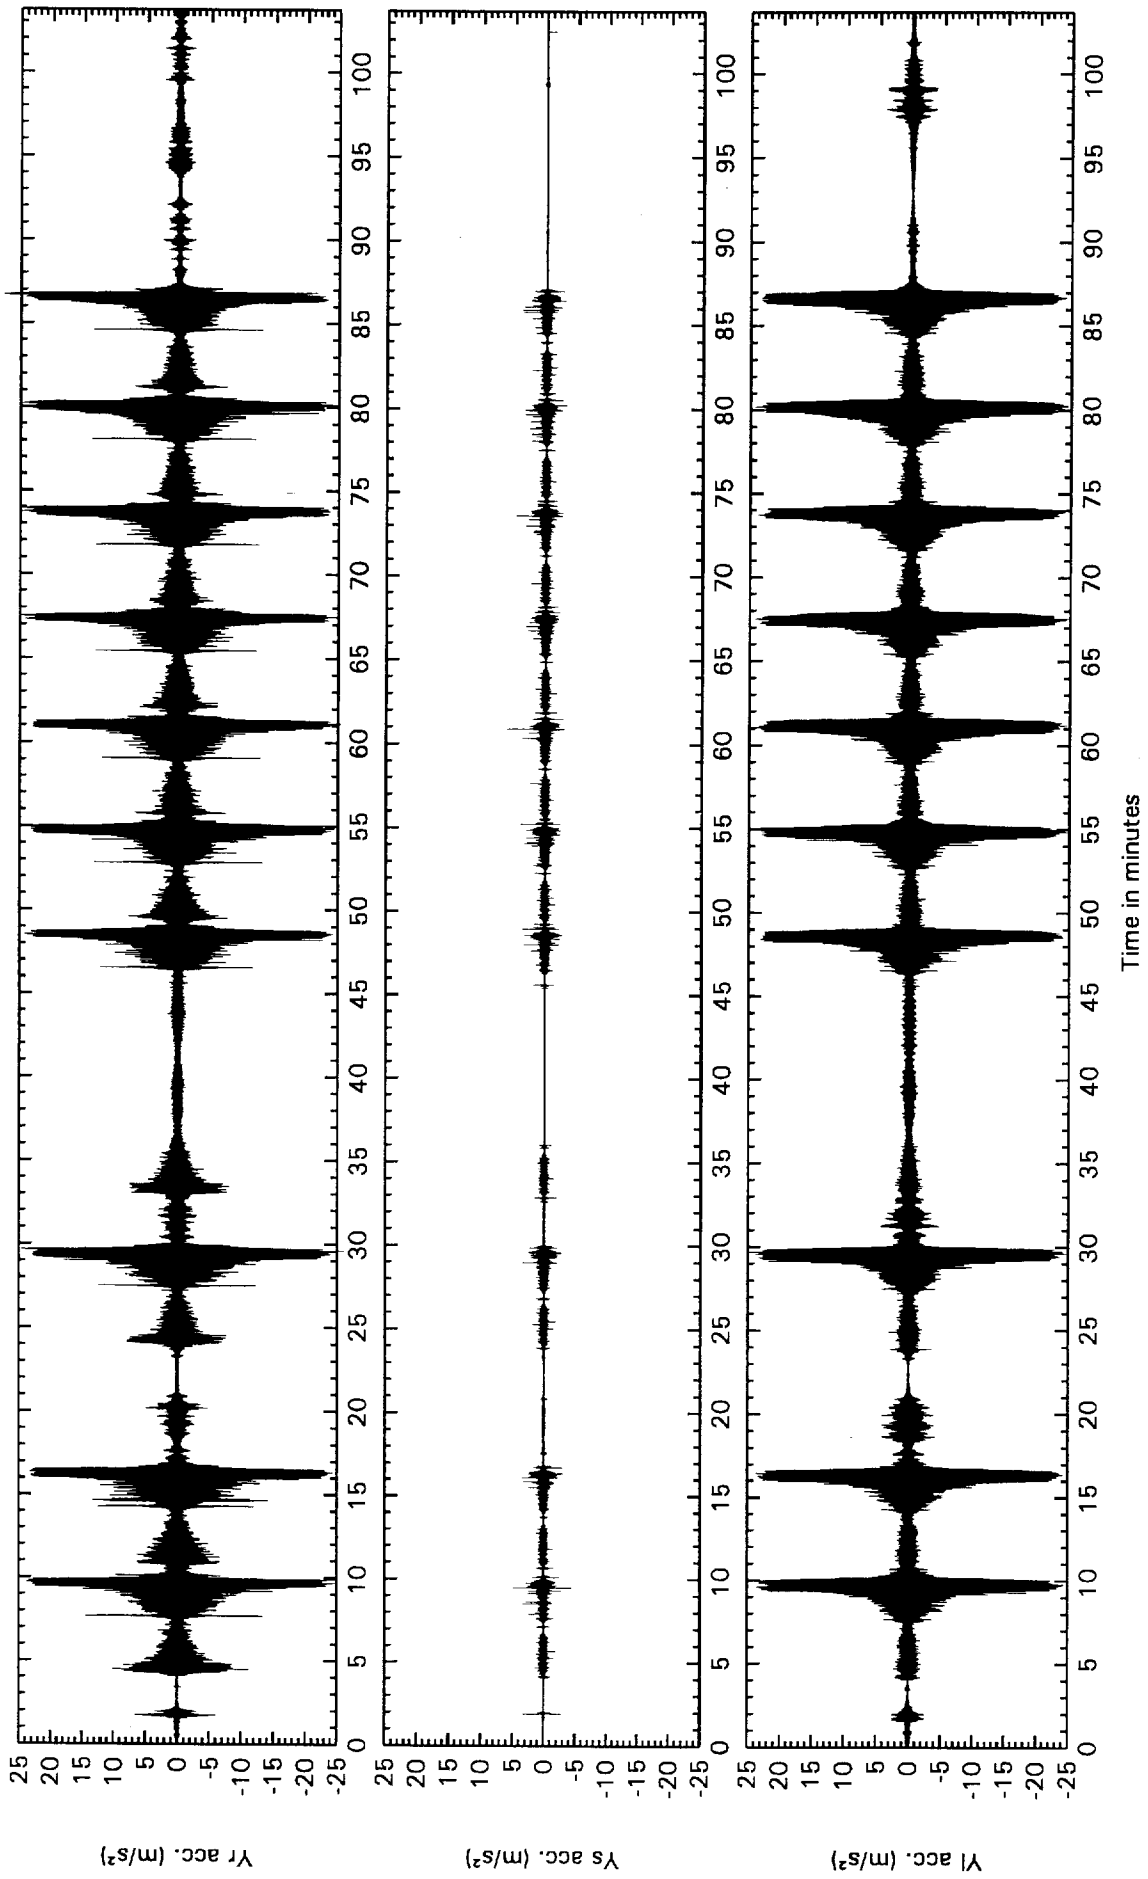
Figure B10: Winder BB: Rope acceleration measurements in the Y-direction.

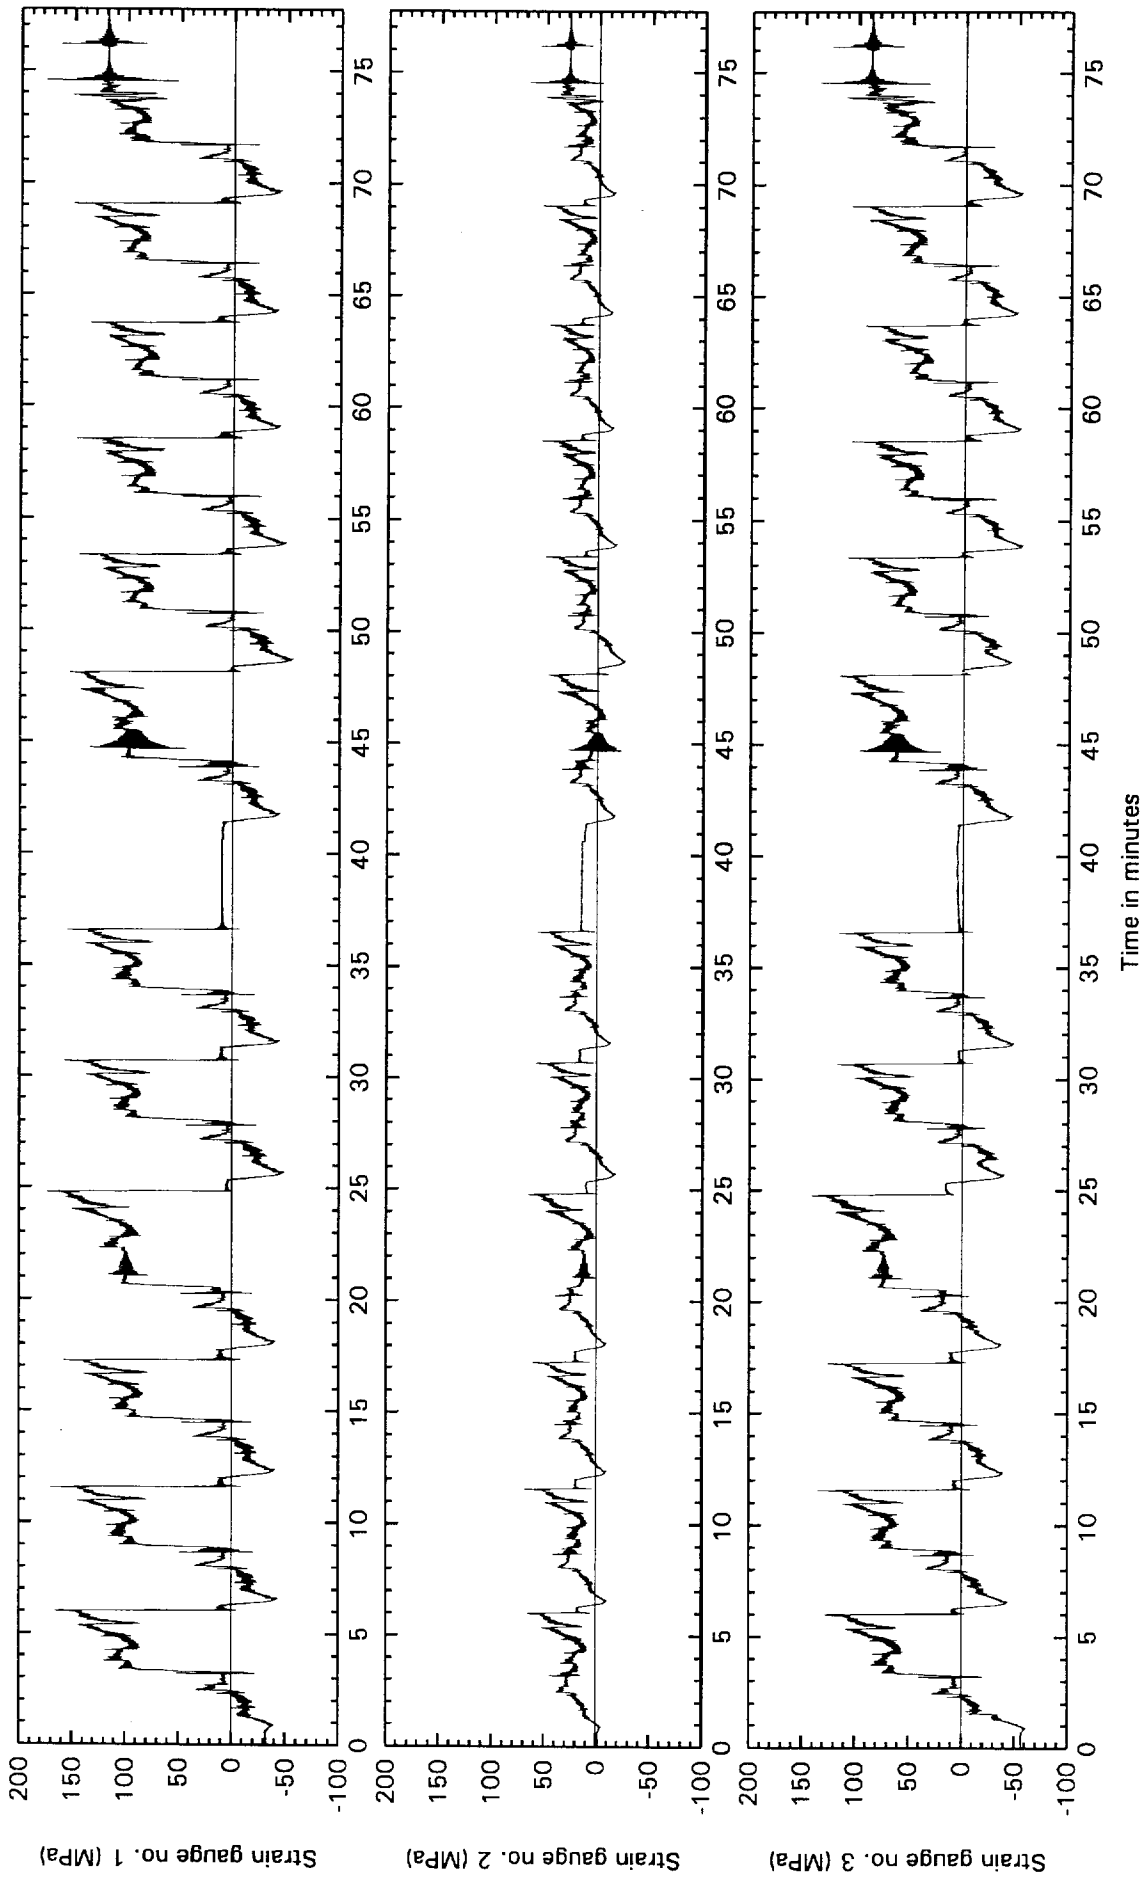
Figure B11: Winder CC: Stress measurements.

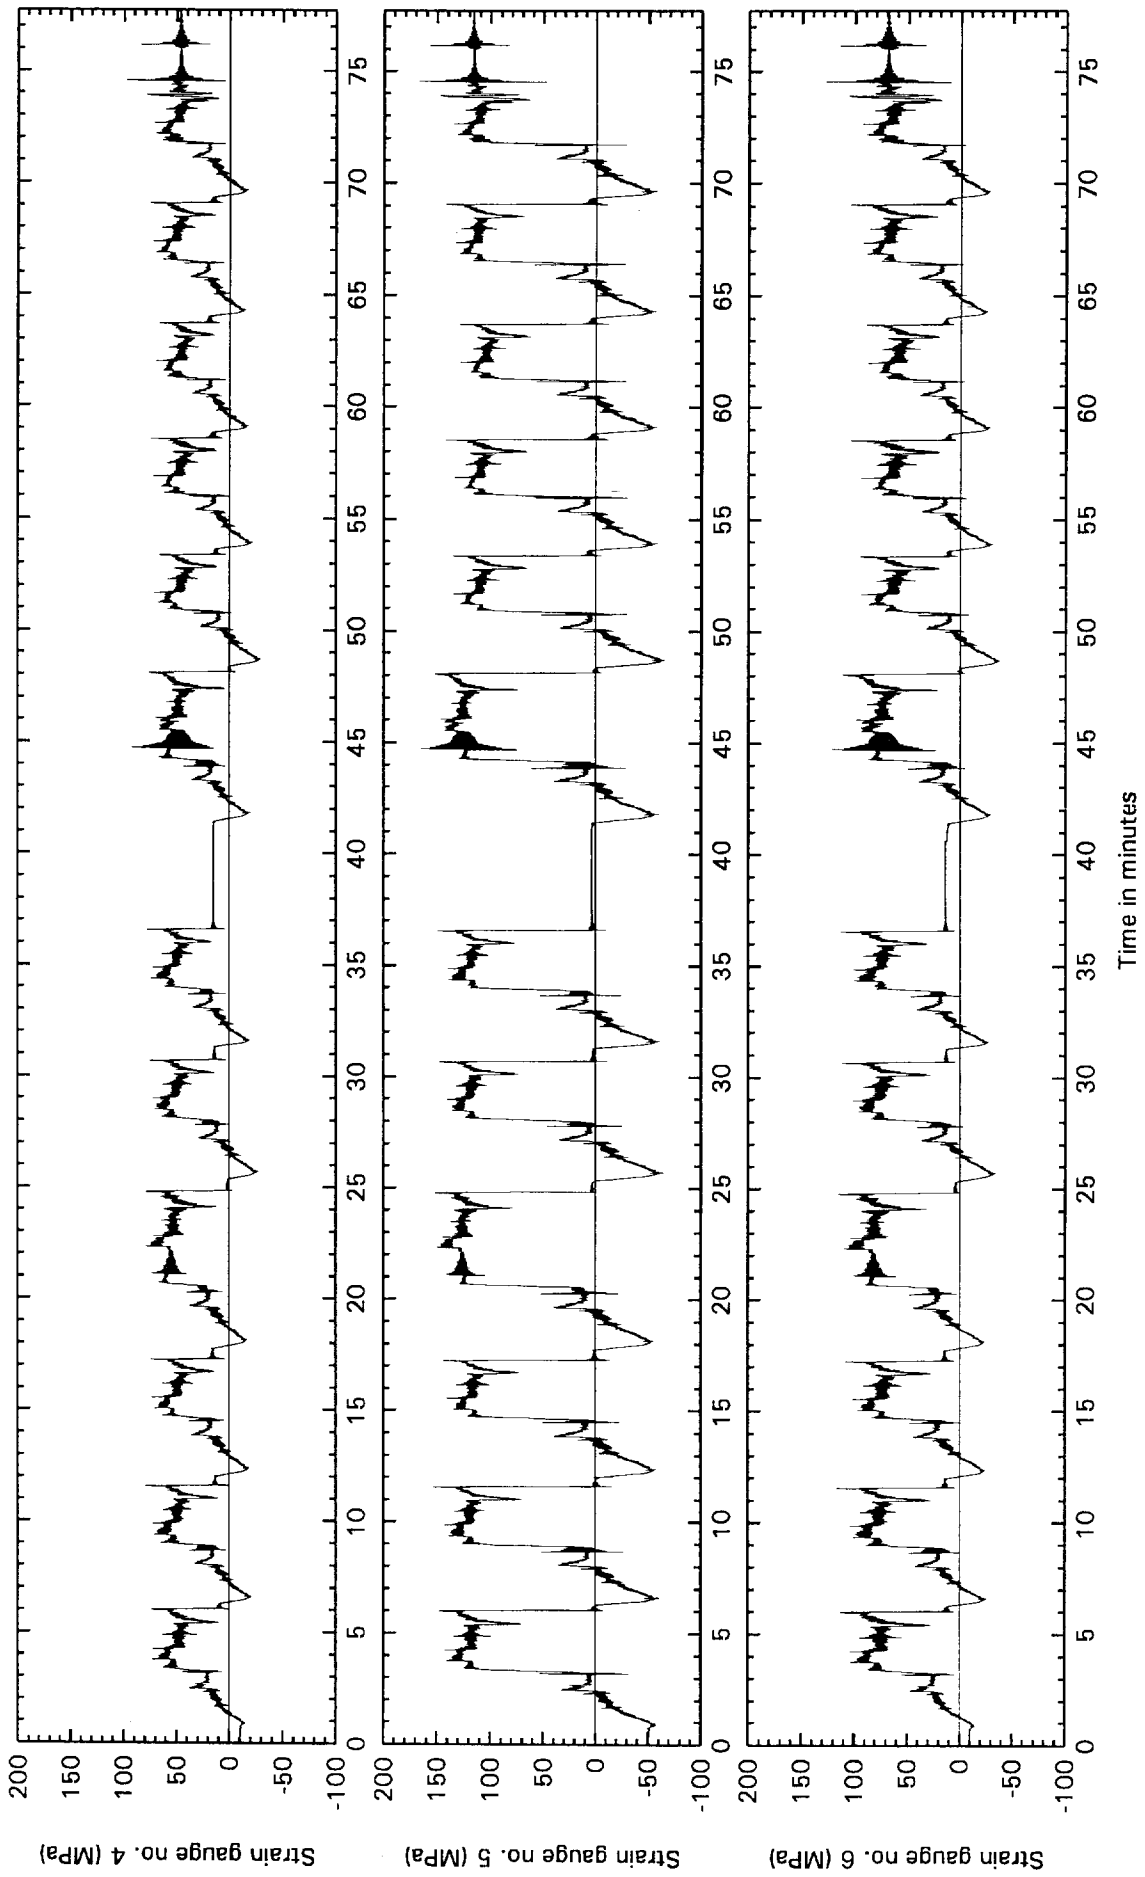
Figure B12: Winder CC: Stress measurements.

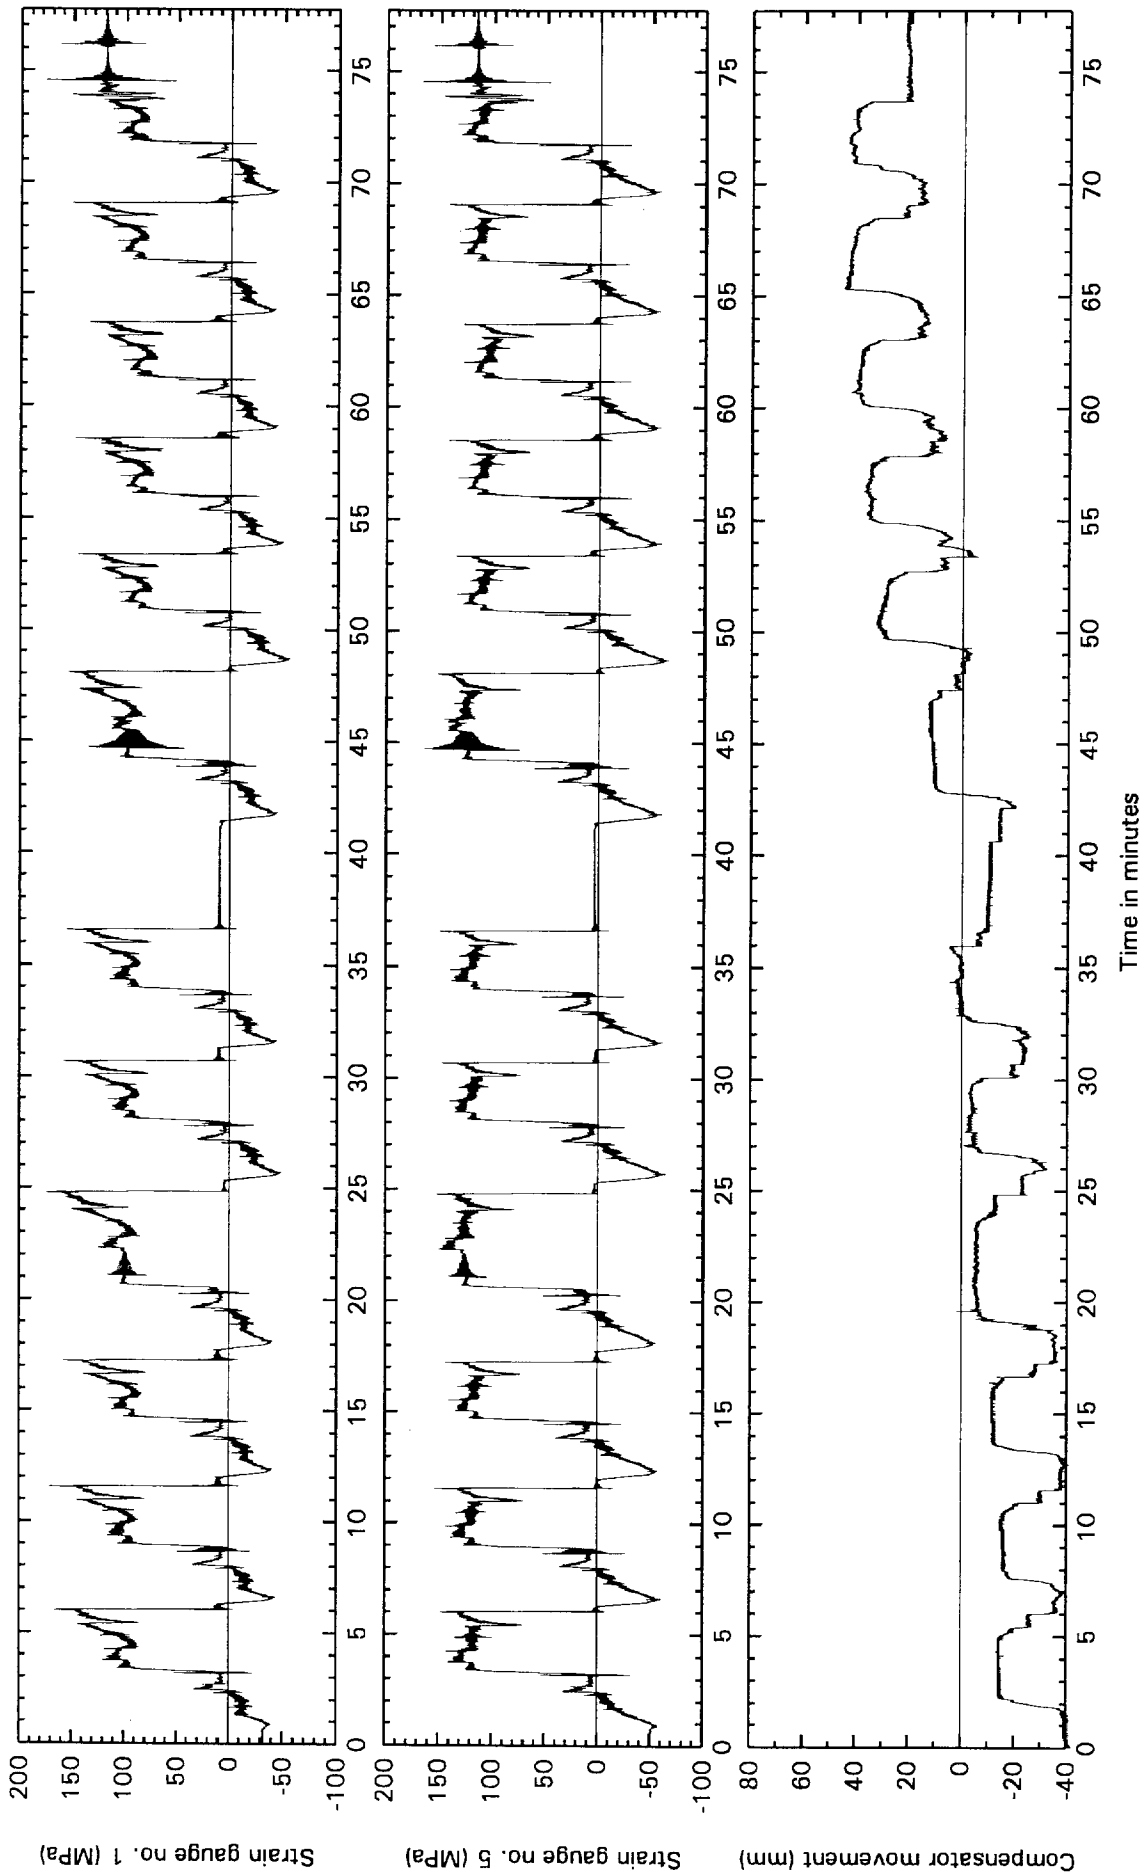
Figure B13: Winder CC: Stress measurements and compensating sheave rotation.

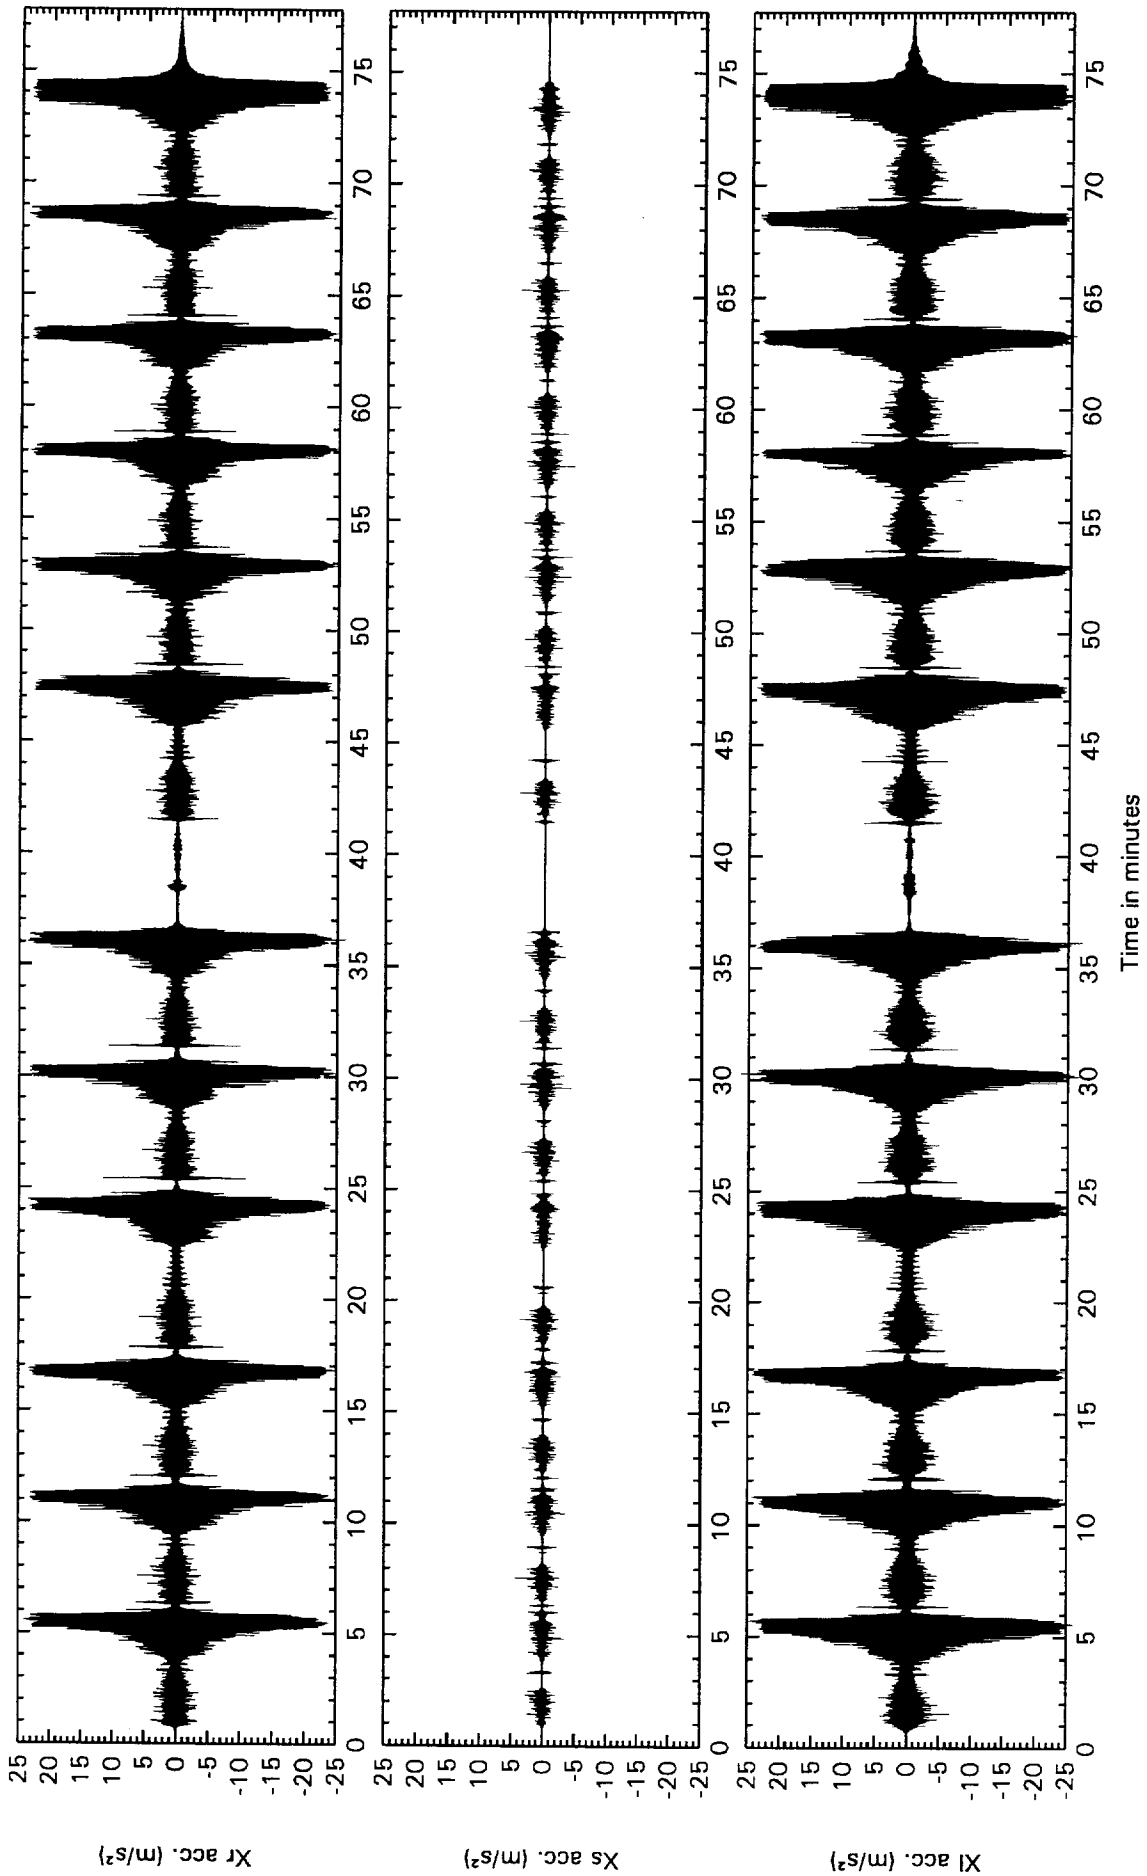
Figure B14: Winder CC: Rope acceleration measurements in the X-direction.

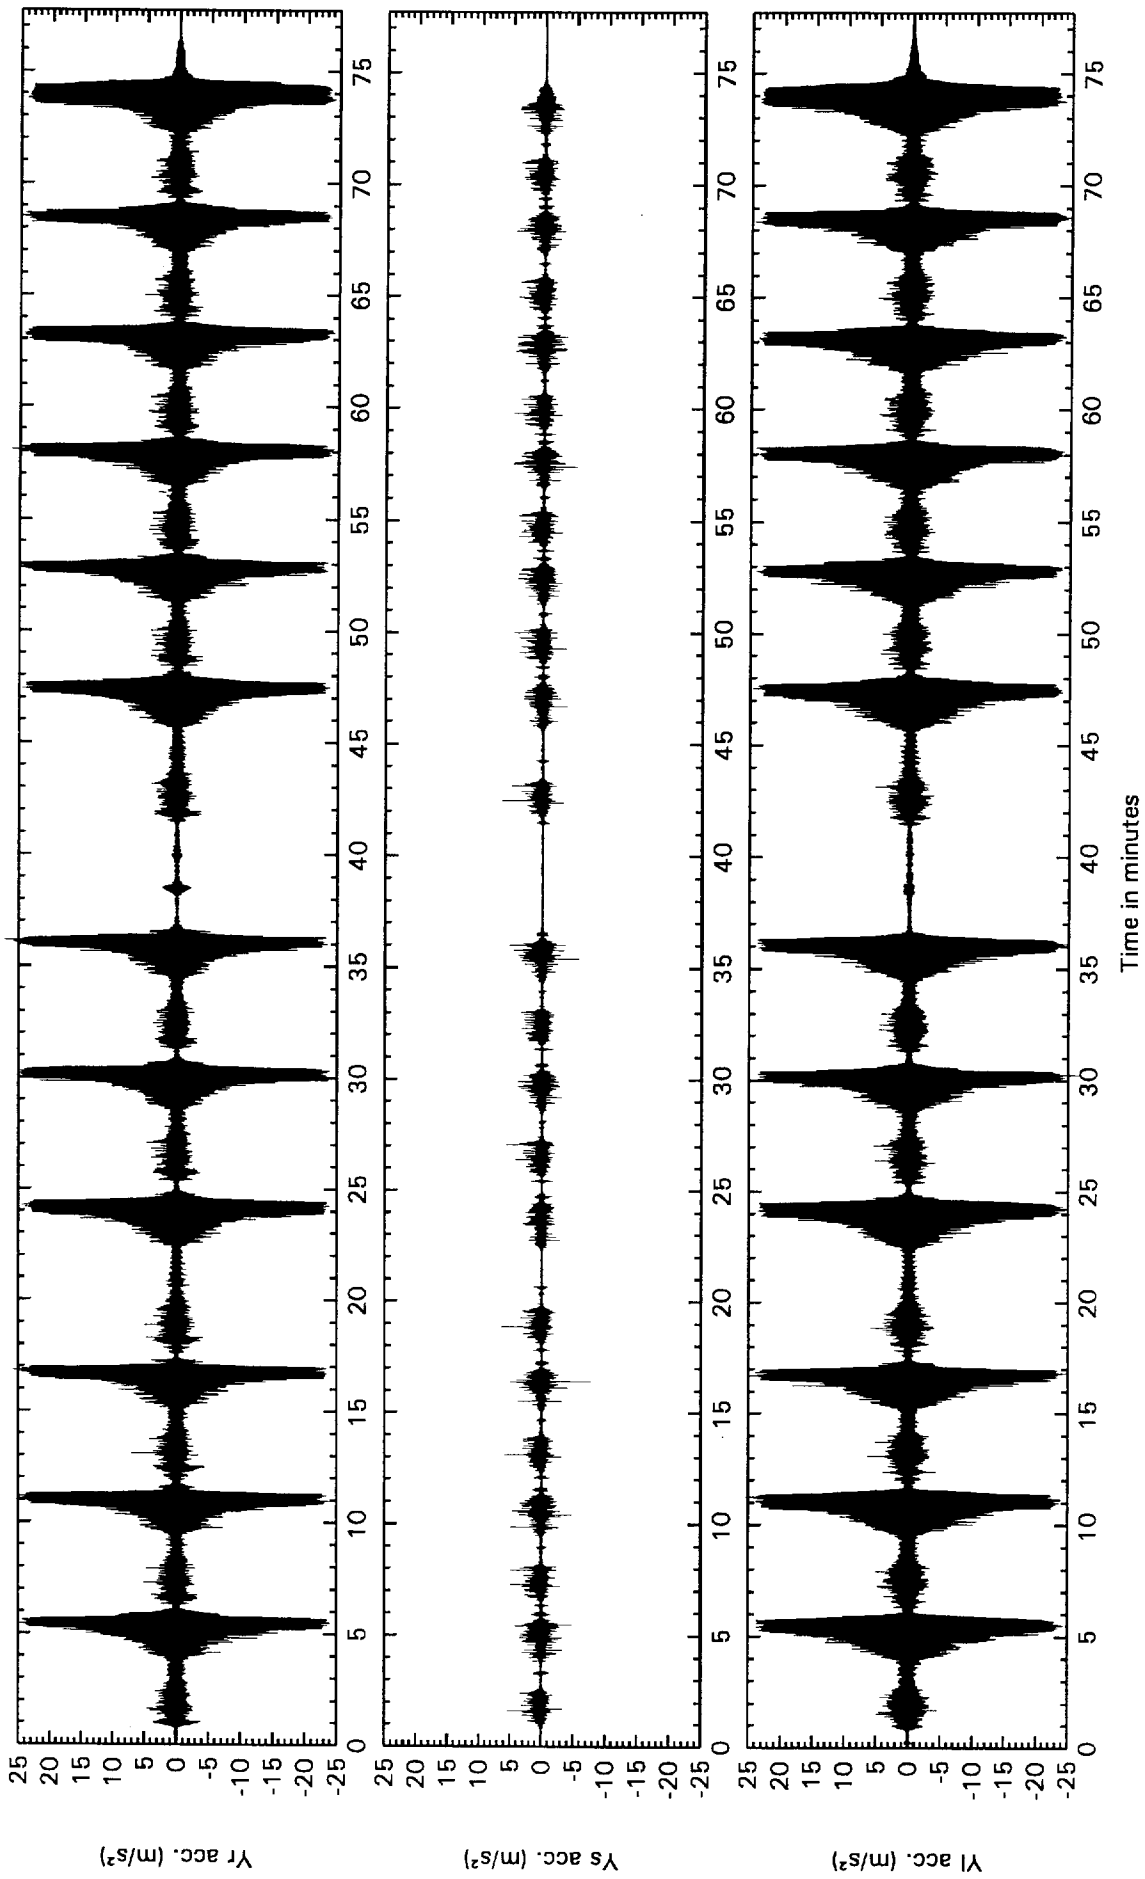
Figure B15: Winder CC: Rope acceleration measurements in the Y-direction.

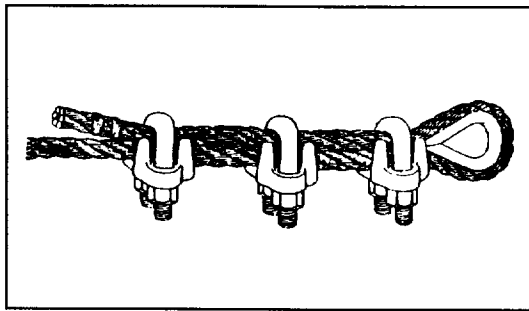
**2.2.2.2 Thimble Eye with Rope Clips.** Small winders operating in shallow shafts often have ropes terminated by means of a thimble and rope clips. Properly done, this type of termination is safe and reliable. When assembled in accordance with the instructions<sup>3 4 13</sup> (see paragraph 1.5 in Appendix A, page 46), an efficiency of about 80 % can be expected. However, this method is only appropriate if suitable rope clips are available. Properly designed and manufactured clips must be used with the saddle suitably formed to match the lay of the rope. Incorrectly made saddles are dangerous to use. Detailed instructions for assembling and tightening rope clips may be found in Appendix A, page 46. It is equally dangerous to use clips which have been incorrectly installed as the efficiency can be reduced to as low as 40 %. In addition, excessive torque on the bolts results in damage to the rope with a consequent reduction in efficiency.

**Figure 5** Correctly Assembled Rope Clip Termination

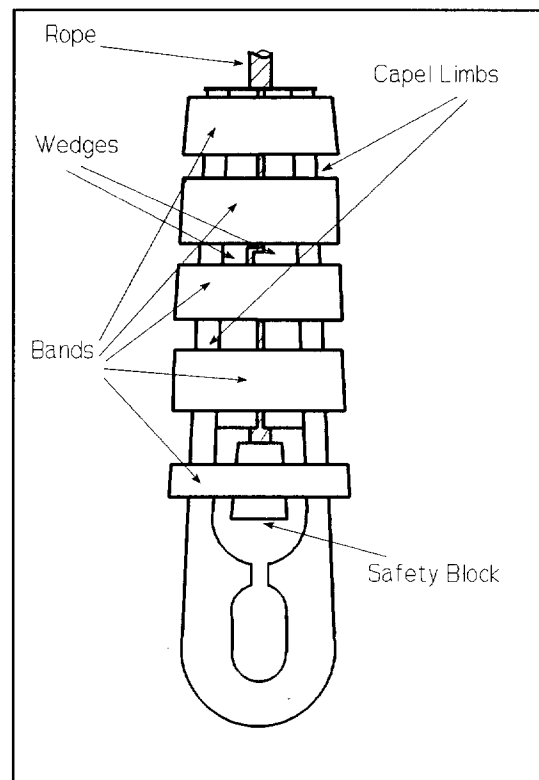
Figure 9 Wedge Capel

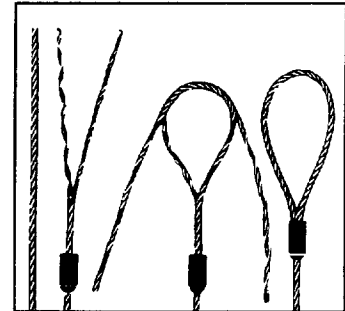
In the other a Flemish eye is formed as illustrated in Figure 17. In this case the rope is split into two tails that are then bent in opposite directions and reformed into a rope eye. The tails are secured with a pressed or swaged sleeve. Although more difficult to make, this termination can also be fitted with a thimble.

**Figure 17** Ferrule Secured Flemish Eye

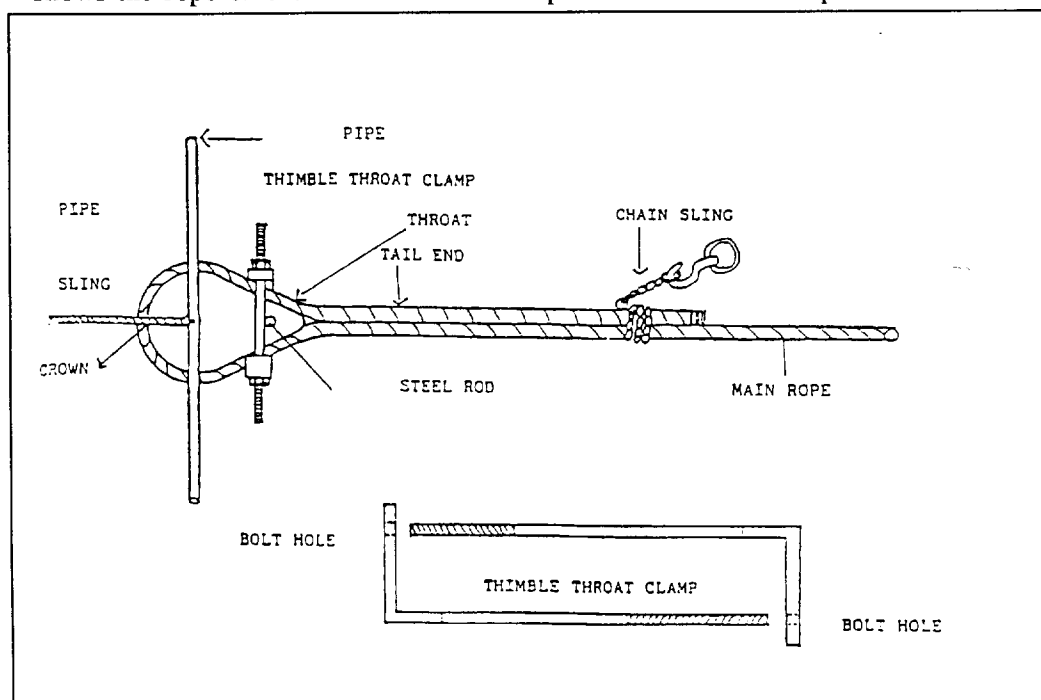
- Measure up the rope and mark where it is to form the centre of the crown of the eye, making due allowance for the loss in the straight length caused by the curving of the rope around the thimble. Place the thimble with its crown on this mark and bend the short end (tail end) of the rope around it, in the groove of the thimble, leaving the tail end of the rope to protrude which will provide the length for the tucking tails. (This length should be  $80 \times$  rope diameter).
- On small diameter ropes, bending the rope round the thimble can be done by hand, but in the case of large diameter ropes a thimble throat clamp should be used. Force the two parts of the rope together at the point of the thimble, i.e. the throat of the eye. Figure 22 shows the rope on the thimble once this operation has been completed.

**Figure 22** Illustration of the Rope Secured on the Thimble with a Thimble Throat Clamp.

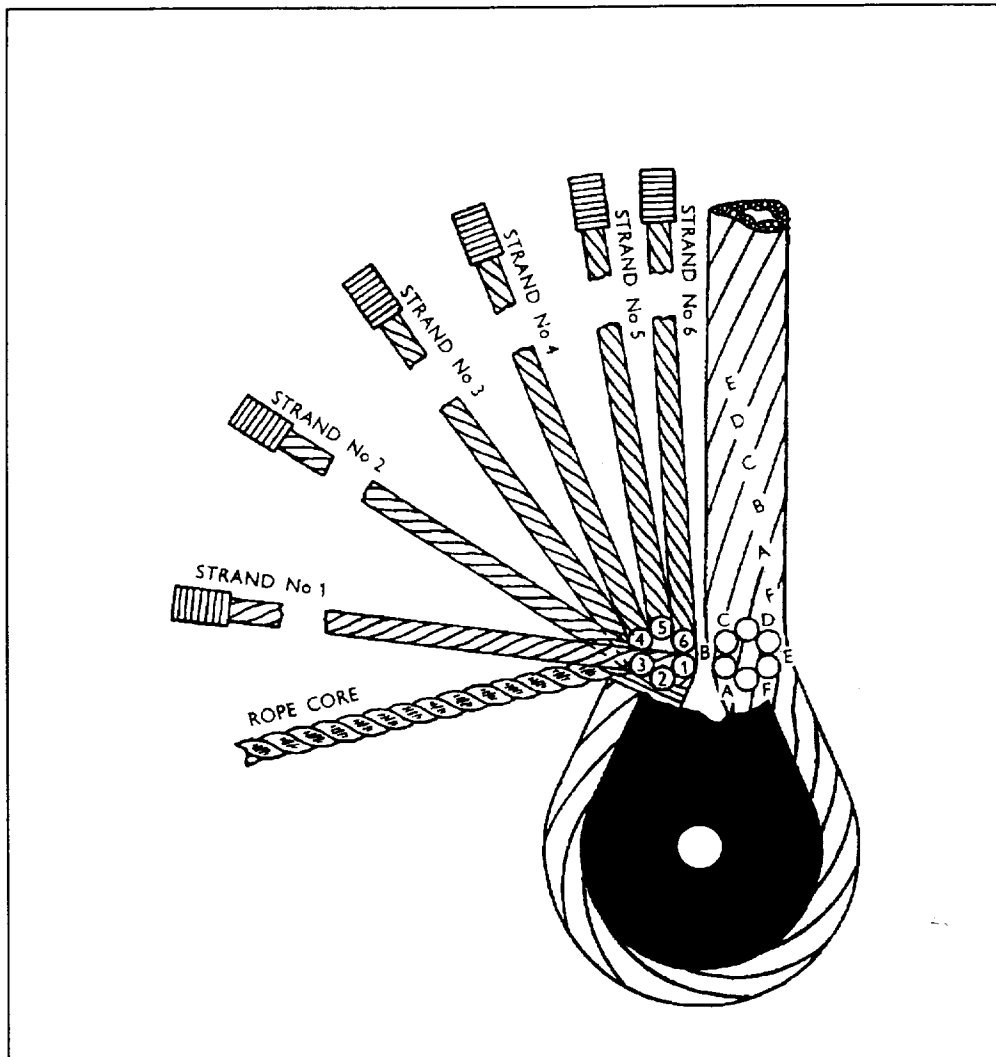
**Figure 24** Illustration of the Main Rope with all the Tails Opened Out.

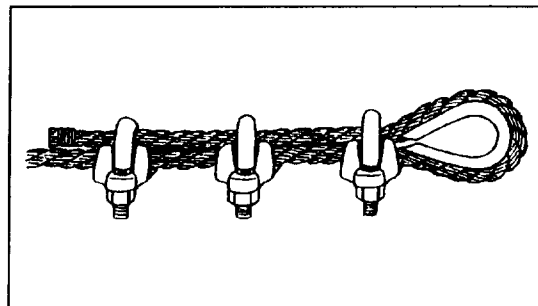
**Figure 53** Third Step in Installing Clips

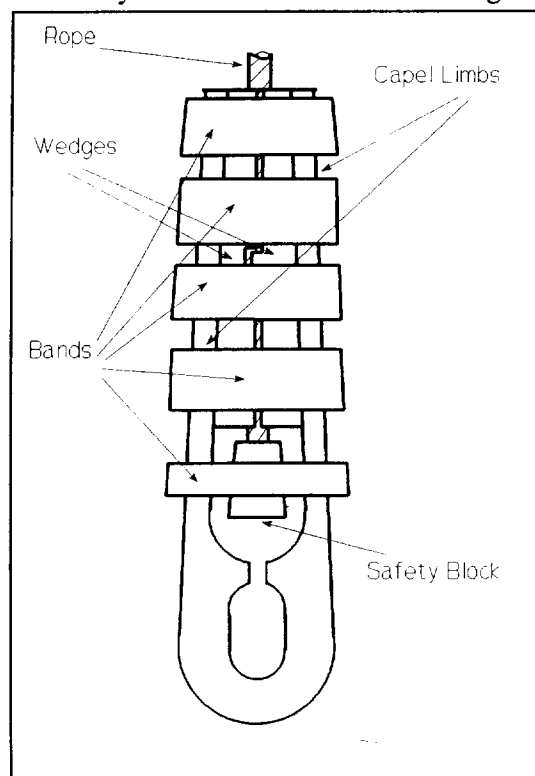
**Figure 54** Wedge Type Capel
