Title: THE SAFE USE OF MINE WINDING ROPES

Volume 3: Rope Terminations

Project No: GAP 054

**LABORATORY EVALUATION OF  
WHITE METAL AND RESIN CAPPINGS  
FOR USE AS WINDER ROPE  
TERMINATIONS**

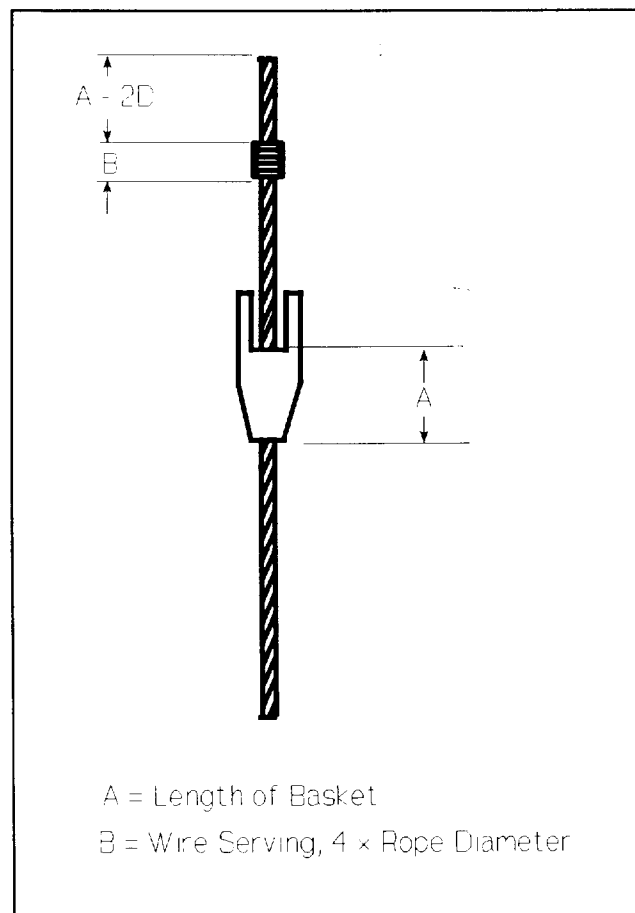
Figure 57 Wire Serving Applied and Socket Threaded on rope

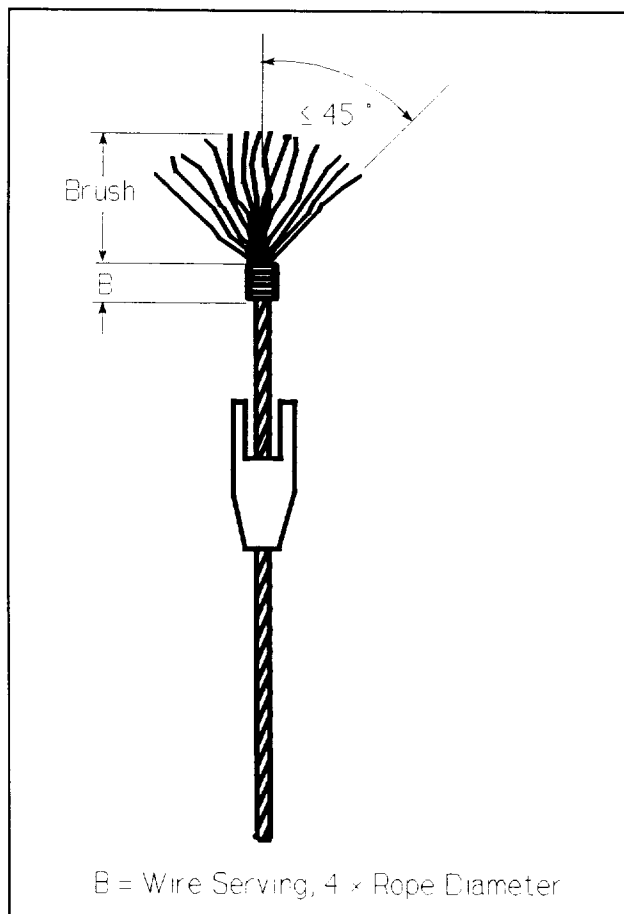
**Figure 58** Brush Formed and Cleaned

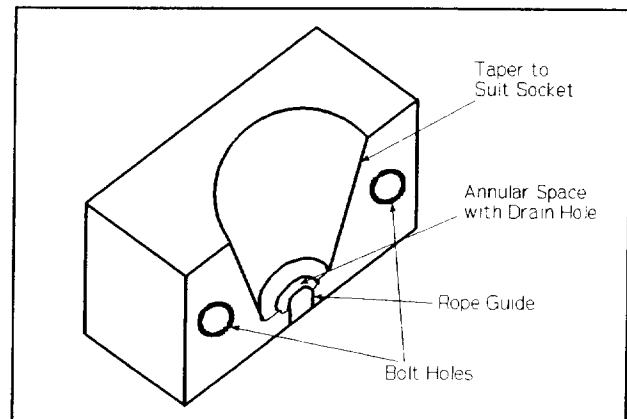
**Figure 59** Schematic Diagram of Half of Self Centring Socket Clamp
