Safety in Mines Research Advisory Committee

Final Report

Discard criteria for mine winder ropes

Research agency: MIKE VAN ZYL INCORPORATED
Project number: GAP 502
Date: September 2000

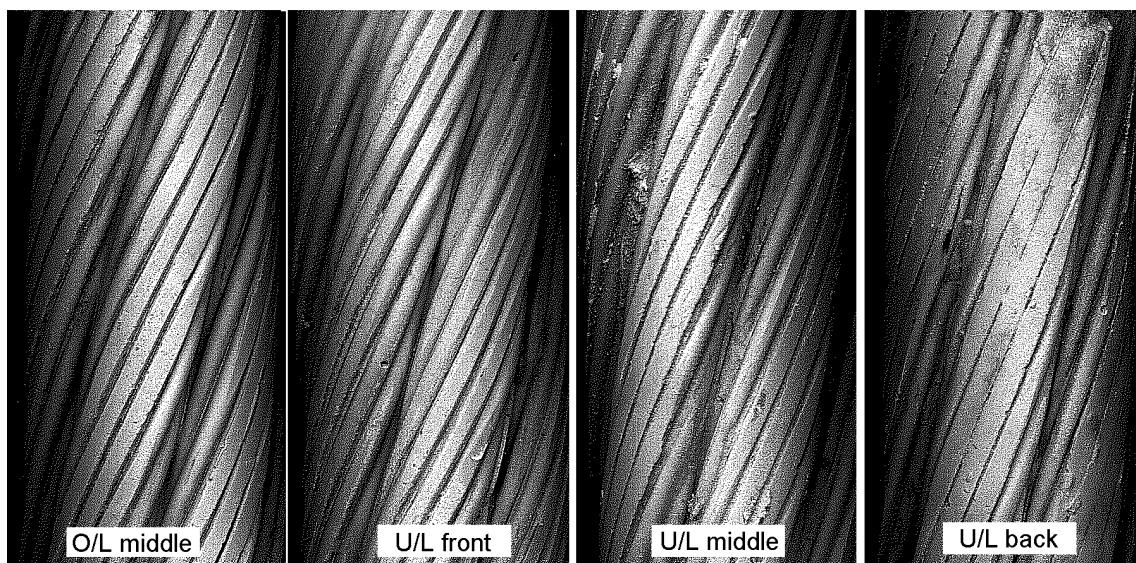
The physical appearance of the ropes after four years in service is shown in Fig. 3.1. Severe plastic deformation is noticeable on the image of the back end of the underlay rope. This image shows that the small valleys between the wires in a strand were already nearly "filled" at that time. Visually, the ropes did not deteriorate much more during the last 1½ years in service. The plastic deformation was evenly spread around the circumference of the rope.

Figure 3.1: Physical appearance of the ropes used for diameter reduction tests

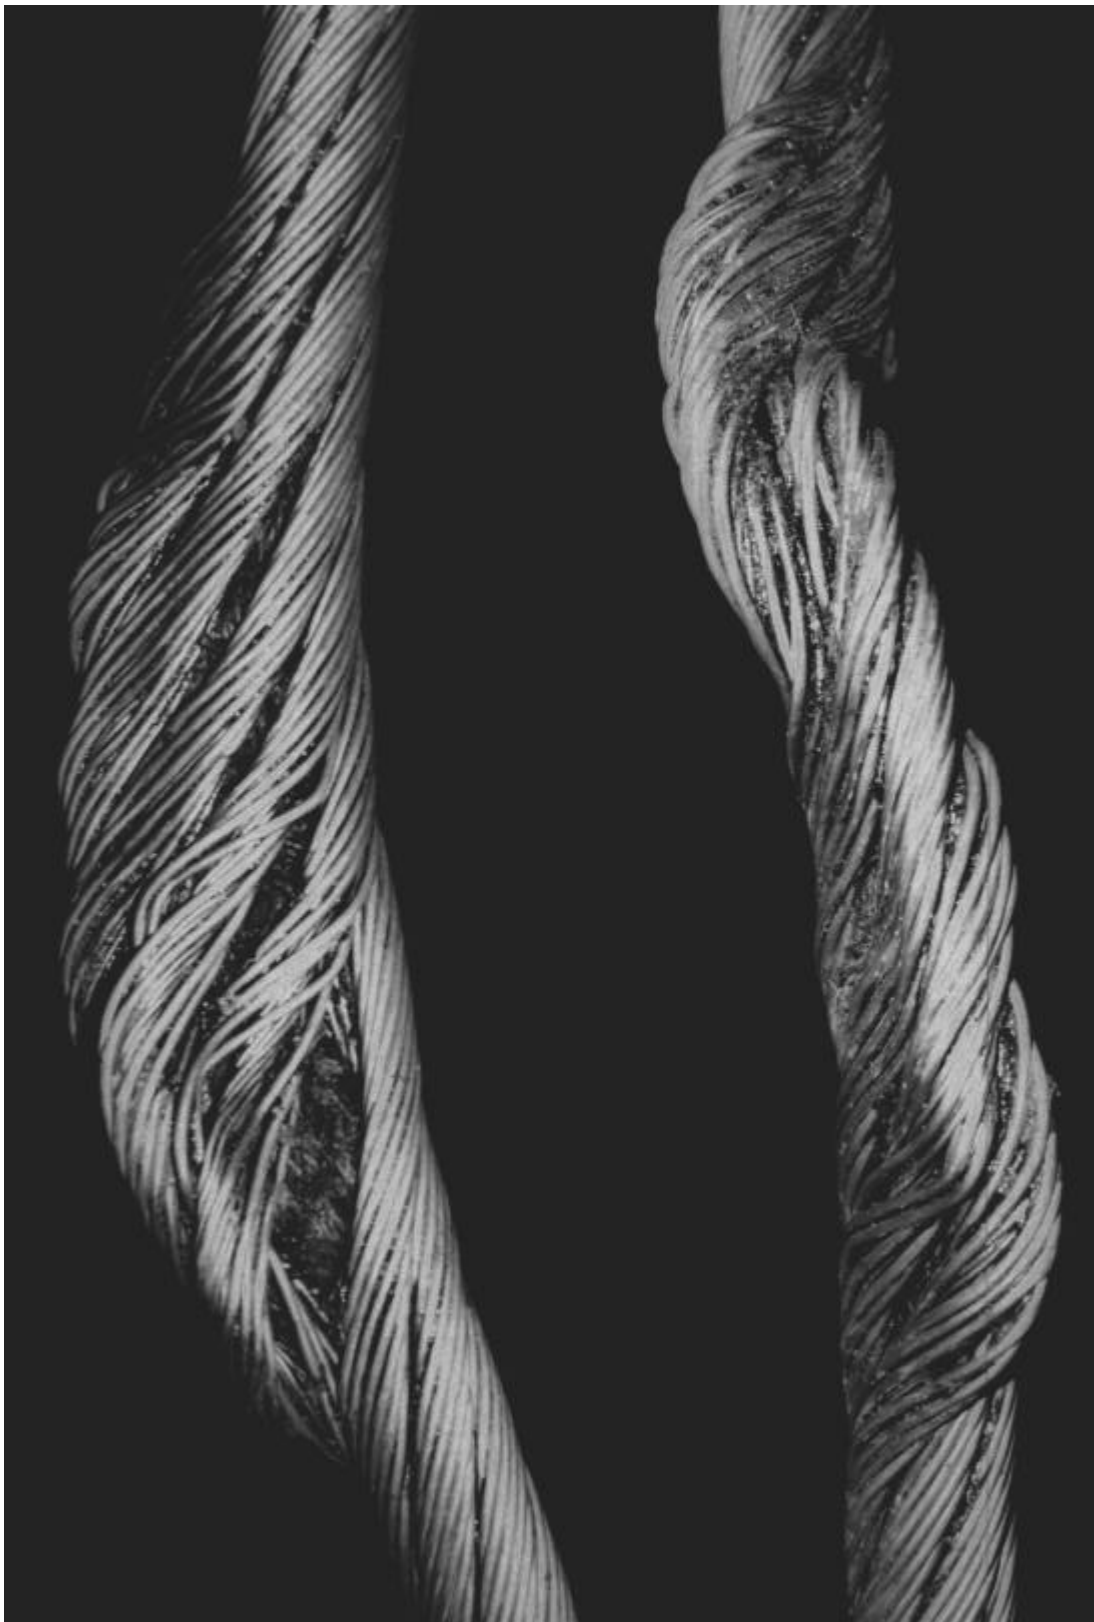
A section of a dead turn of a triangular strand rope on a winder drum was severely deformed when this section of rope was extruded between two rope turns of the next rope layer. The reason (which is not of direct concern) was most probably that the dead turns were not properly tensioned. The extent of the rope distortion is shown in Fig. 5.1.

A standard test specimen was cut from the 1 800 MPa rope. Although the rope was severely deformed, there were no broken wires visible. As the load increased during the tensile test, the distorted part of the rope "closed" again into its original shape. The breaking strength of the rope was only 2,6% down from the new rope strength, but the plastic fraction of elongation was down to 0,8%. Although a rope with damage as shown will be discarded, it is encouraging that an 1 800 MPa triangular strand rope could retain a very large portion of its tensile strength after being severely deformed. However, should winding operations have continued after the damage occurred, rope deterioration would have been extremely rapid.

Figure 5.1: An extruded drum dead turn.

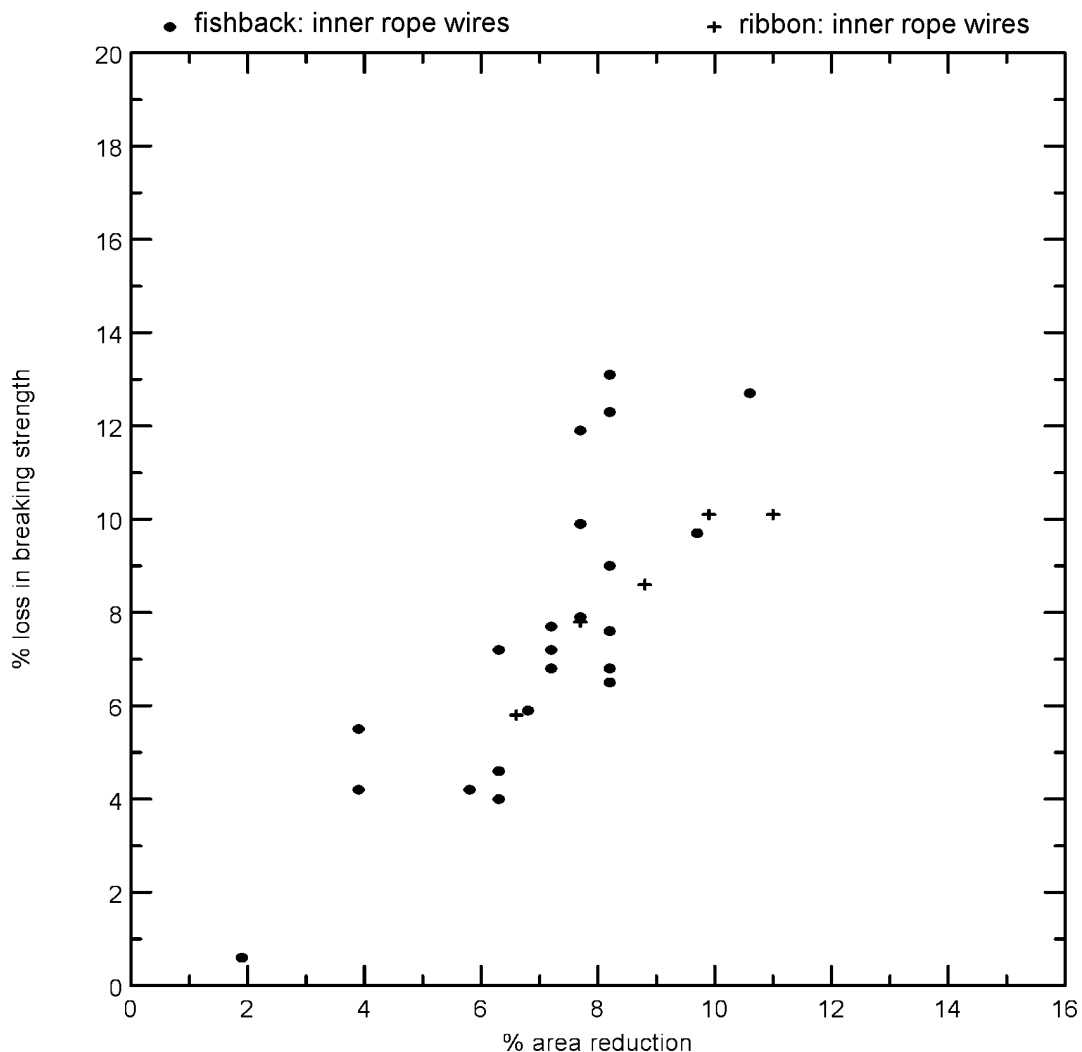
Generally the breaking strength losses were of the same percentage as the area reductions from the cut wires (see Fig. 7.1). Asymmetrical distributions of broken wires in the inner rope part did not make as much difference as was the case for the tests on triangular strand ropes.

Figure 7.1: *All non-spin ropes tested: Loss in breaking strength vs. total area reduction from cut inner rope wires.*

For area reductions of 7,7% to 8,2% for inner rope wires cut, strength losses varied between 6,5% and 13,1%. Although it can be reasoned that such a variation is of the same order as that observed for tests on pure triangular strand ropes,² the following

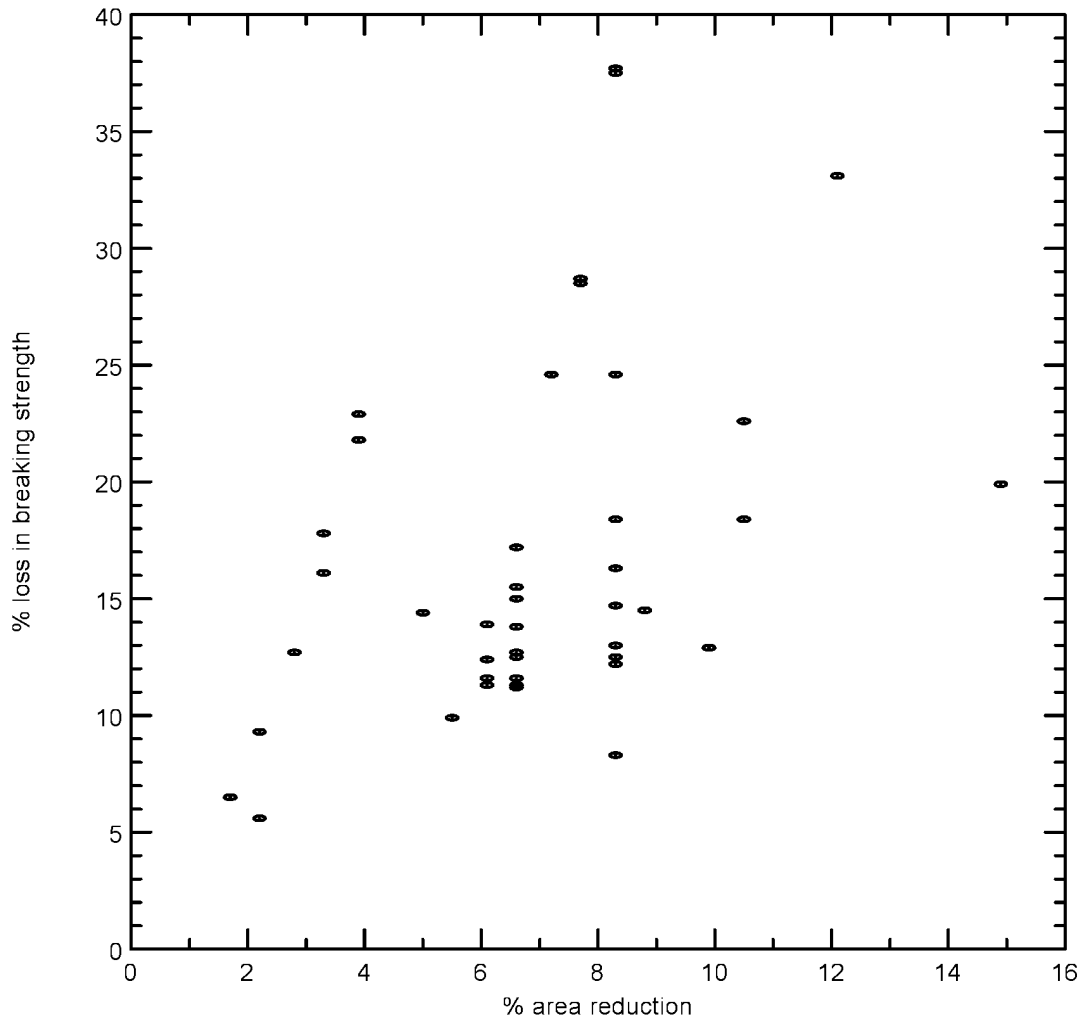
The situation seems to be much more complicated than had been experienced with tests on triangular strand ropes. Furthermore, Fig. 7.2 shows that a total area reduction of 2% could already give a strength loss of 10%.

Figure 7.2: *First strand failures of the ribbon strand rope: Loss in breaking strength vs. total area reduction from cut outer strand wires.*

Generally the breaking strength losses were greater for the specimens with the larger number of cut wires in an outer strand. The larger breaking strength losses were also experienced (as should be the case) for the shorter elongations to failure. The elongation to failure of a strand with cut wires decreased as the number of cut wires increased. For wires cut in one and two strands, the weakened strands all failed at loads less than the remaining strength of the specimens.

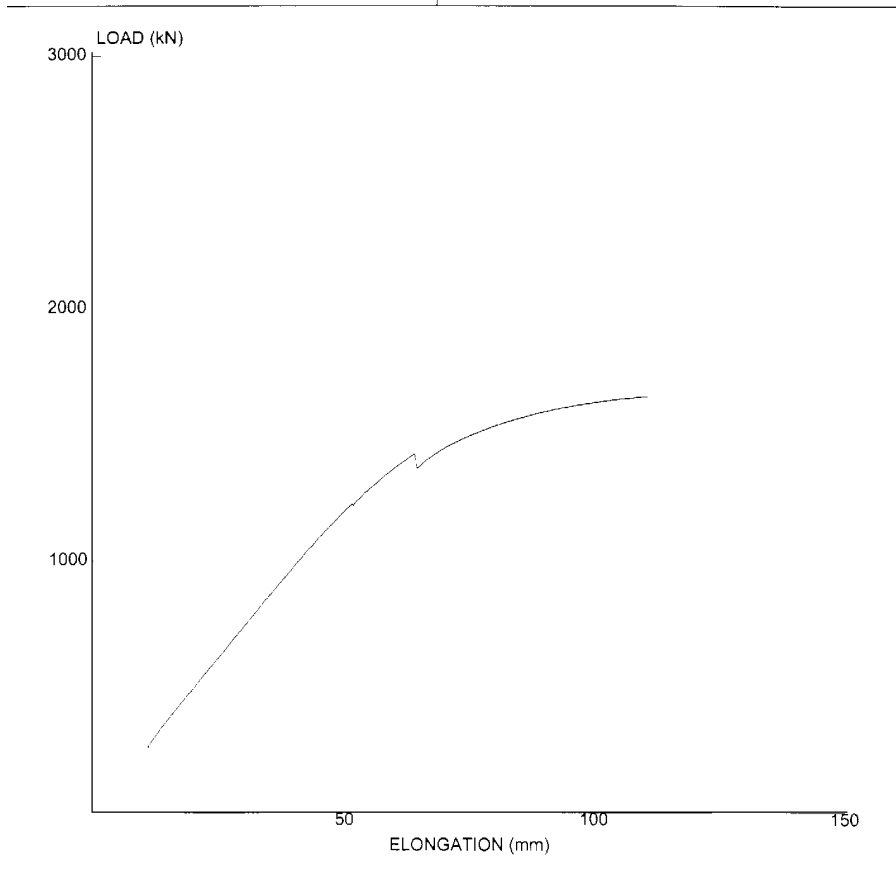
Figure 8: Load-elongation graph of a fishback rope specimen with 40% of the wires of a single outer strand broken.

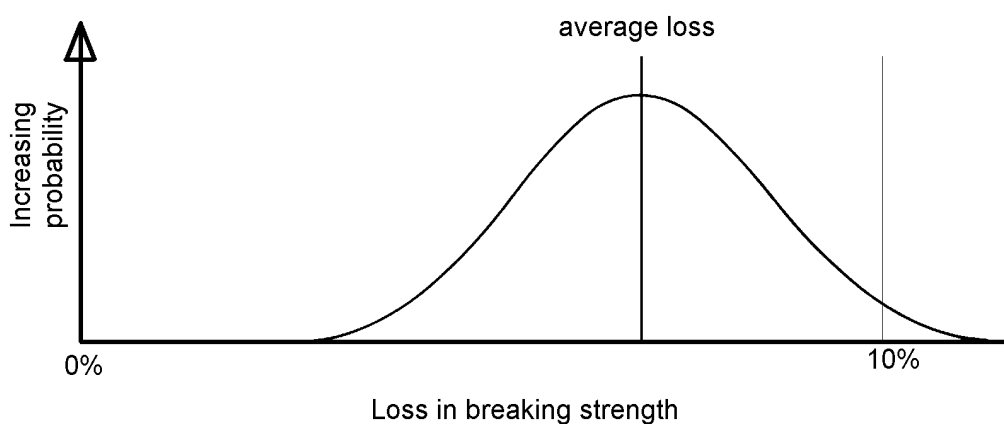
Figure A2 illustrates the above graphically.

Figure A2: *Assumed breaking strength loss distribution for a selected allowable reduction in rope steel area from broken wires.*

- Assumed that the scatter in breaking strength for a given configuration and number of broken wires (area reduction) would have a "normal distribution".
- Selected a maximum allowable reduction in steel area from broken wires such that the average loss in breaking strength (for the selected steel area) plus either one standard deviation or two standard deviations would be 10%. For a rope sample with the number of broken wires equal to the selected amount of area reduction, the probability that the breaking strength of the rope sample will be greater than 10% would then be 15% (one standard deviation) or 2% (two standard deviations).

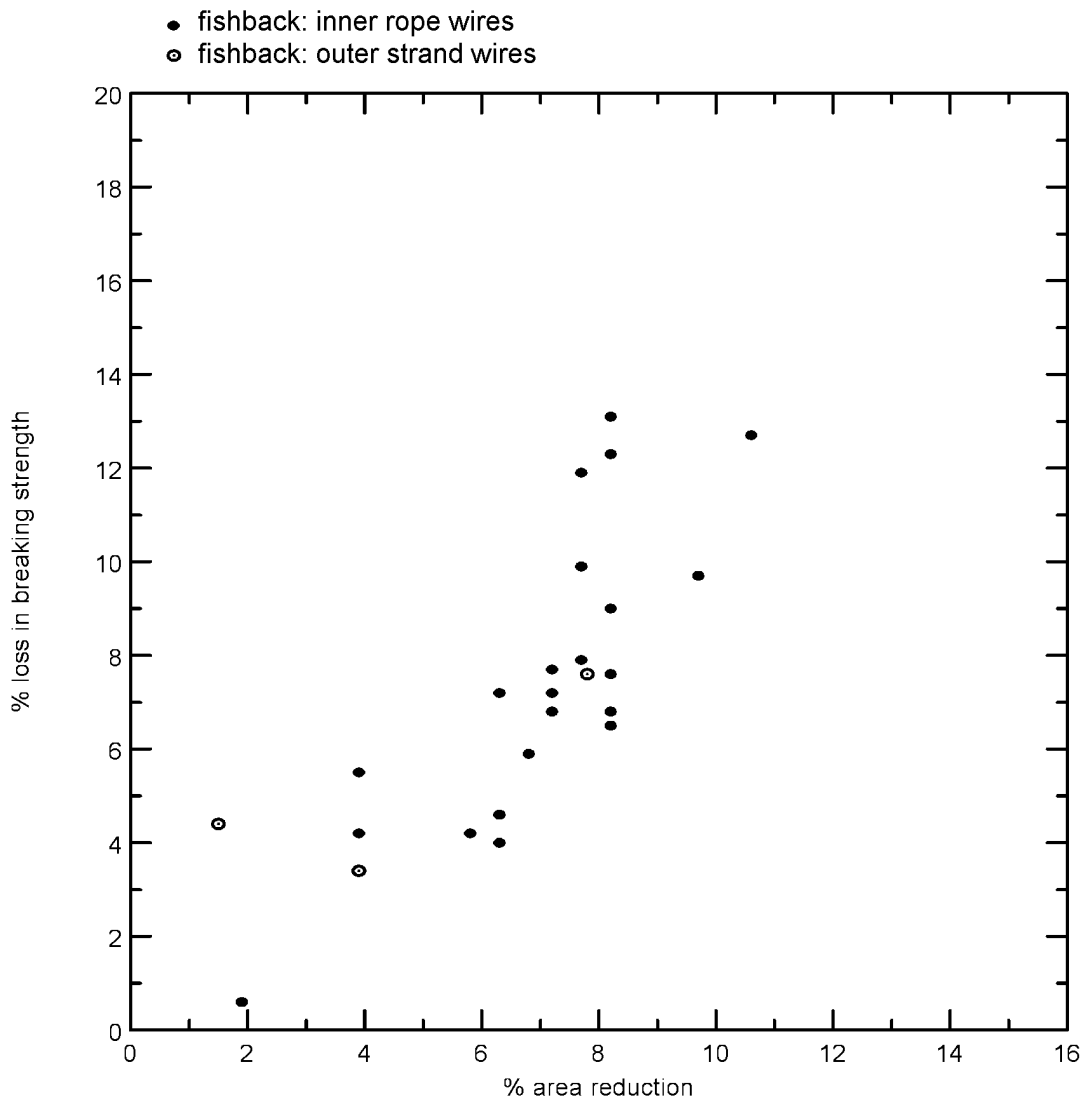
Figure B1.3: Results of cut wire tests on fishback ropes.

- For a number of specimens with only inner rope wires cut, only outer strands failed during the test.
- For a number of specimens the losses in breaking strength were noticeably less than the reductions in steel area.

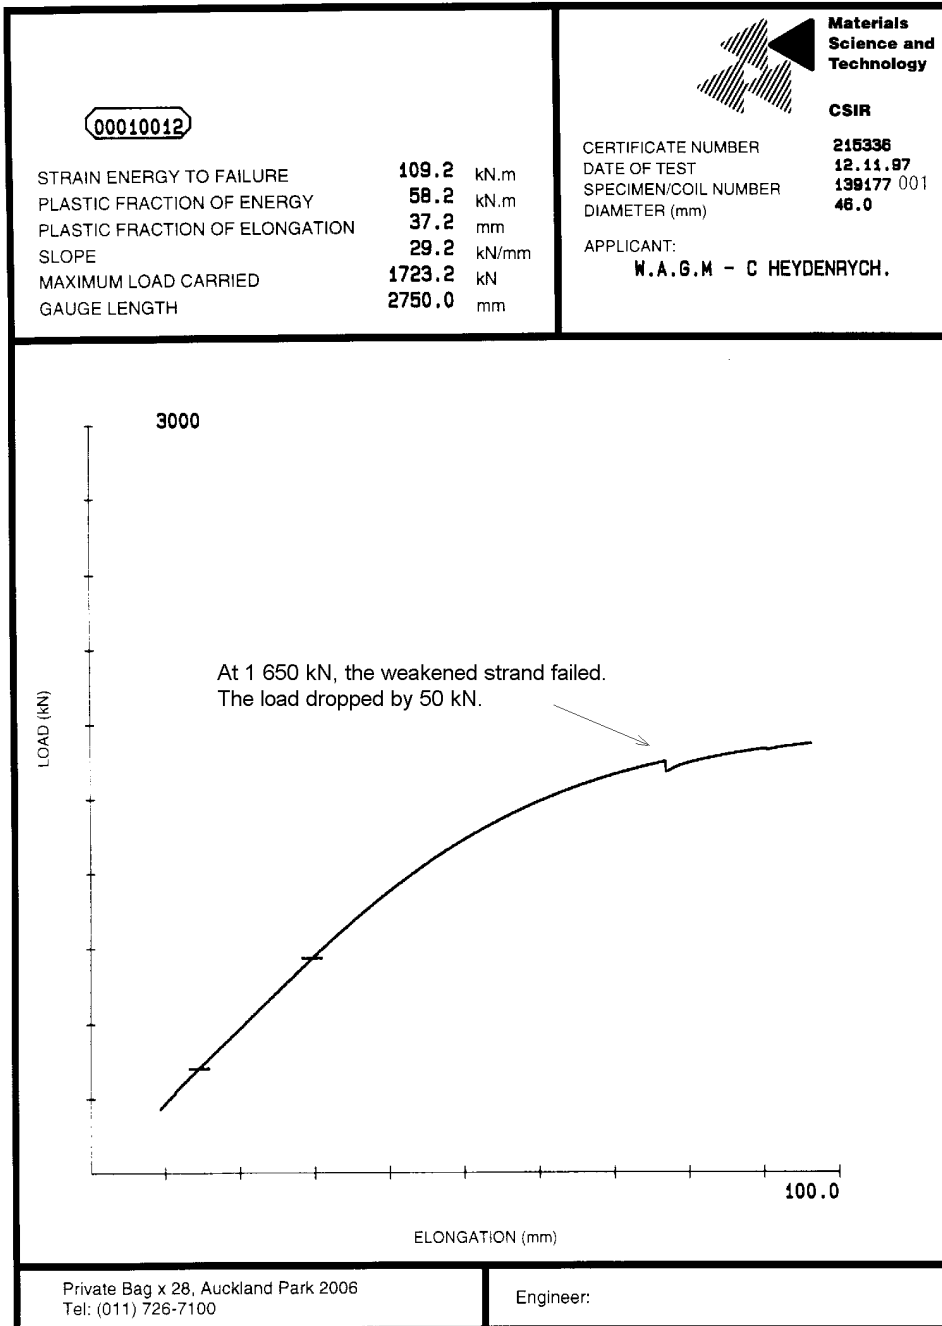
Figure B2.1.2.1: *Load-elongation graph of specimen 15-1. Three wires cut in one outer strand.*

The "breaking strength" of 1723 kN was therefore the same as the strength of a specimen with one outer strand cut completely.

The "first wire failure" recorded at 1610 kN was, of course, after the strand failed, and was simply a visual observation of the load displayed.

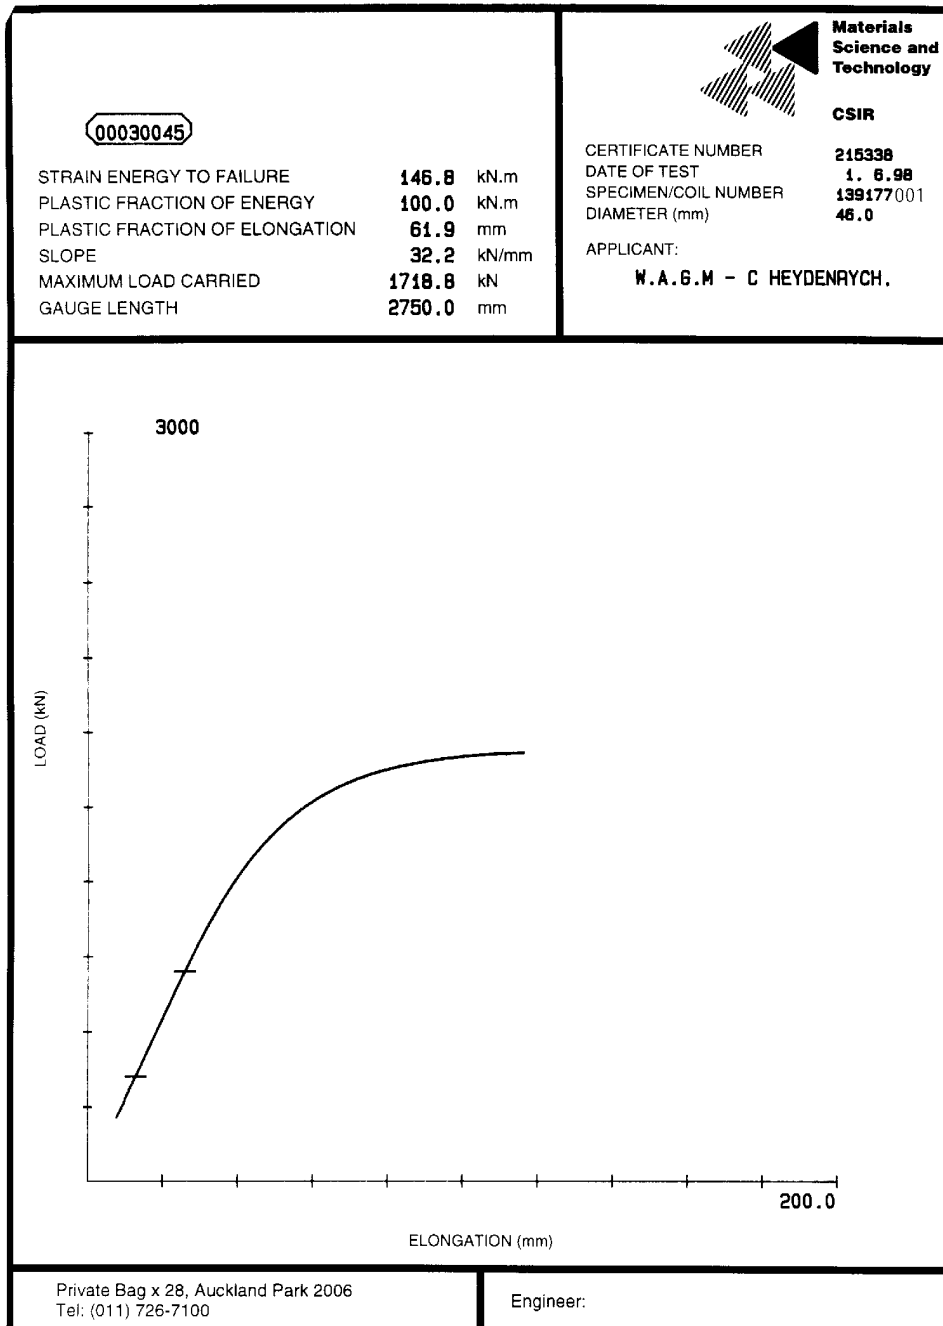
Figure B2.1.2.2: *Load-elongation graph of specimen 15-9. One complete outer strand cut.*

The test certificate recorded: First wire failure at 1 410 kN, breaking strength of 1 721 kN, and that only one outer strand failed (should have been two strands; probably for the same reason as given for specimen 15-3).

The load-elongation graph looked similar to that of specimen 15-1. The weakened strand failed at a load of 1 380 kN (and at an elongation of approximately 50 mm). The drop in load at failure of the weakened strand was of the order of 10 kN. The test was continued until another outer strand failed. The "breaking strength" of 1 721 kN was therefore the same as the strength of a specimen with one outer strand cut completely.

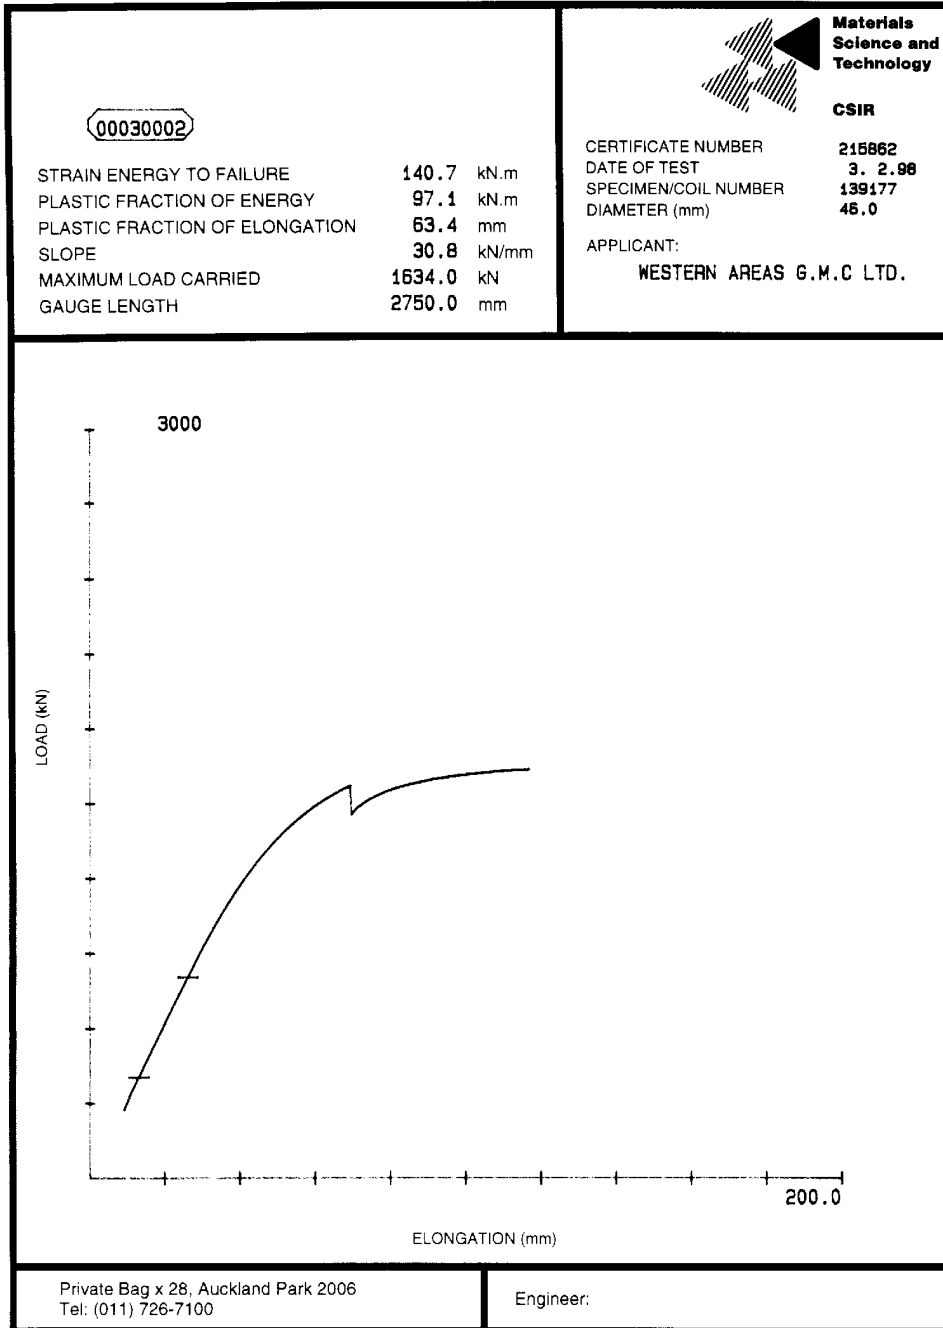
A typical load-elongation graph of specimens with one outer strand cut completely and wires cut in an adjacent strand (that of specimen 15-14) is shown in Fig. B2.1.3. Although it has been mentioned that a winder will not continue to operate when a strand is broken on the winder rope, the results are analysed to establish the failure behaviour of ropes.

Figure B2.1.3: Load-elongation graph of specimen 15-14. One outer strand cut completely plus three wires in an adjacent strand.

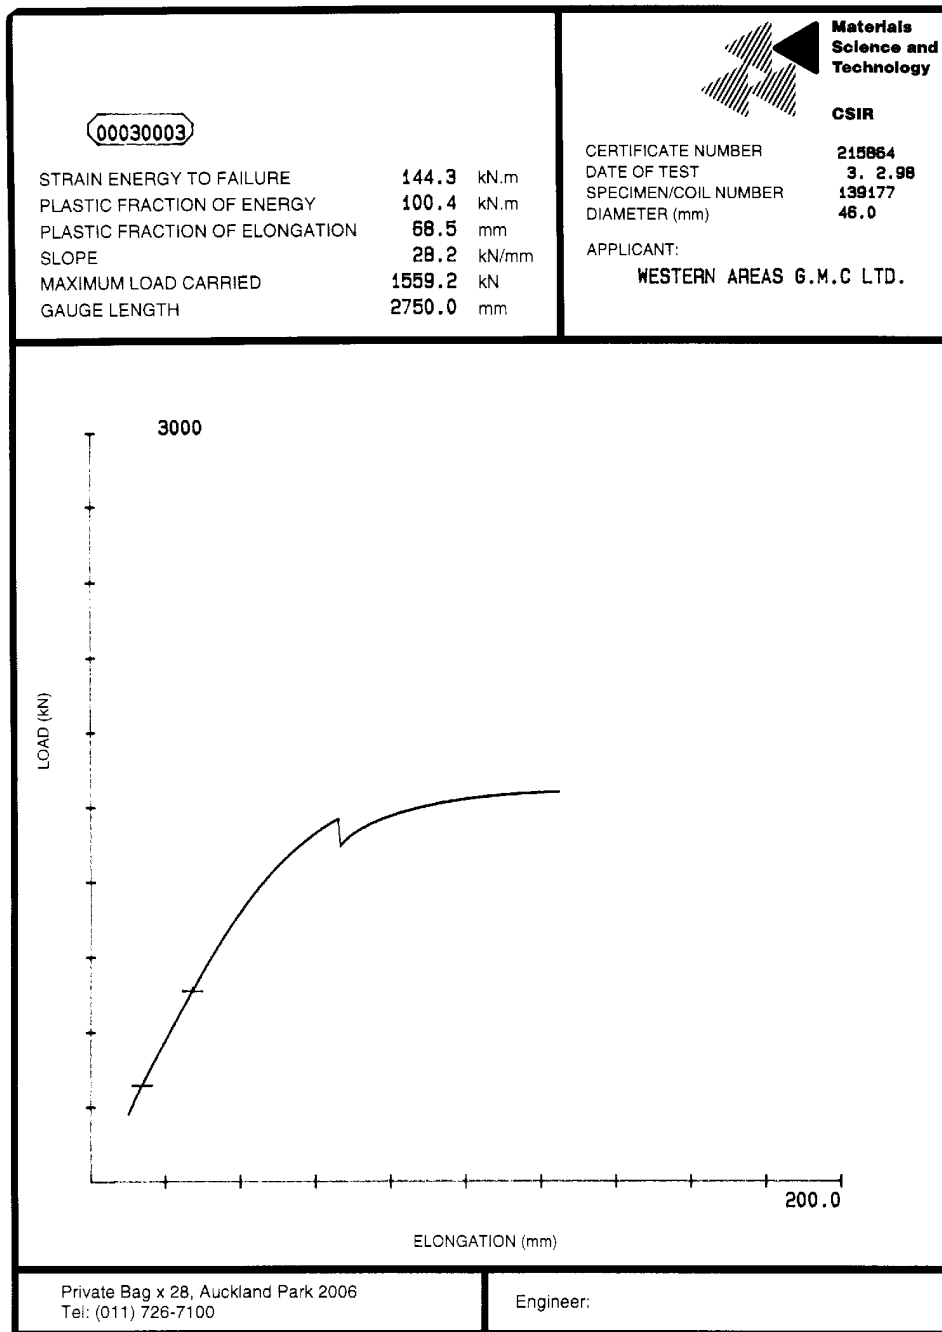
Figure B2.1.4: Load-elongation graph of specimen 15-27. Two outer strands cut completely plus three wires in an adjacent strand.

The load-elongation graph of this specimen is shown in Fig. B2.1.4. The weakened strand failed at a load of 1 440 kN (and at an elongation of approximately 70 mm). The drop in load at failure of the weakened strand was in the order of 100 kN. The test was continued until another outer strand failed. The "breaking strength" of 1 559 kN was therefore the same as the strength of a specimen with three outer strands cut completely.

The test certificate recorded: First wire failure at 1 400 kN, breaking strength of 1 559 kN, and that only one outer strand failed; should have been two strands for reasons given earlier (the weakened strand and one more strand) and that is disregarding the two

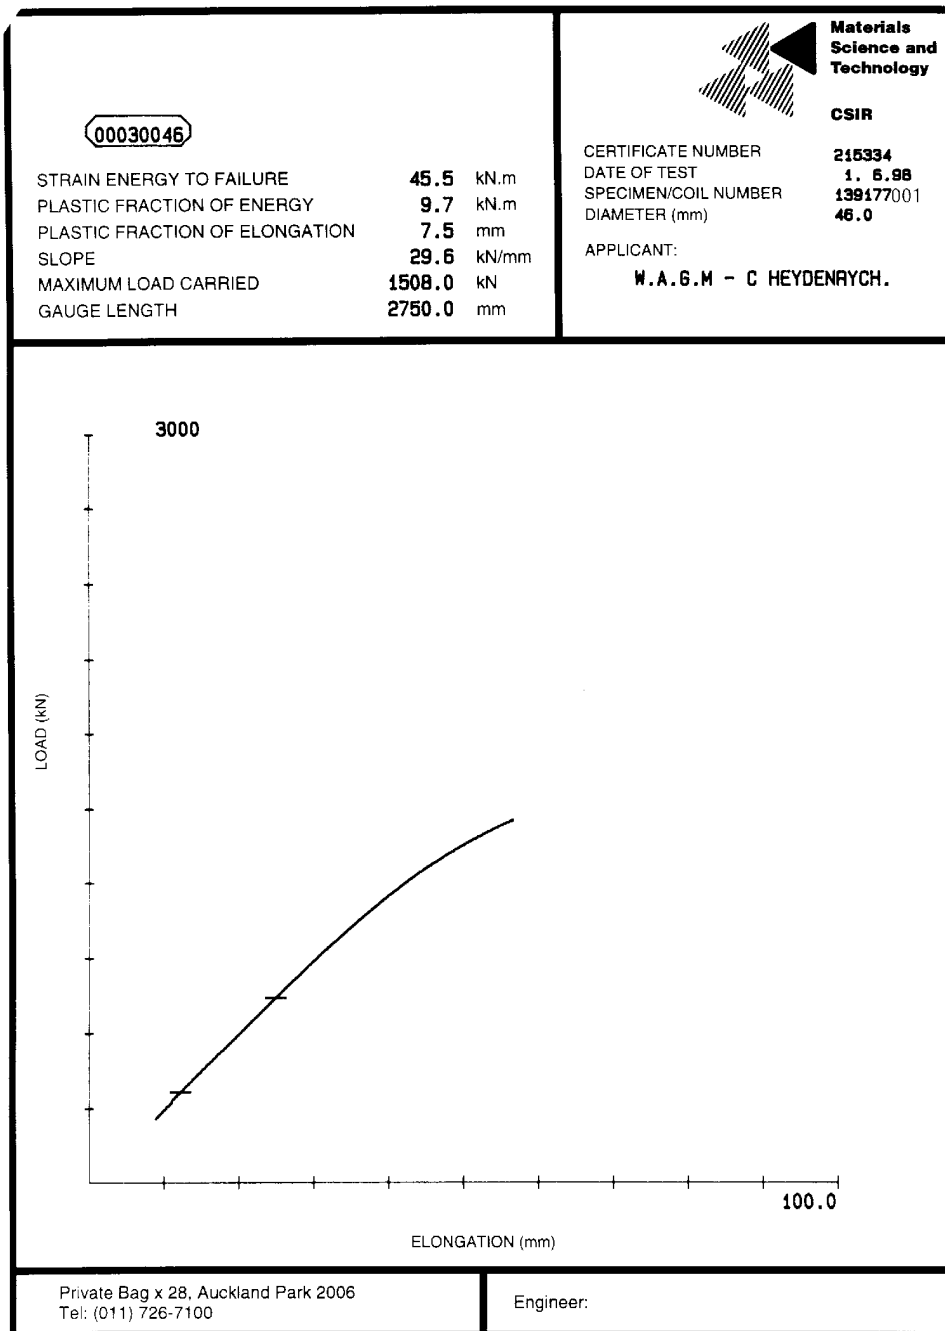
The load-elongation graph of this specimen is shown in Fig. B2.1.5.

Figure B2.1.5: Load-elongation graph of specimen 15-26. Four wires cut in each of four outer strands.

The four strands that failed were presumably the weakened strands. They failed simultaneously at a load of 1 508 kN (and at an elongation of approximately 55 mm). The test was terminated when the four strands failed.

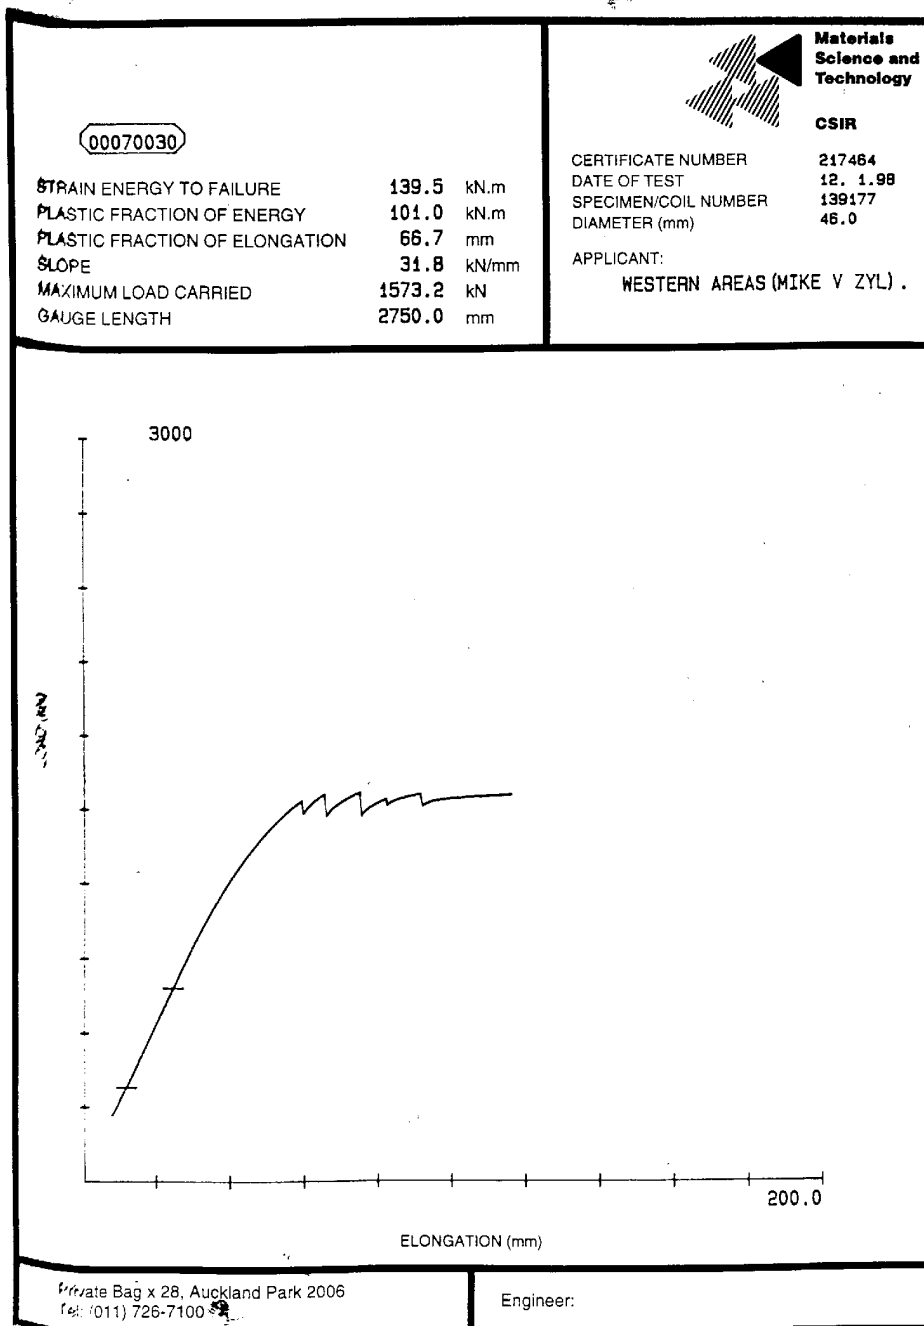
The load-elongation graph of this specimen is shown in Fig. B2.2.2.1. The first of the weakened strands failed at a load of 1543 kN (and at an elongation of approximately 60 mm). A second strand failed at a load of 1 563 kN (elongation of 65 mm). The maximum load was reached when a third strand failed (at 1 573 kN, elongation 75 mm). As mentioned before, the specimens were tested under a protective cover, and therefore it cannot be deduced from the graph what happened after maximum load was reached.

Figure B2.2.2.1: *Load-elongation graph of specimen 15-30.
Four wires cut in each of three outer strands.*

The test certificate recorded: First wire failure at 1 540 kN, a breaking strength of 1 573 kN, and that all strands failed except two inner and two outer strands.

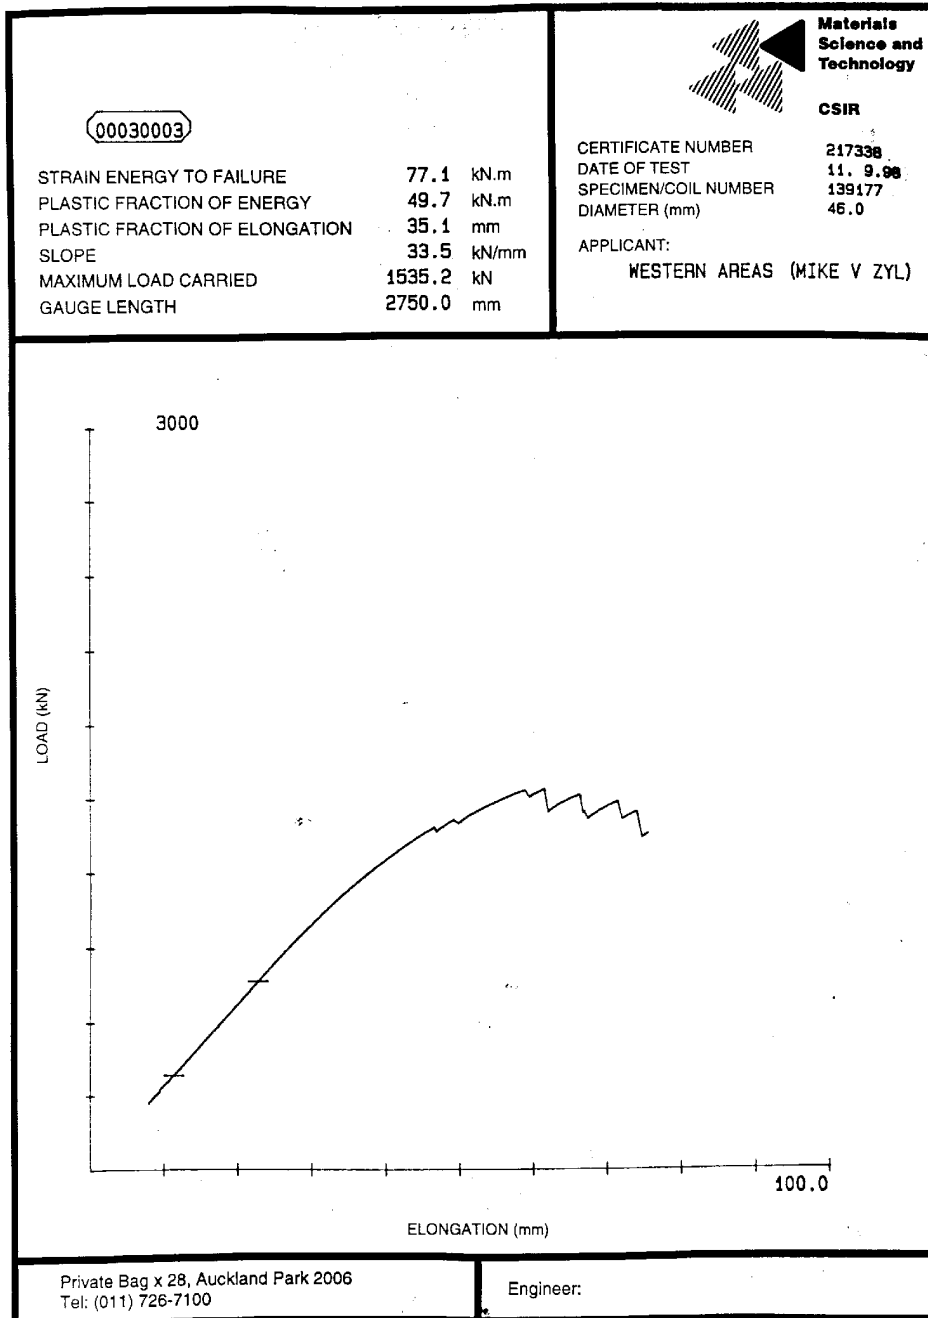
One further detail not experienced in earlier tests (GAP439) is shown in Fig B2.2.2.2, the load-elongation graph of specimen 15-43. Small load drops occurred at an elongation of 50 mm and just before the first strand failed at an elongation of 60 mm. The slopes of the load drops suggest that these drops may not be wire failures but that the cut wires at the "damaged" outer strand sections may have been slipping back (creating larger gaps between the cut ends). The actual events can, however, only be determined if a specimen is tested without a protective shield.

Figure B2.2.2.2: *Load-elongation graph of specimen 15-43. Four wires cut in each of three outer strands.*

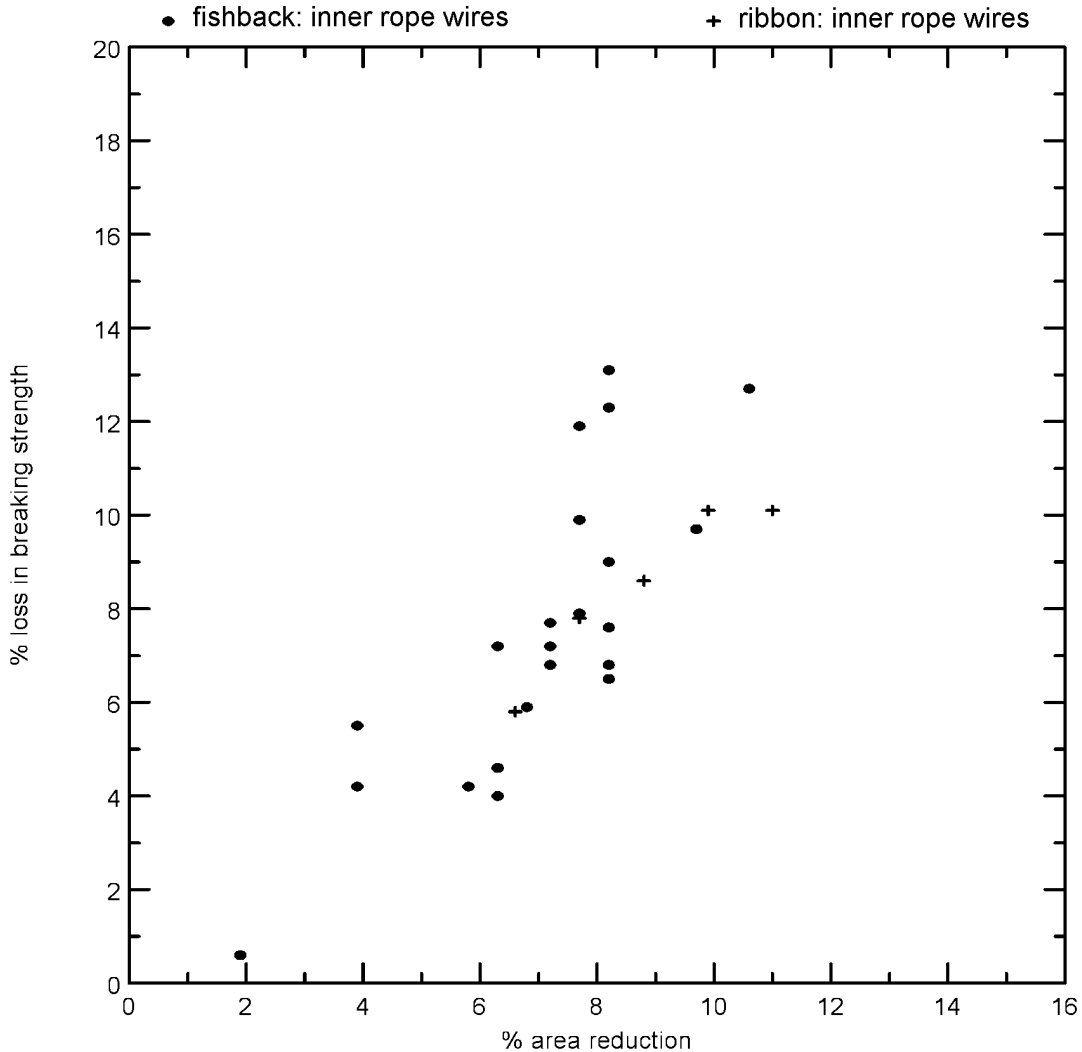
Figure B3.1 shows the loss in breaking strength for the area reductions from cutting wires on the inner triangular strand rope part of both the 18 strand fishback rope specimens and the 15 strand ribbon strand rope specimens.

Figure B3.1: *All non-spin ropes tested: Loss in breaking strength vs. total area reduction from cut inner rope wires.*

The inner triangular strand rope of the 18 strand fishback rope was identical to the inner rope of the 15 strand ribbon strand rope. Similar behaviour could therefore be expected for cut-wires in the inner ropes of both rope constructions. Although only a few ribbon strand specimens were tested, and only one specimen of a specific cut-wire configuration, the results of the ribbon strand rope specimens fit well into the results of the fishback rope specimens (for which more than one specimen of a specific cut-wire configuration was tested).

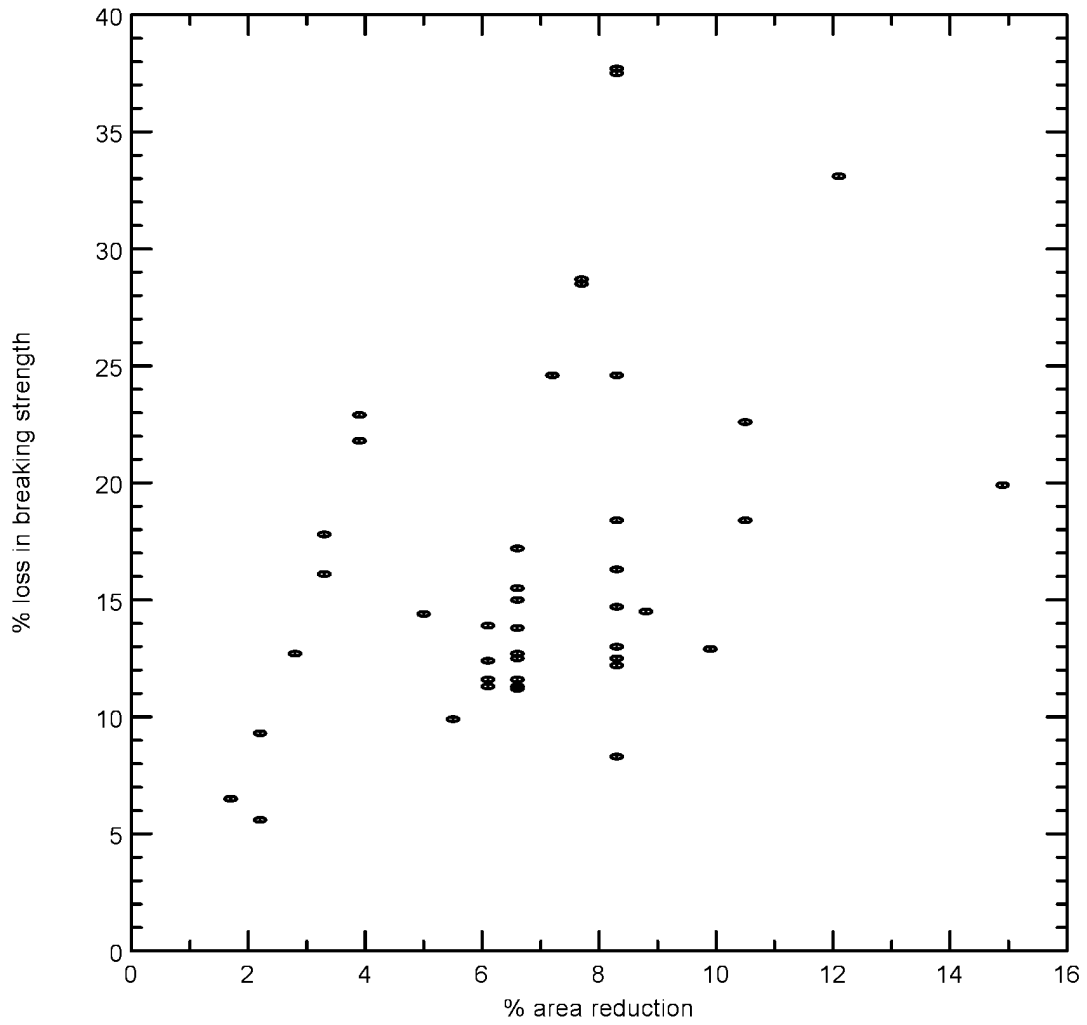
Figure B3.2: *First strand failures of the ribbon strand rope: Loss in breaking strength vs. total area reduction from cut outer strand wires.*

The larger-than-anticipated strength losses for weakened outer strands are explained later in this report. It is also shown that the failure load of a weakened outer strand is influenced by the length of the tensile test specimen.

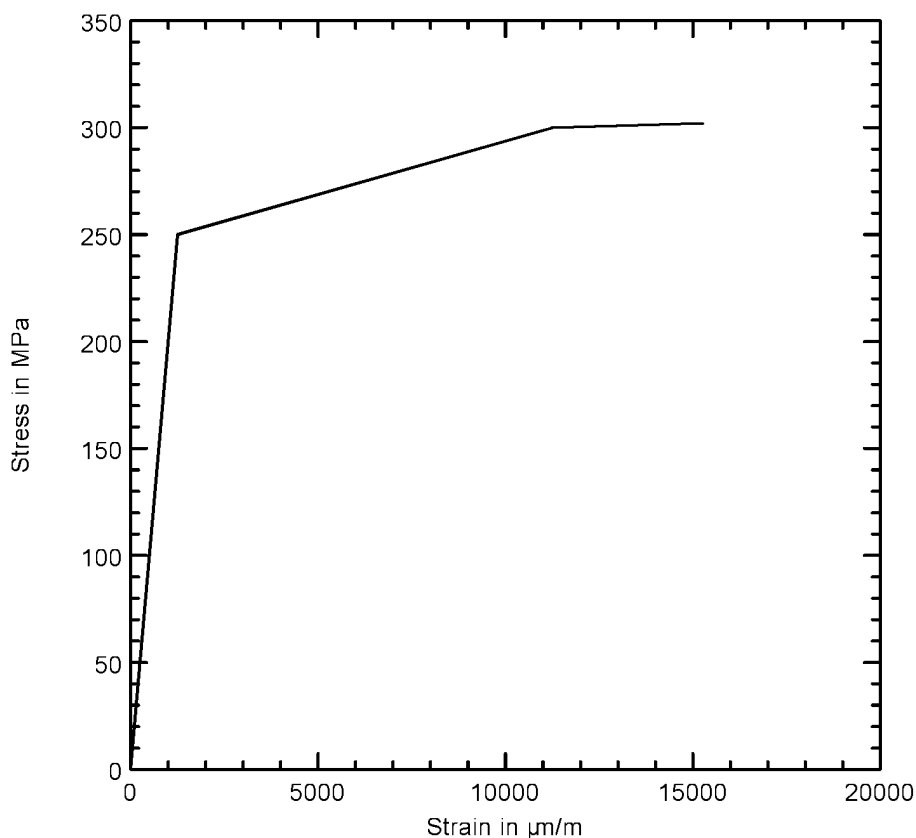
Consider a one metre long steel bar with a cross-sectional area of 20 mm². Assume that this steel bar has stress-strain curve as given in Fig. C1.

Figure C1: Assumed stress-strain relationship for a steel bar

The assumed stress-strain curve shown in Fig. C1 includes an approximation of the plastic behaviour of the steel. The steel is elastic (at 200 GPa) up to 250 MPa after which it becomes plastic and eventually fails at a stress of 302 MPa and a strain of 15,25 mm/m. The assumed plastic behaviour of the steel is approximated by two linear functions (5 GPa from 250 MPa to 300 MPa, and 0,5 GPa from 300 MPa to 302 MPa). Although the linear approximation of the plastic behaviour may be somewhat crude, it made the calculations easier to execute and to understand. The assumed stress-strain behaviours in the section of the report is for demonstrative purposes only and do not necessarily approximate the behaviour of any given steel.

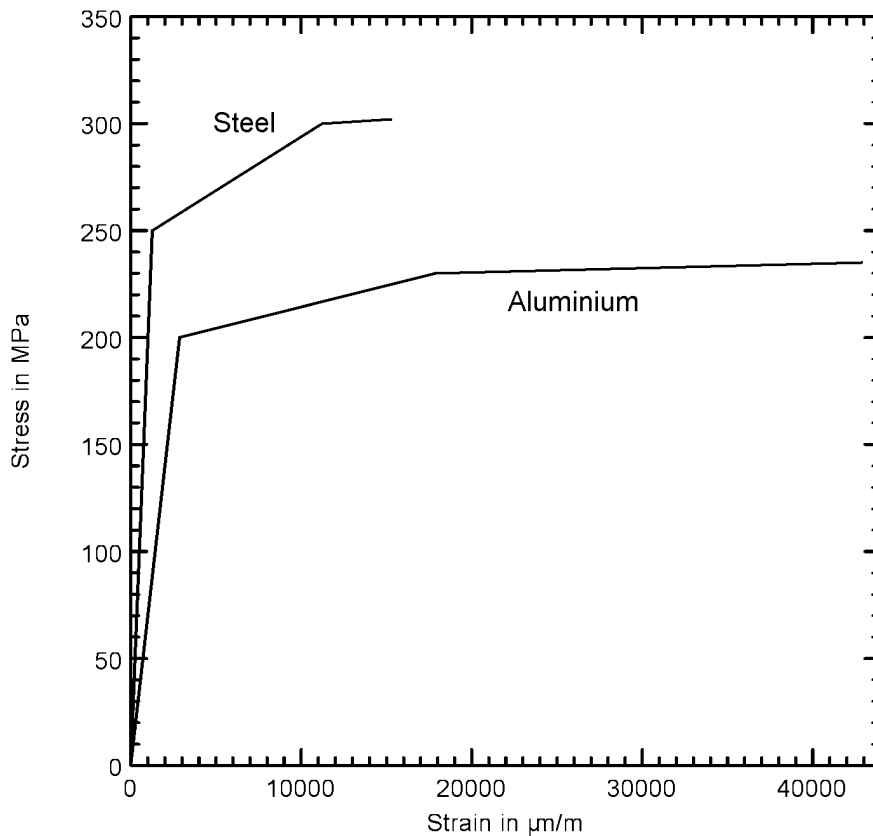
bars and three aluminium bars was selected for this illustration. All six bars have cross-sectional areas of 20 mm². The assumed stress-strain relationships for the bars are shown in Fig. C3.

Figure C3: Assumed stress-strain relationship for steel and aluminium.

One steel bar will have a breaking strength of 6,04 kN, and one aluminium bar will have a breaking strength of 4,70 kN. Theoretically an assembly of three bars of each will have a strength of 32,22 kN, but if the six bars are loaded together, the steel will fail before the aluminium has reached maximum strain and stress. The breaking strength of the assembly is 31,61 kN (98% of theoretical) and will have an elongation at failure of 15,25 mm.
