Safety in Mines Research Advisory Committee

Final Report

Discard criteria for mine winder ropes

Research agency: MIKE VAN ZYL INCORPORATED
Project number: GAP 502
Date: September 2000

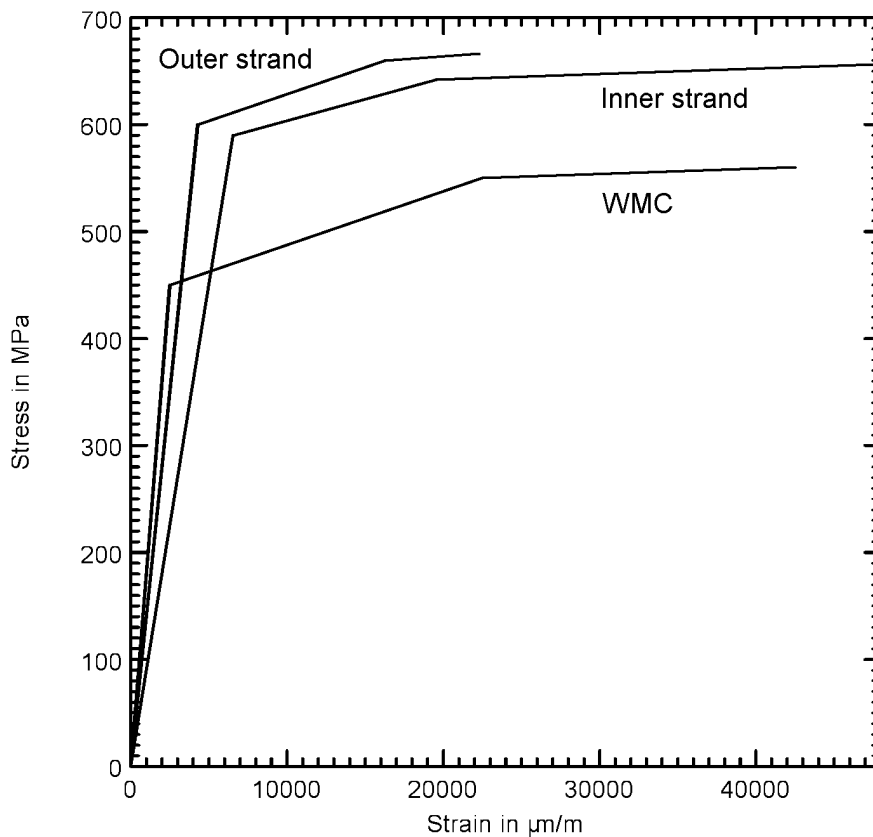
Stress-strain behaviours, as shown in Fig. C4, were assigned to the three different steel bars (strands). In this case "strain" reflects the behaviour of a "strand" as part of the rope.

Figure C4: *Assumed stress-strain relationships for the three strand types in a non-spin rope*

With the stress-strain relationships of Fig. C4, a 3 m long bar will fail at:
