Safety in Mines Research Advisory Committee

Final Report

**Stope gully support and sidings
geometry at all depths and at
varying dip**

GAP 602

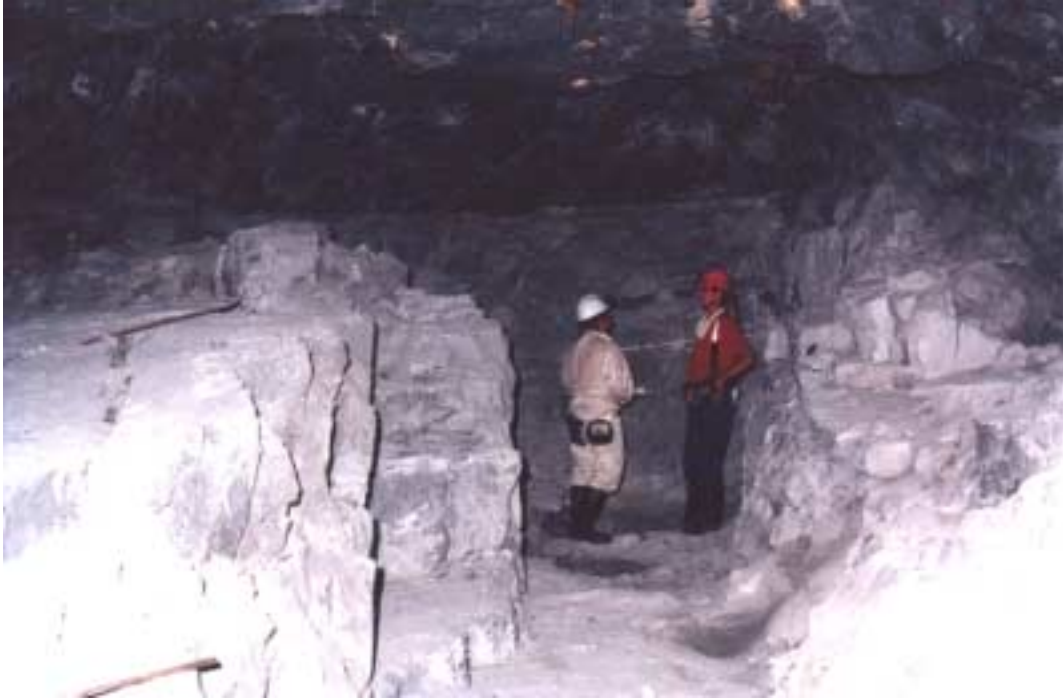
Figure 4.10 - Gully cut in a high stope width area in competent, jointed strata on the Beatrix reef at approximately 900 m depth. The gully is in the centre of a panel mining high channel widths, and is very stable, tending to break out along joint planes

Stress fracturing is not a concern and, in very competent ground such as massive high strength quartzites, very stable and unsupported gullies can be cut (Figure 4.10). Sidewalls of gullies tend to break along joints and hangingwall problems relate to bedding and the creation of brows (Figure 4.11) on the gold mines. In the Bushveld complex bedding-type partings are largely absent and joint-bound wedges or zones of more intense jointing are the main concern (Figures 4.12 and 4.13). In general, where such hazards exist, shallow mining practice includes the addition of extra in-stope pillars either side of gullies to limit spans and ensure stability, plus the omission of any down-dip sidings.

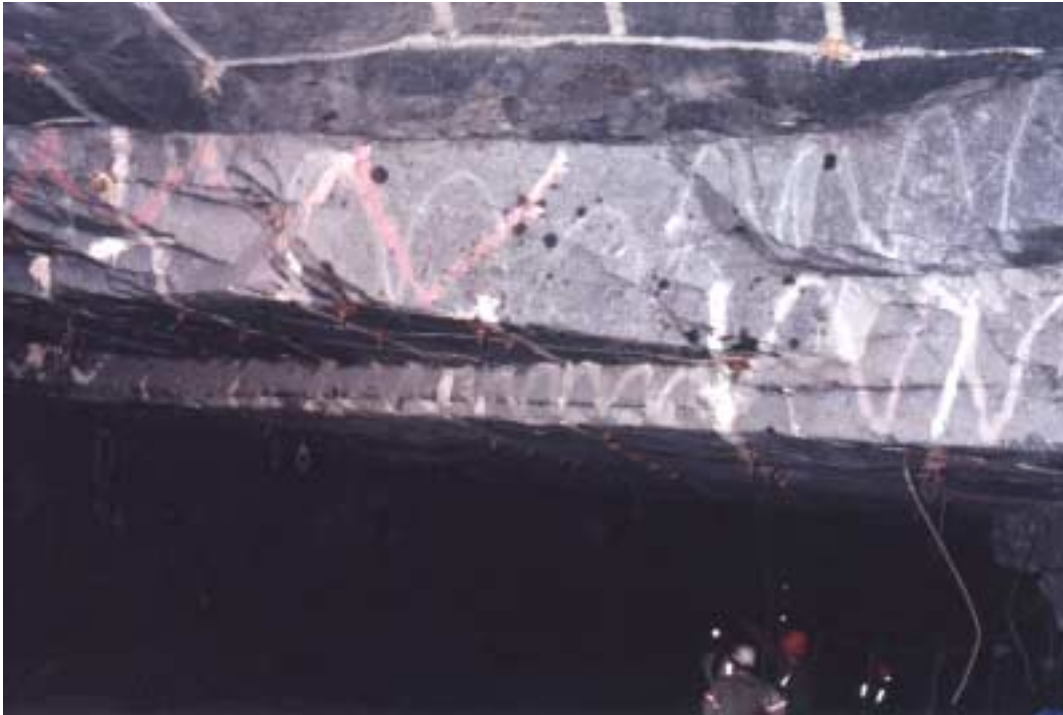
Figure 4.11 - Brow in massive, bedded quartzite over a gully on the Beatrix reef at 900 m depth

At shallow depth, elongates are preferred as gully edge support in the platinum mines due to their high stiffness in a low closure environment. On shallow, pillar supported gold mines such as Beatrix (Beatrix reef) and Tau Lekoa (VCR) mining without gully edge support is generally feasible (see Figures 4.10 and 4.11).

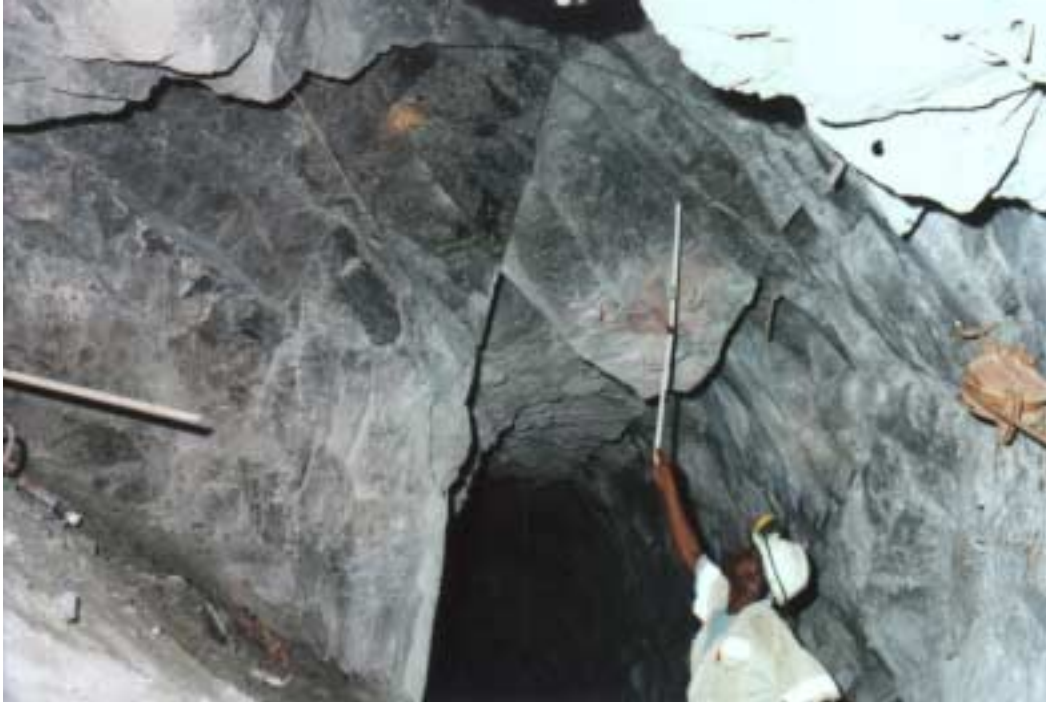
Figure 4.12 - Hazard resulting from joint-bound wedges over a strike gully on the Merensky Reef at approximately 300 m depth. An additional pillar is left on the up-dip (left) side of the gully to reduce the risk of a fall

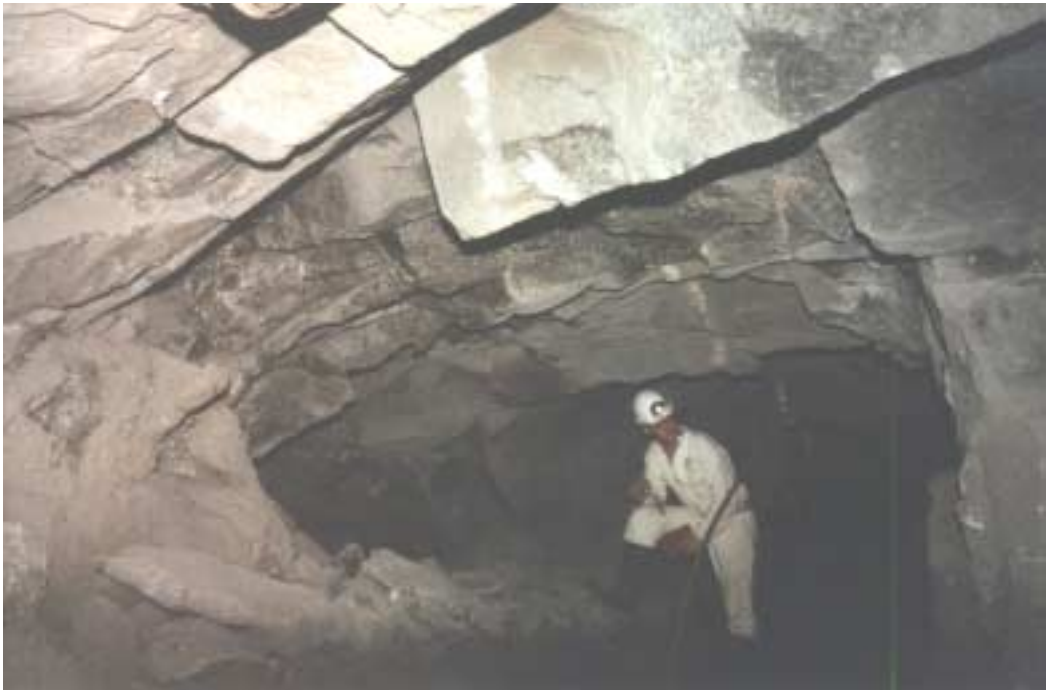
Figure 4.13 - Zone of dense jointing creating a hazard on the Merensky Reef at 600 m depth. Siding left on left side of gully and additional in-stope pillar left on right

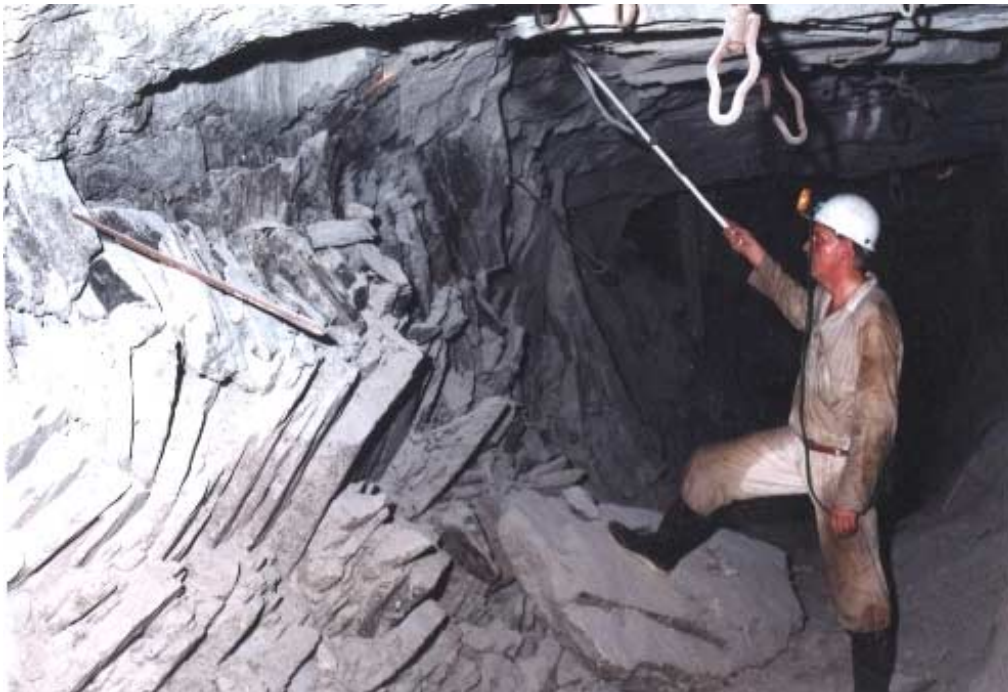
Figure 4.14 - Crush pillar directly adjacent to a gully (with no siding) is yielding in response to stope closure, resulting in slabbing being pushed, or toppling, into the gully – Merensky Reef 700 m depth

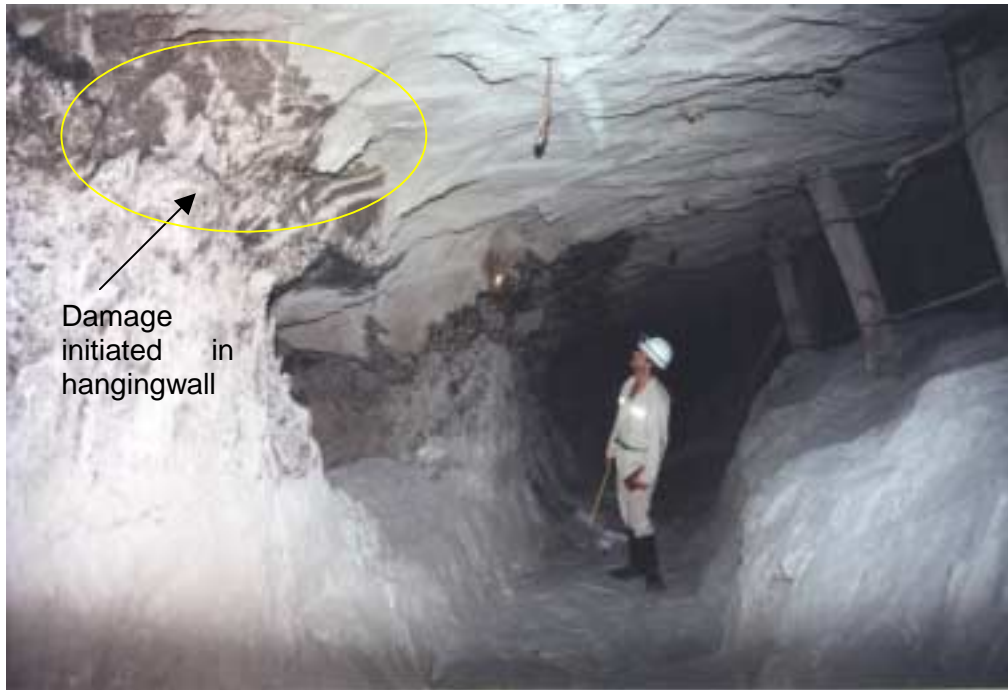
Figure 4.15 - Gully with no siding on the Merensky Reef at 800 m depth. Conditions are stable, although spalling has clearly occurred along the pillar sides. Note that pillar edge damage runs up and into the hangingwall.

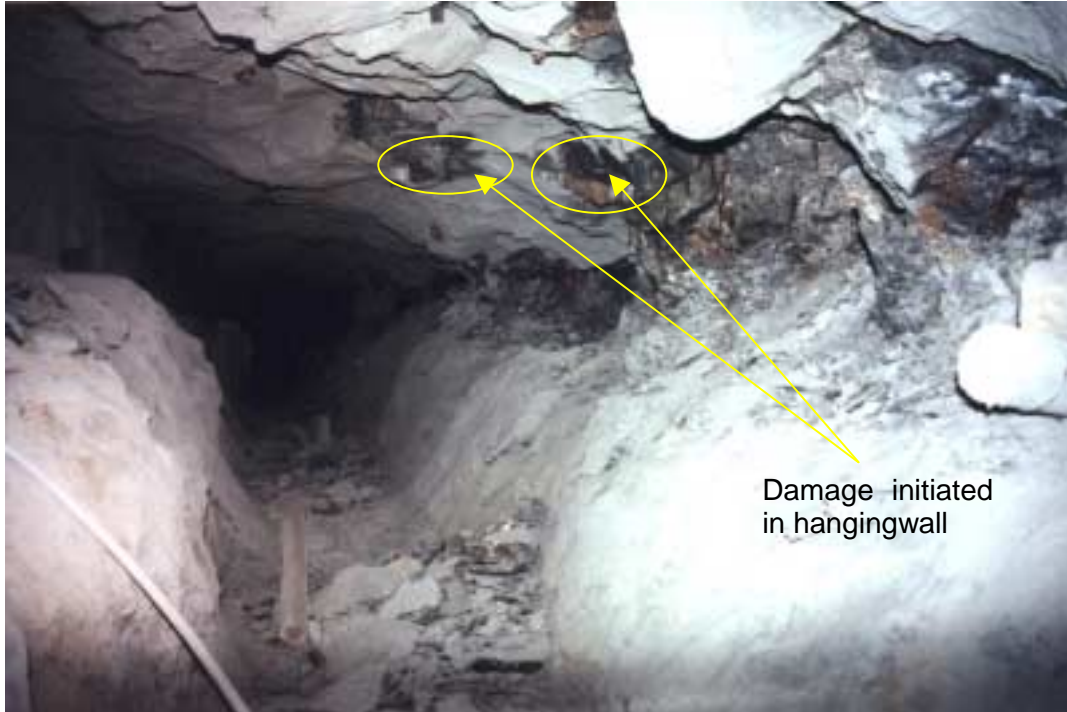
Figure 4.16 – Merensky Reef showing a short, 0.5 m siding blasted concurrently with gully advance using a single corner hole

When pillar deterioration occurs it frequently only effects the pillar sidewalls (Figure 4.14), however, where rock strengths are relatively uniform across hangingwall, reef and footwall, damage on-reef may progress into the gully hangingwall (Figure 4.16). Where this happens a significant hazard may be created (Figure 4.19). Loss of gully hangingwall integrity, the prevention of pillars spalling into gullies causing bulking of the down-dip sidewall, can only be achieved by moving the gully away from any pillar. This involves cutting a siding.

1. Advanced with the ASG heading face, blasted as part of the gully round – frequently these are only 0.5 to 1 m in width and are excavated by drilling a single extra hole into the corner of the gully (Figure 4.16). This is very crude and results in a sloping sidewall from siding corner down to the gully floor. It is not supported and results in the hangingwall span from pillar to timber elongates on the up dip side of the gully being increased by 1 m. Hangingwall gully support is generally increased from rows of 3 rebars to rows of 4 rebars to cater for the increased span.

In terms of improving pillar performance, a siding of approximately 1 m width, even with sloping floor, appears to improve pillar behaviour based on underground observations alone. There is reduced damage in the gully sidewall, with the pillar edge generally yielding only within the confines of the siding. When the siding width is reduced to 0.5 m, the impression gained is that sidewall damage still occurs in the gully sidewall, and, in addition, if hangingwall damage occurs during pillar crushing, the slabs which peel away still lie over the gully, presenting a fall of ground hazard (Figure 4.16).

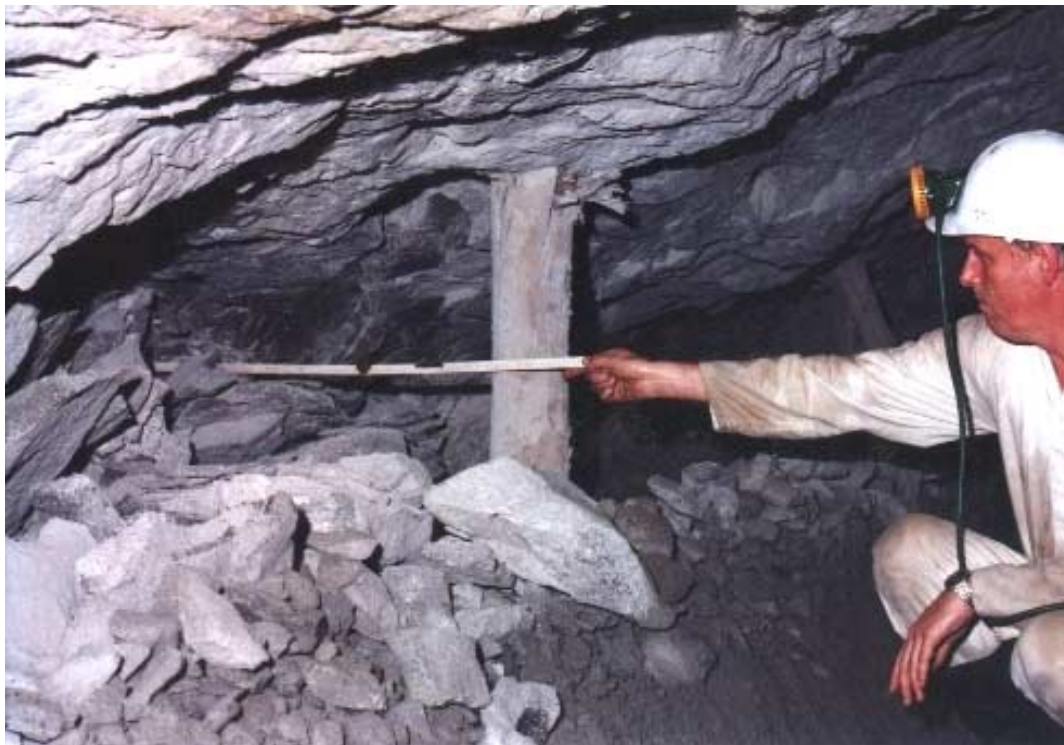
Figure 4.17 – Merensky Reef - lagging 1 m wide supported siding

2. The siding lags the ASG gully heading, and is blasted using a series of slipping holes. The siding width generally exceeds 1 m and is generally supported by a row of timber elongates, hence minimising the span across the gully (Figures 4.17 and 4.18). Frequently, no additional hangingwall bolting is used in these circumstances.

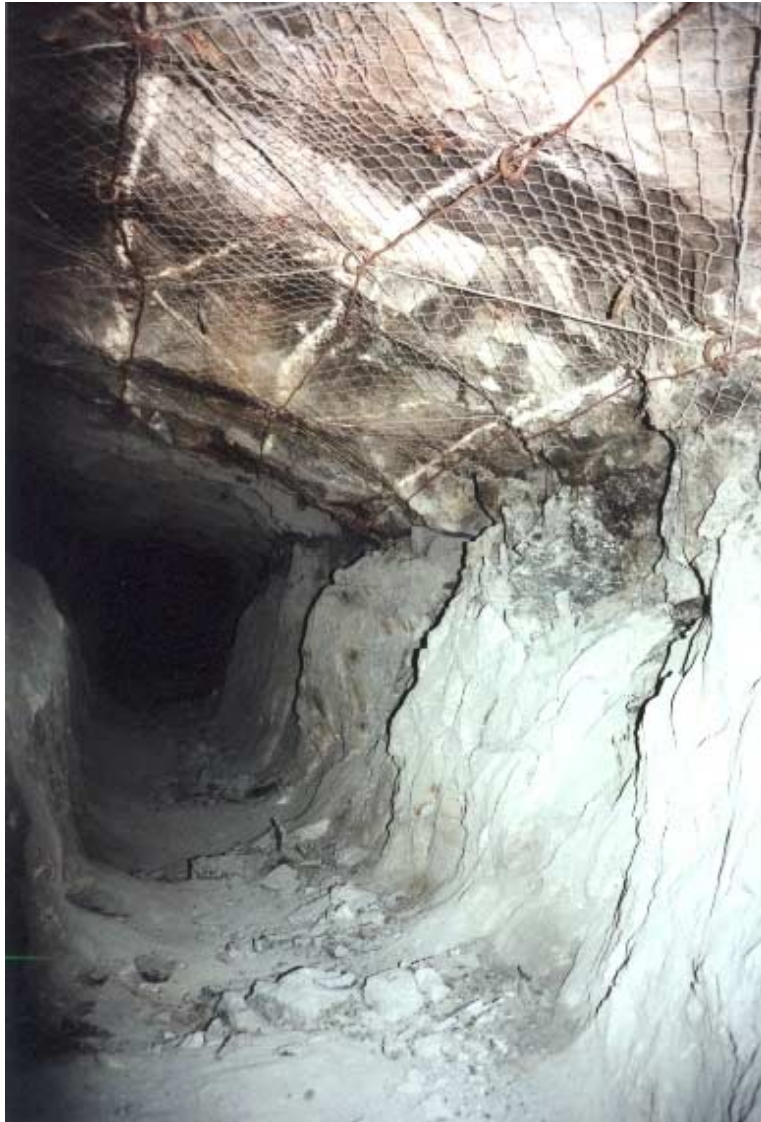
Figure 4.19 - Merensky Reef gully where a crush pillar lies on the gully edge and during crushing has damaged the hangingwall resulting in mesh and lacing application to control minor falls

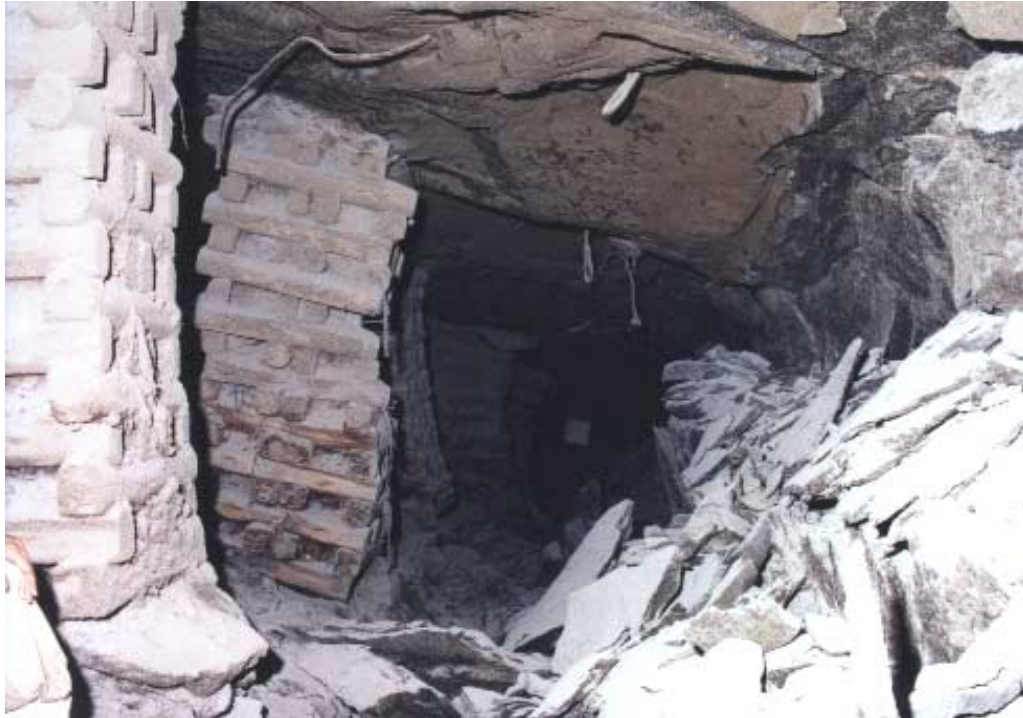
Figure 4.20 - Merensky Reef - no siding. Severe spalling down-dip

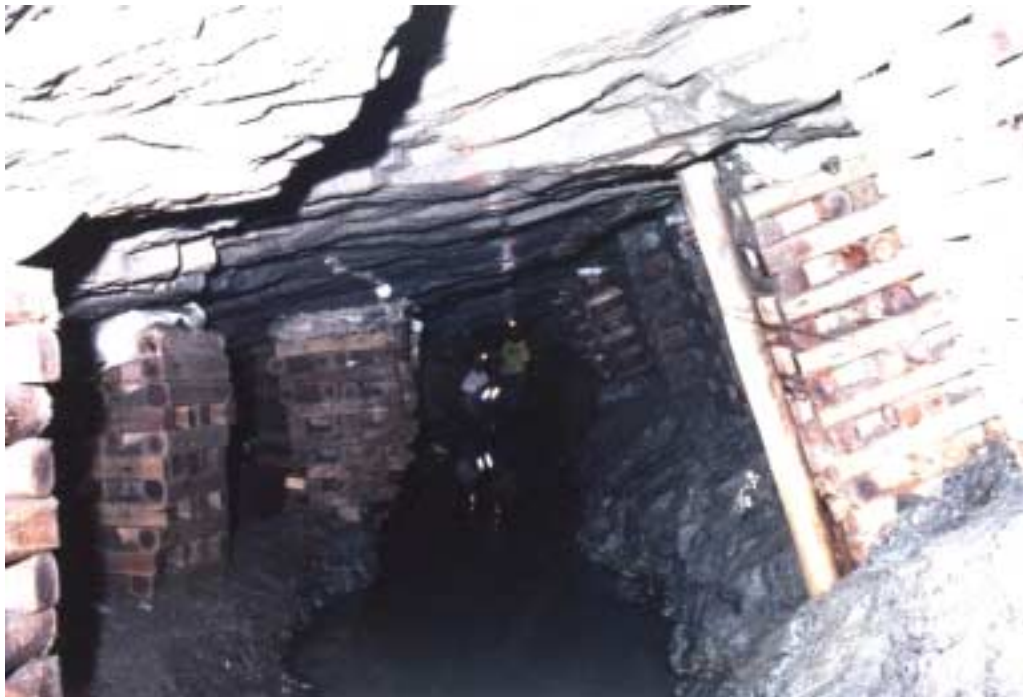
Figure 4.21 - Gully with lagging siding. Down-dip siding has a flat floor due to stress fracture damage. Down-dip packs are vertical

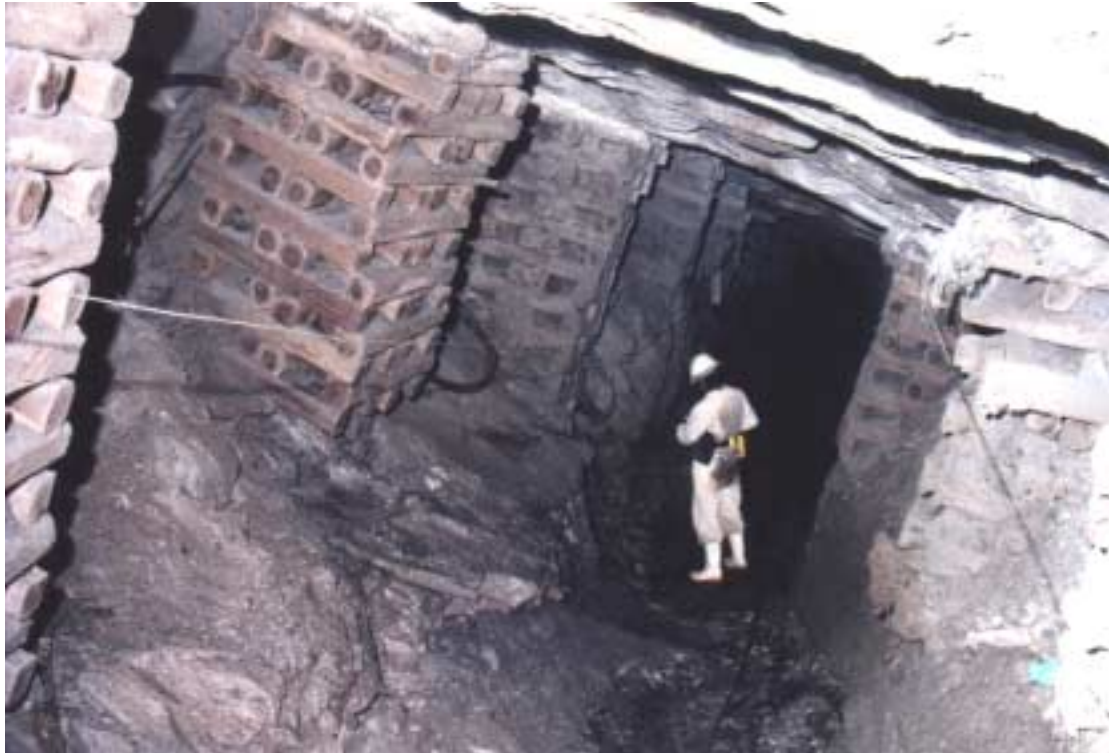
Figure 4.22 – Merensky Reef - footwall lifted gully in wide heading at 2000m below surface. Due to down dip sidewall integrity, all packs are normal to dip

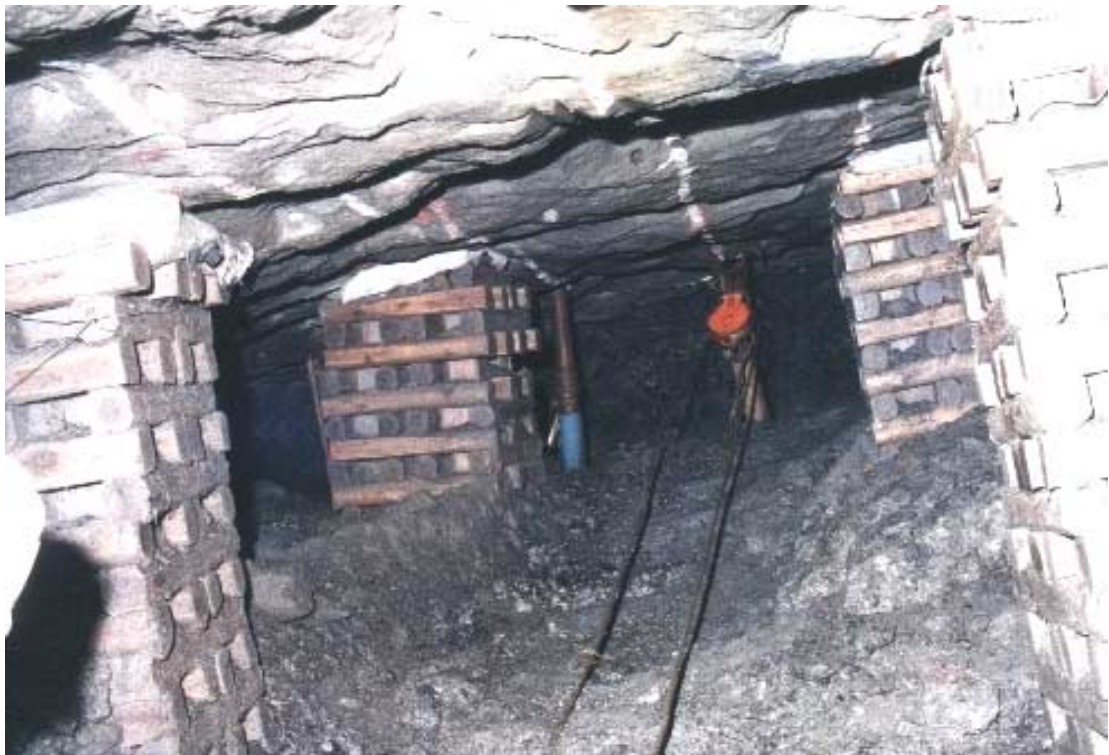
Figure 4.23 - Merensky Reef - conditions in a wide heading with footwall lifted gully at 2000m below surface

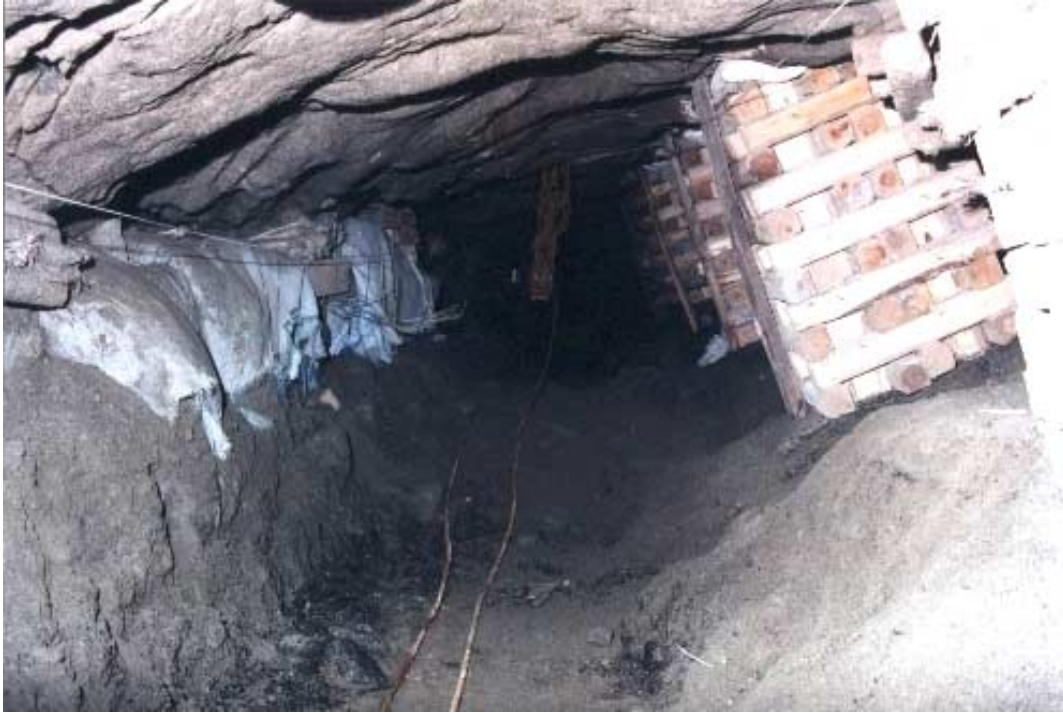
Figure 4.24 – Conditions along a footwall lifted gully on the Merensky Reef at 2000m. Note backfill installed on the down dip side

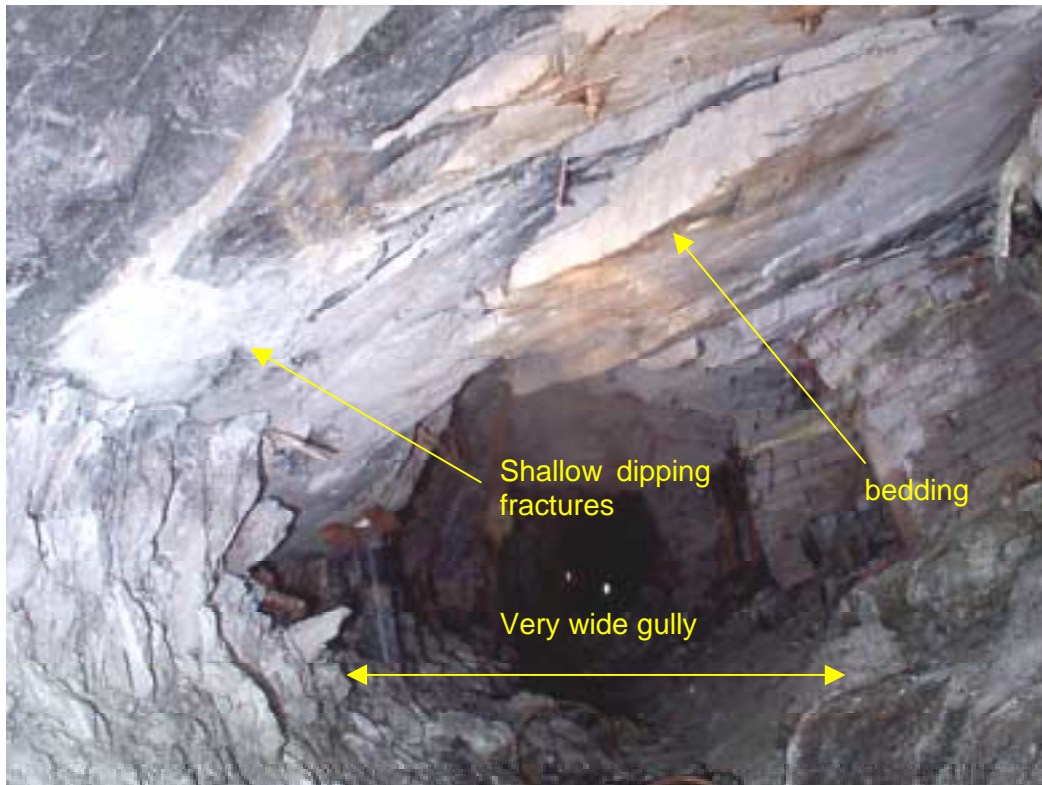
Figure 4.27 - Basal Reef – the effect of a lagging siding on hangingwall conditions – view from face area looking back along gully

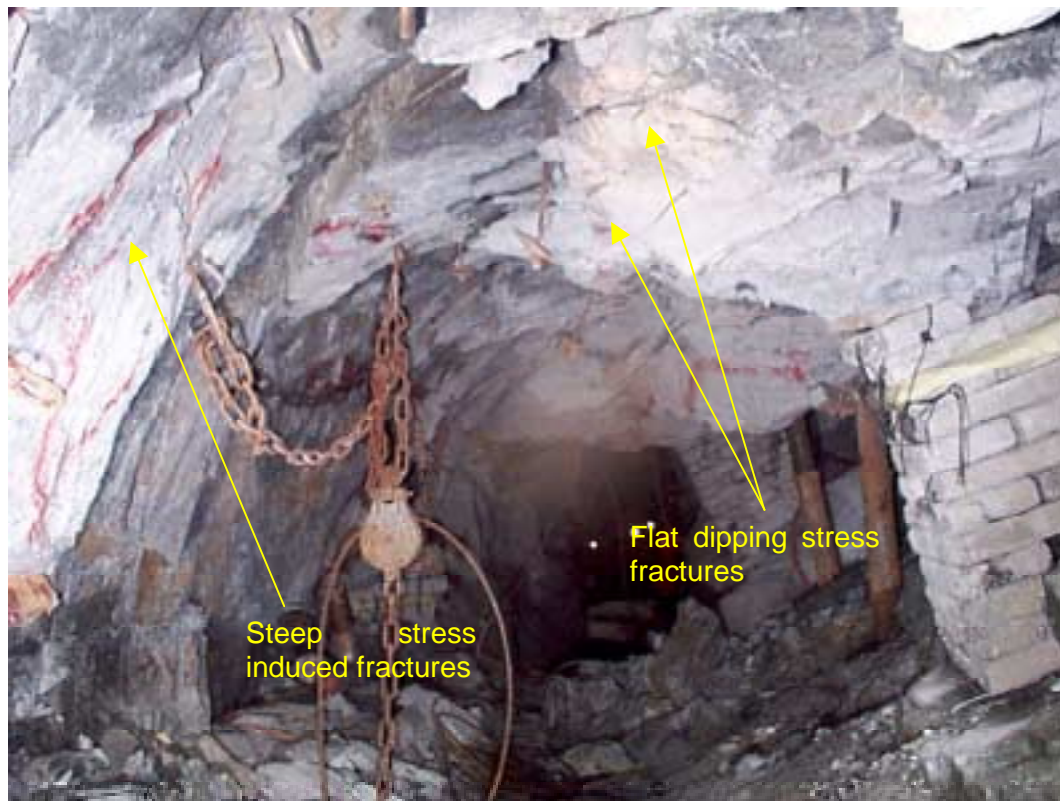
Figure 4.28 - Basal Reef - combined effect of an ASG heading, plus a lagging siding when strata is well bedded

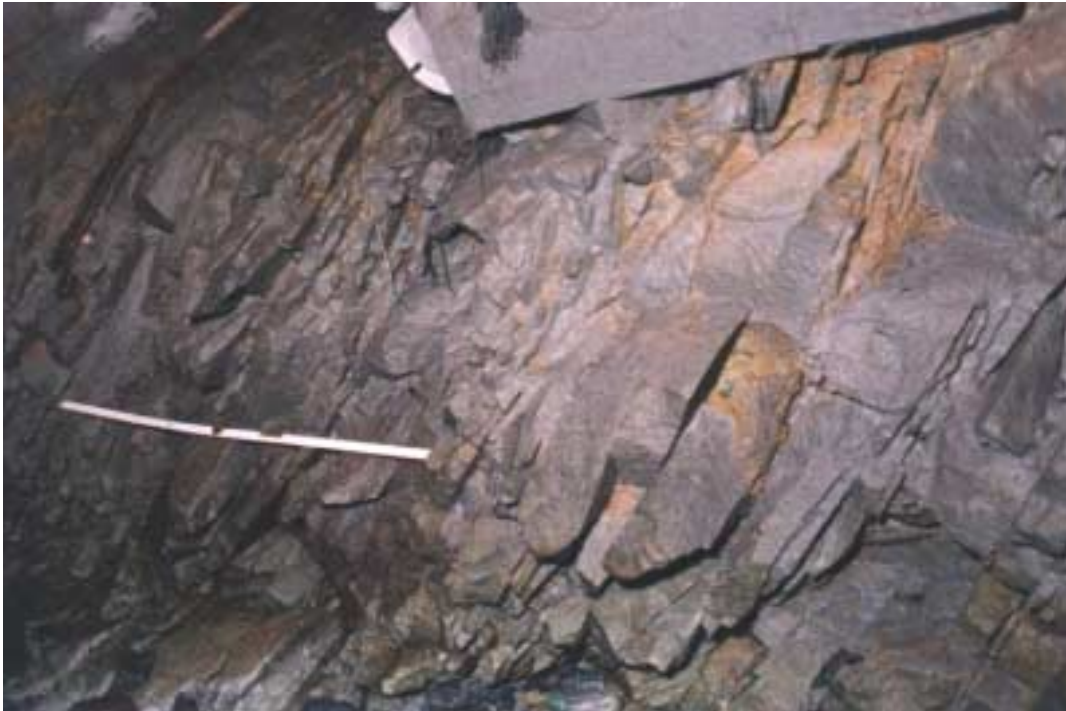
Figure 4.29 - Typical high density stress fracturing in gully sidewalls in VCR footwall quartzites

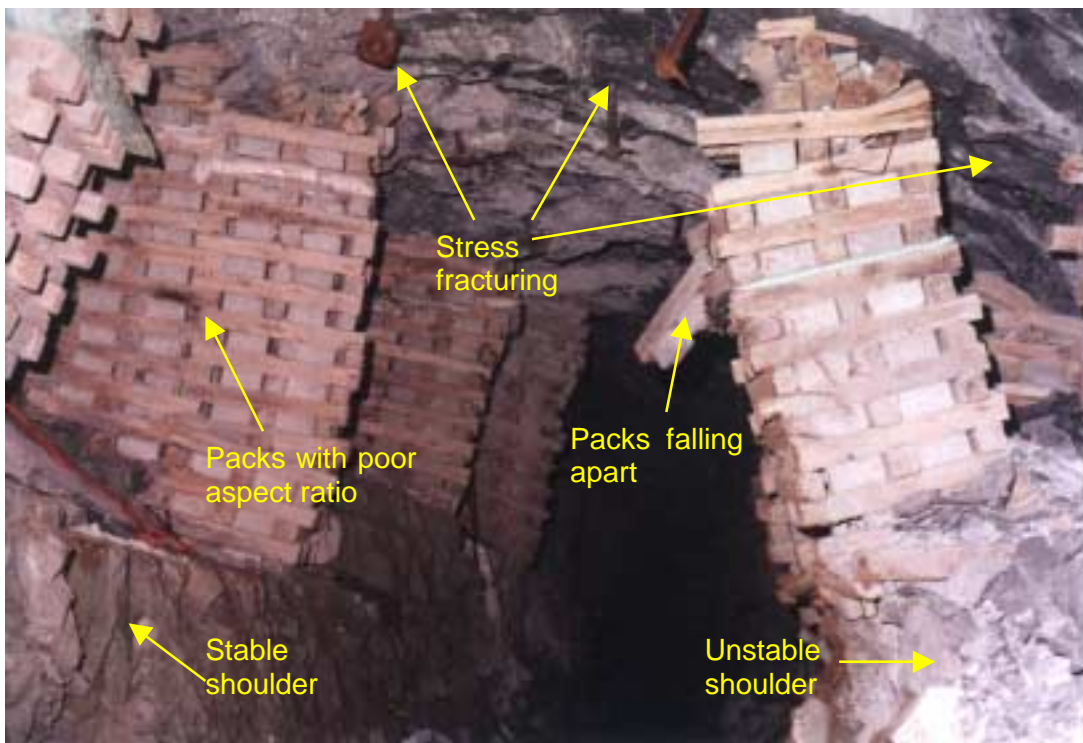
Figure 4.33 – VCR - Typical conditions that may develop along a gully created as an ASG with lagging siding under high stress

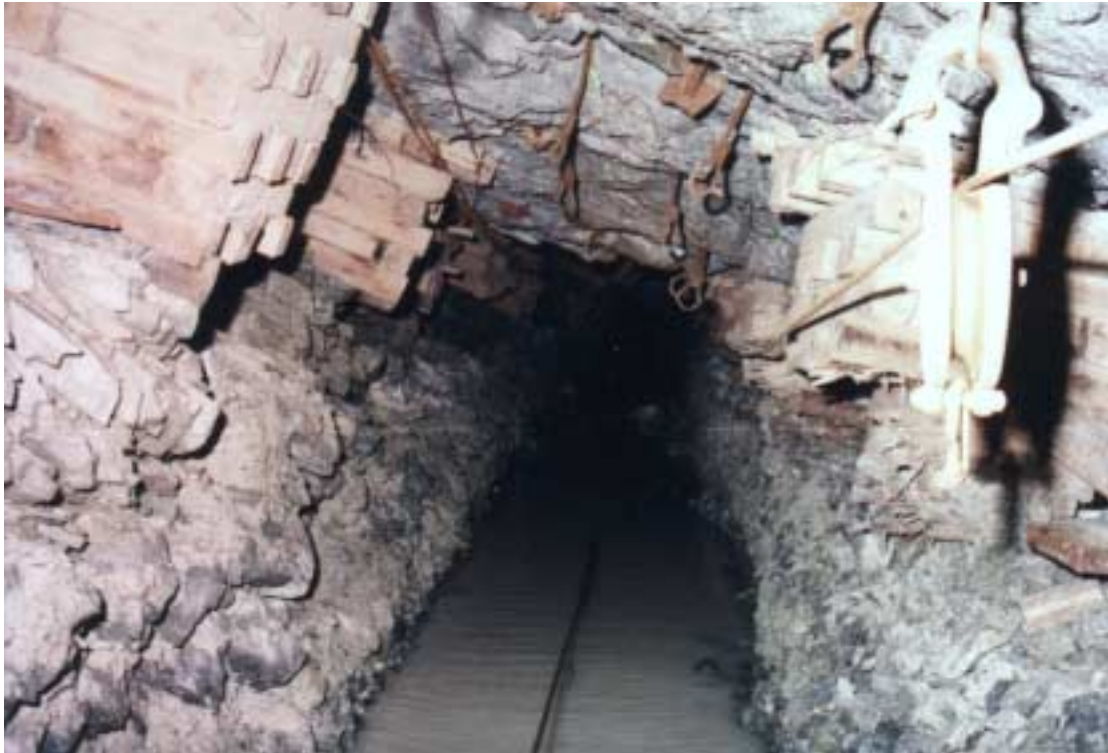
Figure 4.34 - Carbon Leader wide heading footwall lifted gully with good hangingwall conditions at 3200 m depth

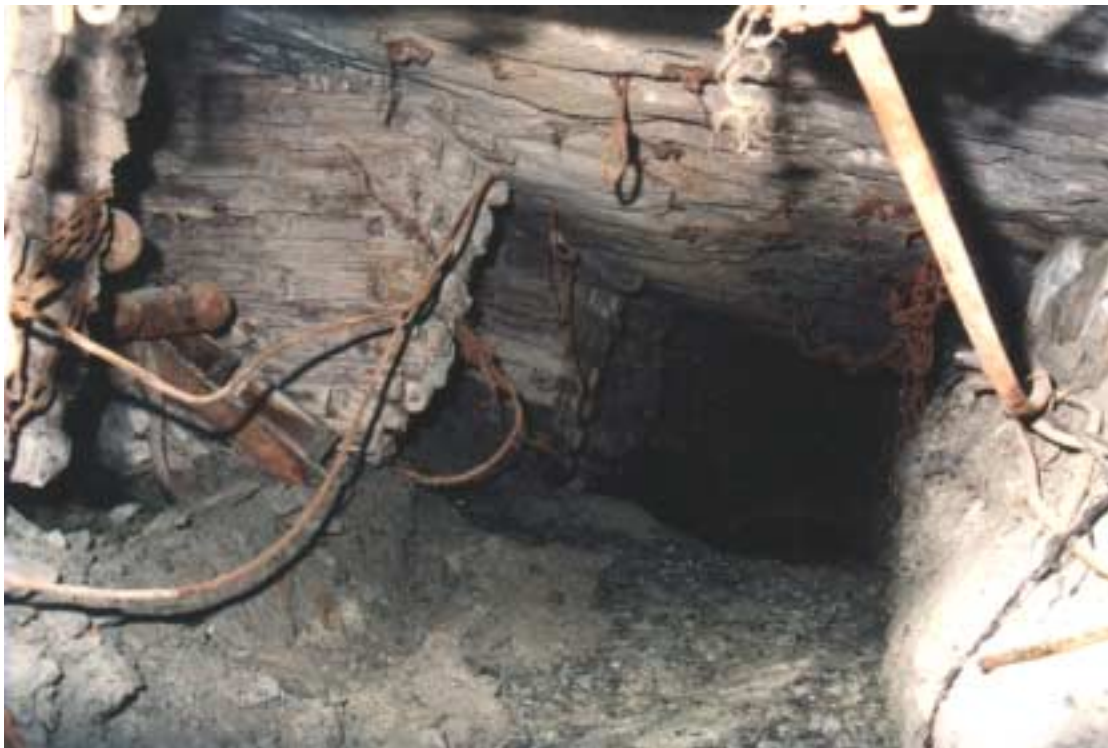
Figure 4. 35 - VCR footwall lifted gully – good hangingwall conditions

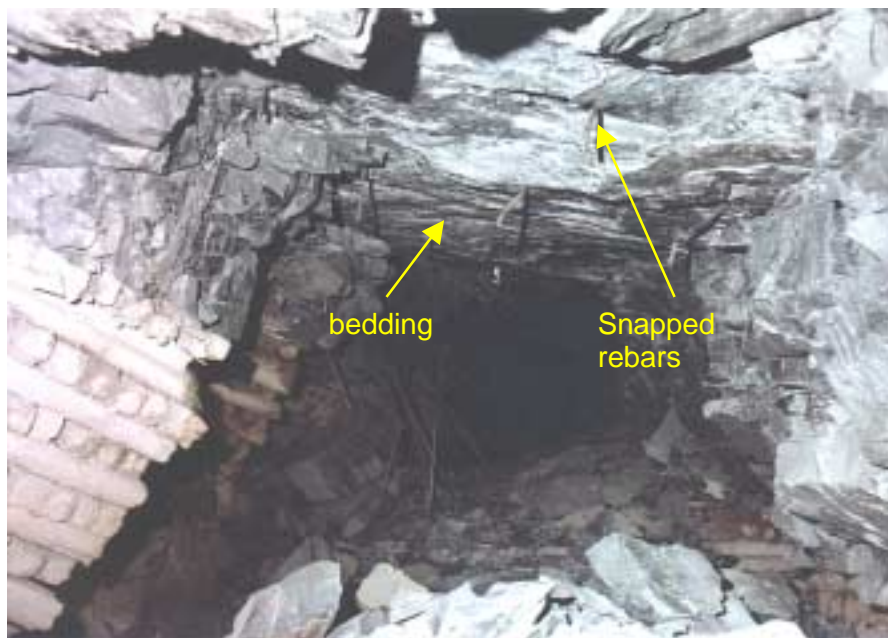
Figure 4.36 - Collapse back along a gully as a result of seismic activity. The hangingwall has collapsed between packs up to a bedding parting. Rebars are snapped or exposed

- Collapses at the face prior to cutting and supporting the siding.
- Falls of ground back along the gully, often running from the face for many metres into the back area, where fragmented rock falls from around tendons. Except where the collapse occurs up to a high and well-defined parting (as shown in Figure 4.36), the tendons rarely snap and frequently few packs are dislodged although hangingwall falls may be in excess of a metre in height.
- Where there is solid ground a short distance down dip of the gully, packs built in sidings get ejected into the gully, often aided by poor siding geometry (In the example shown in Figure 4.37 packs have been destroyed on a VCR reef drive, leading to extensive hangingwall collapse).
- Collapse of gully sidewalls due to sudden increased pack loading.

A point to note about all these areas of damage is that falls depend on pre-existing damage, or geological structure. Hence minimisation of seismically induced falls largely depends upon adopting gully design layouts that minimise stress damage and fracturing, or orientate fractures into directions where they prove easiest to support. An important issue is an apparent tendency for face bursting to occur more readily where face height is increased. Thus at depth, face bursting occurs more readily in full-height ASG headings than in the adjacent narrower stopes. This type of occurrence counts against the use of anything other than wide headings and footwall lifted gullies under high stress conditions.

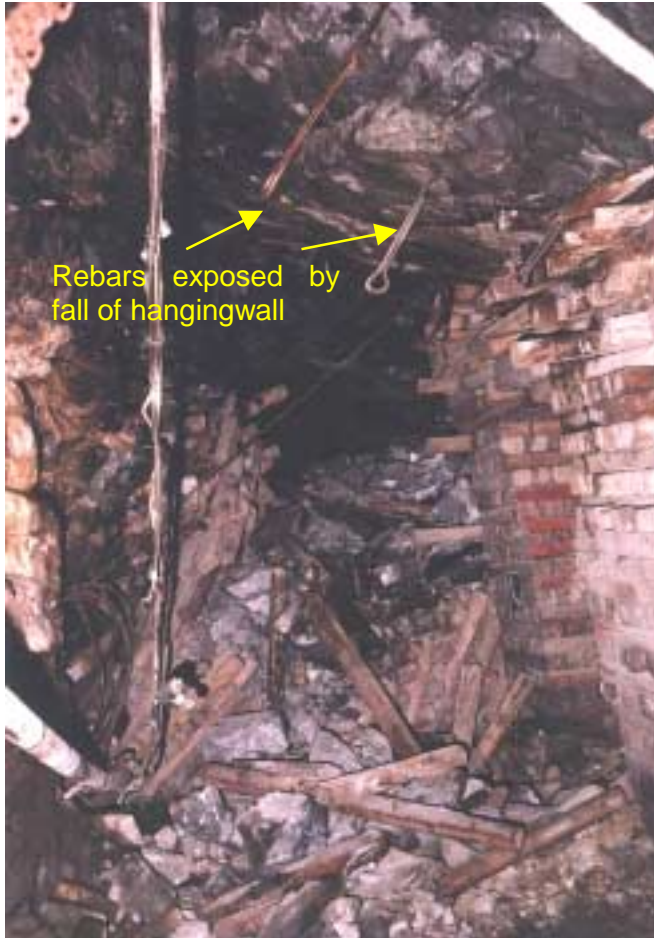
Figure 4.37 - Collapse of a reef drive on the VCR horizon due to ejection of packs from the siding by a seismic event

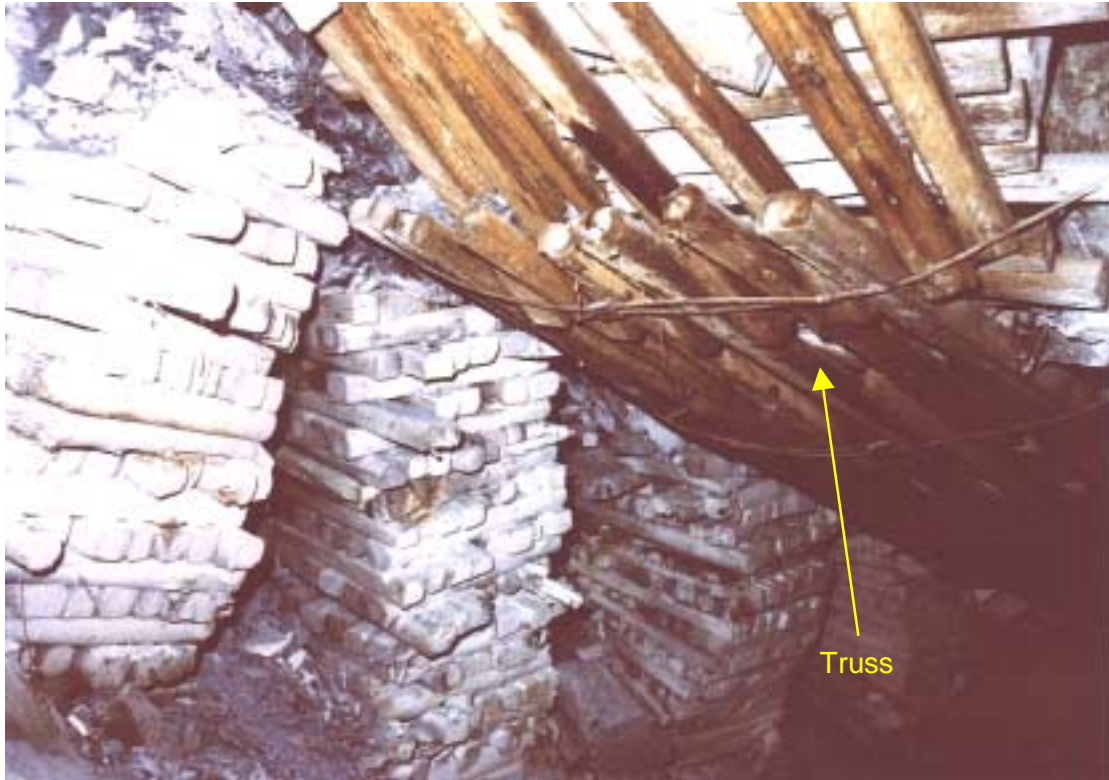
Figure 4.38 – On-reef trackless roadway supported with trusses and cribbing (before rockburst)

Another method of providing total area coverage, while the gully hangingwall remains relatively intact, is the use of trusses and cribbing. Trusses consist of two cables, installed in separate holes, which are tensioned against each other and provide confinement to the rock mass between the two anchorage points. In gullies, trusses can be installed such that the holes are drilled over pack positions on either side of the gully. A series of trusses along the gully can be used to hold timber cribbing against the hangingwall. An example, photographed on the VCR horizon during the early 1990's, is shown in Figures 4.38 and 4.39. The first figure shows the trusses and cribbing immediately after installation. They are in the hangingwall of a 3 m wide on-reef trackless roadway. Trusses are installed across the gully while cribbing is installed along it (or parallel to it). An advantage of this situation is that height was available to drill correctly angled holes for the trusses. Normal gullies tend to be more confined. Figure 4.39 shows, for comparative purposes, the condition of the roadway after a nearby magnitude 3 event. While packs have collapsed along the roadway sidewalls, the hangingwall has remained relatively intact, and firmly controlled by the trusses.

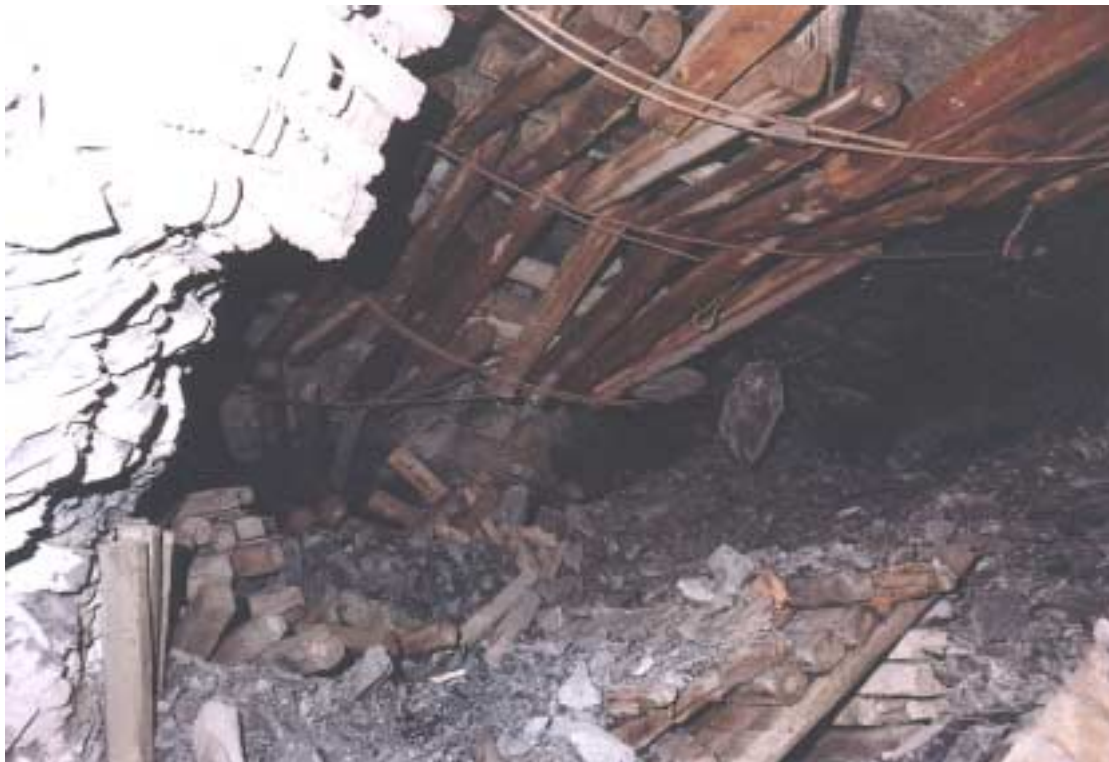
Figure 4.39 – Roadway after seismic damage – packs collapsed, trusses and hangingwall intact (after rockburst)

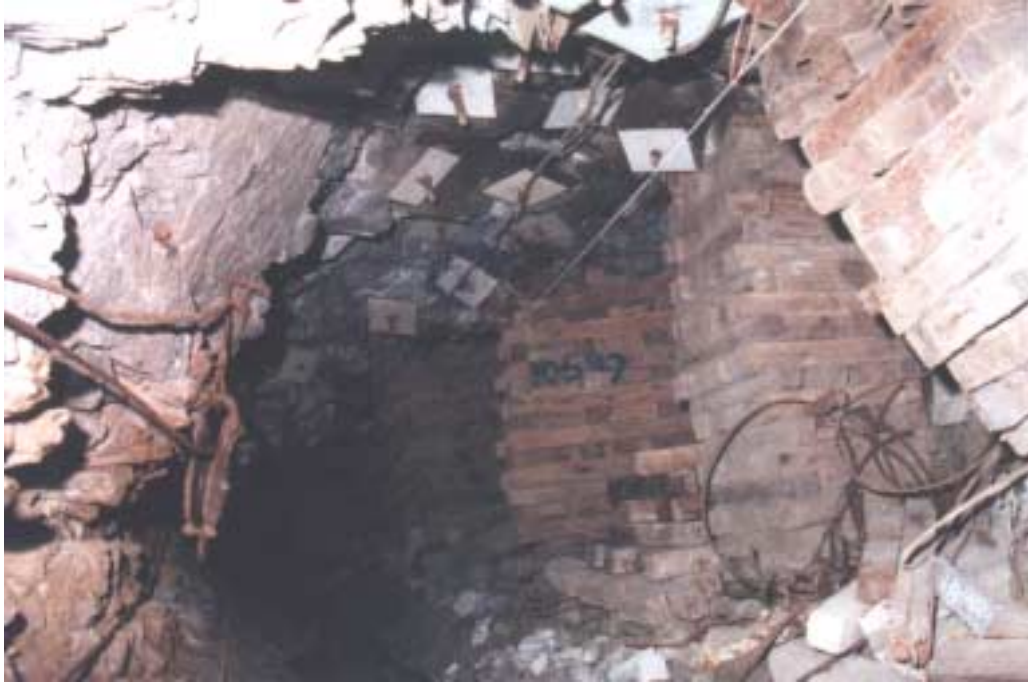
Figure 4.40 – Ground consolidation by injection grouting in the partially collapsed hangingwall of a VCR strike gully at 2800 m depth

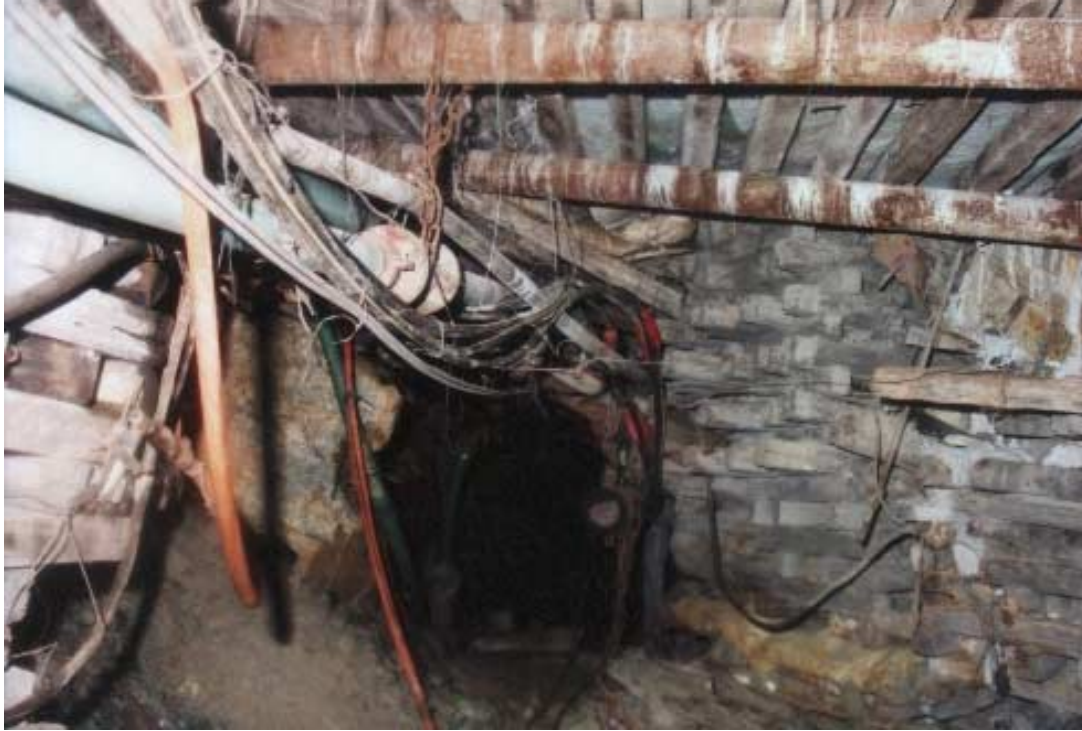
Figure 4.42 – Strike gully on the Carbon Leader reef at 2900 m depth, where a stable long term access has been achieved through using sets and void filling
