Safety in Mines Research Advisory Committee

Final Report

**Stope gully support and sidings
geometry at all depths and at
varying dip**

GAP 602

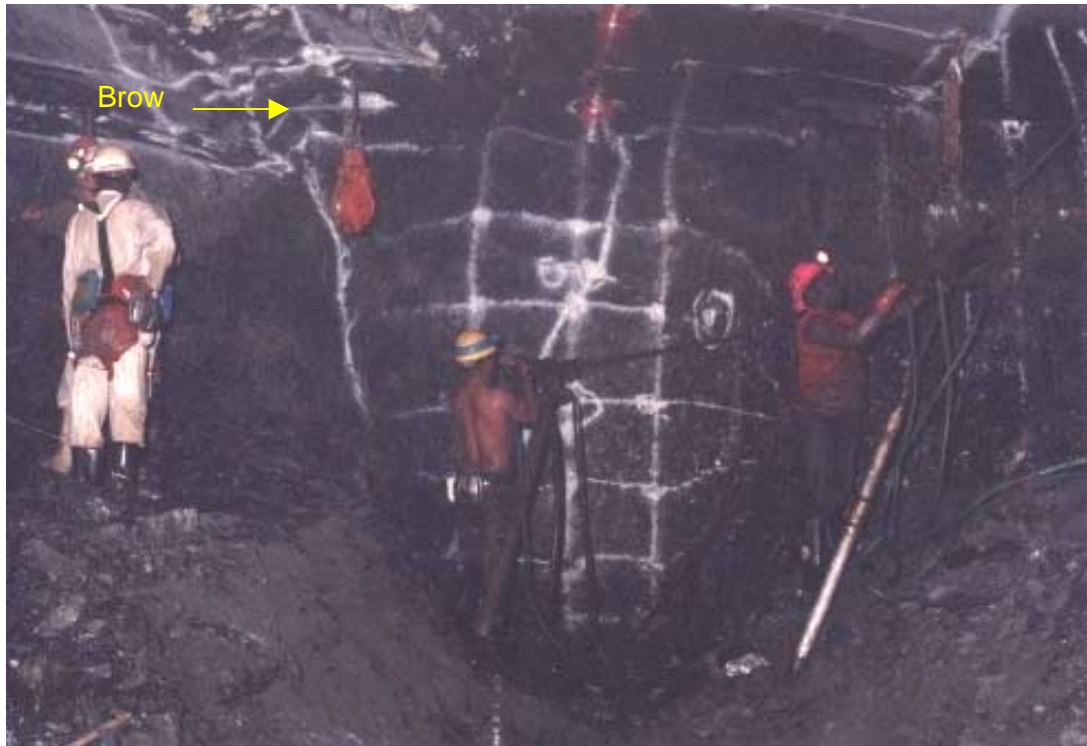
Figure 4.43 – Development-type round with a burn cut, used to advance an ASG-type gully, here shown in a high stope width area at shallow depth

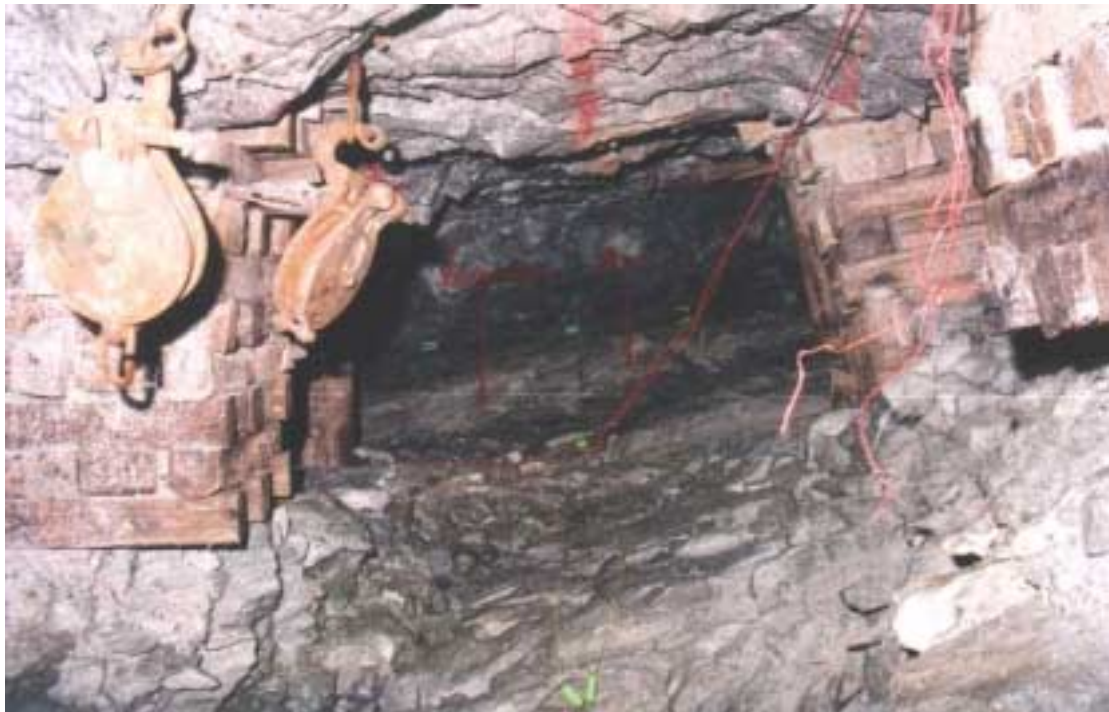
Figure 4.44 – View into a Carbon Leader wide heading showing the face charged up and ready to blast. The cut is out of sight on the up-dip side. Good conditions exist over the gully

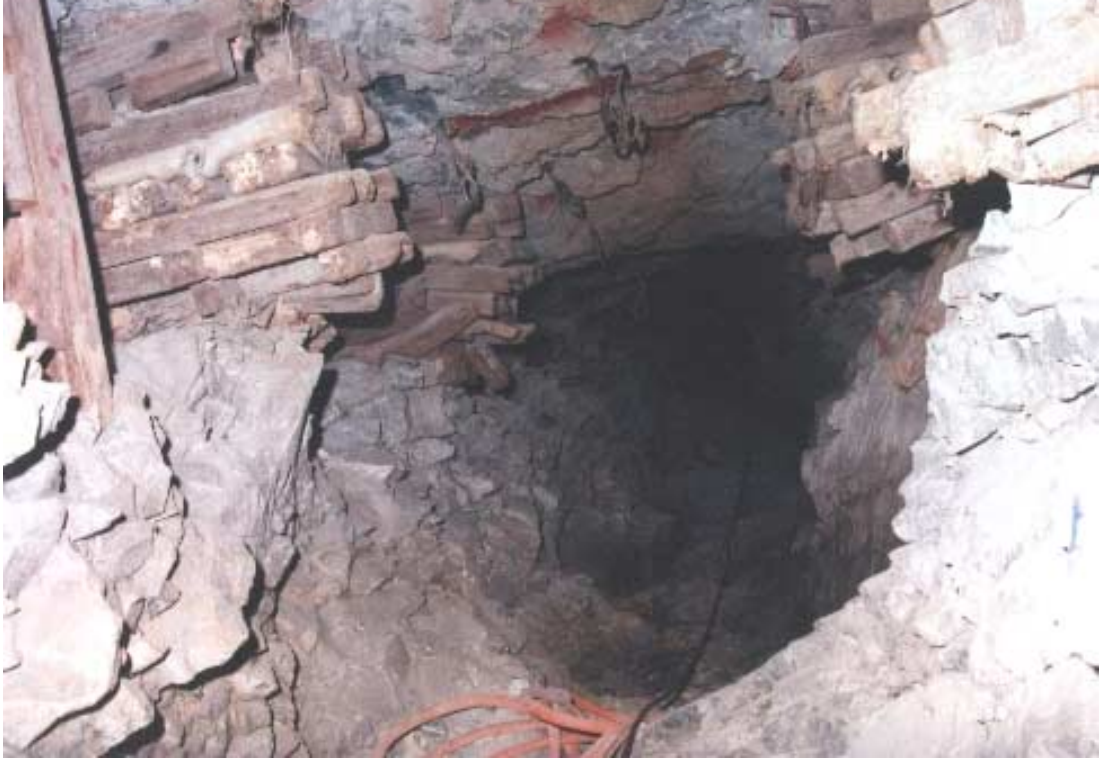
Figure 4.45 – VCR - Poor footwall lifted gully conditions resulting from blasting practice where holes are drilled downward into the stope footwall and a long distance of gully is ripped simultaneously.

Figure 4.46 – Gully ripping blasting practice in a wide heading, which gives rise to conditions shown in Figure 4.45

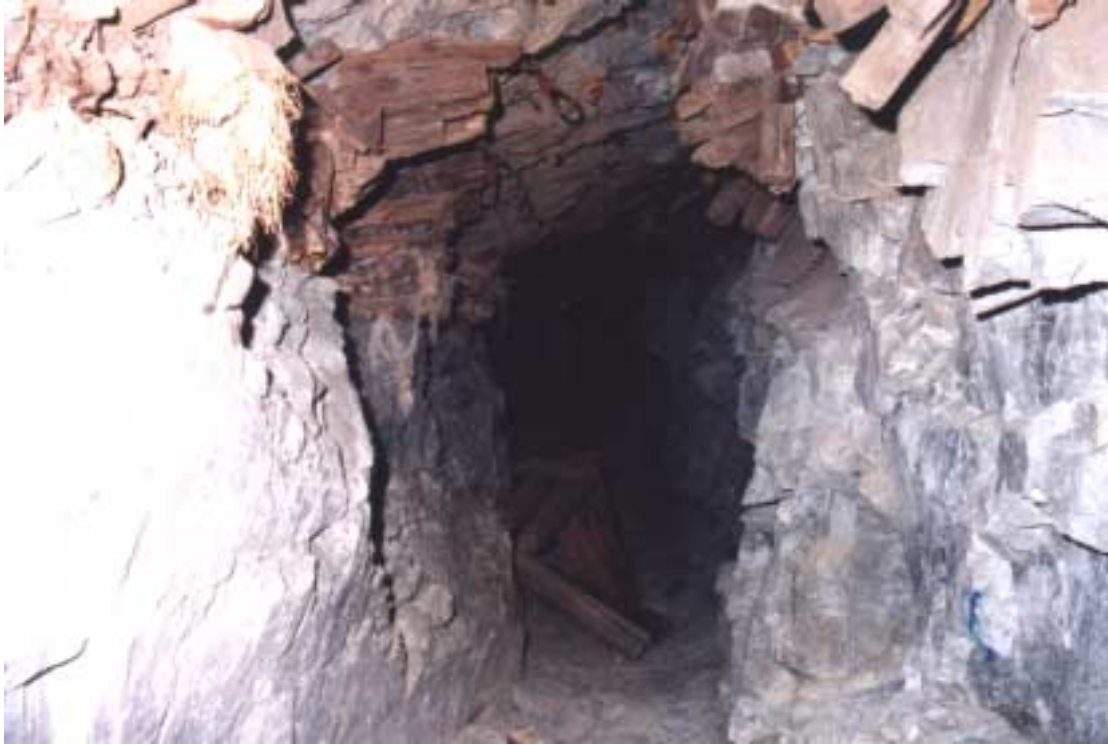
Figure 4.47 - VCR – good blasting practice - footwall lifted gully advanced incrementally by drilling horizontally in the gully face

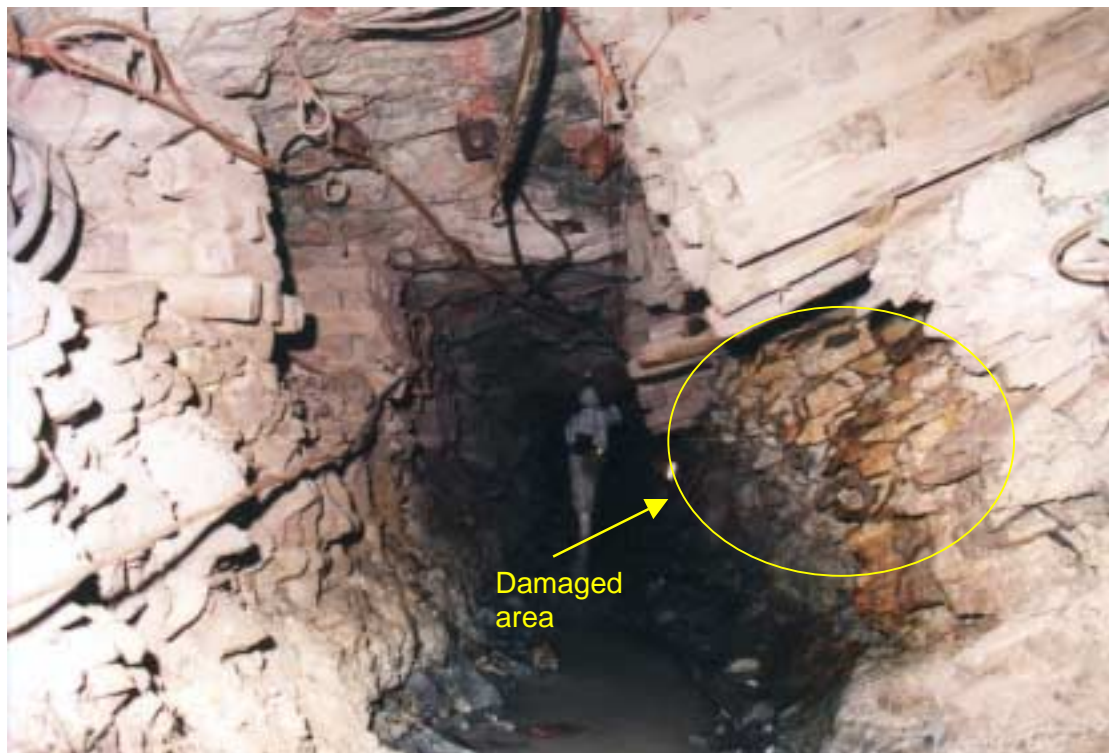
Figure 4.48 – Scraper erodes up dip sidewall of gully beneath packs

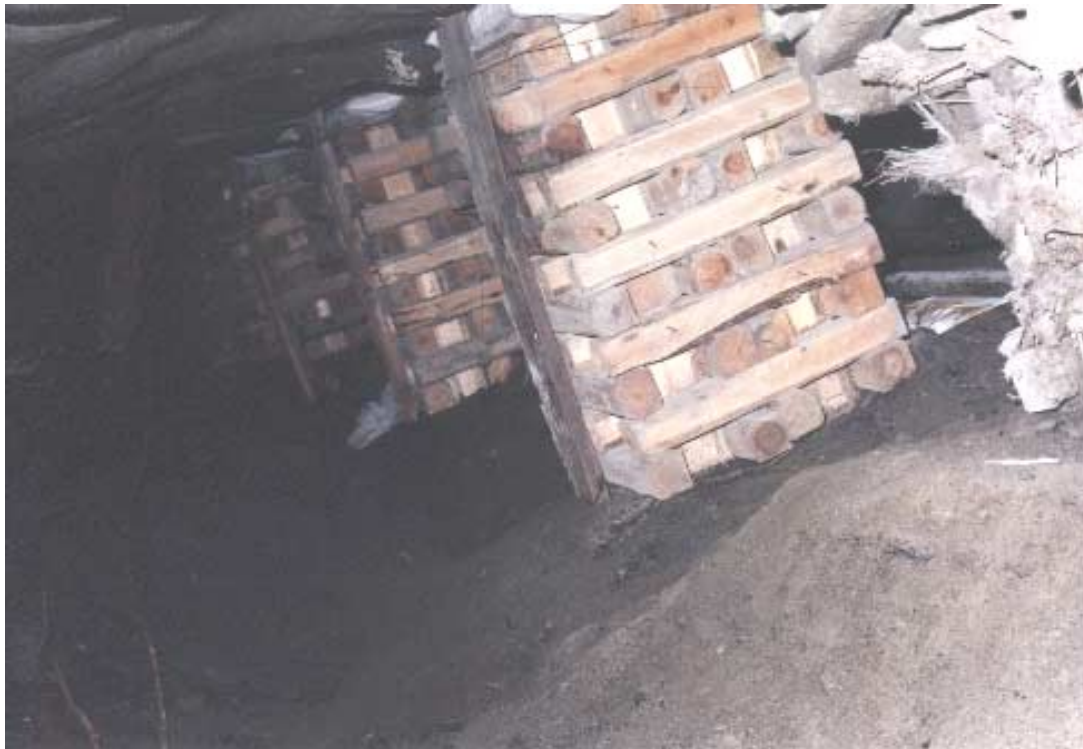
Figure 4.49 – Correctly constructed packs, normal to reef, prestressed, with a grout bag

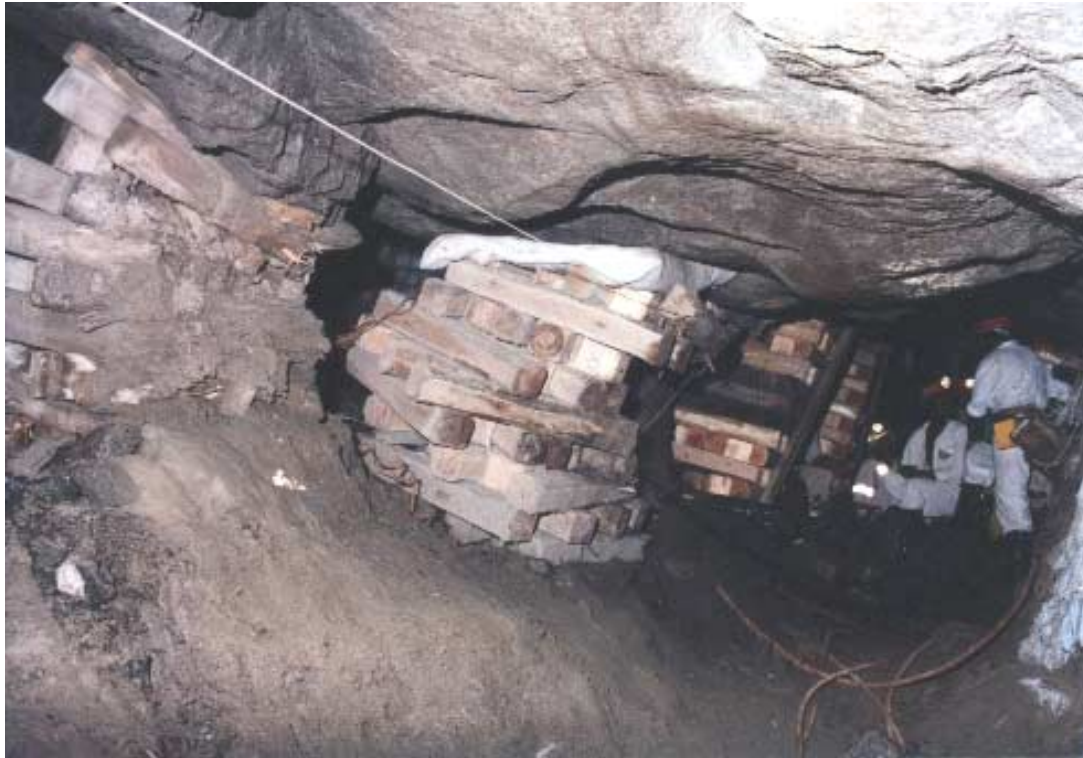
Figure 4.50 – Gully shoulder and hangingwall unevenness results in uneven compression of pack and its eventual disintegration

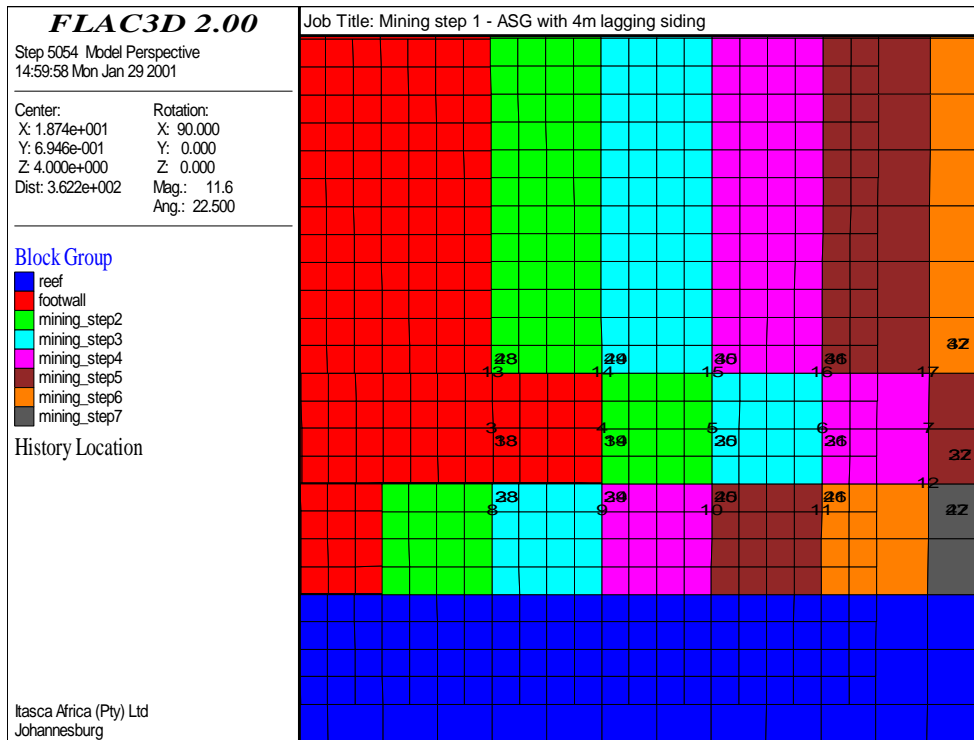
Figure 5.35 – Sequence of advance in the ASG case(top), showing points at which strains, stresses and closures across the gully were monitored. Lower points shows numbering used in this report for the sequence of points within each monitoring ring

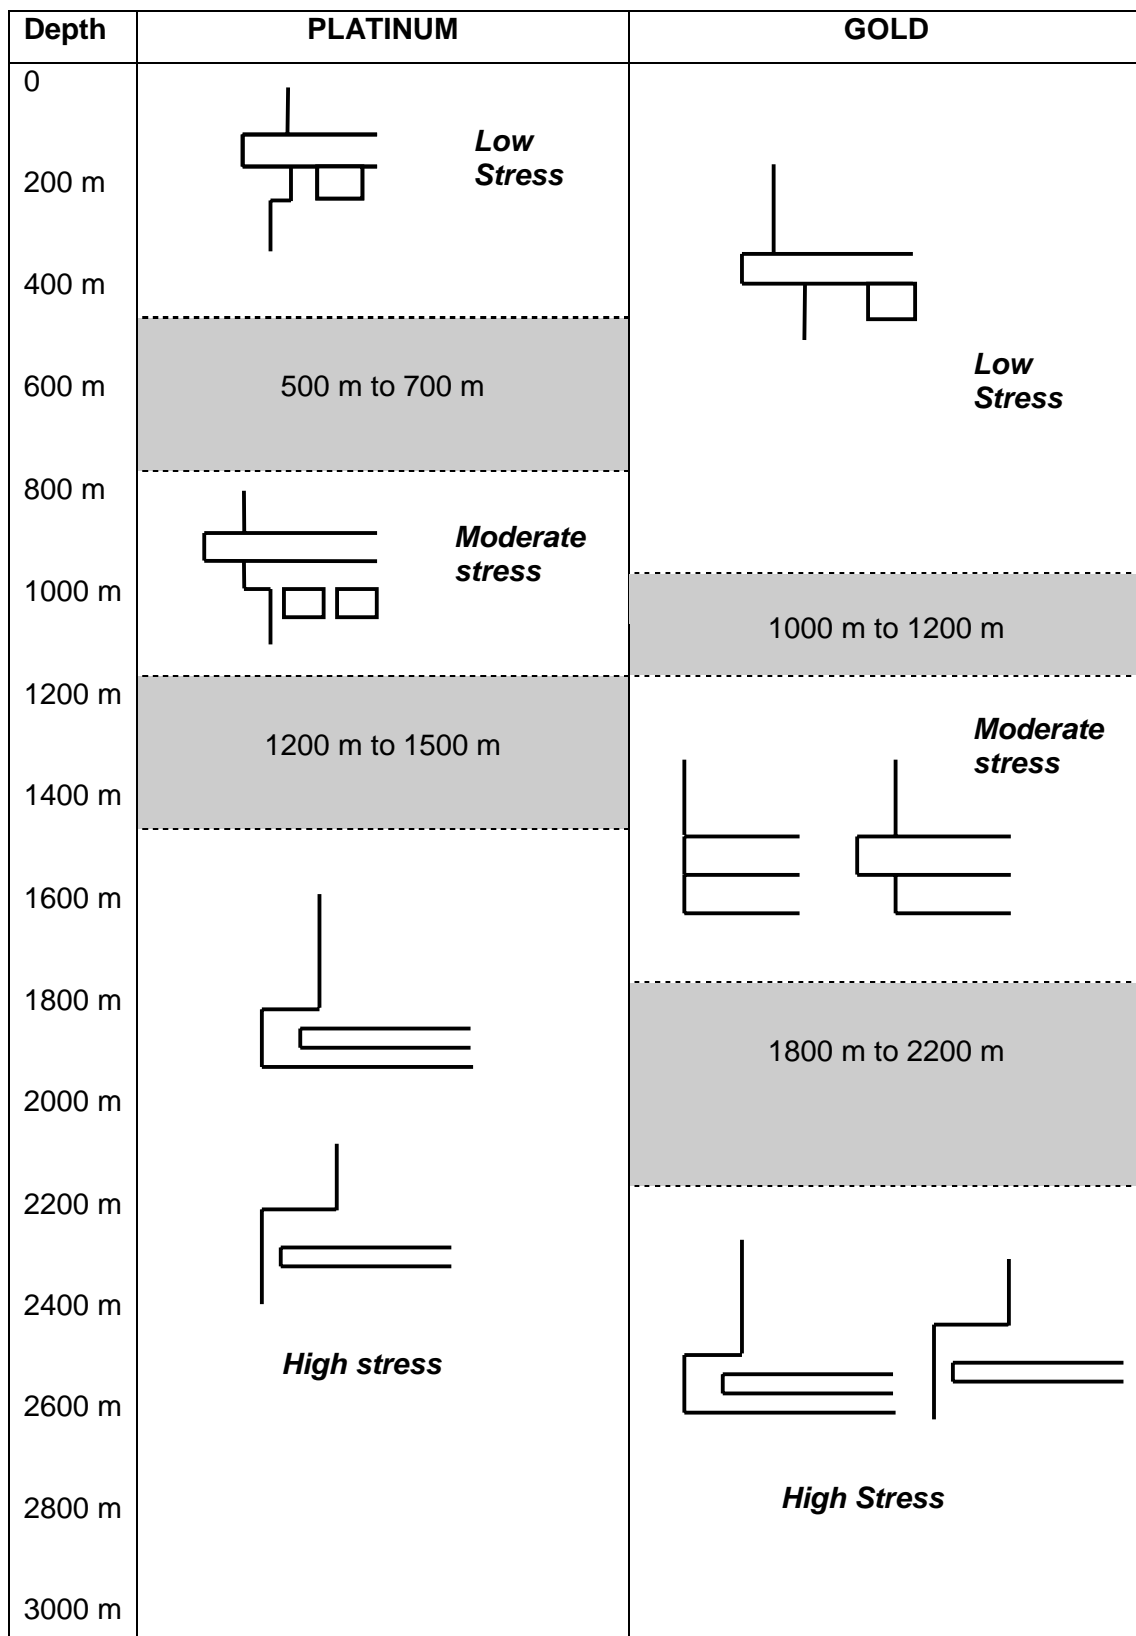
Figure 6.1 – Recommended gully geometries as a function of mining depth in gold and platinum mines

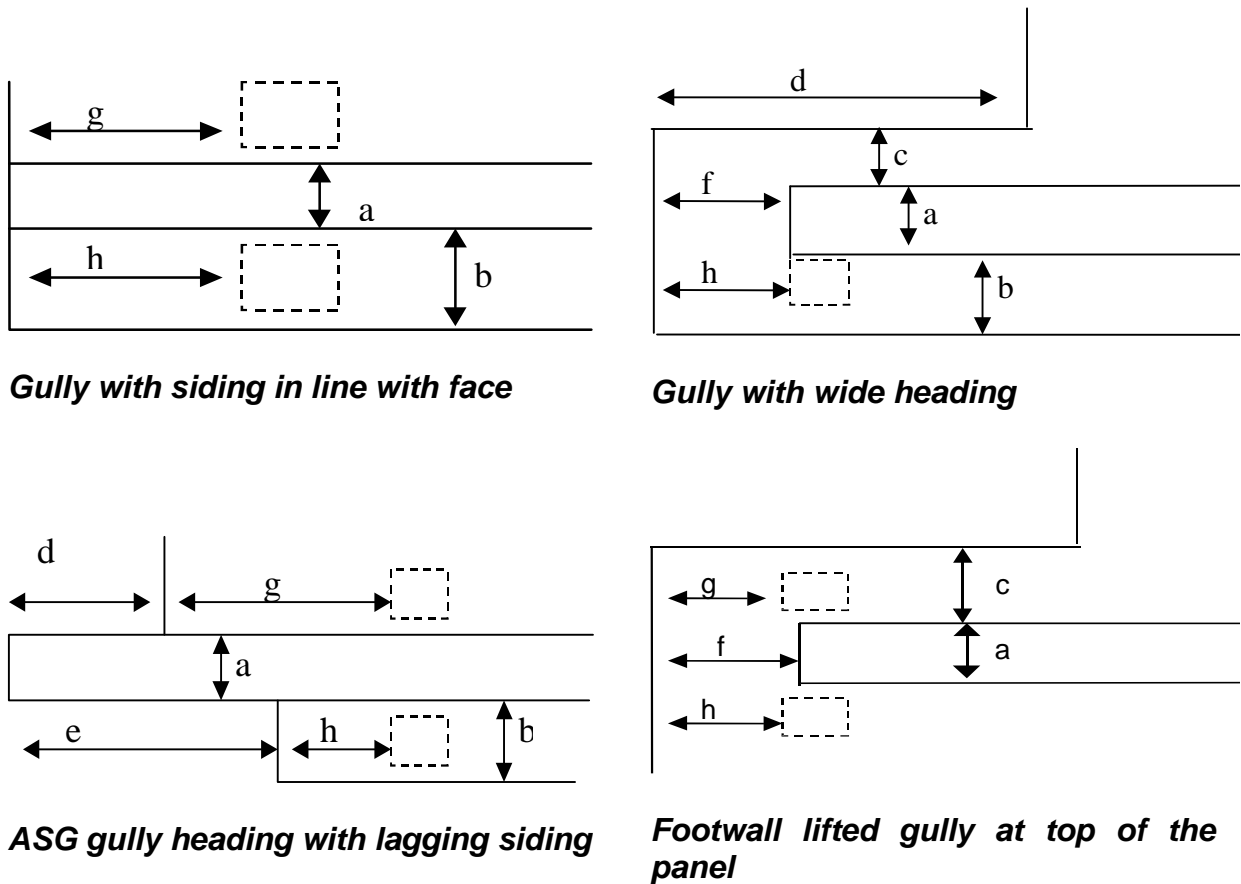
Dimension	Recommended value
a	Gully width	Less than 2 m, wider possible if ground conditions and support permit.
b	Width of down dip siding	Not less than 2 m from gully edge
c	Width of up dip siding	Not less than 2 m from gully edge
d	Lead from stope face to face of gully heading	For an ASG 2 m maximum. 1 m or less is preferable. For a wide heading 10 m maximum.
e	Distance of lagging siding	Lagging sidings not recommended but tolerable in certain circumstances (e.g. massive and competent strata, or where plastic shales exist, e.g. B Reef). Absolute maximum distance of 6 m.
f	Distance from face to footwall lifted gully	Distance flexible, but gully should lead stope face by 1 m to provide scraper over-run.
g & h	Distance from face to pack or elongate	Should be kept to a minimum. 4 m maximum distance.
l	Gully depth	If tendons are required for hangingwall support a minimum depth of 1.8 m is required from hangingwall to footwall.
