# **Safety in Mines Research Advisory Committee**

Final Project Report

## **The Identification, Investigation and Analysis of End-of-wind Protection Devices for Vertical and Incline Shafts**

**LGI, University of Pretoria  
GAP 638c  
December 2000**

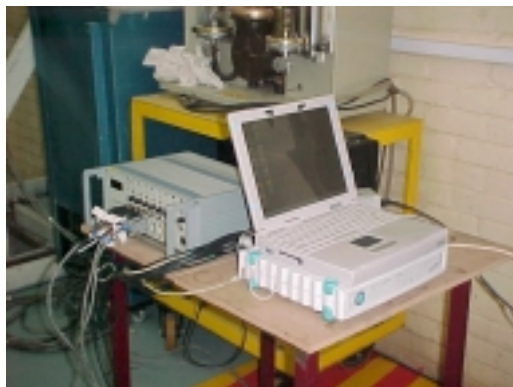
Figure 4.4-1: Acquisition equipment

The system was instrumented with piezoelectric accelerometers that enabled the measurement of acceleration with regard to the three main axes (x, y and z). Two normally open switches were also placed a specific distance (100 mm) apart to enable the speed measurement of the falling conveyance before impact. The accelerometers were connected to a signal conditioner that enabled the conditioning and amplification of the accelerometer signals. The normally open switches were connected to an external voltage source that emitted a specific voltage level when the switch was closed. The accelerometer and switch voltage signals were digitally sampled through an analogue-to-digital system.

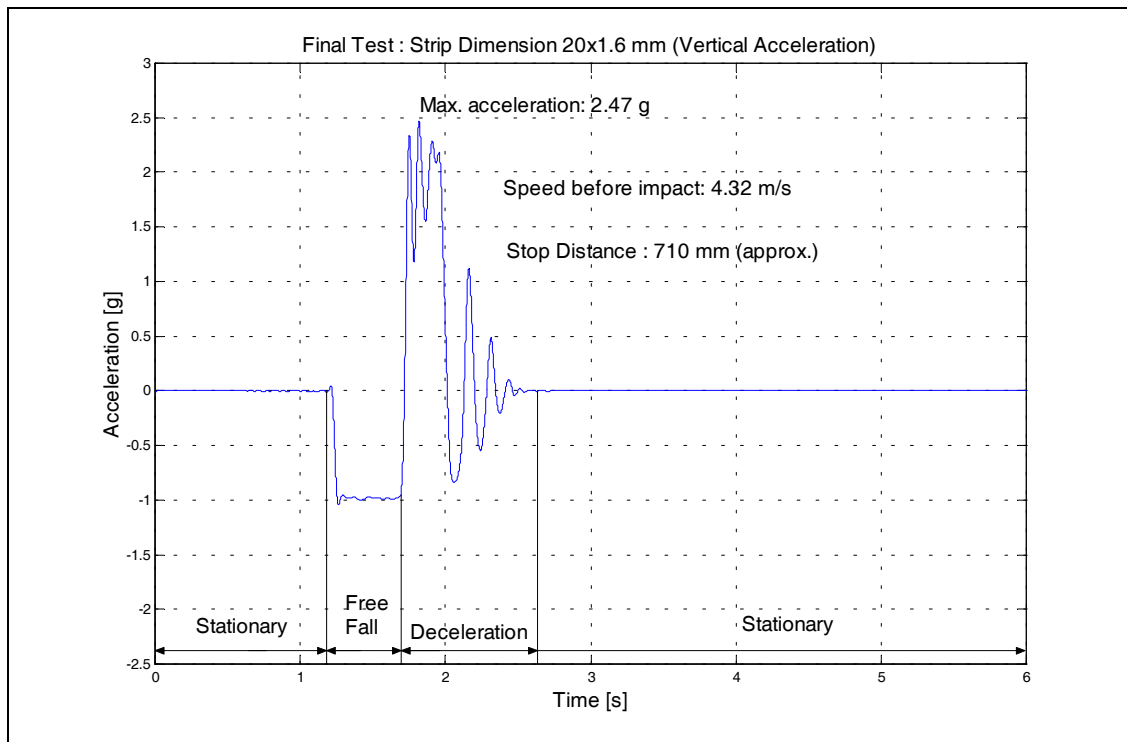
Figure 4.4-4: Spring-damper system test result graph

Test no. (Concept 1)	Strip dimensions (width x depth)	Maximum peak deceleration (g)	Stopping Distance (mm)
1	10 x 3	5,80	Run through to bump stop
2	12 x 2	3,45	Run through to bump stop
3	20 x 2	3,79	Run through to bump stop
4	15 x 1,6	3,17	Run through to bump stop
5	20 x 1,6	2,47	710
6	20 x 1,6	2,62	690
7	20 x 1,6	2,53	710

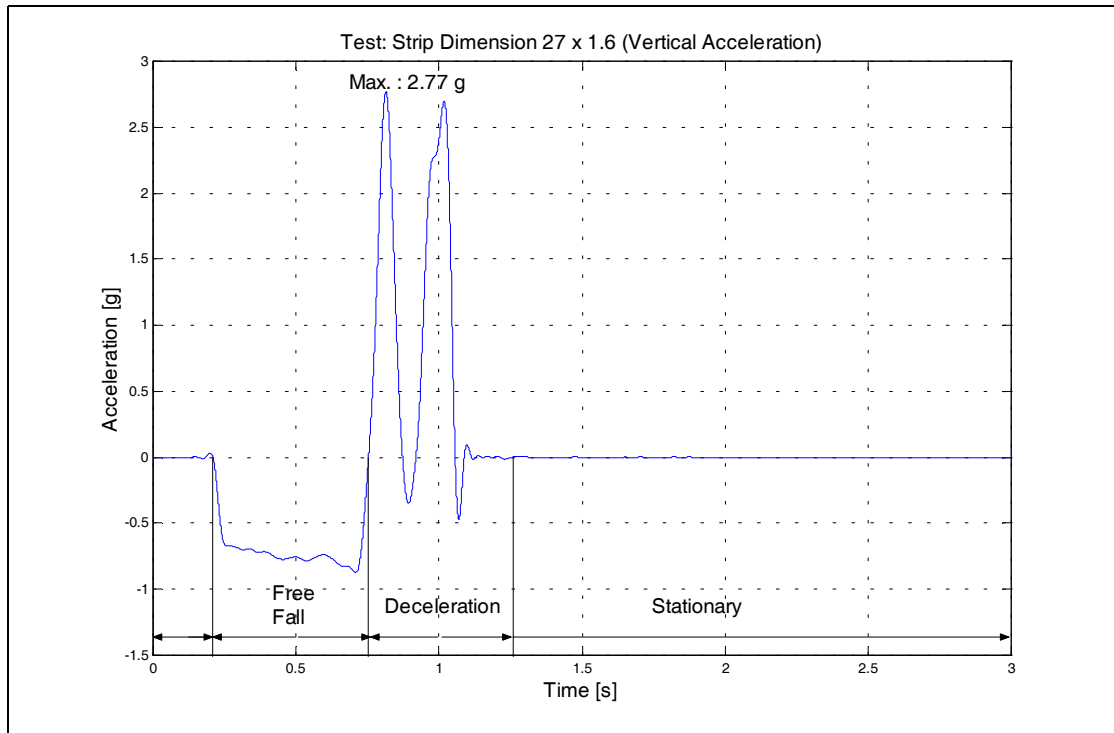
Figure 4.4-5: In-line spring system test result graph

Test no. (Concept 2)	Strip dimensions (width x depth)	Maximum peak Deceleration (g)	Stopping Distance (mm)
1	34 x 1.6	3.18	610
2	33 x 1.6	3.04	637
3	27 x 1.6	2.77	680

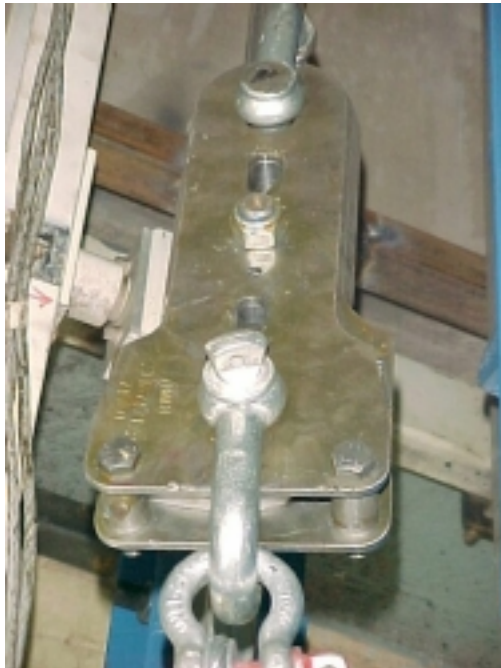
Figure 5.2-1: “Humble hook” assembly

The overwind protection can be divided into two different operations. The first operation is the cable detachment, which is performed by the “humble hook” (See paragraph 2.4.3.4.1). The “humble hook” mechanism, referred to in figure 5.2-1, operates on a scissors principle. It is kept closed by a shear pin, that is sheared when the hook assembly is pulled into a hole in a plate (spectacle plate) at the top of the shaft headgear. This detaching mechanism is currently used in mines.

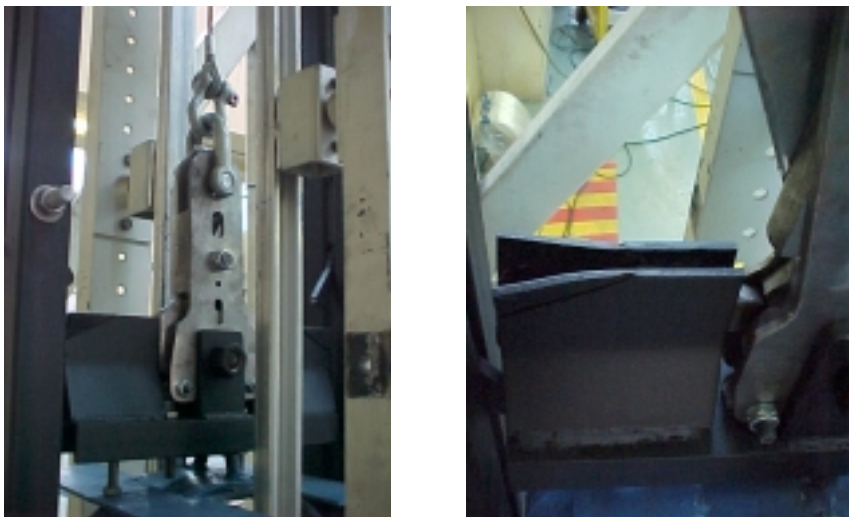
Figure 5.2-6: Alternative detaching mechanism

The alternative detaching mechanism does not make use of the spectacle plate to activate the “Humble hook”. A horizontal force on the scissor plates is used to activate the detaching hook. Horizontal forces and not the vertical force of the spectacle plate activate the scissor plates of the detaching hook. The alternative detaching mechanism is shown in figure 5.2-6.

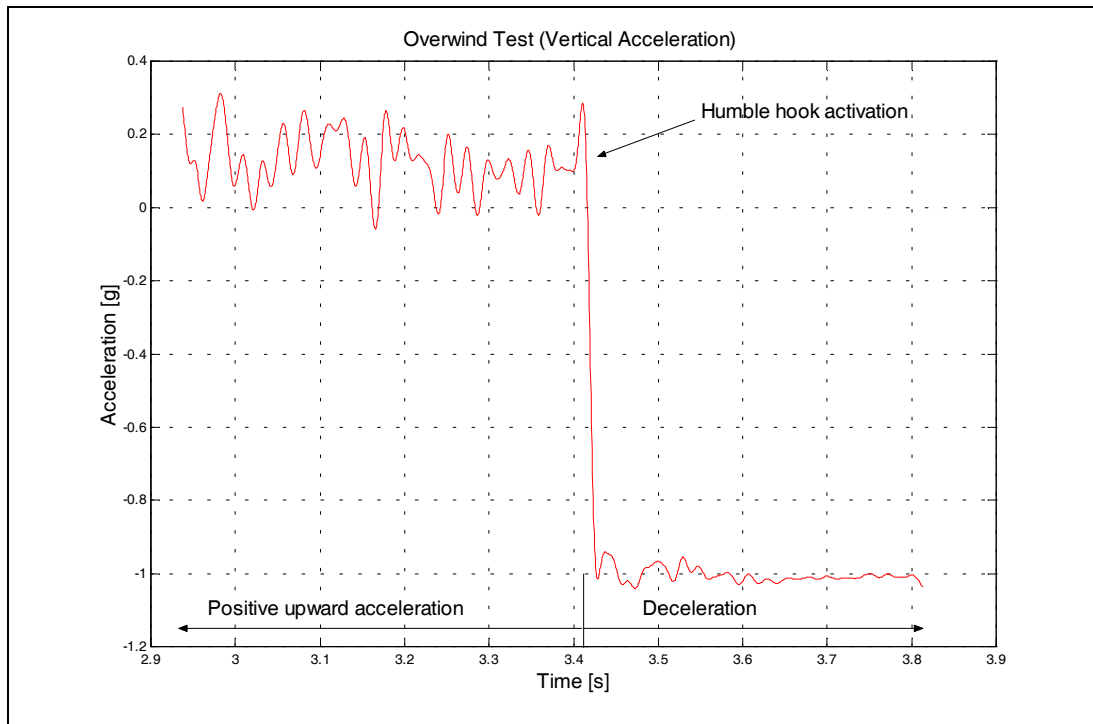
Figure 5.4-1: Overwind test result - dummy cable

The accelerometer data was recorded digitally through the use of an analogue-to-digital system. The data was sampled at a sampling frequency of 1600 Hz with a cut-off frequency of 150 Hz. The data was calibrated and the data represented in graphical format. The test results of the two different concepts evaluated are depicted in Appendix D.

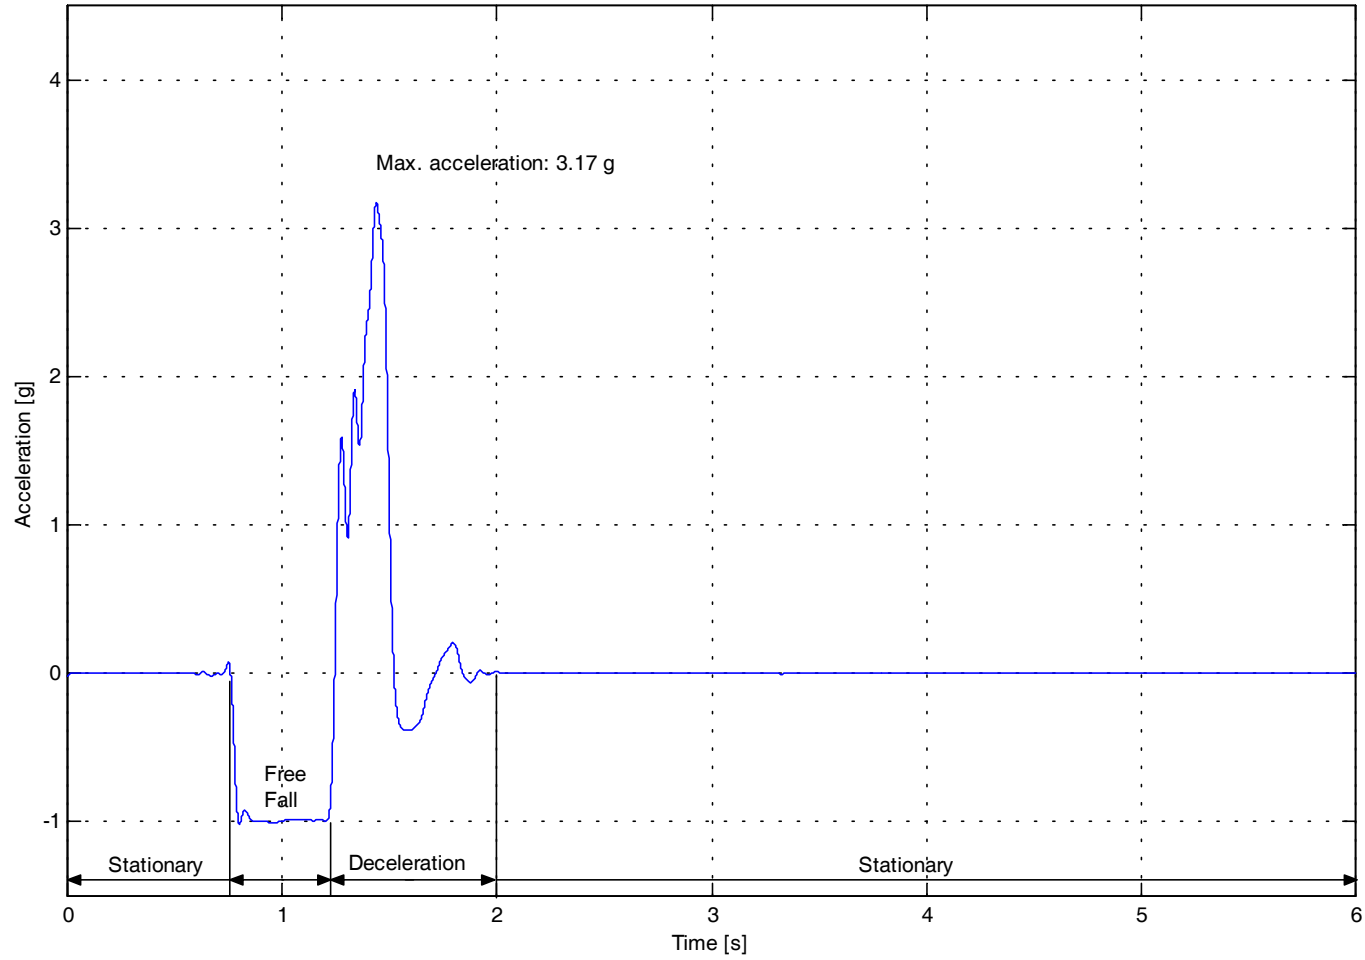
Spring/Damper Bell Crank System - Test : Strip Dimension 15x1.6 mm (Vertical Acceleration)
