# THE REAL CAUSE OF DETRIMENTAL CARBONATION IN CHEMICALLY STABILIZED LAYERS AND POSSIBLE SOLUTIONS

P B Botha  
Transportek, CSIR, Republic of South Africa  
pbotha1@csir.co.za  
C J Semmelink  
Construction Problem Solutions cc, Republic of South Africa  
conprosol@lantic.net  
J Raubenheimer  
Raubex, Republic of South Africa  
raubex@roadworks.co.za

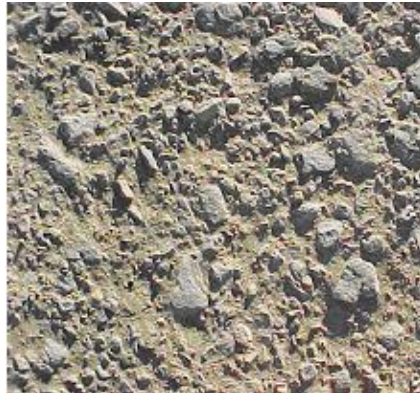
Figure 1 - View of the broomed surface of stabilised base showing coarse finish after removal of fines which did not stabilise and compact just before priming and sealing, shortly after stabilisation before priming and surfacing (taken at the time of construction)(Simmelink et al, 2001)

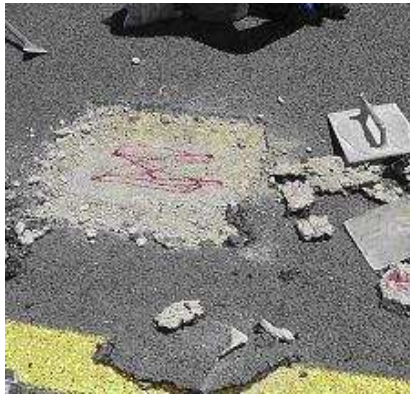
Figure 2 - The dry layer under the Bitumen-Rubber seal is shown in the photograph, limited CO<sub>2</sub> exposure and a built up of moisture under the seal has created this condition. The carbonation tests show that no carbonation took place, the dry condition shows the destructed top portion of the layer (Semmelink et al, 2002)

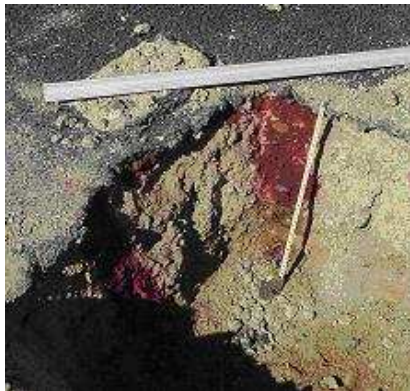
Figure 3 - The stabilised layer shows no signs of the carbonation reaction, note how dry the surfacing is (Semmelink et al, 2002)

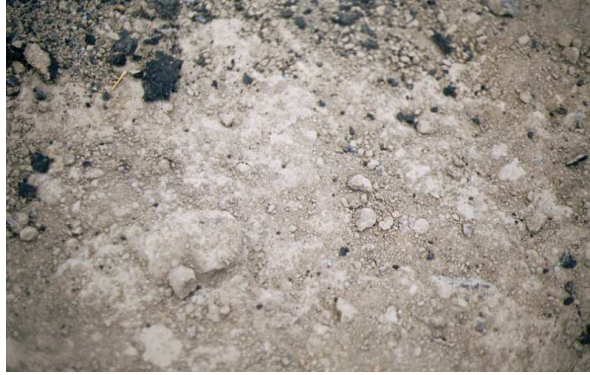
The failure shown in Figure 1 occurred at Heidelberg, Mpumalanga Province, South Africa where the dolerite was stabilised with foam bitumen and cement (Semmelink et al, 2001). The recycled base course was accepted after initial construction for placing the medium continuous asphalt. 14 days later the base showed signs of deterioration as seen in Figure 5.

Figure 4 - Close-up view of surface of recycled weathered dolerite surface where the surfacing broke loose showing the loose material

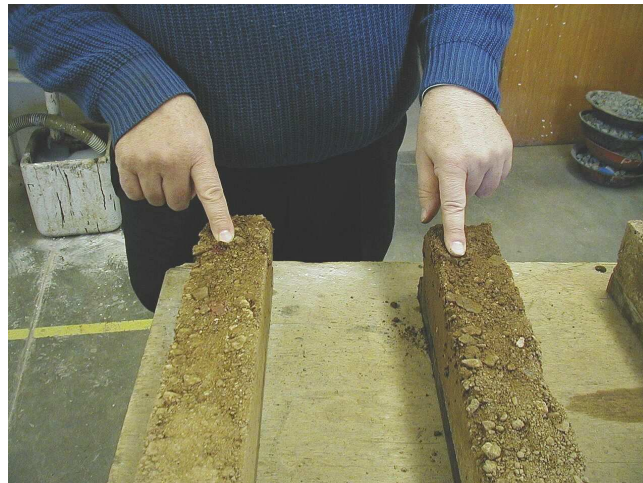
This drop in pH can be demonstrated by the extended ICL/ ICC and water driven process where the CO<sub>2</sub> is excluded and only water is provided (Figure 5) produced a failed surface similar to that found in the field after 7 days ambient curing.

During the technical audit field investigation of the Hopetown site, the lowest densities found for the 0 – 50 mm and the 50 –200 mm layers were 90% and 98% modified AASHTO respectively. Erosion beams were manufactured using these densities. The two beams cured under simulated site conditions by placing the beams in sealed stainless steel chambers with sufficient curing water and placing them in the direct sunlight during the day for 6 days, were compacted to 90% and 98% of Mod AASHTO respectively. Both other beams compacted to 98% of Mod AASHTO. One was cured as per standard test method using rapid oven-curing in a sealed chamber with free moisture at 72 °C for 6 days, and the other sealed beam with free moisture was placed in a constant humidity room at 25 °C for 6 days (Semmelink et al, 2002).

Figure 5: A similar loose layer formed in the top layer of the two samples. This is the water simulated process without the presence of CO<sub>2</sub> done in the laboratory (Semmelink et al, 2002)

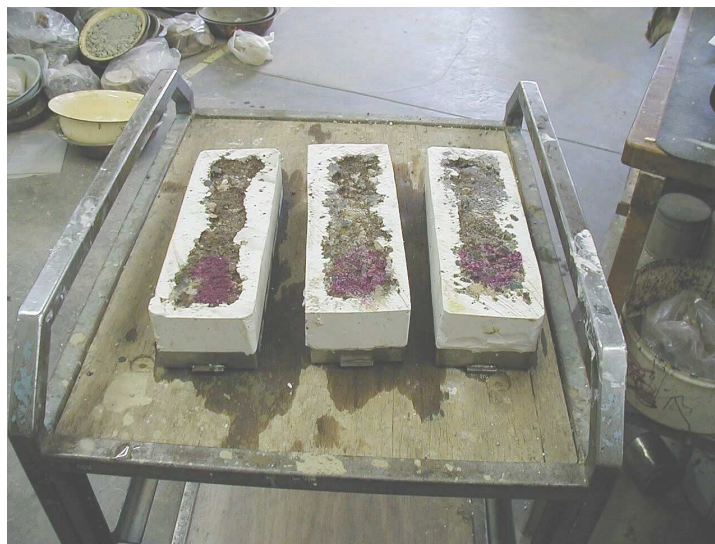
Photograph 6: Site cured beam (56 compaction hammer blows), site cured beam (42 compaction hammer blows) and humidity room cured beam prior to erosion beam test showing the dark pink colour stain of the phenolphthalein solution (Semmelink et al, 2002)

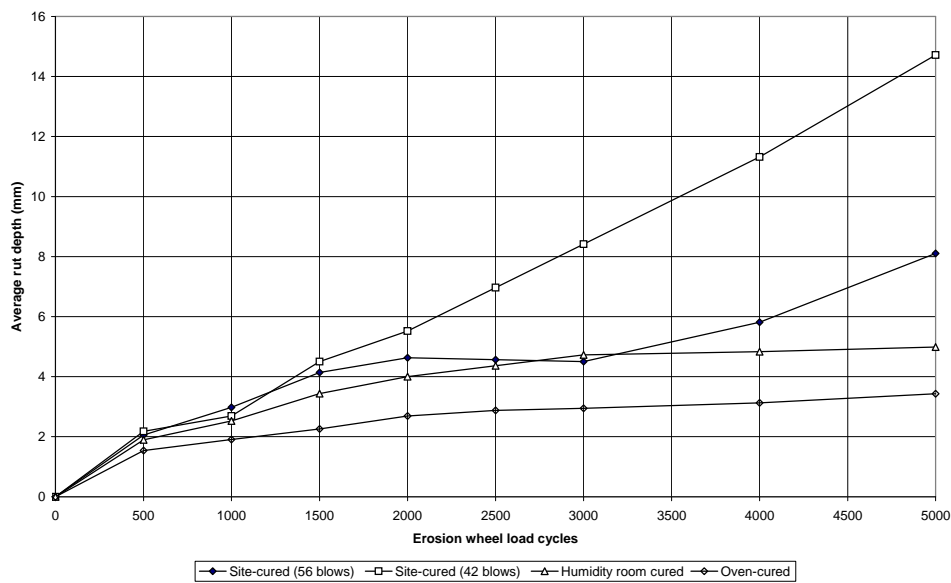
Figure 7 shows the erosion results of the four beams in graphical format.

**Figure 63: Erosion rut depth against number wheel load cycles for the four beams**

The four beams were tested and the outcome of the test results is graphically displayed in Figure 63. The erosion loss measurements of all the samples were already beyond the proposed maximum specification loss of 0.5 mm after the first 250 cycles. From this it can be deduced that the prescribed stabilizing agent produced a sub-standard stabilized layer with a long-term durability problem built into it by the design.
