Final Project Report

**Improved understanding of the use of short tendons
for stope support under rockfall and rockburst
conditions (Phase I)**

Research agency: CSIR Mining Technology

Project number: GAP 849

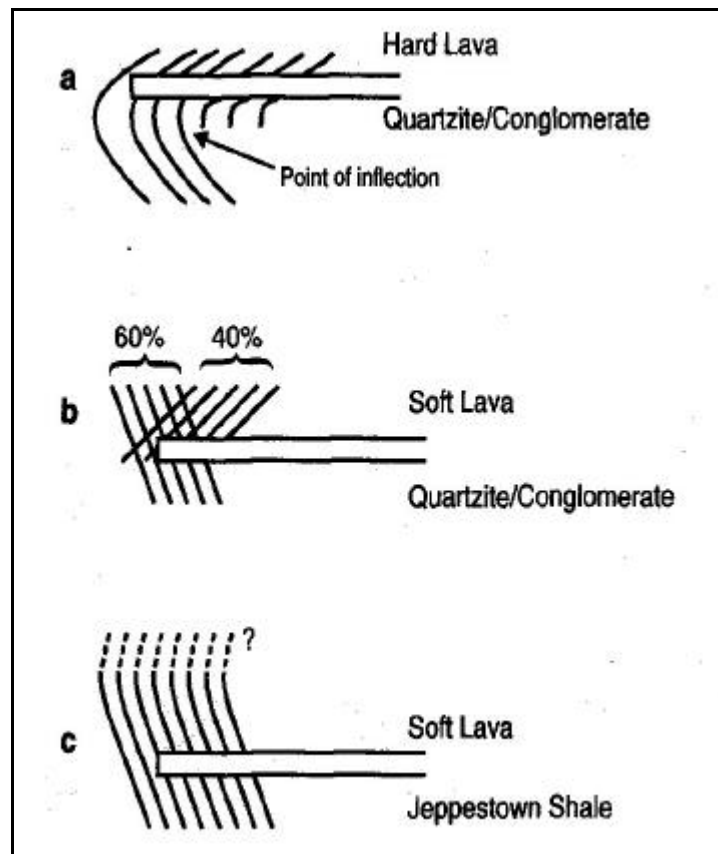
Figure 7. Variability of fracture pattern in the VCR due to hangingwall and footwall material

Local conditions may greatly influence the fracture pattern around a stope. For example, the VCR hangingwall is generally one of two types of lava, with the footwall consisting of a variety of materials. The influence of these various conditions on fracture pattern is illustrated in Figure 7.

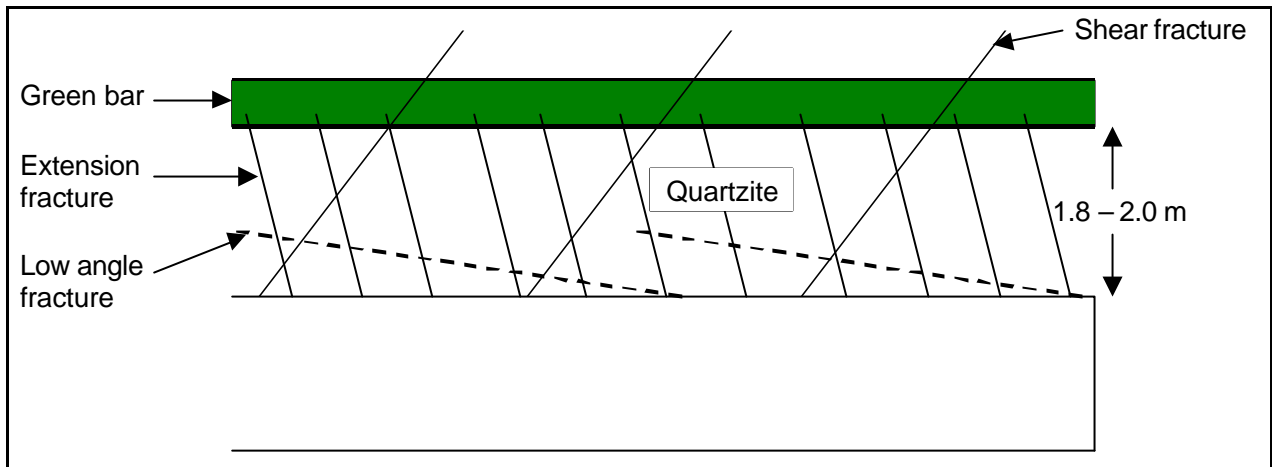
Figure 10. Generic Carbon Leader hangingwall

The Carbon Leader reef is typical of Basal, Main, Elsberg, Bird and Doornkop reefs. The stoping width is typically around 0.9 m to 1.3 m, but occasionally up to 4 m. The rock mass is particularly strong in this region, often exceeding strengths of 300 MPa. There are few bedding planes, if any in this region, except for those around the Green Bar layer which is encountered 1.8 m to 2 m above the stope. Fracturing is intense and complex, with discontinuity spacings of 0.01 m in some places. Low-angle fractures are also commonly encountered. Dip is typically 20°. The closure rate is around 10 mm/day in backfilled stopes, and up to 50 mm/day where backfill is absent.

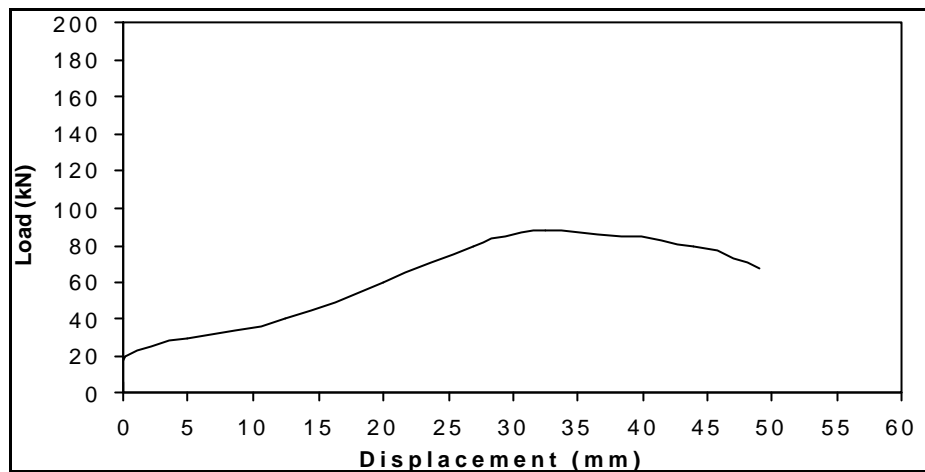
Figure 14. Expansion shell anchored rockbolt - tensile loading across a joint (after Stillborg, 1994).

A load-displacement curve of a typical expansion shell rockbolt is shown in Figure 14.

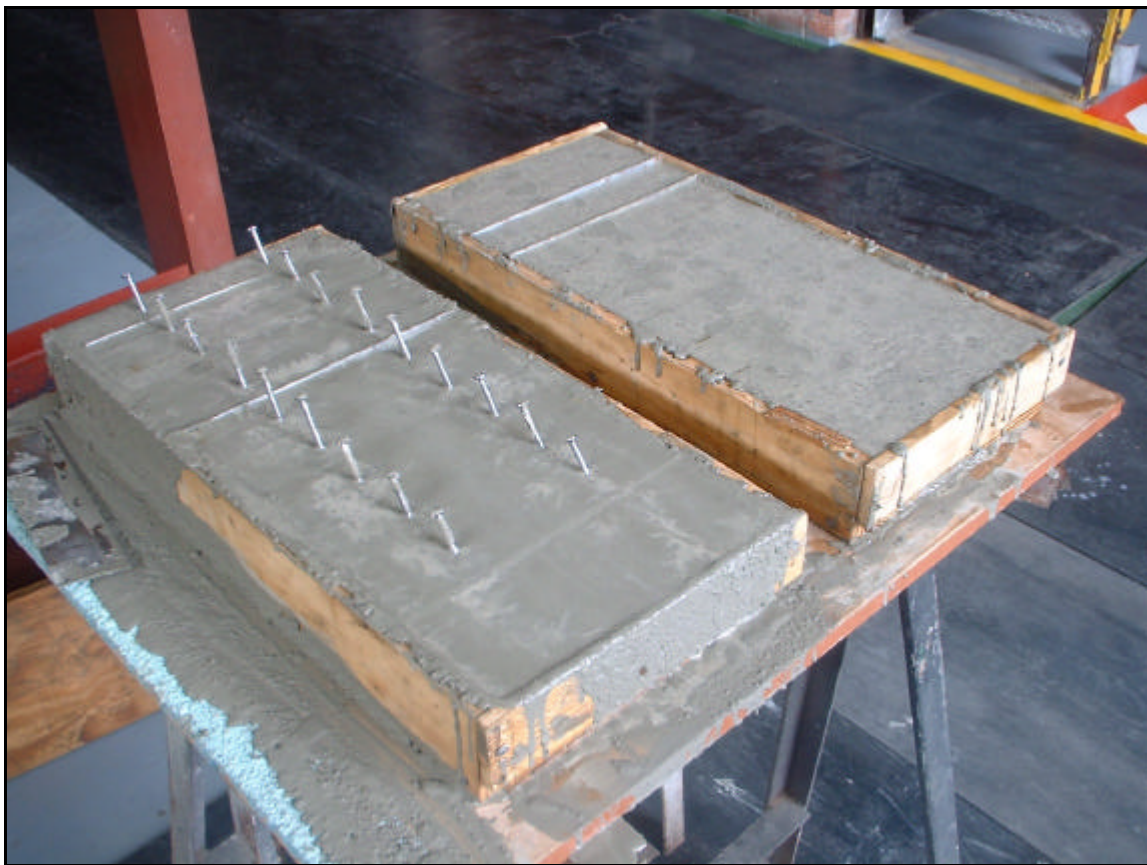
Figure 22. Tray moulds for unbolted and bolted layers after concrete pouring

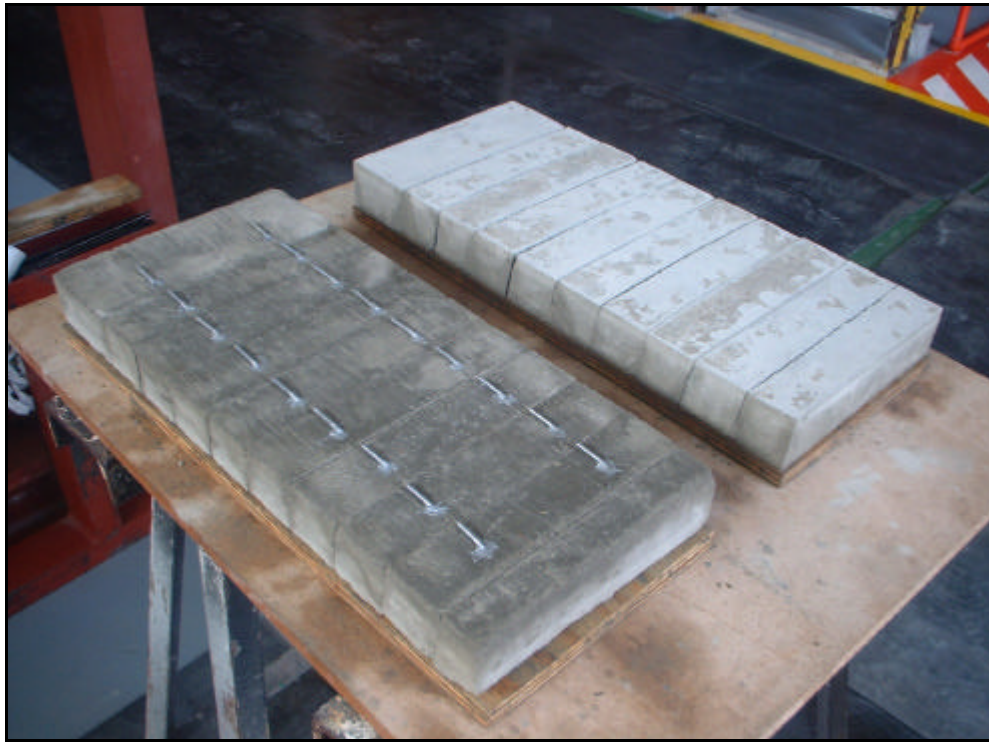
Figure 24. Lower bolted layer and upper unbolted layer

The “bolts” were pieces of 3 mm diameter standard steel wire. The pieces were inserted in the holes created by the nails. Pratley epoxy was used as “resin” to fix the reinforcement in place. A fully grouted bar was modelled in this way. The free ends of the bolts were bent back until parallel with the underside of the bolted layer. Following installation, the epoxy was left to cure for 90 minutes before the testing procedure began. Figure 24 shows both the layers just prior to testing.

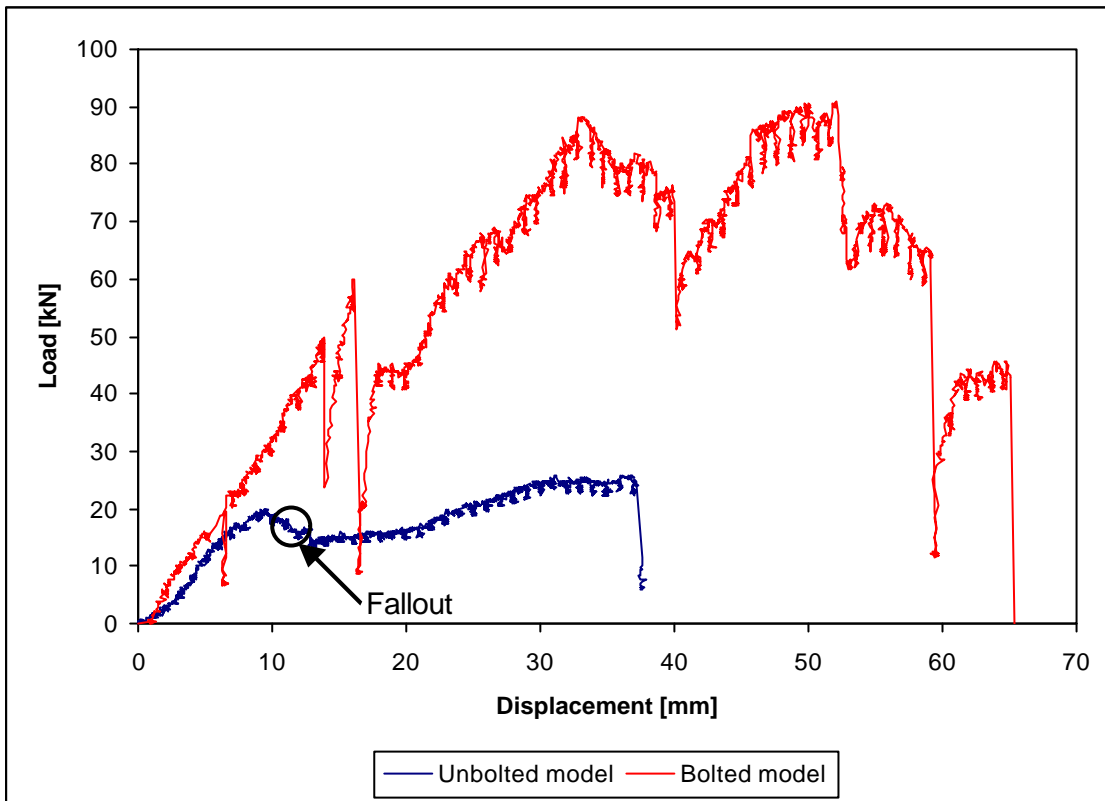
Figure 28. Load–displacement curves for the bolted and unbolted models

The load–displacement curves for the two models are presented in Figure 28. The approximate strength of the unbolted model is 20 kN and for the bolted model, 90 kN, indicating an increase in strength of 450 %. The individual curves are examined in more detail with the aid of photographs, taken at various stages of loading and deflection.

At approximately a 12 mm displacement, most blocks of the lower layer fell out. The drop in load at this point is indicated in Figure 28. The shape of the beam before and after this event is illustrated in Figure 30. The test was continued until it seemed that a constant load had been achieved. The bricks and remaining concrete blocks showed significant damage at this point and it was believed that the strengths of the materials were now being tested rather than the integrity of the beam. The test was stopped and the Terratek piston retracted, at which point the entire model collapsed as the confining stresses imposed by the Vetter Bag suddenly forced blocks both upwards and downwards. The bag was fully inflated and unloaded following the collapse.

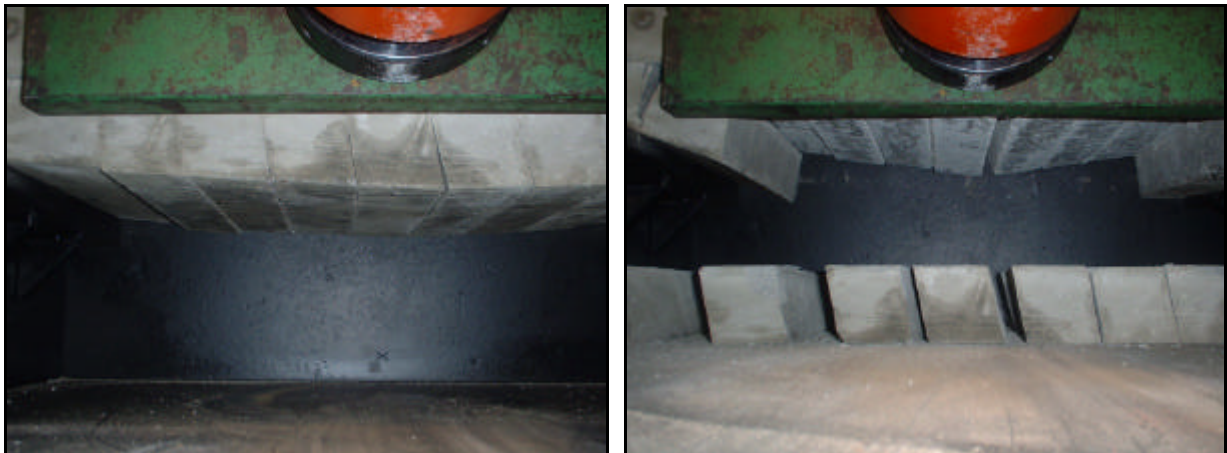
Figure 30. Underside of the beam before and after fallout

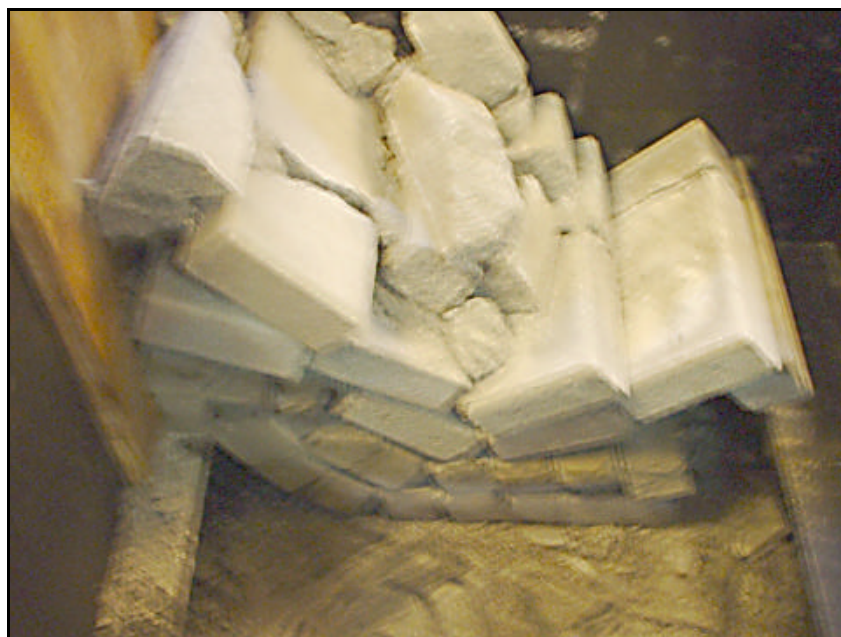
Figure 33. Final state of the bolted model

The test was stopped after the model collapsed. Rotation of the supporting blocks resulted in a sudden loss of confinement which caused the model to fail. The final state of the model with all loading apparatus removed is presented in Figure 33. Note that the bolted layer still provides support on the left-hand side. Most of the bolted layer was intact and could be removed in one piece. Blocks that had broken at the ledge contacts had obviously separated. Bond failure was observed in many of the bolts. A significant number of pull-out-type partial failures was observed.

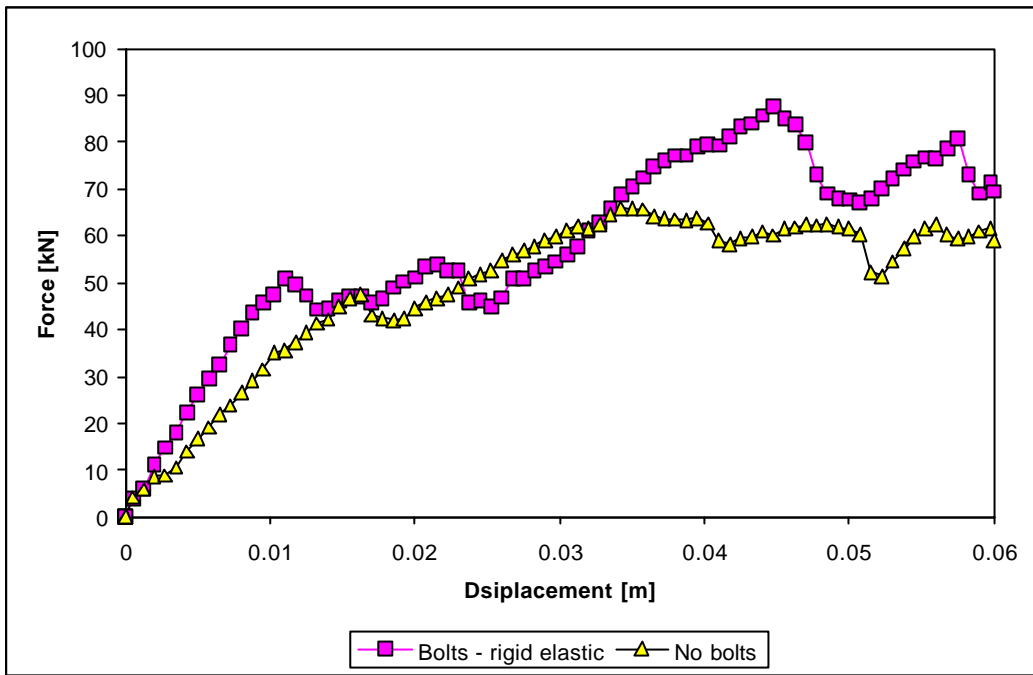
Figure 35. Load-displacement curves of numerical models of lab tests

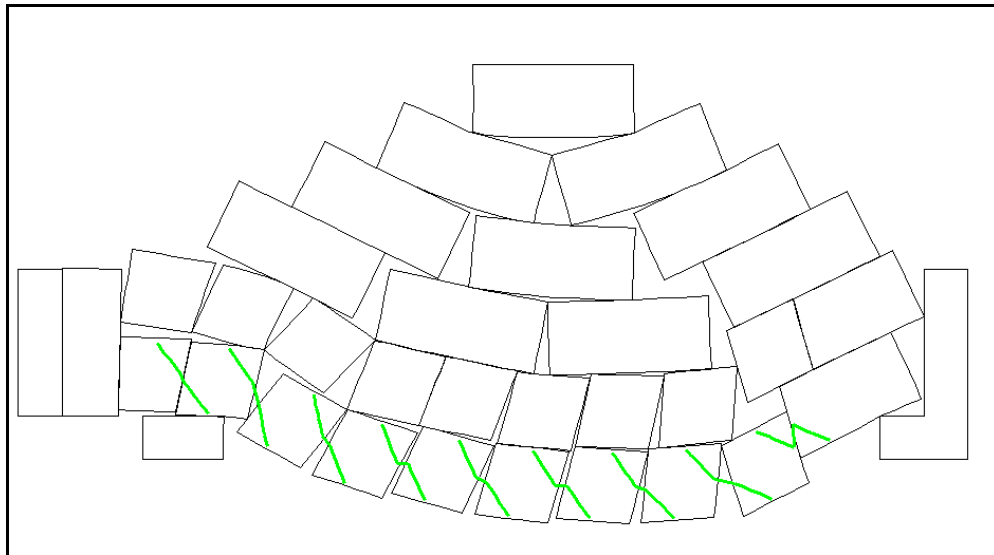
Figure 37. Final state of the bolted numerical model

Figure 36 and Figure 37 show the final states of the unbolted and bolted models respectively. The loss of contact in the bottom layer of the unbolted model indicates that the beam is fully unstable and about to fall freely. The bottom layer of the bolted model is still intact and very similar to the final beam shape observed in the laboratory – see Figure 31. Of note are the bending/shear deformations of the bolts. Judging from the photographs, shearing deformation could initiate after about 30 mm, which corresponds to 0.3 m closure in the full-scale stope. This could indicate a shear deformation requirement for bolts in the face area, particularly for more complicated rock mass block geometries.

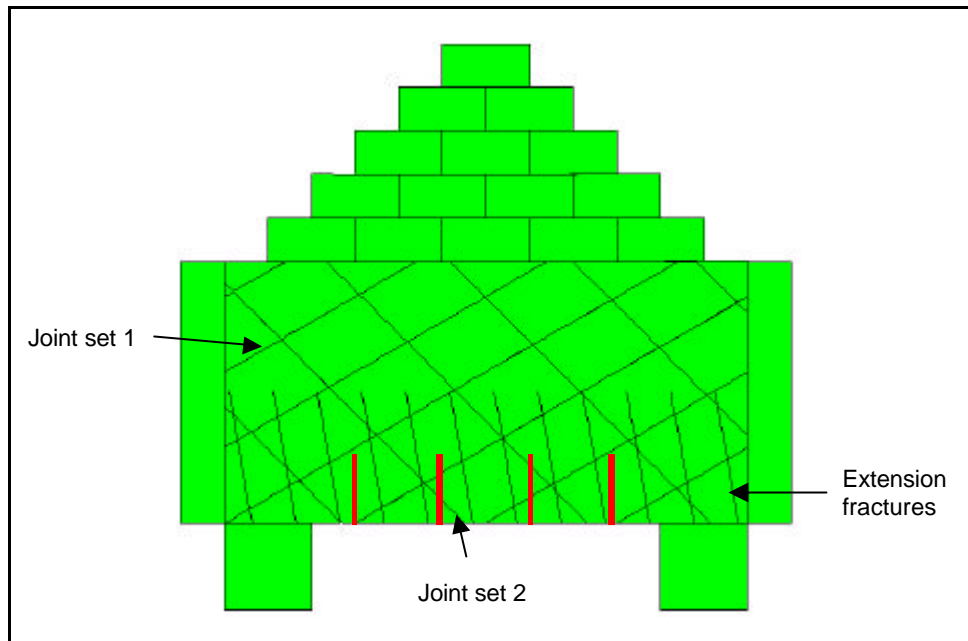
Figure 39. VCR model geometry

The VCR model geometry is illustrated in Figure 39. Bolt positions are indicated. Bolt orientation is vertical.

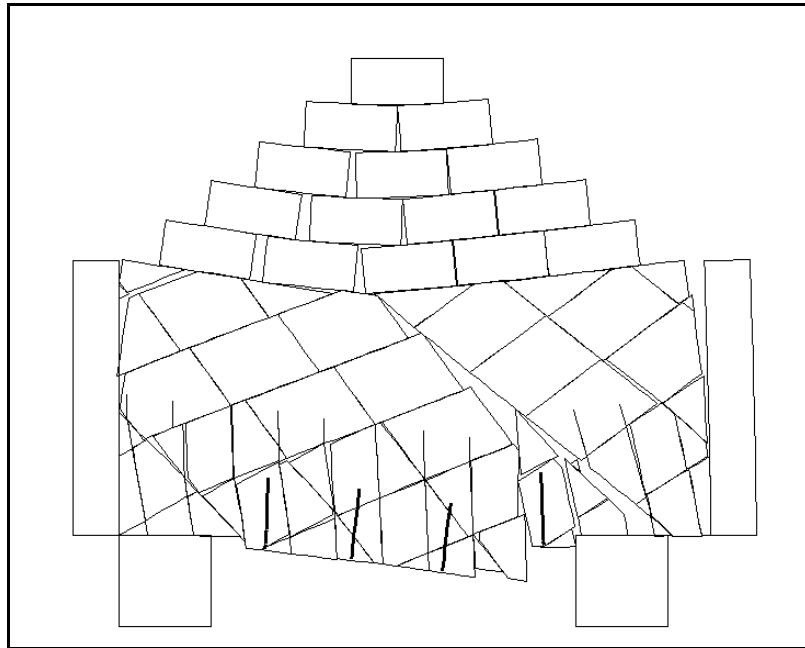
Figure 42. Final state of the bolted model

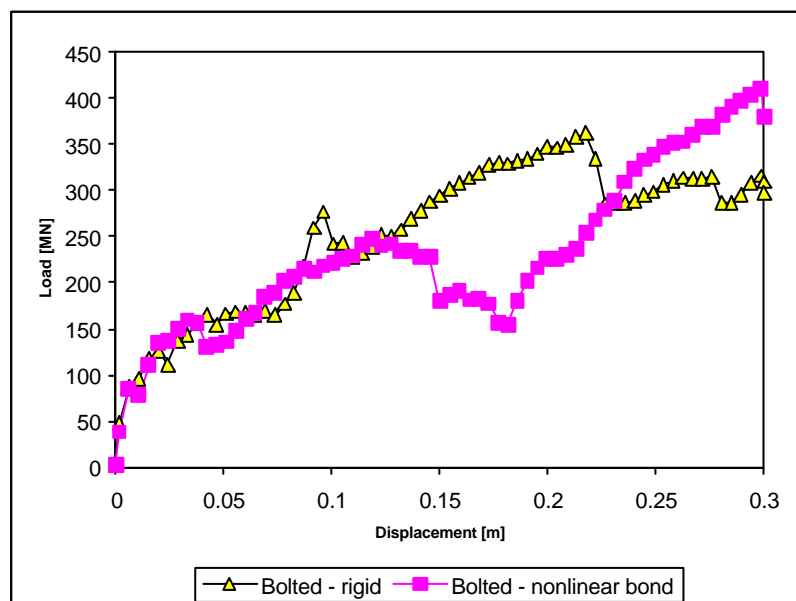
Figure 52. Response for the Carbon Leader hangingwall reinforced with rigidly bonded bolts and with “soft” non-linear bond and material models

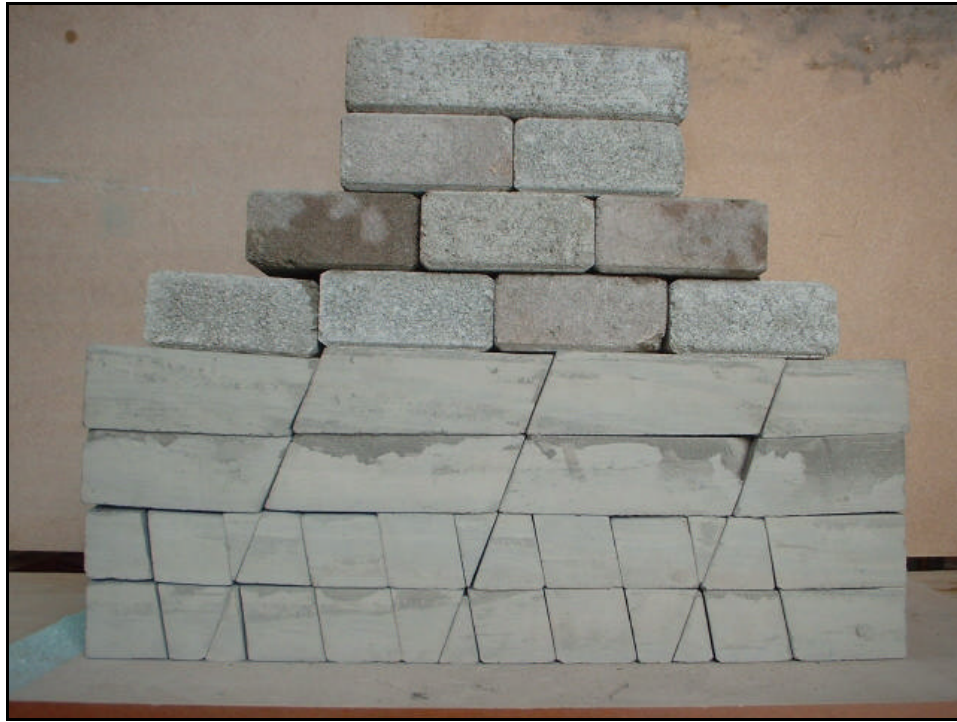
Figure 55. Vaal Reefs laboratory model

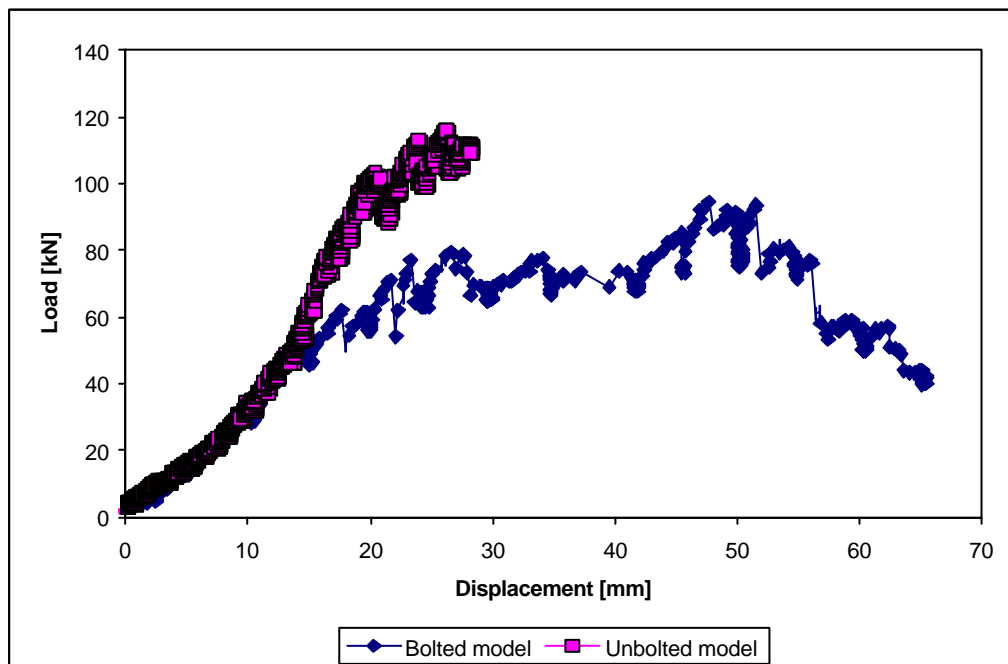
Figure 57. Load-displacement curves for the Vaal Reefs Laboratory models
