ESTUARIES OF THE CAPE

REPORT NO. 24

ONRUS (CSW 14)

REPORT NO. 24: ONRUS (CSW 14)

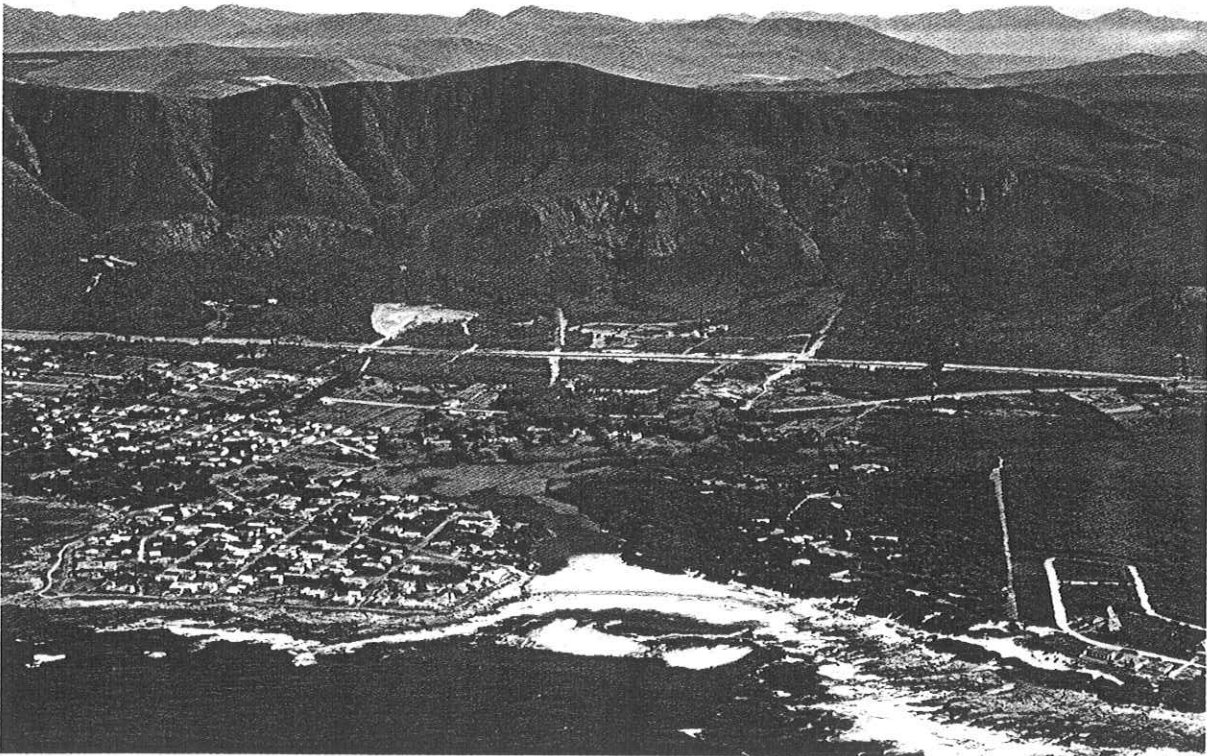
FRONTISPIECE: ONRUS ESTUARY – ALT. 460 m, ECRU 79-10-16

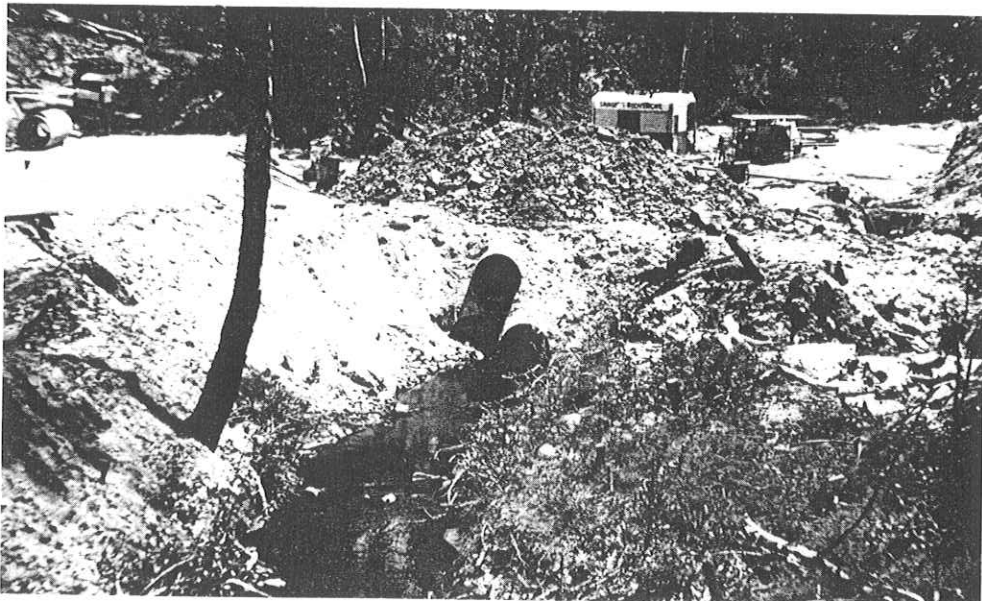
FIG. 5: The new Onrus/Hermanus highway bridge under construction. Temporary gravel fill threatens to add further sediment to the Onrus Lagoon unless there is thorough rehabilitation after completion of the bridge (ECRU 79-12-06).

A few low bridges connect farms on the western river bank with the Onrus/Caledon road (R320). The main Onrus/Hermanus road crosses the river on the coastal plain. Three bridges have been constructed at this point. The original bridge was washed away by floodwaters in the late 1940s, a second bridge was then constructed just north of the old main road and subsequently the new Onrus/Hermanus highway bridge was built north of the previous main road. During construction of this bridge, three pipes were placed in the riverbed and covered with gravel (see Figure 5). The construction of bridges by this method can have serious ecological consequences unless clearing-up operations are

conducted before heavy rains wash the temporary fill sediment downstream, further aggravating the problem of siltation in the estuary. As can be seen from the following figures the new bridge offers far less obstruction to flow than the previous bridge did, and clearing-up operations after construction have been more than adequately carried out.

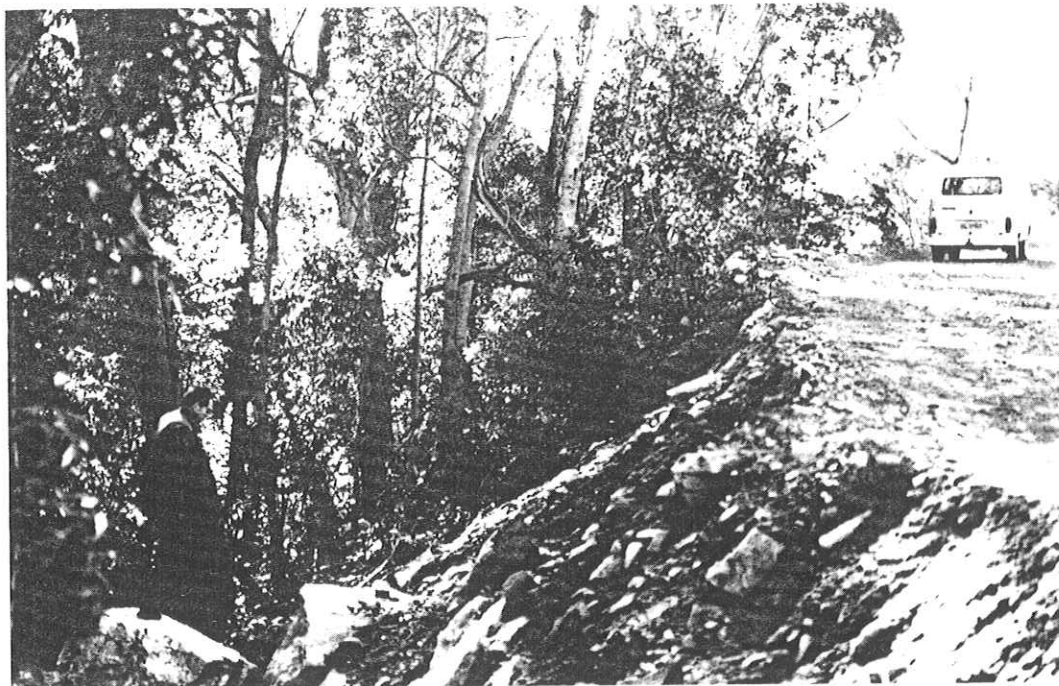
FIG. 8: Encroachment of the embankment of the Onrus to Caledon gravel road onto the Onrus riverbed. Run-off from this road could be a source of sediment to the lagoon during storm conditions. (ECRU, 83-05-19).

Another important source of sediment is the run-off from the gravelled Onrus/Caledon road. At the time of the ECRU Survey this road was being widened and the road embankment had encroached onto the streambed in places (see Figure 8). The erosion of this embankment will also result in sediment being carried downstream.

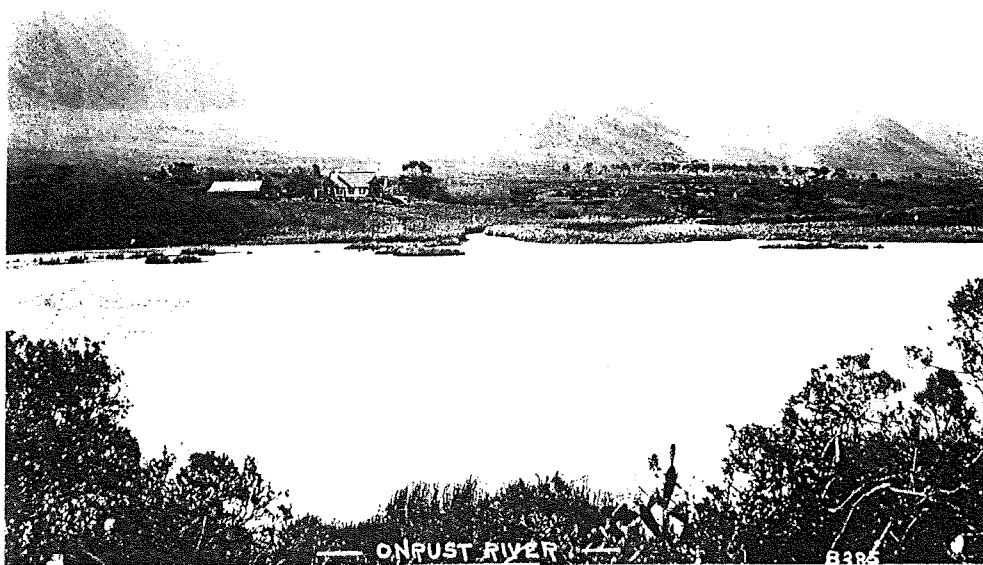
FIG. 10: Onrus Lagoon 1921, photographed from "Sleepy Lagoon", Protea Street. The wide lagoon is fringed with a narrow *Phragmites* bed. Islands in the lagoon are vegetated with a *Scirpus* species. (Photograph by courtesy of Mr Swingler.)

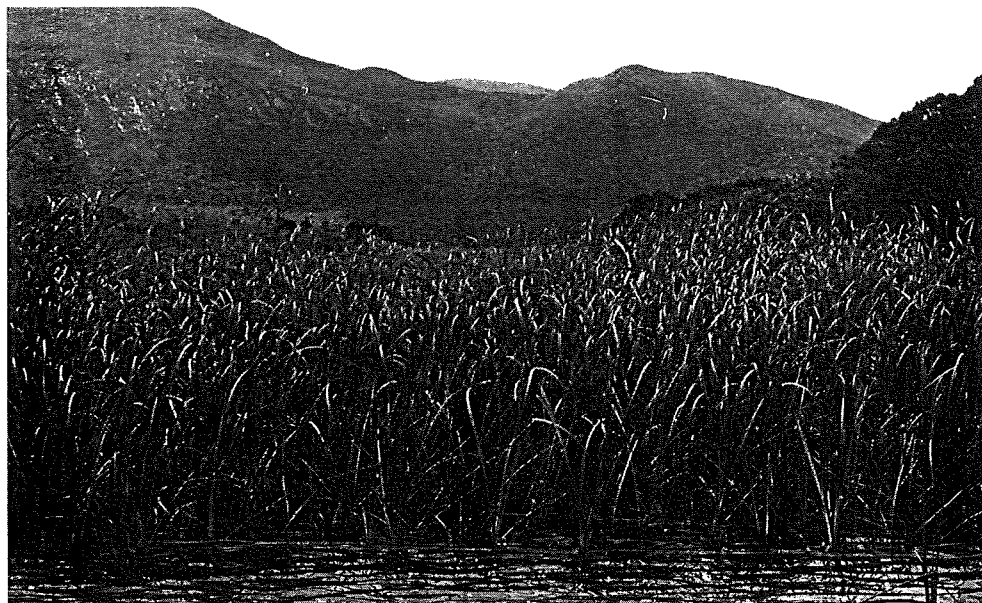
FIG. 14: Papkuil or the bulrush *Typha capensis* growing in an old river channel (Damstra, November 1979).

The bulrush or papkuil, *Typha capensis*, grows in dense single-species stands in localized areas around the lagoon (see Figure 14). The long strap-like leaves fan out from a central point under water. New leaves are constantly being produced from the centre. The dense cylindrical spikes containing the male and female flowers are produced in December and January.

Typha was found in an old channel in the eastern part of the lagoon as well as in a belt north of the blind channel. A sharp division often occurs between *Phragmites* and *Typha* beds. In contrast to *Phragmites*, *Typha* seldom occurs along with *S. triqueter*.

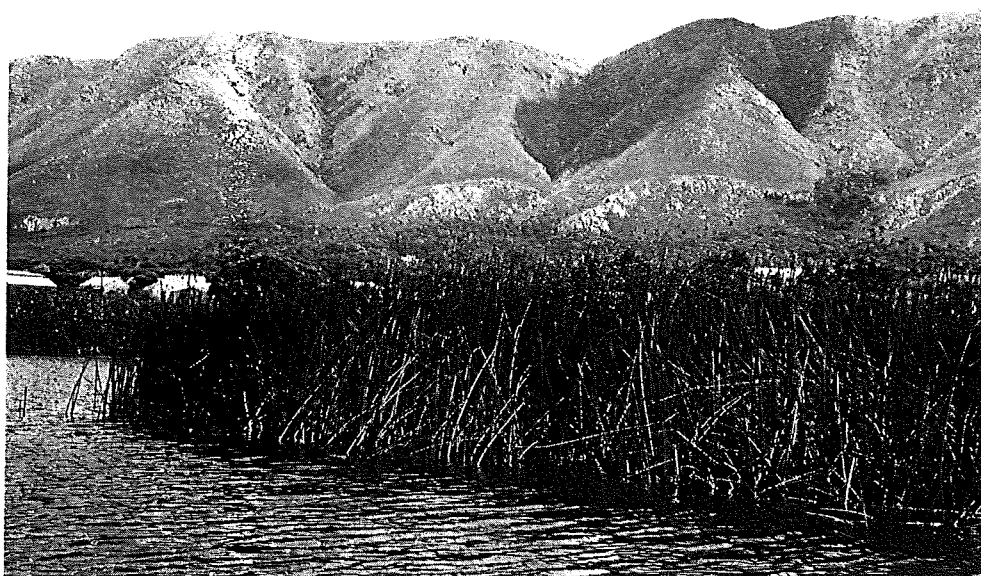
FIG. 15: The recently developed *Scirpus littoralis* island in the centre of the lagoon. (Photograph by courtesy of Mike Cherry, November 1979).

The recently-developed island in the centre of the lagoon is colonized by *Scirpus littoralis* (see Figure 15). This is an erect reed with narrow cylindrical stems which grow from underground rhizomes. The growth of this island has been remarkably rapid. By July 1980 rhizomes of *Scirpus littoralis* had extended northwards, completely closing the eastern channel.

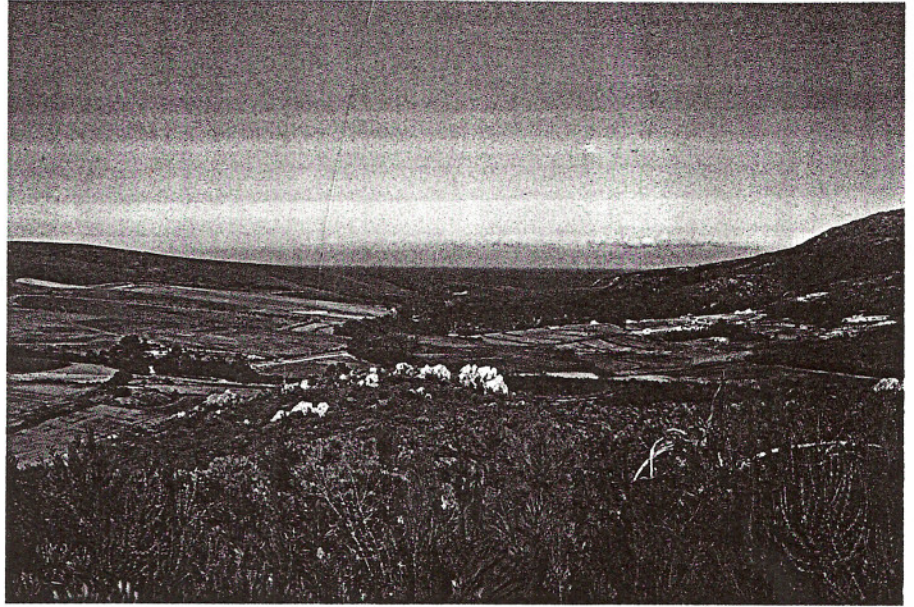
PLATE I:

The catchment area of the Onrus River called "Hemel en Aarde". Mountain fynbos in the foreground with cleared agricultural lands and the tree lined river course in the valley. (ECRU, 83-05-19).

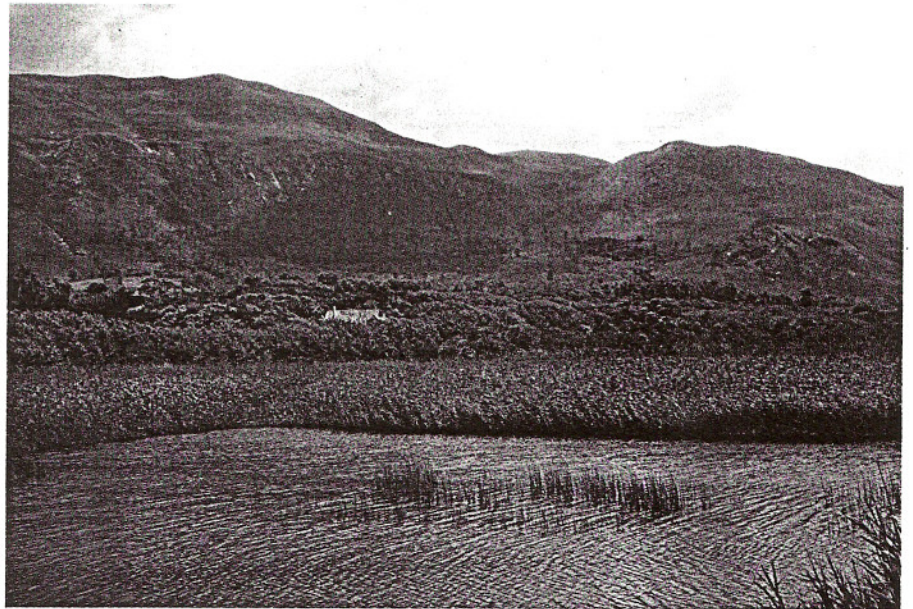
PLATE II:

Extensive beds of "Fluitjiesriet", (*Phragmites australis*) now occupy the once open lagoon which was used for boating and swimming. (ECRU, 79-12-06).

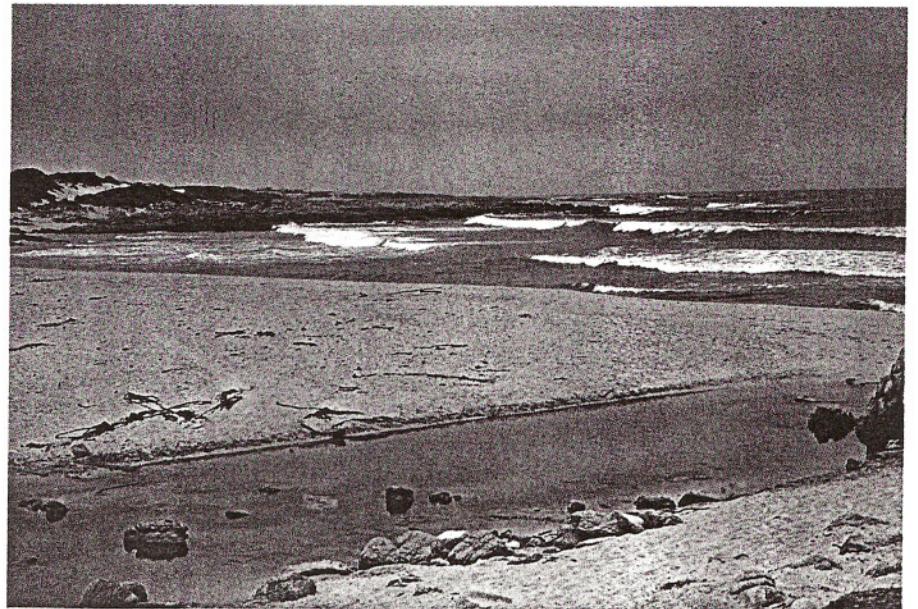
PLATE III:

The mouth of the Onrus Lagoon showing the sandbar and the narrow channel on the western edge through which the lagoon drains after heavy rains in the catchment (ECRU, 79-09-11).

The shape of the lagoon and the relatively small inflow of river water result in very little scouring of the high sandbar at the mouth. This tends to cause retention of sediment in the lagoon. It is improbable therefore that the lagoon will be flushed of its sediment load by natural means.

As already described, the sandbar is breached only partially during floods by the formation of an overflow channel. Quick closing of this channel after a flood is due to the natural rebuilding process by which waves deposit sand on the shore during calm periods. Since Onrus is situated in a small cove on a rocky coastline, there is no large-scale longshore movement of sediment. Any sand removed from the mouth during erosional conditions is usually deposited in an off-shore bar from where it is moved back to the beach during conditions favouring accretion. Data from Voluntary Observing Ships, (VOS), (Swart and Serdyn, 1982) and data from the Slangkop Waverider (Rossouw and Coetzee, 1982) for the area of the south-western Cape Coast were used to determine the factors which affect this coastline. The predominant wave direction is from the south-westerly sector (SSW, SW and WSW): 43 percent. The average significant wave height is 2,2 m and the extreme significant wave height 7 m. The Slangkop Waverider data show an average significant wave height of 2,4 m and a maximum significant wave height of 9 m which agrees with the VOS data.
