ESTUARIES OF THE CAPE

SYNOPSIS OF AVAILABLE INFORMATION ON INDIVIDUAL SYSTEMS

REPORT NO. 31

KEURBOOMS/BITOU SYSTEM (CMS 19)

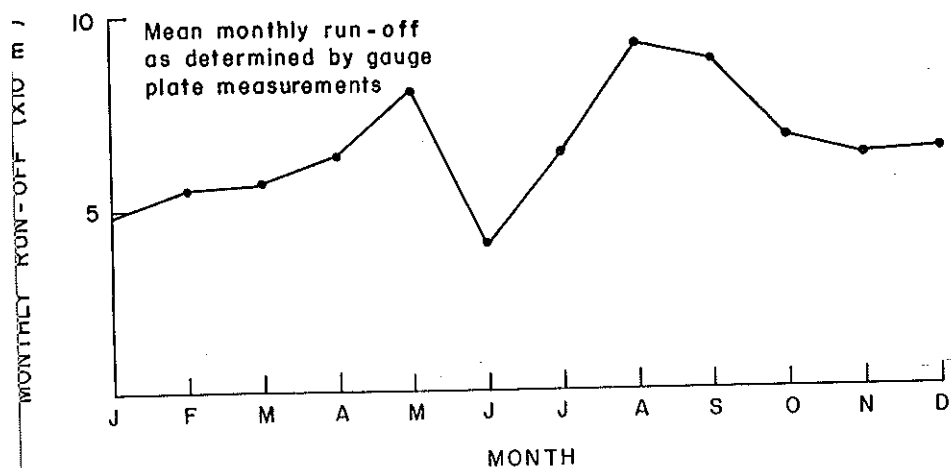
IG. 3: Mean monthly run-off in the Keurbooms River at Newlands over the period October 1970 to June 1981.

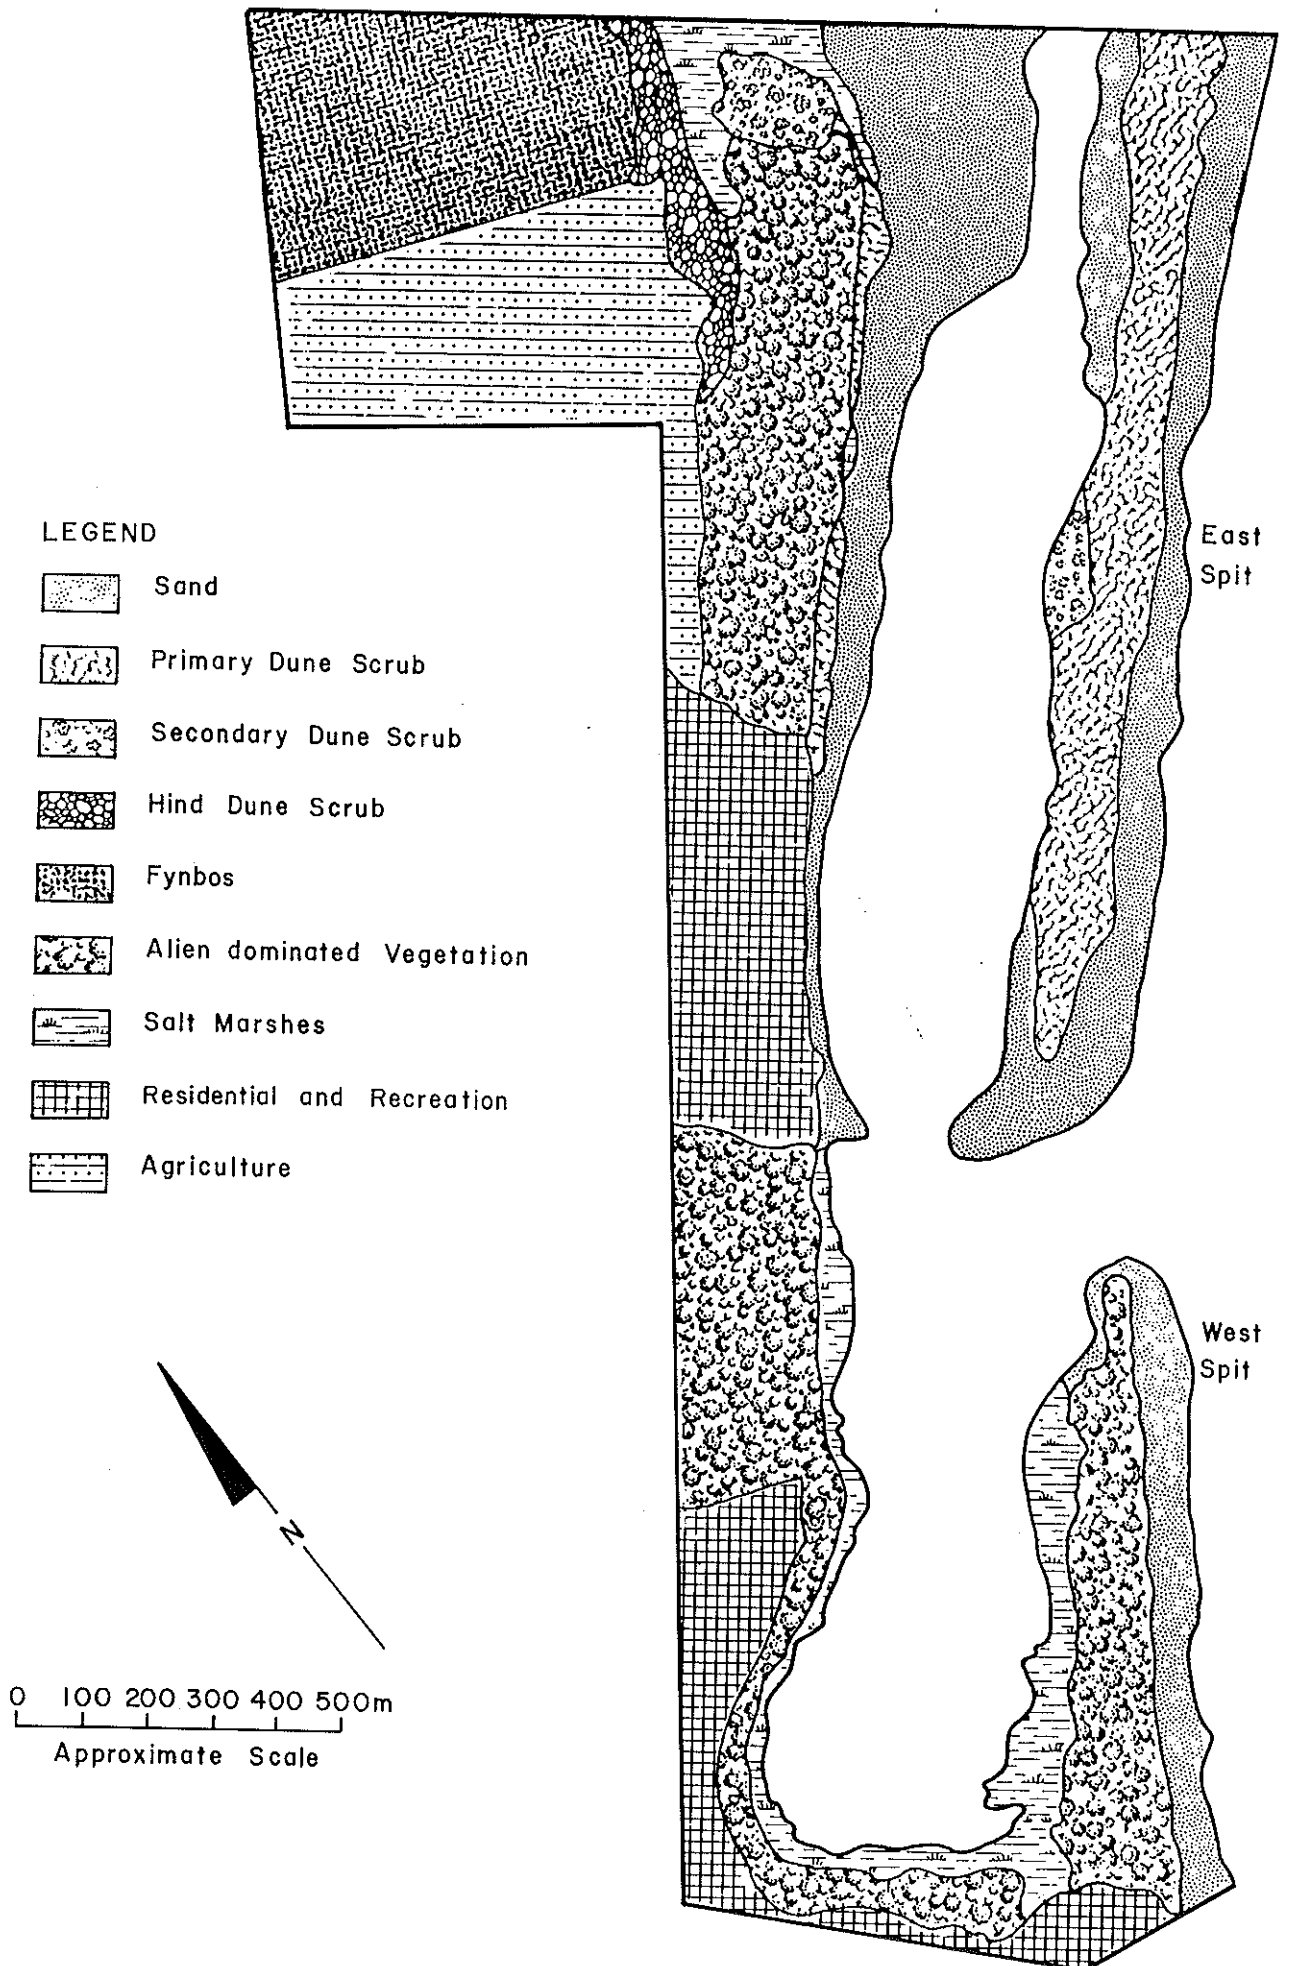
FIG. 11a : The vegetation of the lower reaches of the Keurbooms / Bitou Estuary.
