# ESTUARIES OF THE CAPE

SYNOPSIS OF AVAILABLE INFORMATION  
ON INDIVIDUAL SYSTEMS

### REPORT NO. 16: EERSTE (CSW 6)

COMPILED BY: J R GRINDLEY

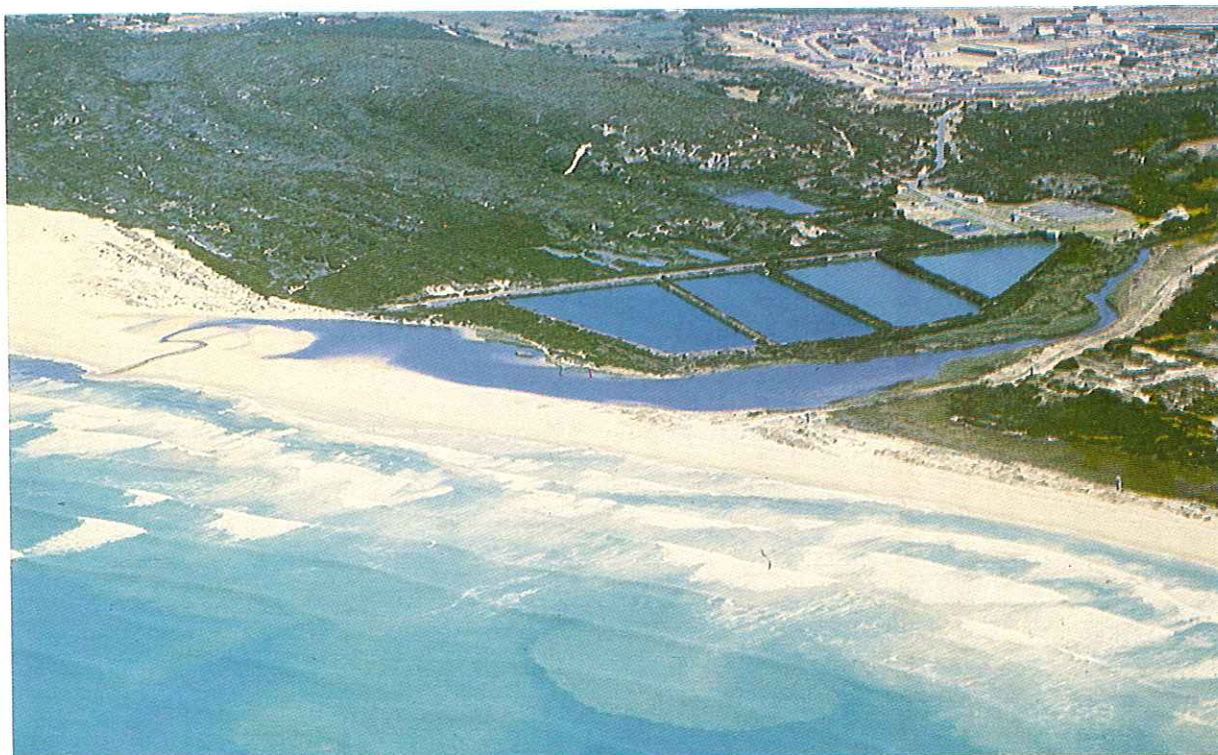
FRONTISPIECE: EERSTE ESTUARY — ALT. 150 m, ECRU 82-12-20

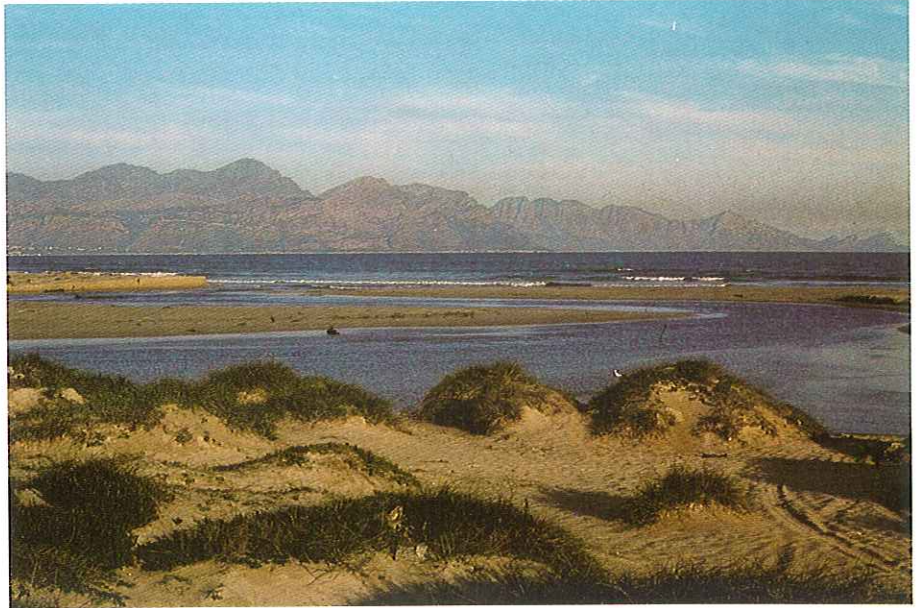
PLATE I:

Eerste estuary mouth in open condition looking south east across False Bay to Kogelberg in the background. The mouth channel changes its position from time to time and newly eroded sand banks are evident in two places in this picture. The hummock dunes in the foreground are covered by the Steekriet, *Eragrostis cyperoides* (J.R. Grindley, 1982-06-07).

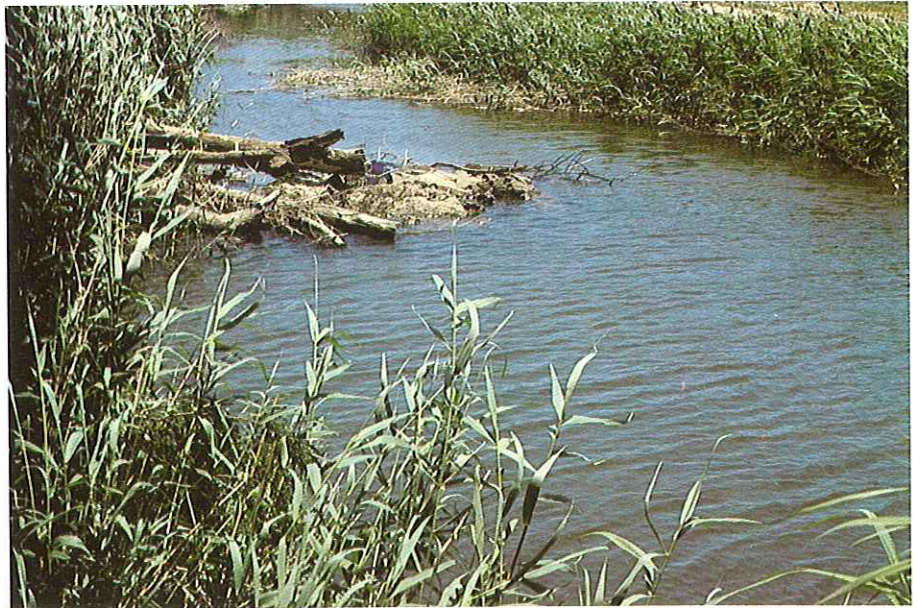
PLATE II:

Eerste estuary approximately 1 300 metres from the mouth where it is a reed fringed channel about 10 metres wide. The reeds are predominantly the fluitjiesriet, *Phragmites australis*. An isolated outcrop of rocks of the Malmesbury series occurs at this point which accumulates floating logs and other litter. (J.R. Grindley, 1981-12-03).

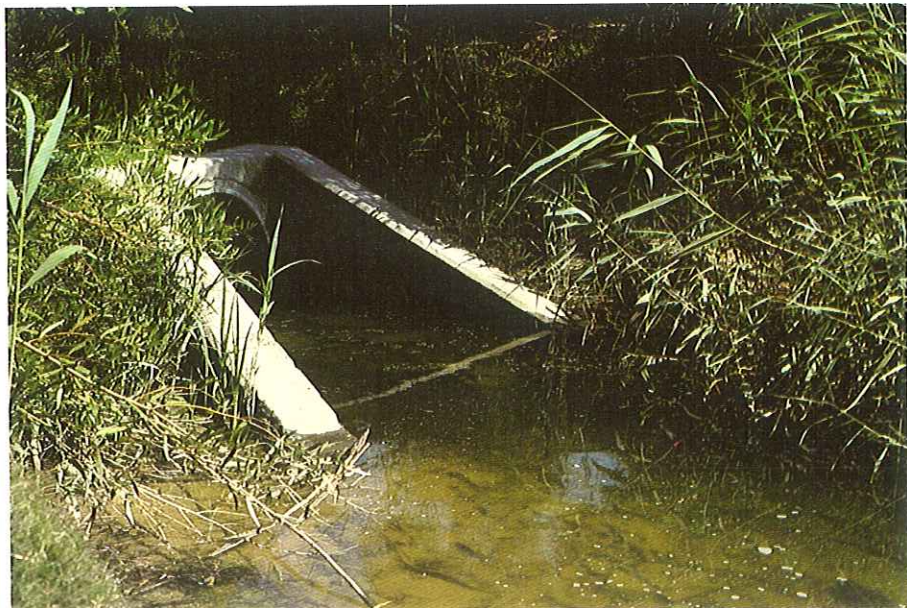
PLATE III:

The sewage outfall approximately 1 300 metres from the mouth of the Eerste estuary. The outflowing treated effluent attracts large numbers of juvenile fish at times. The adjacent vegetation in the picture includes the fluitjiesriet, *Phragmites australis* and Rooikrans, *Acacia cyclops* (J.R. Grindley, 1981-12-03).
