ESTUARIES OF THE CAPE

SYNOPSIS OF AVAILABLE INFORMATION
ON INDIVIDUAL SYSTEMS

REPORT NO. 13

SILVERMINE (CSW 3)

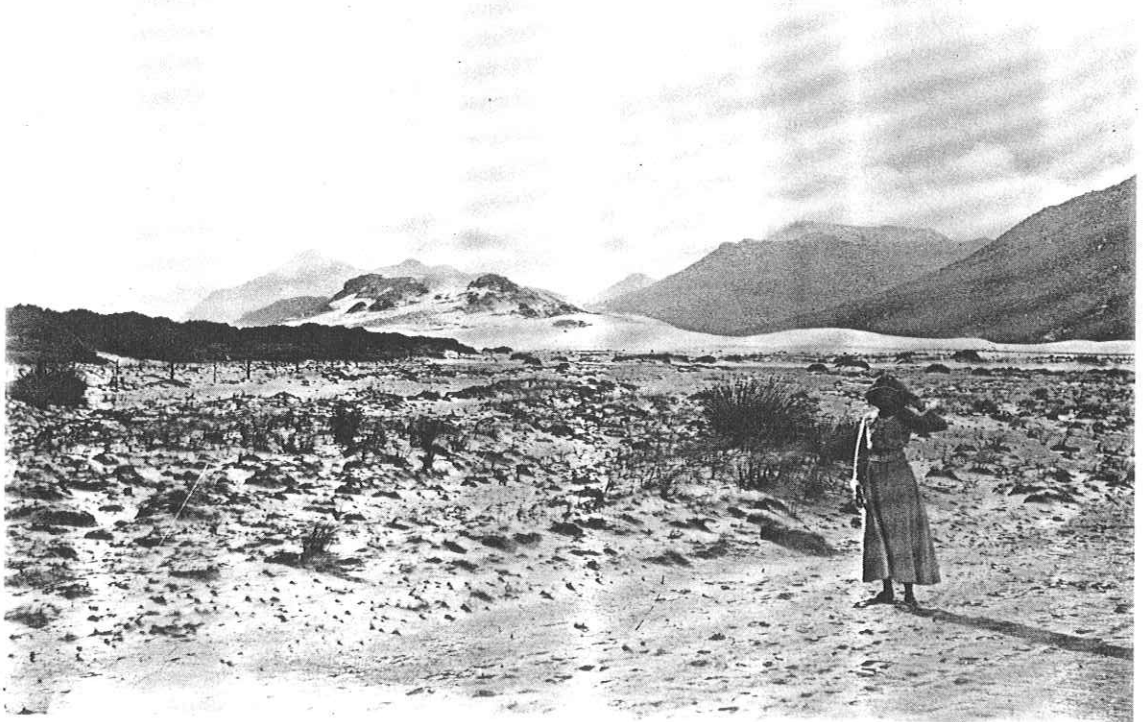
FIG. 1b: The lower part of the Silvermine River valley in 1910. The photograph is taken looking westwards from approximately the centre of the present day shopping area (reproduced by courtesy of Mr M Cobern).

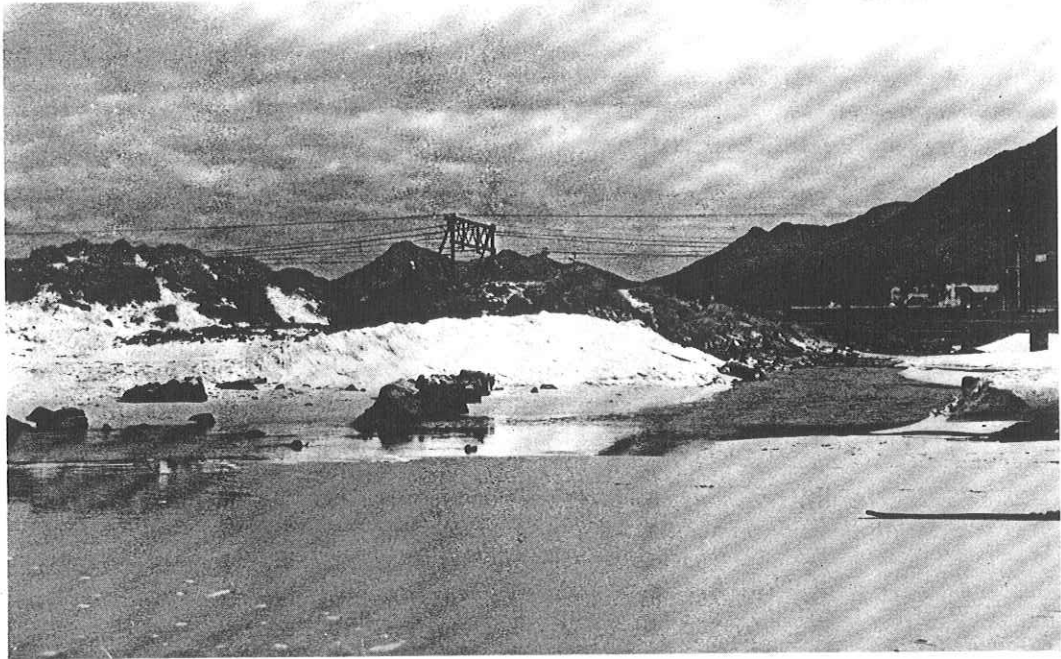
FIG. 6: A barrier of concrete filled oil drums at the Silvermine Estuary.

In places, undercutting of this barrier has taken place and the drums have slumped into the estuary (see Figure 6).

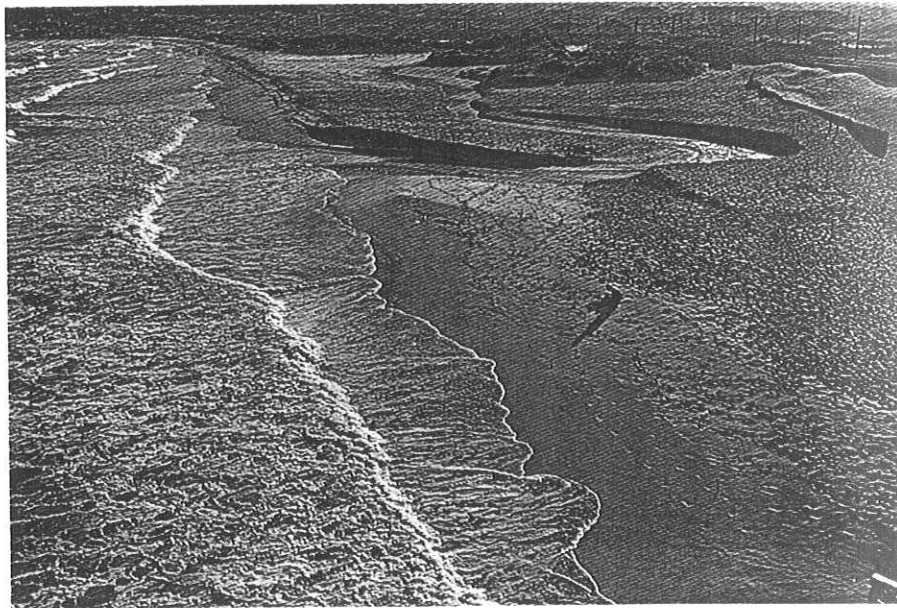
PLATE II: Northward migration of the Silvermine rivermouth can be seen as well as the steep, higher energy section of the northern part of Fish Hoek beach. (E Barnes, Oct 1981).

Mouth behaviour. After natural or artificial breaching of the mouth, the Silvermine River tends to meander under the influence of the prevailing inshore oceanographic conditions (see Plate II and Figure 4).

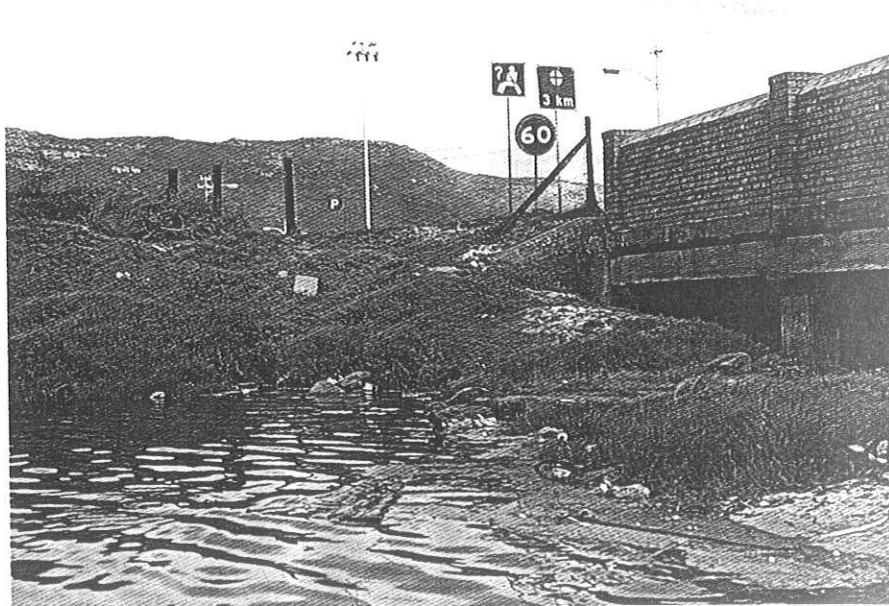
PLATE III: Part of the seasonal lagoon between the road and rail bridges at the Silvermine rivermouth. A stormwater drain outlet can be seen in the centre of the photograph as well as a large amount of litter often found in the area. (ECRU, 82-04-27).
