# ESTUARIES OF THE CAPE

### SYNOPSIS OF AVAILABLE INFORMATION ON INDIVIDUAL SYSTEMS

REPORT NO. 32

VERLORENVLEI (CW 13)

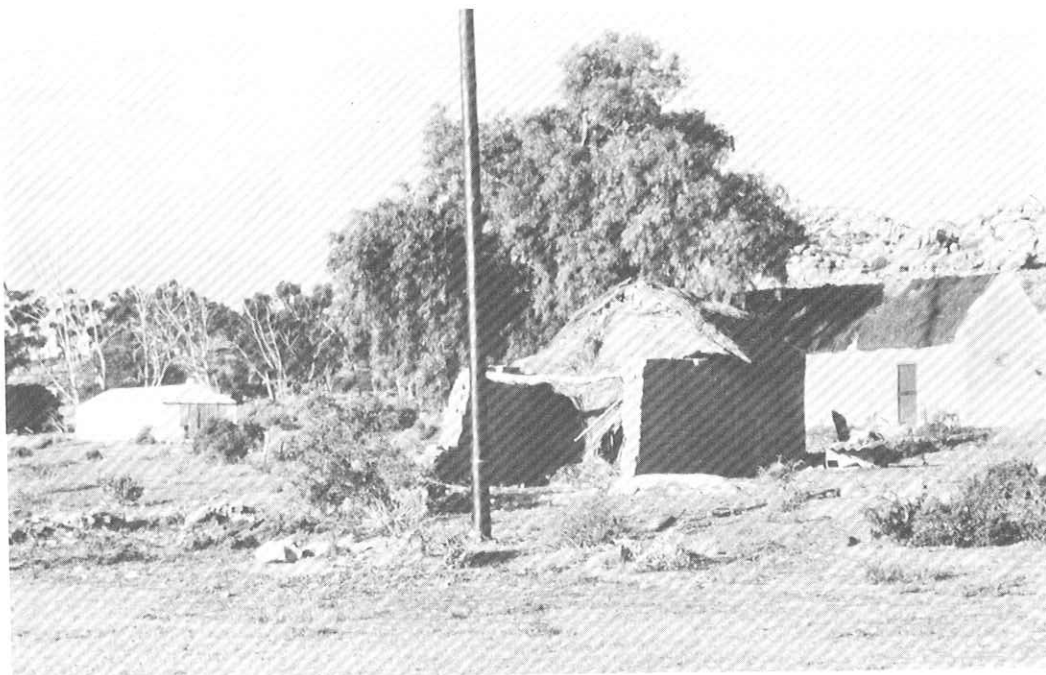
FIG. 3: Powerline support erected in centre of threshing floor. (Photo: S A Sinclair, May 1985).

In their advisory and co-ordinating role the Chief Directorate of Environmental Conservation of the Department of Environment Affairs is required to motivate the controlling authorities to apply the necessary expertise to optimally manage such sensitive areas. Despite this, detrimental activities are still occurring, such as the interference with the flow regime in the estuary by blocking the culverts in the lower causeway, and the siting of an electricity supply pole in the centre of an historic threshing floor in the Verlorenvlei settlement (Figure 3).

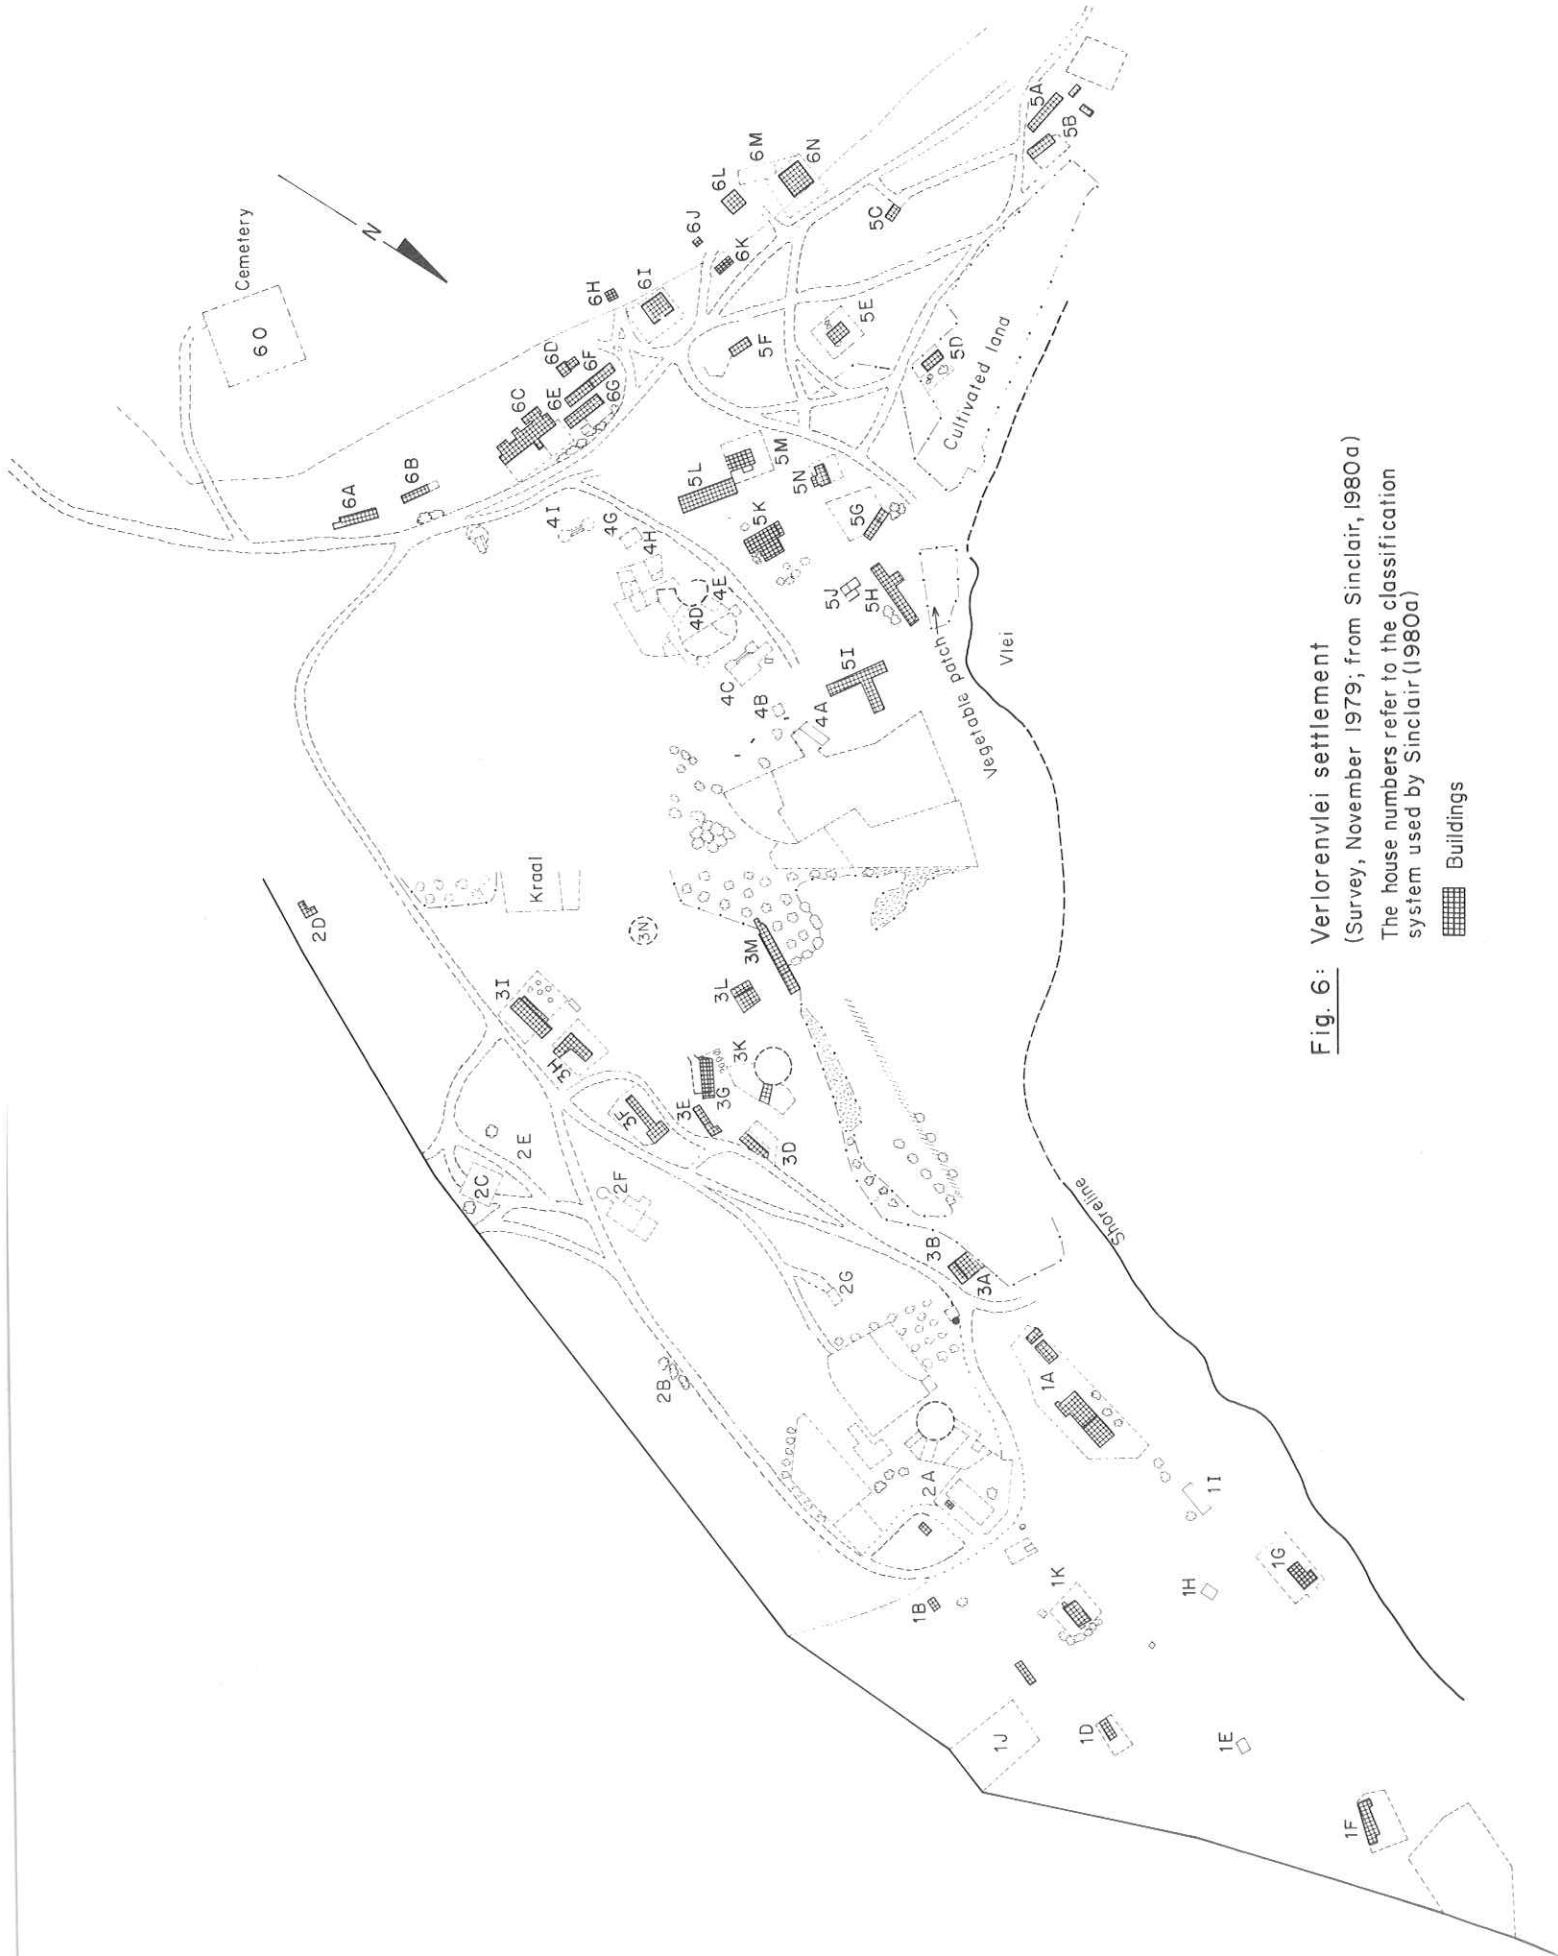
Fig. 6: Verlorenvlei settlement  
(Survey, November 1979; from Sinclair, 1980a)  
The house numbers refer to the classification  
system used by Sinclair (1980a)

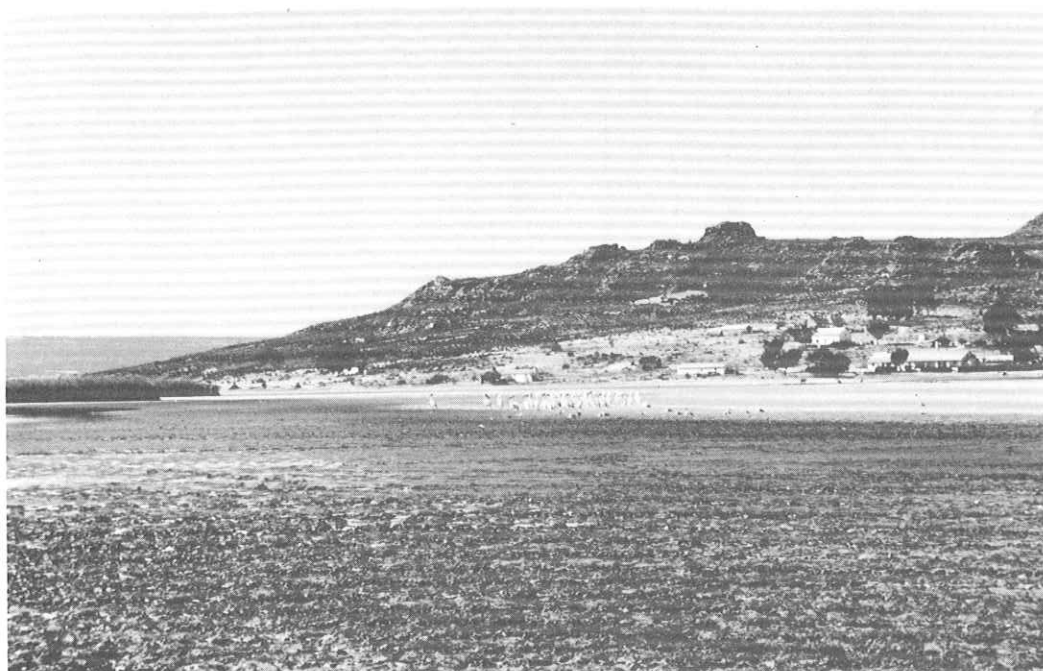
**FIG. 12:** Vlei level in front of Verlorenvlei settlement during May 1981.  
(Photo: P D Morant).

The catchment of Verlorenvlei lies in the winter rainfall area, with more than 80 percent of the precipitation occurring between April and September, and very little in the summer. The level of the lake fluctuates considerably. During winter it fills up and overflows into the sea near Elandsbaai, but during the summer, it gradually drops through evaporation to reach low levels during March/April (Figure 12).

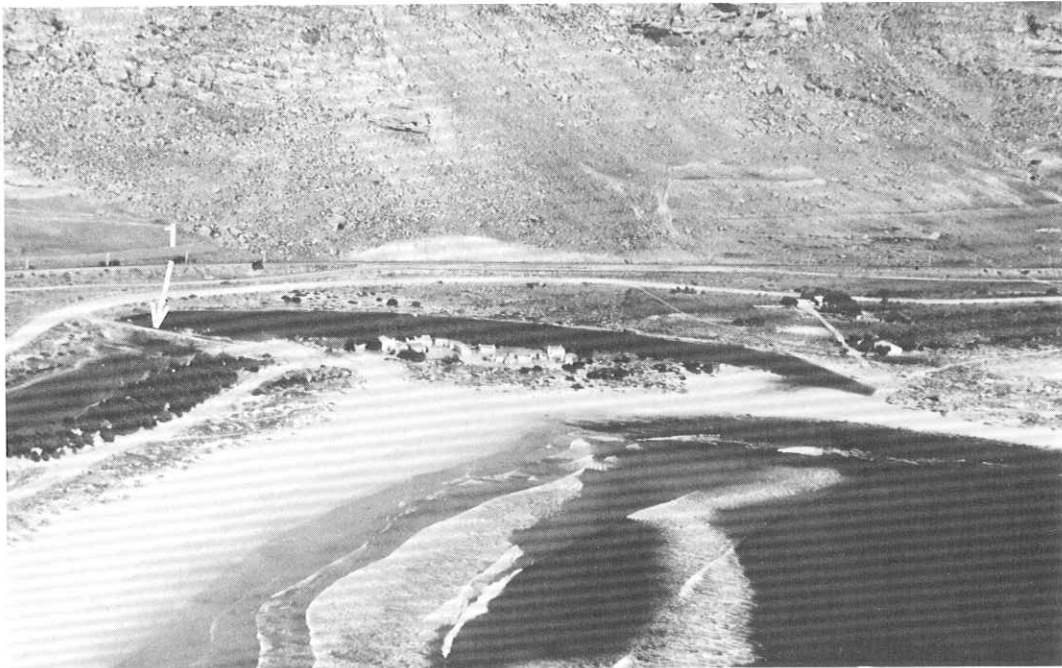
**FIG. 18:** Verlorenvlei Estuary mouth showing the causeway (Obstruction 1).  
(Photo: ECRU 85-06-09).

The sea was relatively calm (1 m swell) and there was no sign of washover visible. It could, however, be envisaged that heavy seas do wash over the bar, which is also indicated by kelp debris present in the estuary behind the bar. During severe storms in May 1984, kelp debris was swept upstream over the first causeway.

- b. Concrete causeway 500 m upstream of mouth (Figures 17, 18 and 19; Obstruction 1).

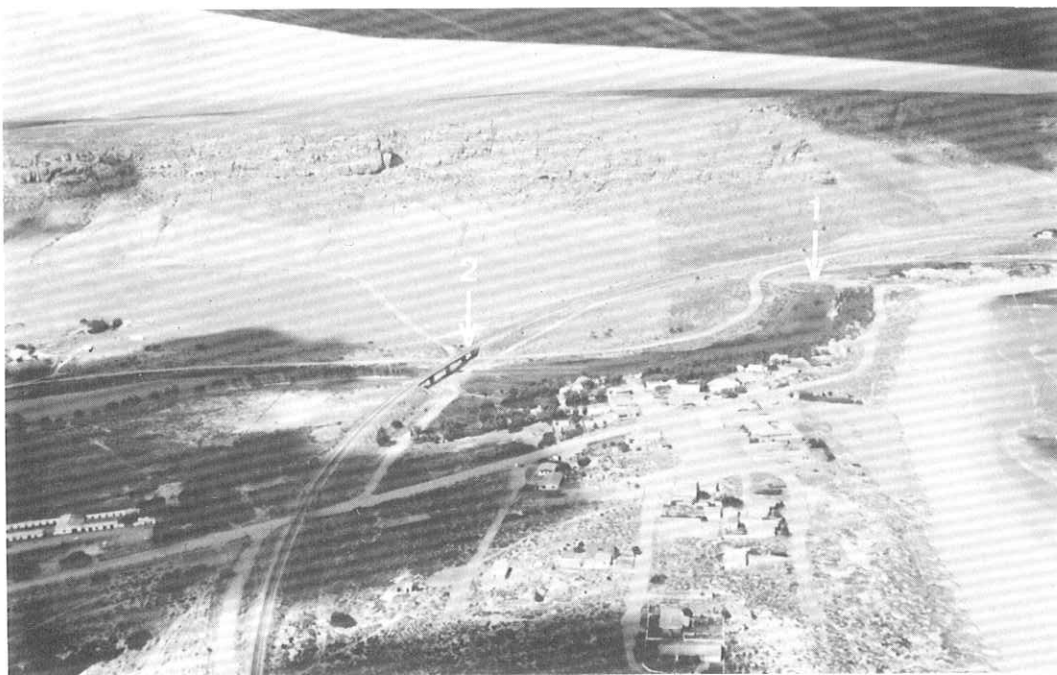
**FIG. 19:** Lower reaches of the Verlorenvlei Estuary showing obstructions 1 and 2. (Photo: ECRU 85-06-09).

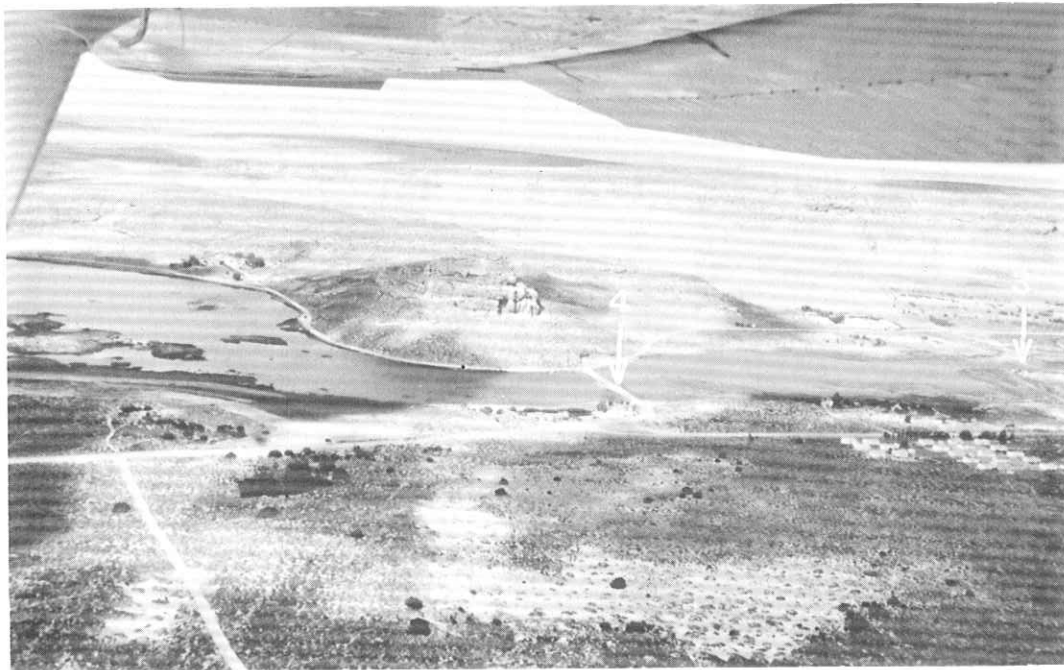
**FIG. 22:** Narrowing of the Verlorenvlei into a channel, with Obstructions 3 and 4. (Photo: P D Morant, October 1980)

e. Road causeway (Figure 17, Obstruction 4; and Figure 22).

The gravel road from the south to Elandsbaai crosses the uppermost narrow section of the estuary channel (2,6 km upstream of the mouth) via a 180 m-long embankment, about 2 m above bed level. About 20 percent of the length of the causeway is open, with four large square culverts which allow normal flow to pass through.

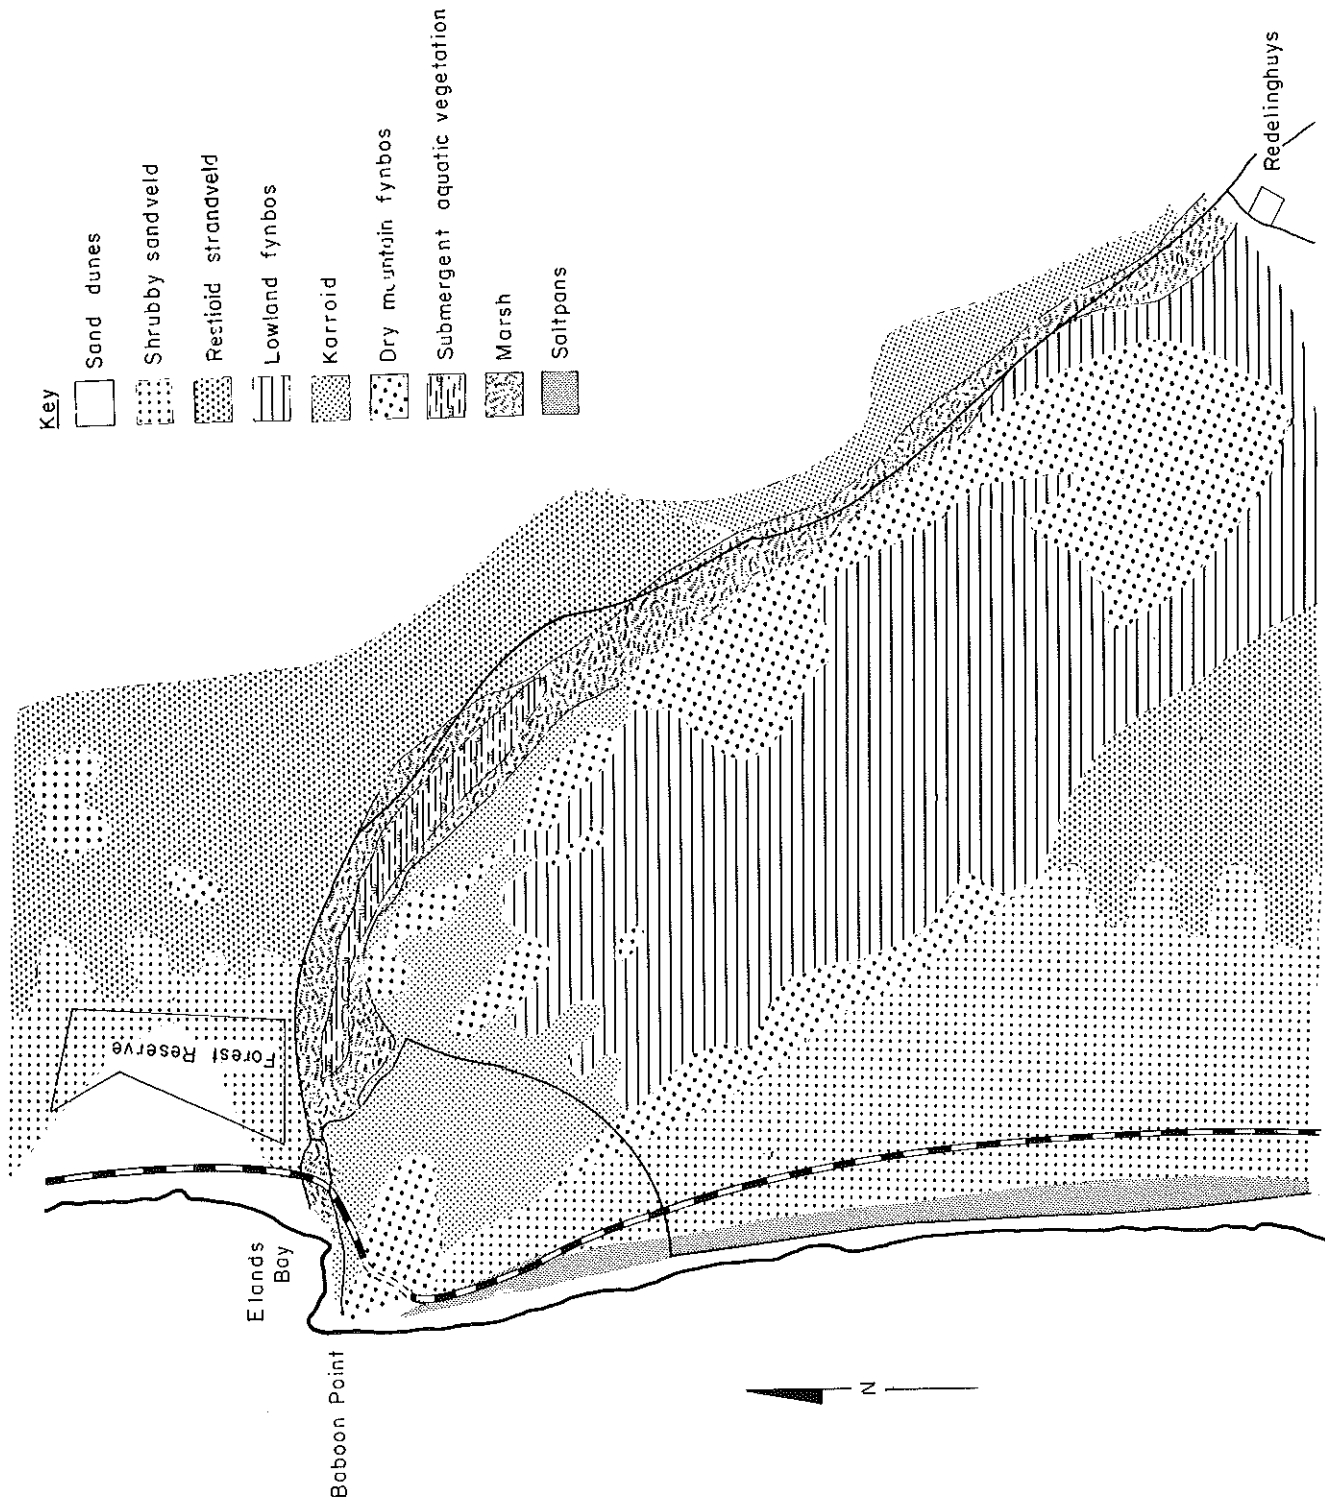
Fig. 24: Vegetation of Verlorenvlei and environs (Botanical survey and mapping by S. Dean, S. B. Lane and F. Stemmet, 1986)

The following description of the vegetation of Verlorenvlei and its environs was compiled by S Dean, botanical consultant (*in litt.*) based on field surveys and mapping carried out for the Department of Environment Affairs in 1986 (Figure 24).

There was, therefore, a need to obtain a more detailed and extensive vegetation map for the Verlorenvlei region, which could provide a baseline map for further refinement in the course of botanical field research. This map has been compiled by S Dean (formerly Milton), based on photographs, orthophoto maps, existing vegetation maps and extensive field surveys. The vegetation map (Figure 24) is provisional, in the sense that it must be refined in the course of future research.

The reeds surrounding the vlei (Figure 24) are dominated by *Phragmites australis*, with smaller communities of *Typha capensis*. Downstream of Redelinghuys fairly wide and open wetlands occur, with patches of mixed sedges and reed communities. After about 8 km, the valley narrows, and the reeds (mainly *Typha*) become denser. About 2 km lower, below Grootdrif Farm, the reeds form an expanse about 1 km wide for another 2 km. They then form fringes along both banks of the vlei, disappearing in places, which are often the points at which seasonal streams enter the vlei. The reed beds then increase in width again in the lower regions where the vlei narrows. There are no reeds in the channel connecting the vlei with the sea (Robertson, 1980).

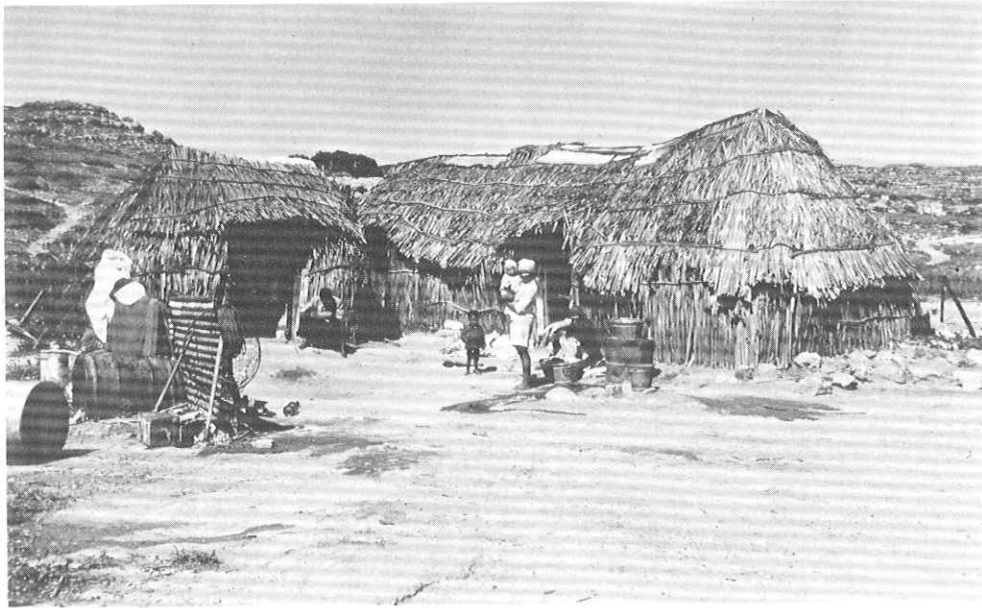
FIG. 25: Reed houses previously on southern shore of Verlorenvlei. (Photo: P D Morant, October 1976).

Reeds from the vlei were used in the construction of the 'langhuisse' surrounding the vlei and in the Verlorenvlei farm settlement (Sinclair, 1980a). They were used in ceiling construction, while *Juncus kraussii* clumps were inverted for use as capping material on the thatched roofs. Some examples of houses constructed entirely out of reeds by the Coloured population existed until fairly recently (Figure 25).

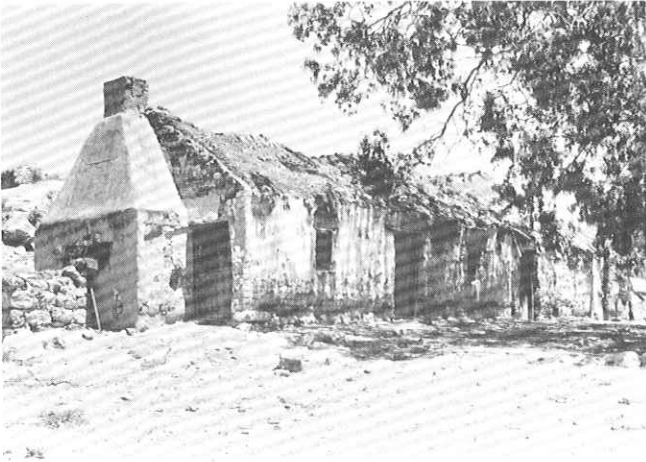
1a

Settlement house VV06B in November 1979. The house had been neither occupied nor maintained for some years. (Photo: S A Sinclair)

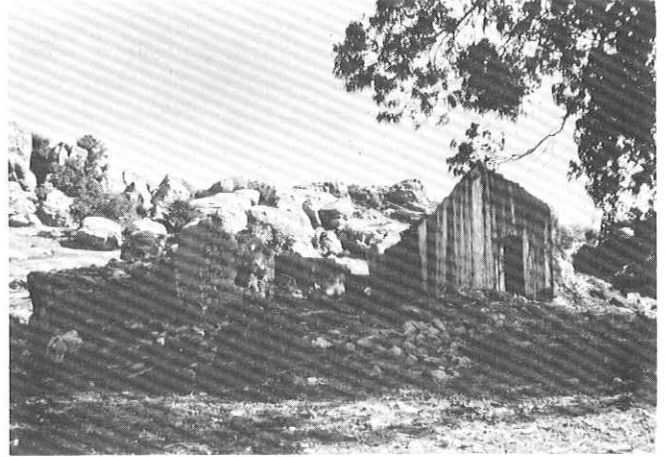
1b

Settlement house VV06B in August 1984, showing decaying effects of natural environmental factors such as wind, rain, birds, rodents, insects and plant growth. (Photo: S A Sinclair).

With regard to the historical, cultural and architectural resources, severe degradation has taken place in the period of delay (Figures 27 to 29). Similarly, the natural components of the system have been degraded during recent years, as shown by examination of a chronological series of aerial photographs and orthophoto maps of the area. A major source of concern is that the rate of degradation is increasing.

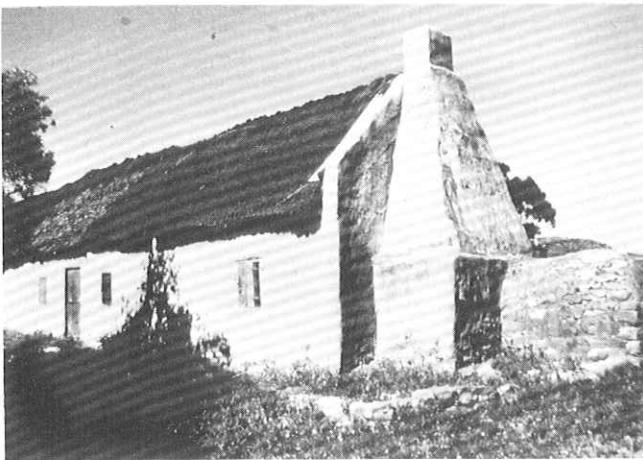
2a

Settlement house VV03M in 1972. Detailed drawings of the house were made by J Walton. (Photo: J Walton, Cape Archives).

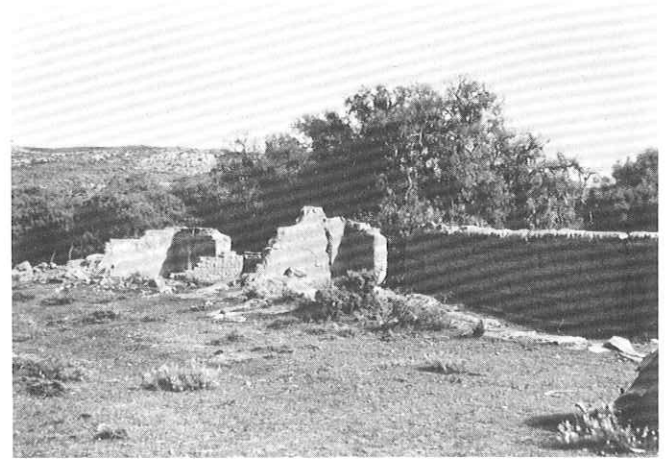
2b

Settlement house VV03M photographed in August 1984, after deliberate demolition some time previously. (Photo: S A Sinclair).
