In-situ Crack Repair by Laser Cladding

Abstract

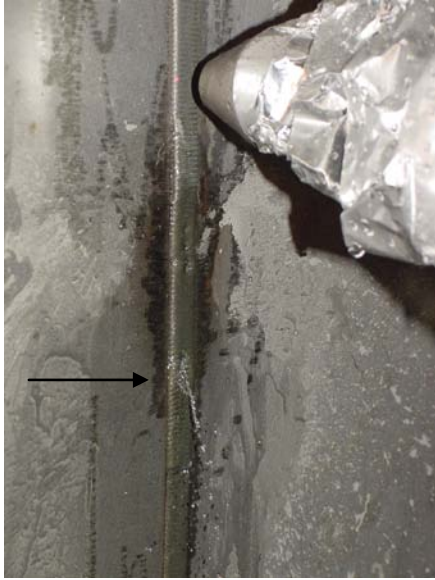
Figure 3: Crack sealing without peening prior to cladding.

The ability of laser cladding to seal leaking cracks is highly dependent on the simulated crack geometry. In some areas where water was squirting out strongly, cracks could be sealed in one pass. In other areas the water flow was too strong to cover the crack in a single pass. Cracks that could not be sealed after the first pass tend to create leaking pores which become even more difficult to seal in subsequent passes as shown in **Figure 3**.

These larger pores create a cavity in which water is trapped. Upon passing over the pore with the laser beam, rapid heating of the water takes place resulting in expanding steam which causes the formation of an even larger pore and is accompanied by expulsion of metal and subsequent cover slide damage.
