Characterization and quantification of preferential flow in fractured rock systems, using resistivity tomography

F May^{1,2}, D Mikeš¹, R Bugan², N Jovanovic² and A Rozanov¹

University of Stellenbosch¹ and Council for Scientific and Industrial Research (CSIR)²

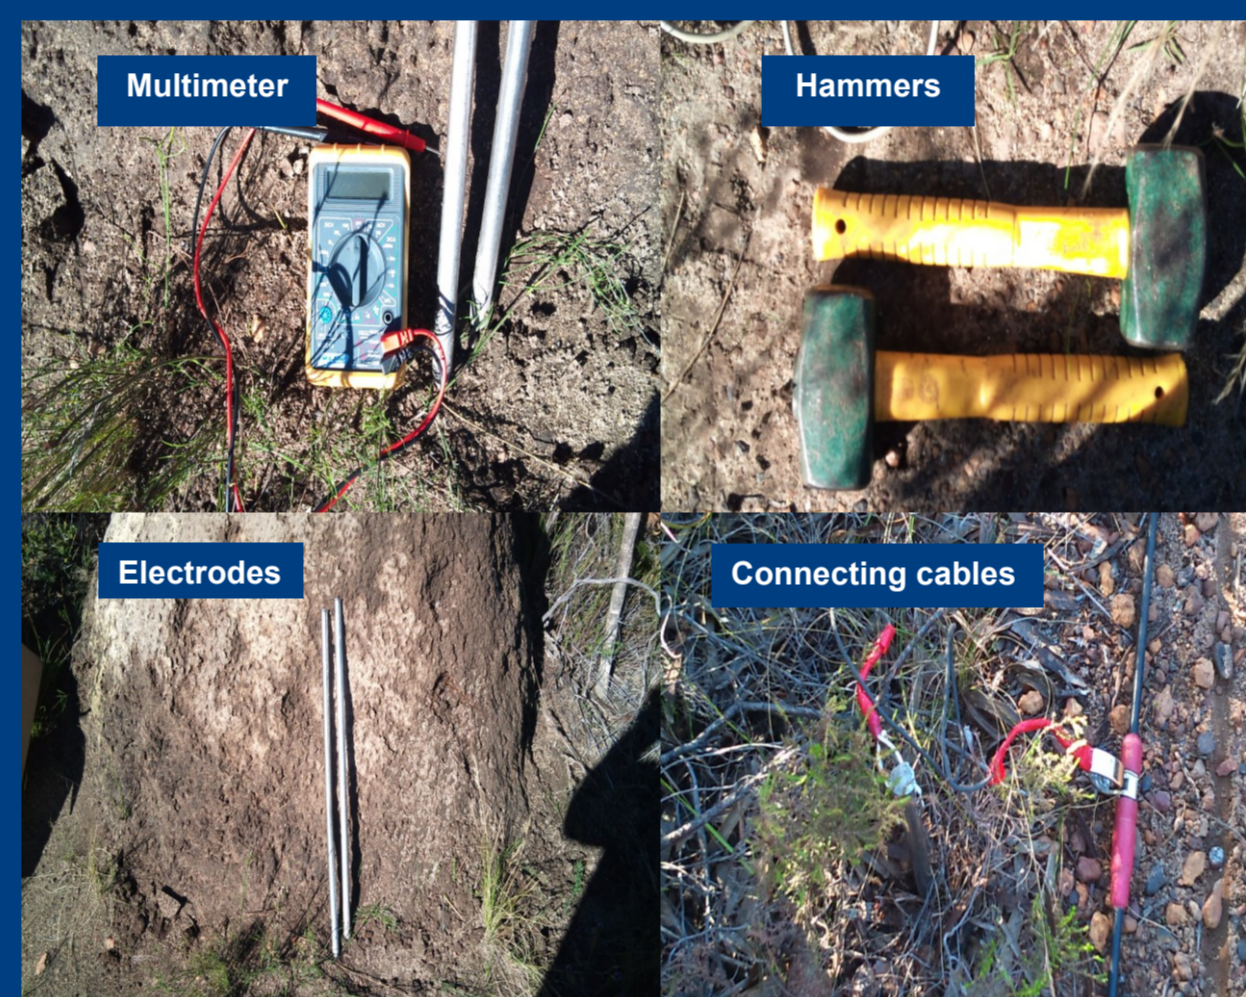
Figure 4

Equipment used for resistivity survey

The method used to acquire survey profiles is after Loke (2001). The standard Wenner Array (Loke, 2001) with 64 electrodes spaced two meters apart were used for the surveys.

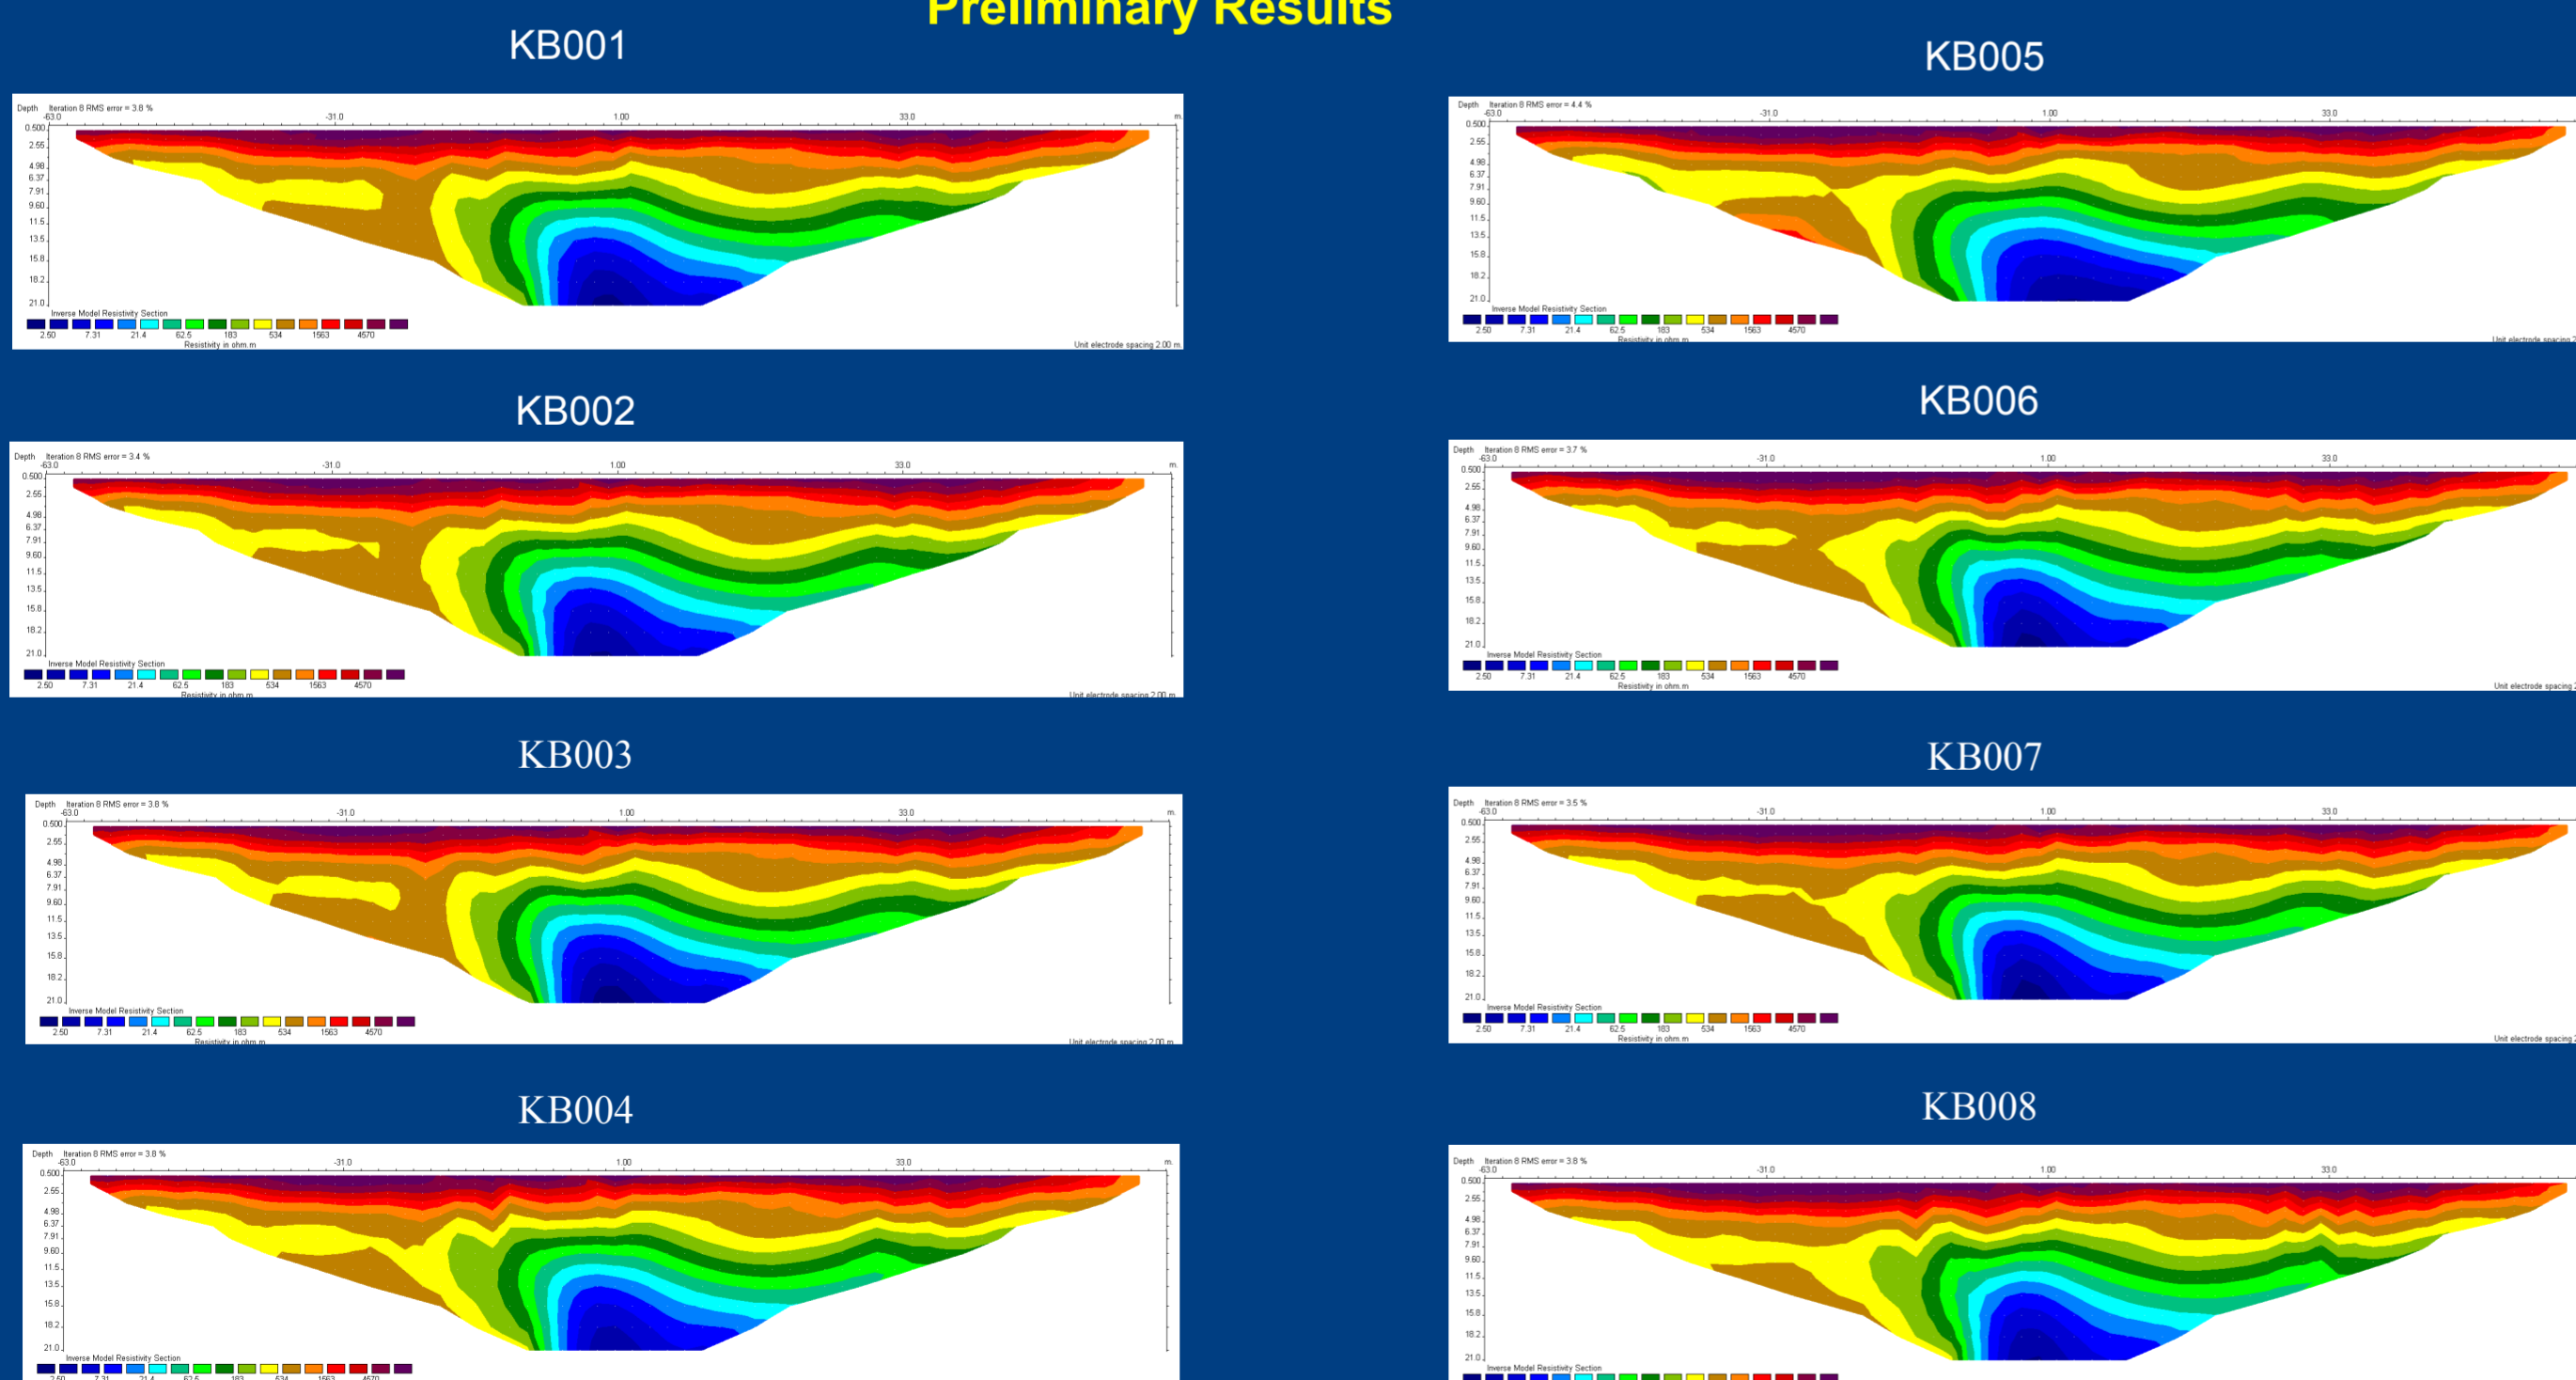
Figure 6

Resistivity images of transect taken from 27/08/2010 to 02/09/2010 see (Table 3)

In July and August 2010, rainfall was not very frequent, which resulted in fewer resistivity profiles being measured than planned. The results of the surveys completed in August and September 2010 are illustrated and discussed below. Resistivity images are shown in Figure 6. The images refer to measurements taken down to 21 m depth, in chronological order from 27/08/2010 to 02/09/2010. The measurements followed a substantial rainfall event that occurred on 21/08/2010 to 23/08/2010 (~40 mm). The measurement transect was on the North-facing slope. (Figure 1). The date, time and weather conditions for each survey are summarized in Table 3. Rainfall during the time of measurement was of a low intensity (a light drizzle).

The low resistivity (blue colour) visible in the images could be an indication of lithology or wetness (Figures 6). Slight variations in the images over time could be due to water flow and drainage. However, rainfall events were relatively small during the measuring period, the recorded variations in resistivity over time were very slight, and further data need to be collected, analyzed and interpreted to make definite conclusions on the applicability of resistivity tomography and time-lapse analysis.
