Key words: weak layers, interlayers, detection, pavement, stabilised

Weak interlayers in flexible and semi-flexible road pavements: Part 1

F Netterberg, M de Beer

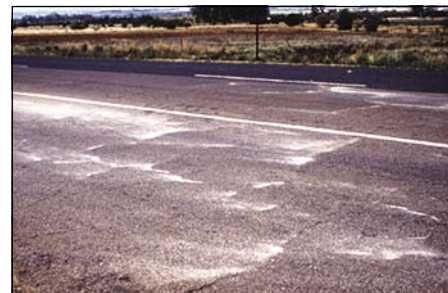
Photo 1 Pumping loose material from a cemented base/subbase pavement at Hornsnek, West of Pretoria during 1985

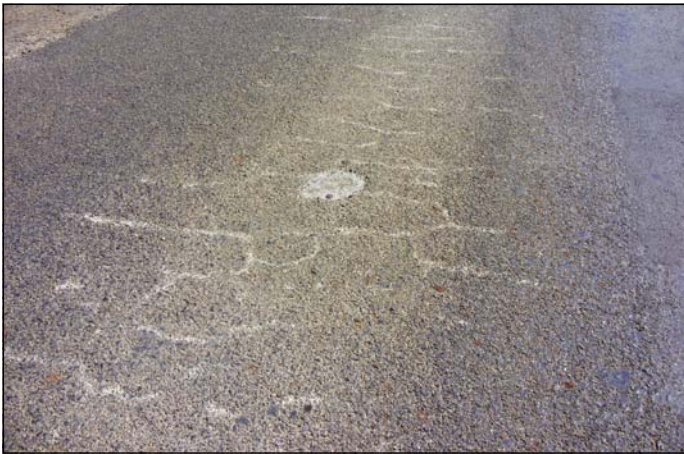
Photo 2 Fatigue cracking and pumping on a recently constructed main road – possible weak interlayer directly under the surfacing seal (courtesy of Dr P Paige-Green)

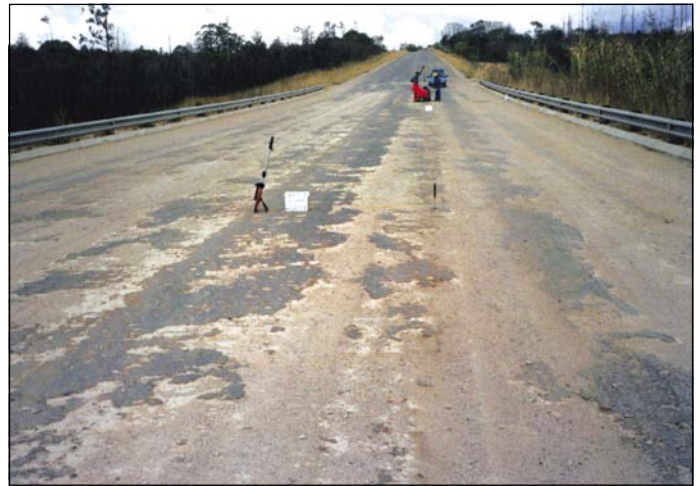
Photo 3 Loss of most of prime under light traffic on same road as in Photo 4

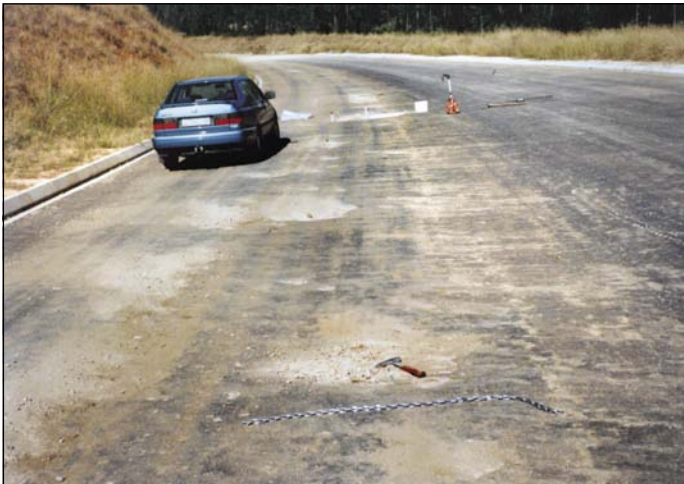
Photo 4 General view of weak, carbonated, primed 3% cement-stabilised weathered granite base disintegrating under light traffic and showing chain drag in foreground

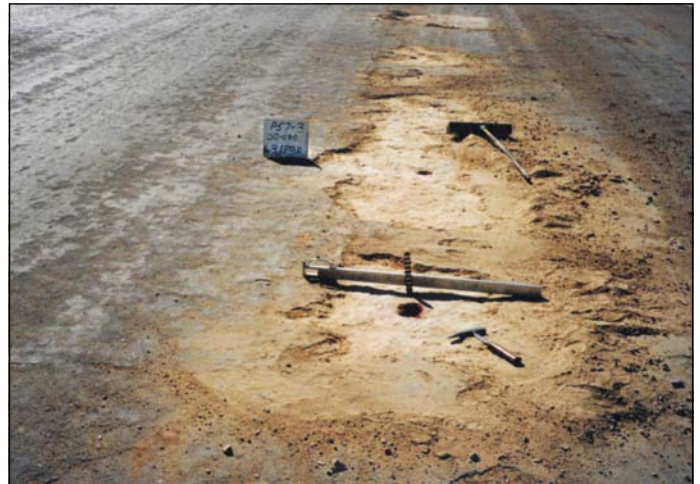
Photo 5 General view of primed, 3% cement-stabilised, weathered granite base after loose to weak upper 25 mm of carbonated material had been hand-broomed off

The failure mode assumed in this analysis is that of weakening and/or crushing of the weak layer on a relatively stronger sublayer (see Photos 5, 6, 10 and 11). The apparent anomaly in Figure 1, whereby increasing the strength of the under (sub) layer decreases the structural capacity, can be explained in terms of the structural pavement strength balance. In other words, it is easier to crack a nut by placing it on a harder surface.

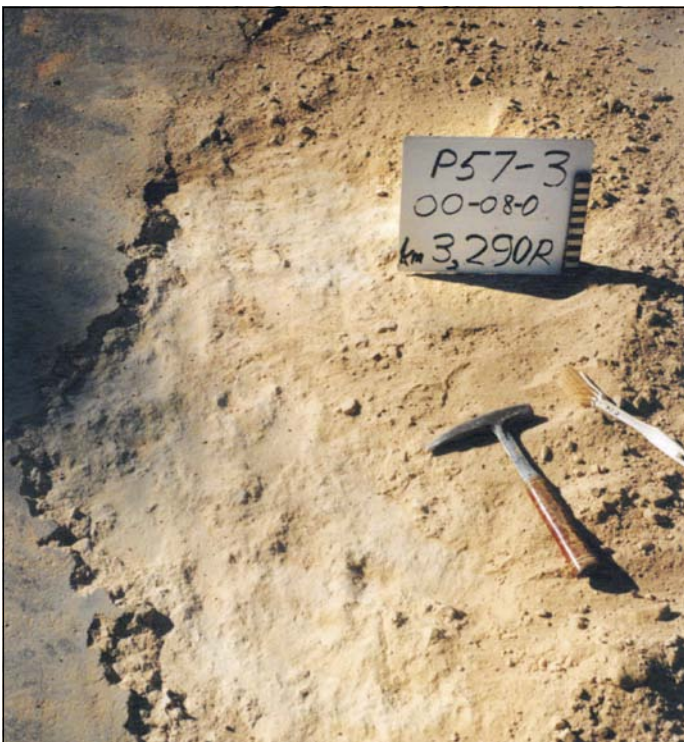
Photo 6 Close-up of Photo 5 showing exposed harder base after loose to weak upper 25 mm of carbonated base had been hand-broomed off

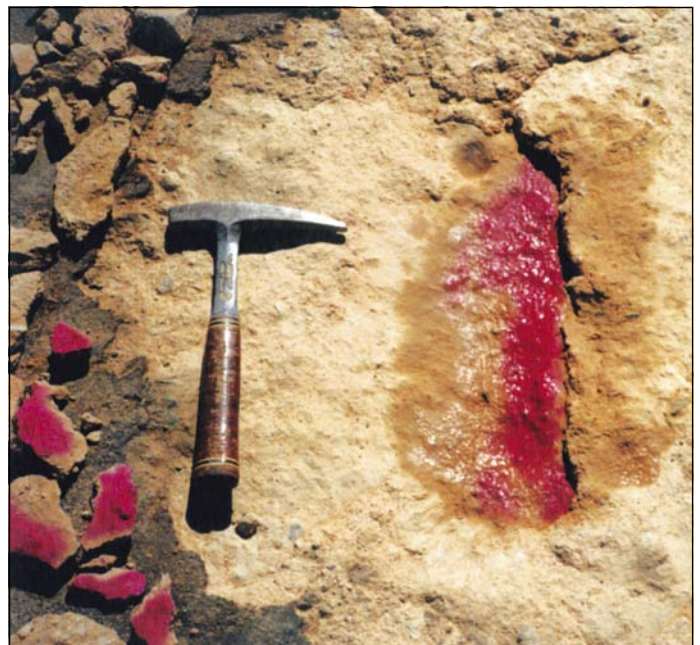
Photo 7 Roller-induced shear plane dipping to right with overturned shear "biscuits" (uncarbonated on lower surface) lying at left. Loose to very weak (could be broomed or easily scratched off) to 20 mm, and carbonated and weak to 40 mm below top of primed, 3% cement-stabilised, weathered granite base. Detected by chain drag

- Sulphate attack on chemically stabilised material
- Detrimental carbonation of chemically stabilised material (common in southern Africa) from top and bottom of cemented layer (Sampson *et al* 1987; Netterberg 1991) (see e.g. Photos 7, 8, 10 and 15 with associated failures)

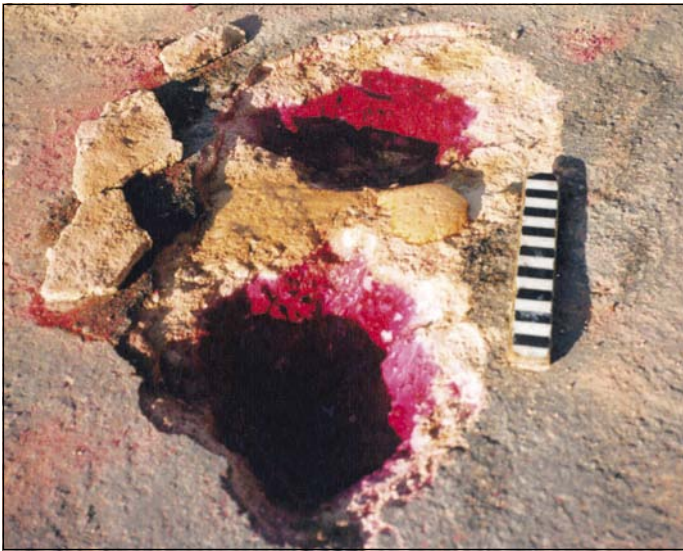
Photo 8 A 7 mm thick "biscuit" on compaction plane, and carbonated and weaker to 15 mm below top of primed, 3% cement-stabilised, weathered granite. Detected by chain drag

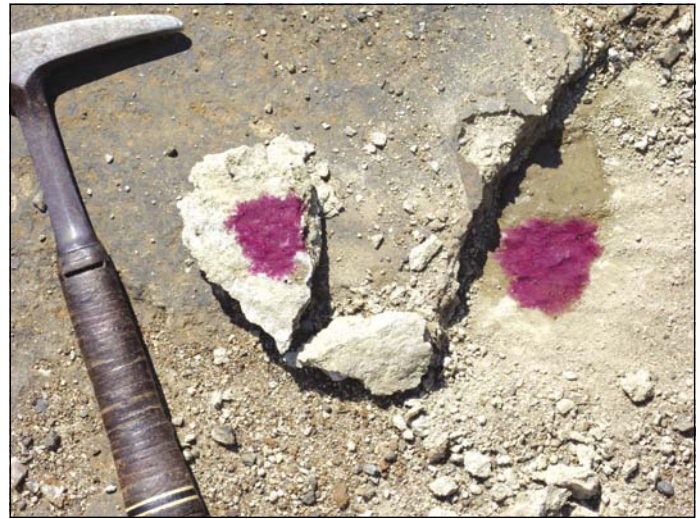
Photo 9 Phenolphthalein tests on a lamination (~ 30 mm) in a recycled cementitious base layer. Most probably the cause of failure in Photo 6. No signs of deleterious carbonation (courtesy of Dr P Paige-Green)

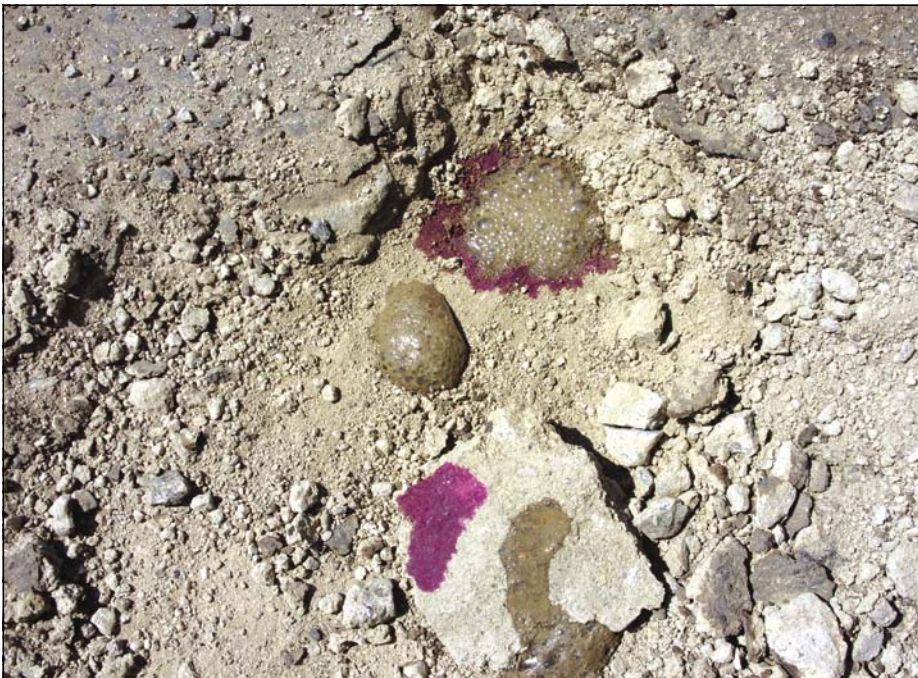
Photo 10 Upper base pavement layer (from Photo 2) showing signs of crushing breakdown and deterioration in the top 30 to 50 mm, with and without signs of deleterious carbonation (courtesy of Dr P Paige-Green)

In terms of consistency, such interlayers may be loose, i.e. with no unconfined compressive strength (UCS), and at a relatively lower density, be relatively weak, i.e. with a reduced UCS, or relatively soft (moist and/or plastic) (see Photos 10, 11, 12, 13 and 15).

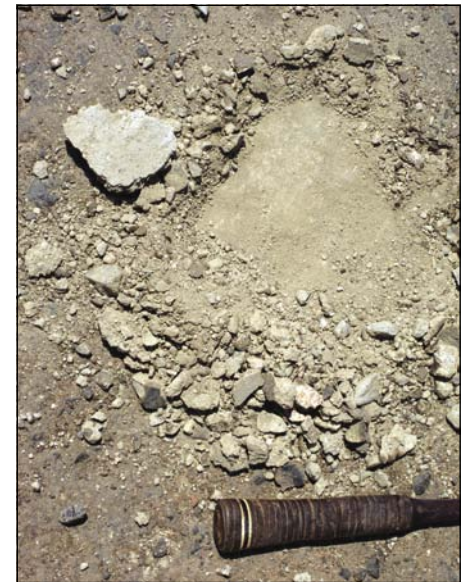
Photo 11 Full crushing/deterioration/breakdown of the upper 30 to 50 mm of the recycled base layer from Photos 2, 9 and 10. Note lamination at bottom of shallow hole (courtesy of Dr P Paige-Green)

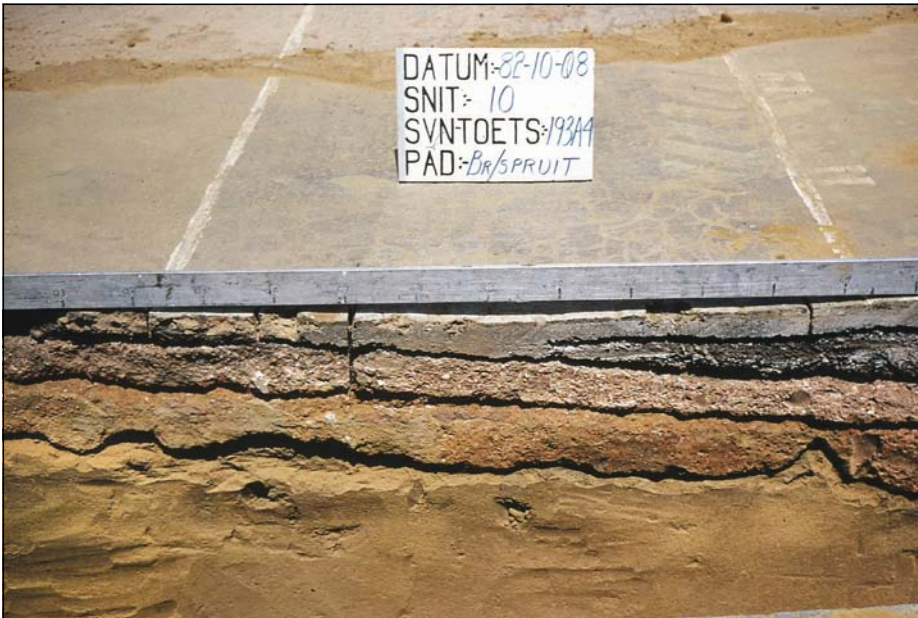
Photo 12 Close-up of Road P95/1 showing poor layerwork construction on one of the HVS test sections. The design requirement was for a 100 mm strongly cemented base – second layer towards the left of the photo

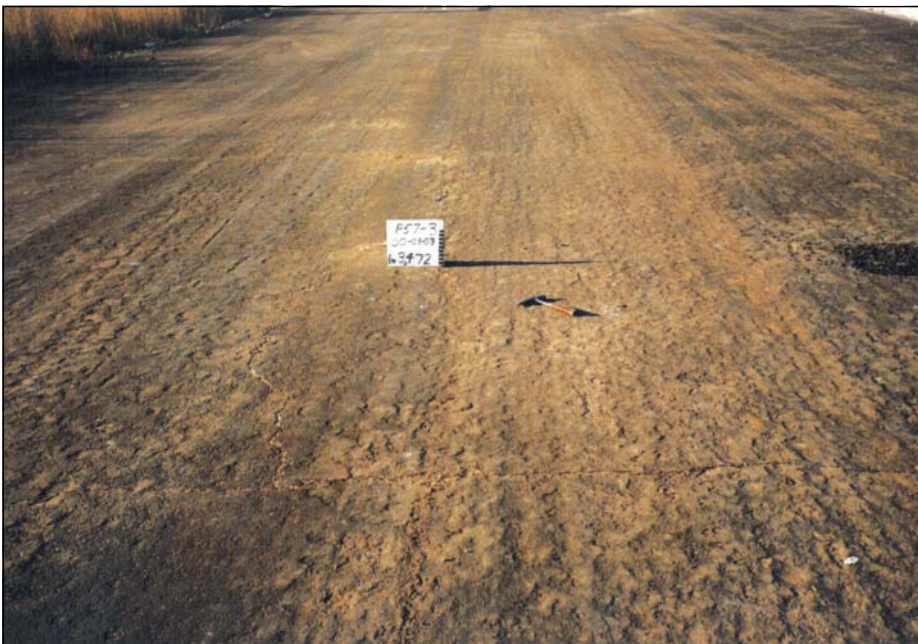
Photo 14 Uneven surface due to use of grid and padfoot rollers too high in base: in addition to undesirable roughness, grid mounds tend to be sheared, and peel and padfoot marks lead to poor bonding and tend to reflect through seal

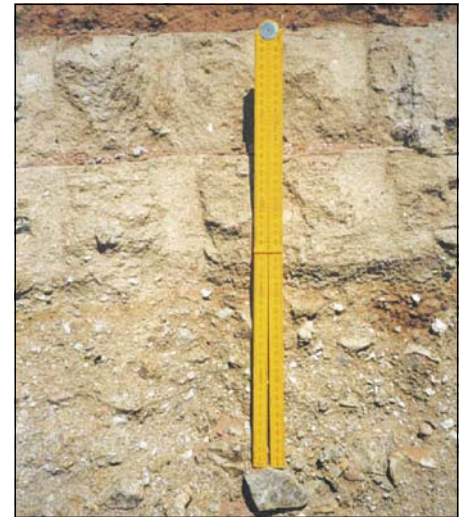
Photo 13 Road layerworks on an excavation. Note some interlayers between 2nd and 3rd layers, as well as between 3rd and 4th layers

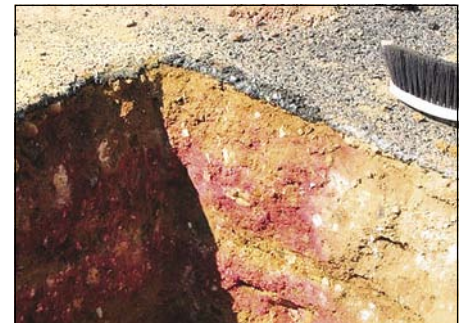
Photo 15 Signs of deleterious carbonation in a cementitious base and subbase pavement (non-pink areas to the right of test pit) (courtesy of Dr P Paige-Green)

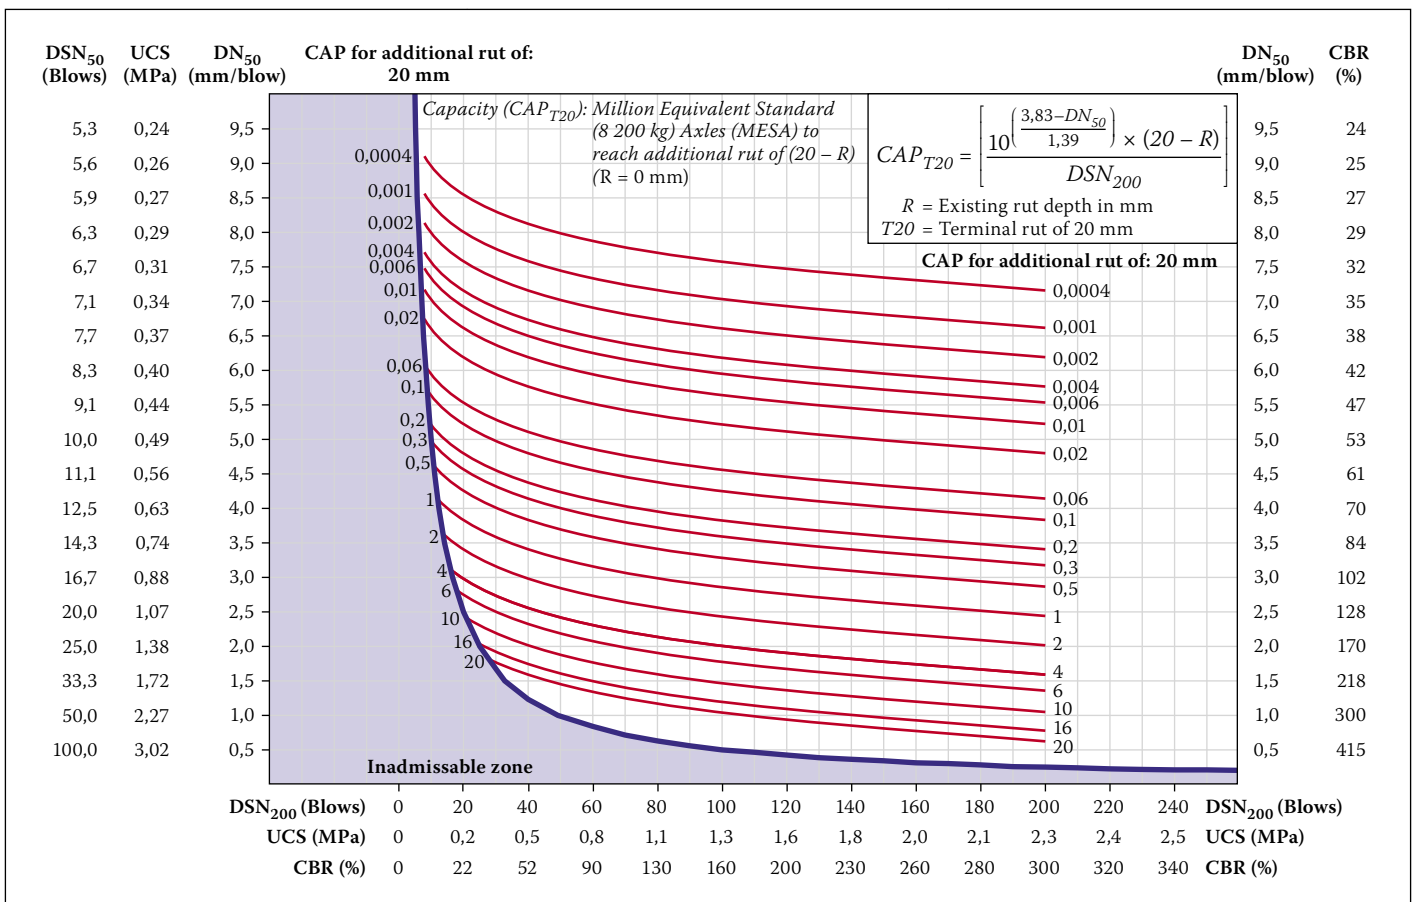
Figure 1 Nomogram for the estimation of the structural capacity of weakly cemented pavements (modified from De Beer 1989b, 1990) (Note that the UCS en CBR figures are the exact equivalents derived from the DN according to CSIR 2007 and would be rounded off in normal practice)

(if the above model is extrapolated beyond DN_{50} of 4,0 mm/blow), relatively low structural capacities (MESA) are indeed indicated, which carry some engineering value. For this reason Figure 1 is extrapolated beyond $DN_{50} = 4,0$ mm/blow.

Table 1 Calculated effect of a weak upper base on the structural capacity of a lightly cemented pavement in comparison with a pavement of uniform strength (also see Figure 1, with R = 0)
