## **Electroluminescence Imaging of Photovoltaic Modules**

**M.T Malefafana<sup>1,2</sup>, L. Pratt<sup>2,\*</sup>, M. Basappa Ayanna<sup>2</sup>, K. Roro<sup>2</sup>**  
**<sup>1</sup>Tshwane University of Technology, Department of Physics,  
Pretoria, South Africa**  
**<sup>2</sup>Council for Scientific and Industrial Research (CSIR), South  
Africa**

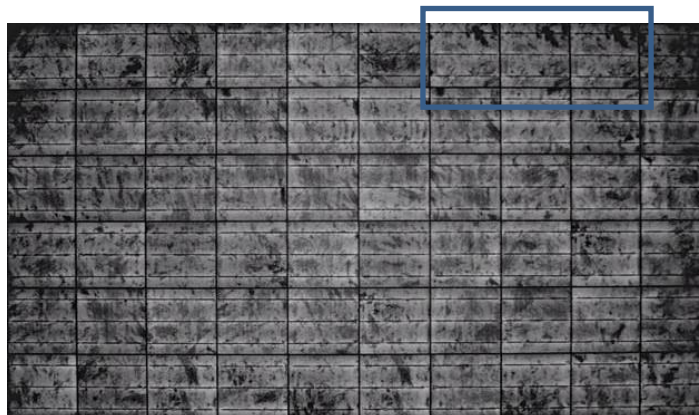
Several EL images are presented below to highlight some of the normal features that can be “seen” with a standard EL image of various PV technologies. Figure 4.1 shows a typical multi-crystalline wafer based PV module (internal CSIR ID = 18000-28). This module consists of 60 square cells interconnected with three ribbons, which can also be deduced from an optical image. The EL image also shows the grain boundaries caused by different crystal orientations that evolve from the ingot production and from this image, one can deduce that some cells in this module were made from wafers cut from the same block of silicon. For example, the three cells highlighted in Figure 4.1 were likely cut from the same block because they show the same grain boundary pattern as one another. Grain boundaries can sometimes be seen with the naked eye, but the anti-reflective coatings on the cells can make them difficult to distinguish. There

are other examples of matching wafers in the image below, and sometimes the match can only be made by flipping or rotating one cell or the other.

Figure 4.1 EL image of multi-crystalline module with square cells, grain boundaries and three interconnect ribbons.
