# Design and Construction of Sustainable Climate Resilient Rural Access Road Infrastructures

Julius Joseph Komba, Raquel Langa, Phil Paige-Green, Benoit Verhaeghe and Refiloe Mokoena

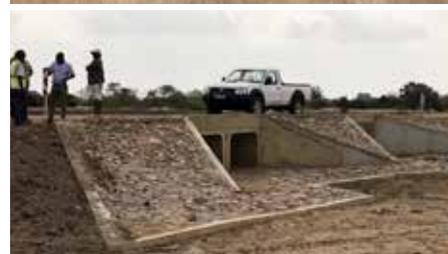
**Figure 15 Before and after construction pictures of the demonstration sections.**

Overall, most of the construction activities had been completed satisfactory. Figure 15 shows the before and after construction pictures. The following observation and recommendations were made:

Sand was found to have accumulated at the inlet and outlet of the culverts at km 43 as a result of rainfall, necessitating routine inspection and cleaning. Furthermore, side embankments appeared to have been damaged by rain due to inadequate compaction, and required some improvements, and

Some drying cracks were observed on the newly constructed gravel wearing course at km 51. The progression of the cracks should be closely monitored during the planned long term performance monitoring.
