## AUTOMOTIVE COMPONENT FAILURES

A. M. HEYES

Advanced Engineering and Testing Services, CSIR, Private Bag X28, Auckland Park 2006,  
Republic of South Africa.

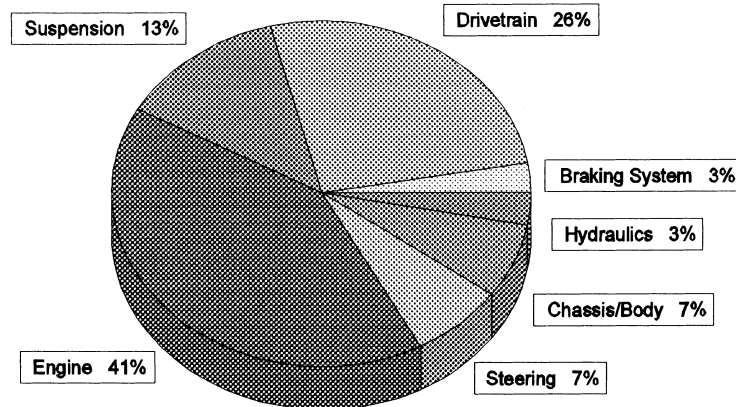
Based on an analysis of seventy automotive component failures received for investigation the distribution of component failure and the distribution of causes are given in Figs 1 and 2 respectively. From this it can be seen that the most common component failure is that of the engine (41%) and that the most common cause of failure is abuse (29%). However, the total contribution to the cause of failure of manufacturing or design errors, raw material defects and or storage procedures is 33%. It can also be argued that as cars are being kept longer, partly due to economic pressures and partly due to improvements in chassis technology, the other components should be designed for a longer lifetime. The inclusion of age related failures as a manufacturing responsibility increases this figure to 43%. This represents a significant area for improvement on the part of the manufacturers. By the same token, the high proportion of failures due to failed repairs (18%) represents an area where increased training in the reconditioning and refurbishing industry may yield significant dividends.

Fig. 1. The distribution of component failures.

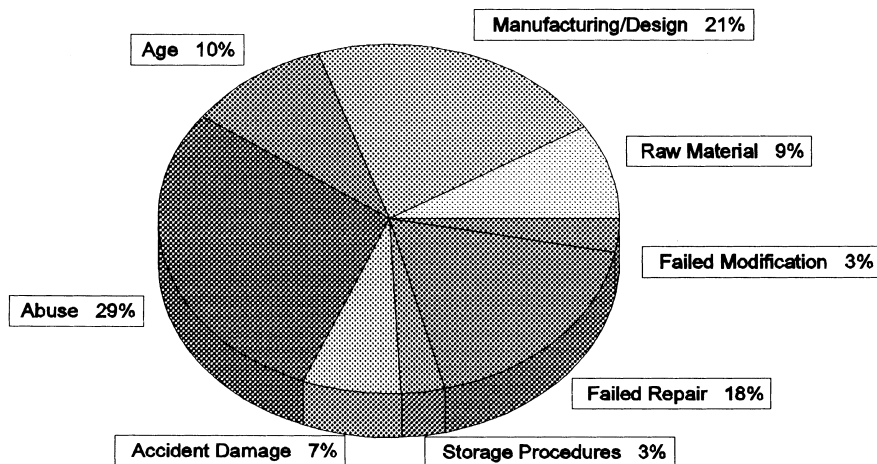
Fig. 2. The distribution of causes of failure.
