FAILURES OF CHAIN SYSTEMS

ALAN JAMES

Abstract—Chains are used for various purposes in a wide range of industries. This paper describes three case studies where a failure analysis was carried out on chains used in markedly different applications. The failure mechanisms emphasize the importance of operating the equipment within the original design parameters, and also that material integrity is fundamental to the operational life of a system. © 1997 Elsevier Science Ltd. All rights reserved.

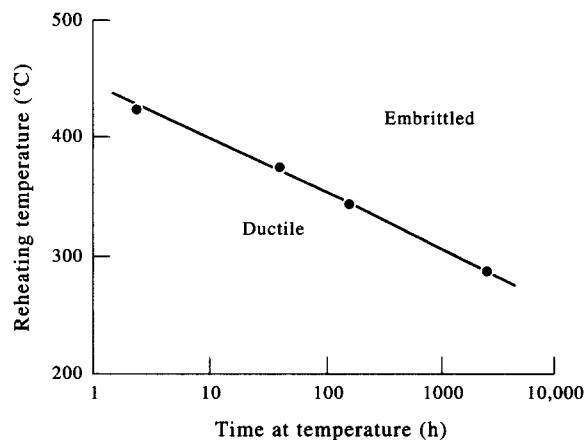
Unlike structural steels, which become softer and more ductile when reheated in service, manganese steels become brittle when reheated sufficiently to induce carbide precipitation or some transformation of the austenite. Generally, manganese steels should not be heated above 260 °C unless such heating is followed by re-solution annealing and water quenching. Embrittlement is time-, temperature- and composition-dependent, as shown in Fig. 8. At 260 °C, transformation requires more than 10,000 h exposure, whereas at 350 °C the exposure period is little more than 100 h. The effect of manganese and carbon content on the embrittlement of manganese steels is illustrated in Fig. 9. Higher nominal manganese and lower carbon contents are more desirable for steels subjected to “high” operating temperatures.

Fig. 8. Time-temperature relationship for the embrittlement of a 13% Mn-1.2% C-0.5% Si steel (courtesy of ASM).

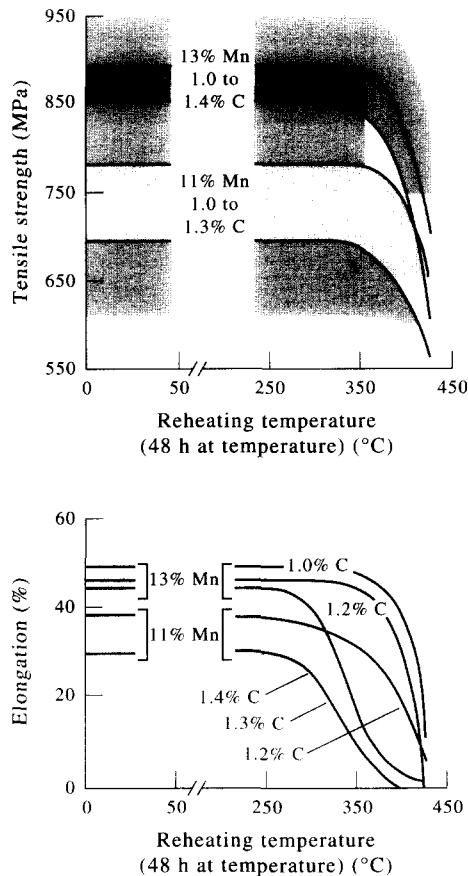
The ASTM A128 Grade C austenitic manganese steel is ideal for wear resistance but should not be used above 260 °C. For slightly higher operating temperatures, molybdenum-bearing steels are

Fig. 9. Embrittlement from reheating manganese steels (courtesy of ASM).

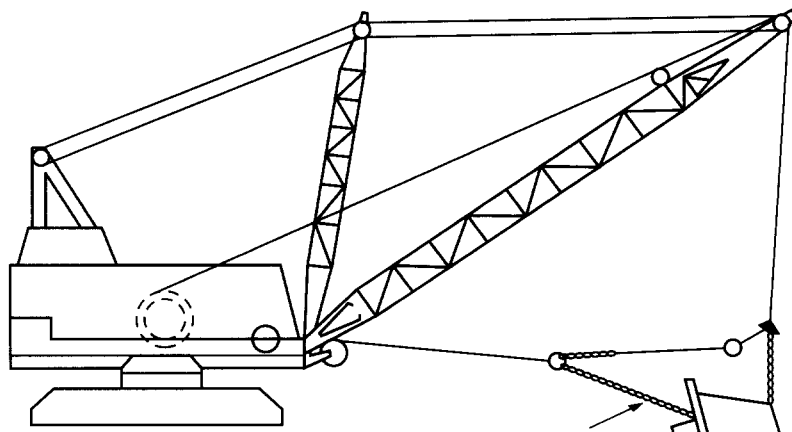
This case study describes the failure analysis of a link from a drag-chain. Drag-chains are used as linkages at the buckets of dragline cranes (Fig. 13). Due to the nature of their use, the chains have to be very robust. Refurbishment repairs of chain links are common. The links are normally cast in sets of four or six, and are subsequently joined to form the chain.

Fig. 13. Schematic diagram of a dragline crane showing the position of the drag-chain (arrowed).
