CHAMBER OF MINES OF SOUTH AFRICA
RESEARCH ORGANIZATION

CAUSES OF FALLS OF HANGINGWALL OVER GULLIES ADJACENT
TO STABILIZING STRIKE PILLARS

P.A. TURNER

RESEARCH REPORT NO. 37/87 (Amended)
PROJECT NO. GR2P
AUGUST 1987

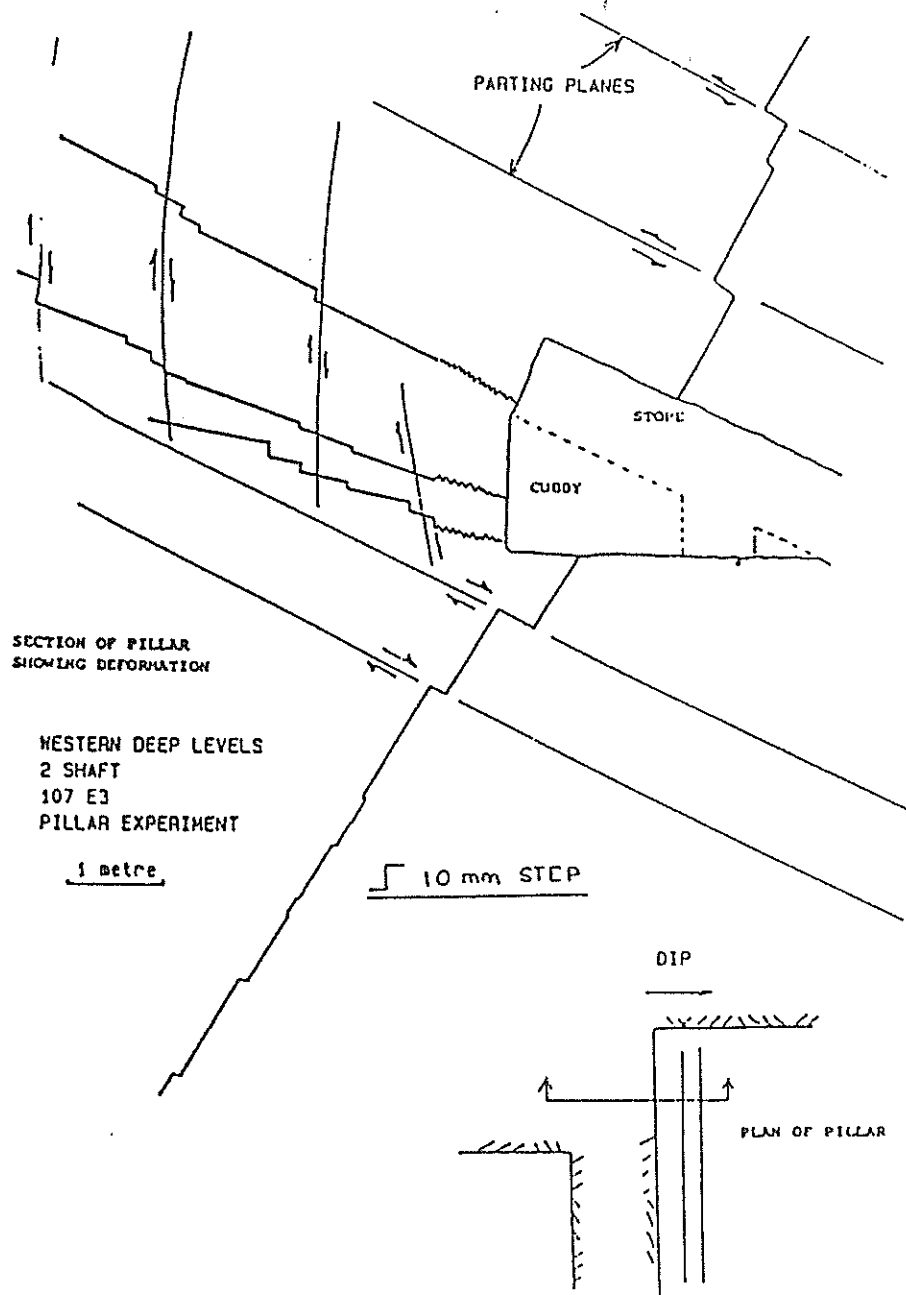
Figure 11 DISPLACEMENTS (STEPS) MEASURED IN BOREHOLES ADJACENT TO A PILLAR (AFTER BRUMMER 1984)

It has been found that in 20 m-wide strike pillars, fracturing with a strike-parallel orientation extends right through the pillars (Hagan and Grobbelaar, 1984). Furthermore it has been found that these pillars deform and displace the rock adjacent to them towards the stope (Figure 11, Brummer, 1984). It was found from measurement of displacements across steps in a borehole, drilled into the hangingwall next to a strike abutment,

that relative to the rock 4 m above the stope, the immediate stope hangingwall moved 25 mm toward the stoped area while the stope face advanced 20 m. As the boreholes were drilled about 20 m behind the stope face, it is probable that a similar amount of movement had already taken place prior to drilling, i.e. about 50 mm by the time the face had moved 40 m.

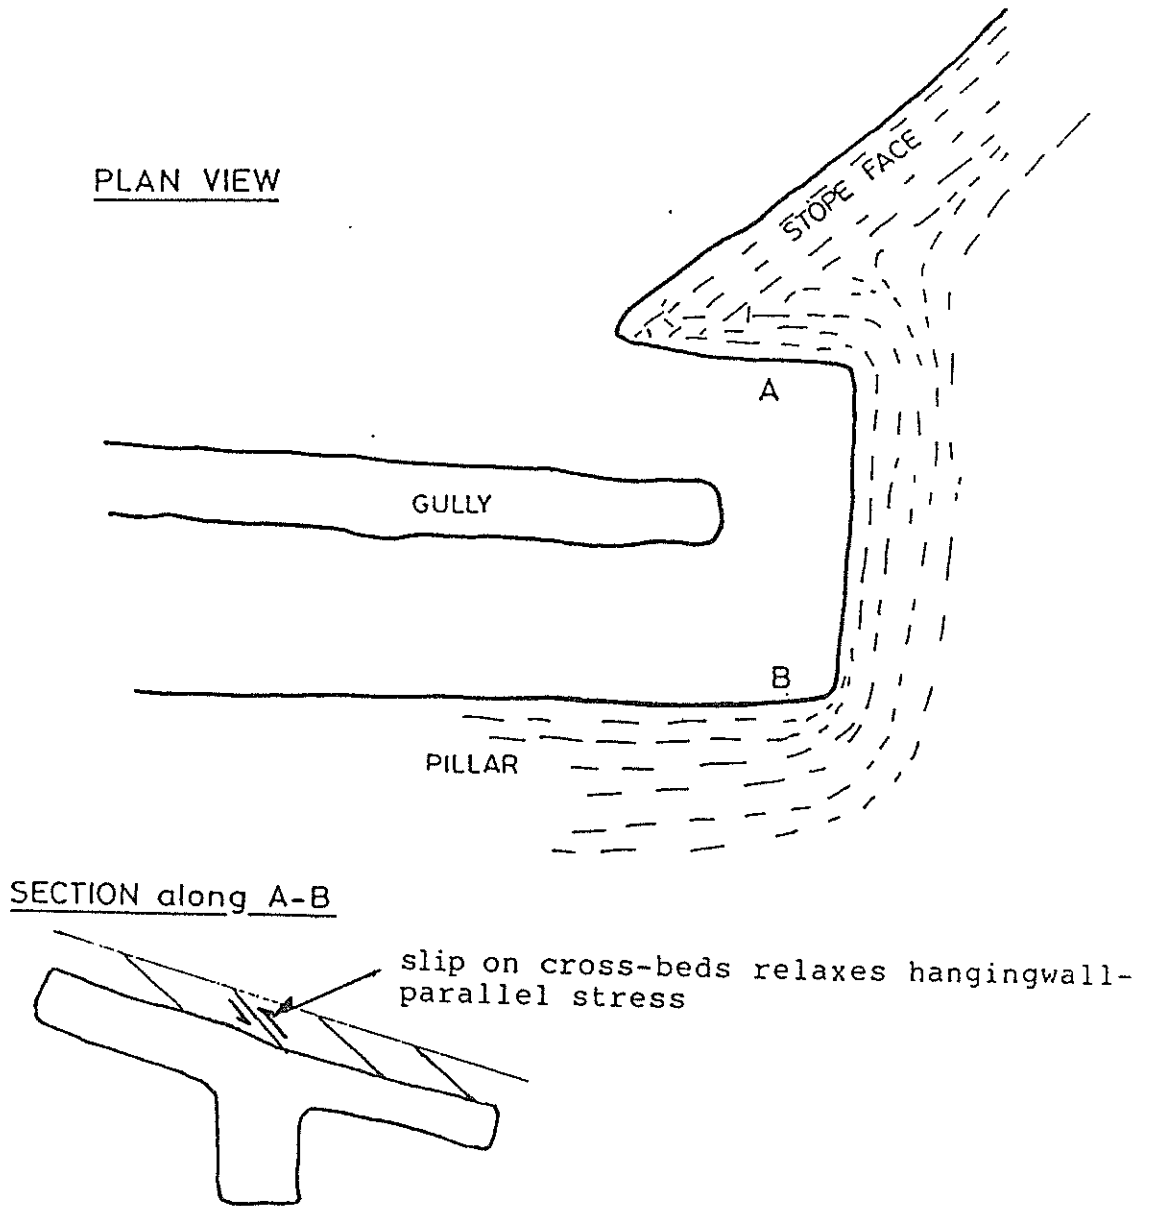
Figure 17 THE CONFIGURATION OF A WIDE ADVANCED HEADING AND A STRONGLY UNDERHAND FACE AS USED AT FRPM

This mining configuration (Figure 17) is used on ERPM where hangingwall-parallel fracture is not developed. This absence of fracturing may not be due entirely to the presence of cross-bed parting planes in the hangingwall. MINSIM analysis shows that the horizontal stresses in the hangingwall are higher (by a factor of about 2 or 3) with this wide-advance-heading geometry than with the heading geometry used in the Carletonville area (Figure 12). However this analysis assumes elastic behaviour. The fracturing ahead of the underhand face may modify the stresses significantly. The matter needs further investigation before this configuration can be tried on Western Deep Levels or Blyvooruitzicht.

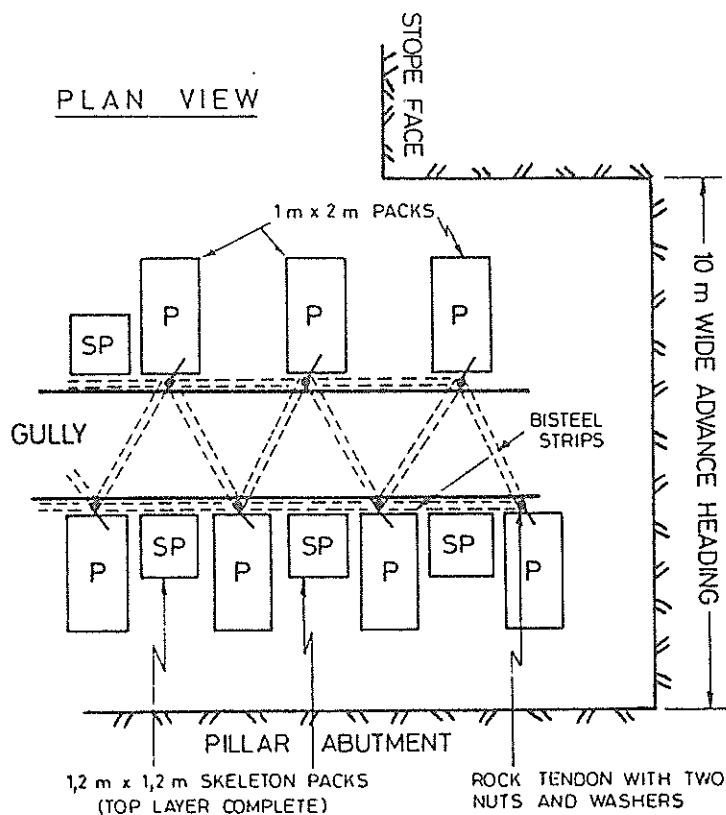
Figure 18a PACKS ALONG SIDES OF GULLY + GROUTED REINFORCING BAR WITH THREAD. BISTEEL STRIPS IN TRIANGULAR CONFIGURATION. SKELETON PACKS BETWEEN STANDARD PACKS HAVE COMPLETELY TIMBERED TOP LAYER

1. Cost (moderate)
2. If gully very full of rock scraper might snag on bisteel

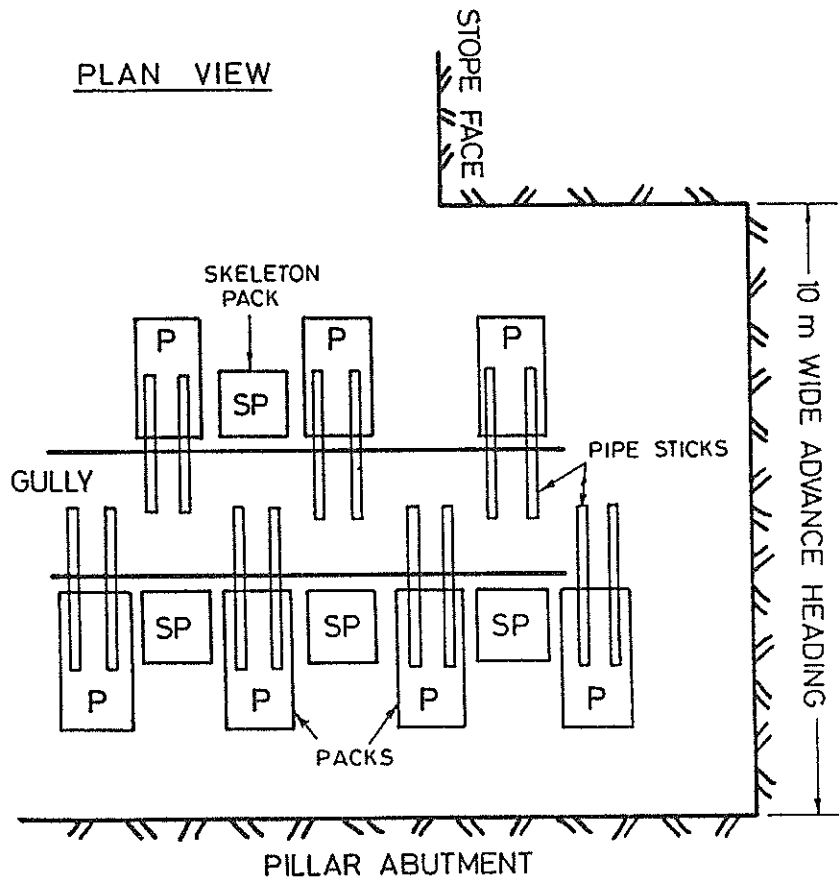
Figure 18b PIPE STICKS, BUILT INTO TOP LAYER OF ELONGATE PACKS, EXTEND OUT OVER GULLY. SKELETON PACKS BETWEEN STANDARD PACKS HAVE COMPLETELY TIMBERED TOP LAYER

1. Cost of pipe sticks
2. Pipe sticks to not cross face-parallel rock beams
3. If gully very full scraper may snag on pipe sticks especially after stope closure

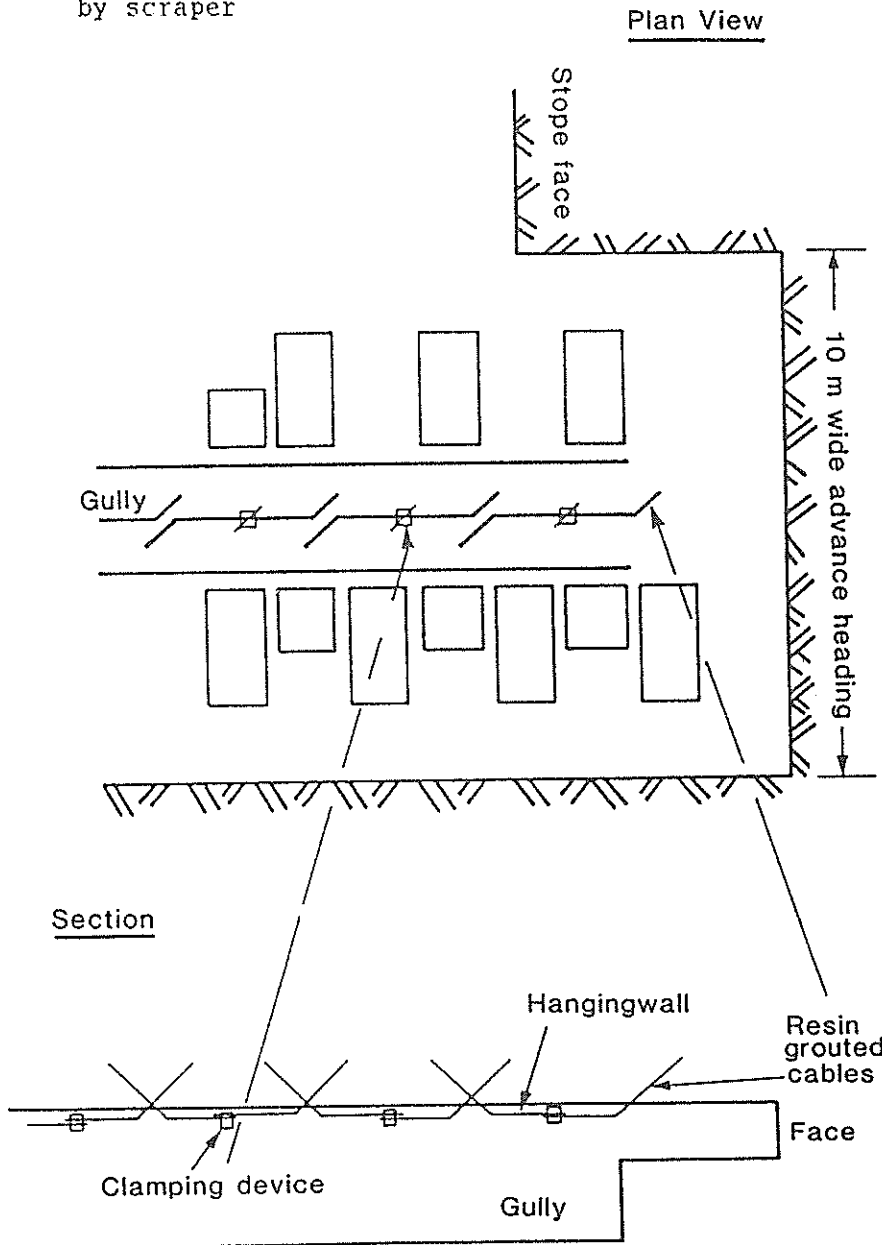
Figure 18c RESIN GROUTED CABLES TENSIONED TO 15 TONS AND CLAMPED. SKELETON PACKS WITH COMPLETELY TIMBERED TOP LAYER BETWEEN STANDARD PACKS

1. Cable does not present very strong initial resistance to downward movement of hangingwall

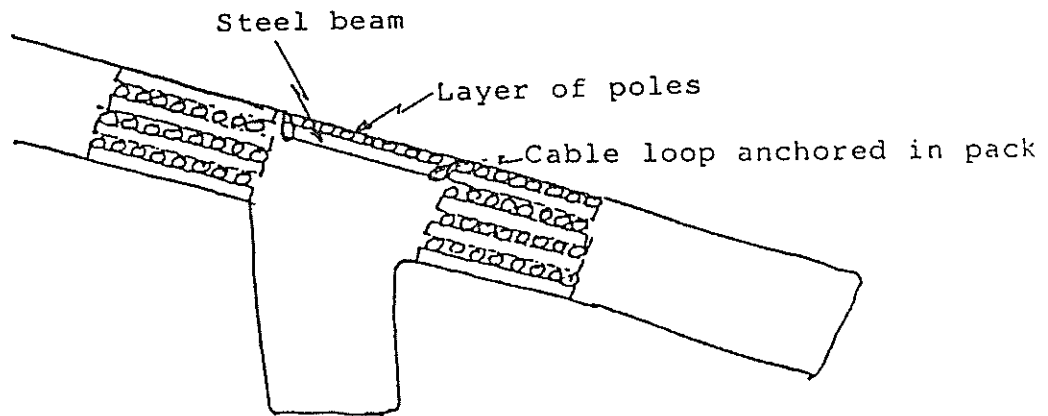
Figure 18d CABLE LOOPS ANCHORED INTO PACK SUPPORT TWO STEEL BEAMS ON WHICH A LAYER OF POLES IS PLACED

1. High cost of steel beam
2. Scraper may snag steel beam if gully very full, especially after stope closure

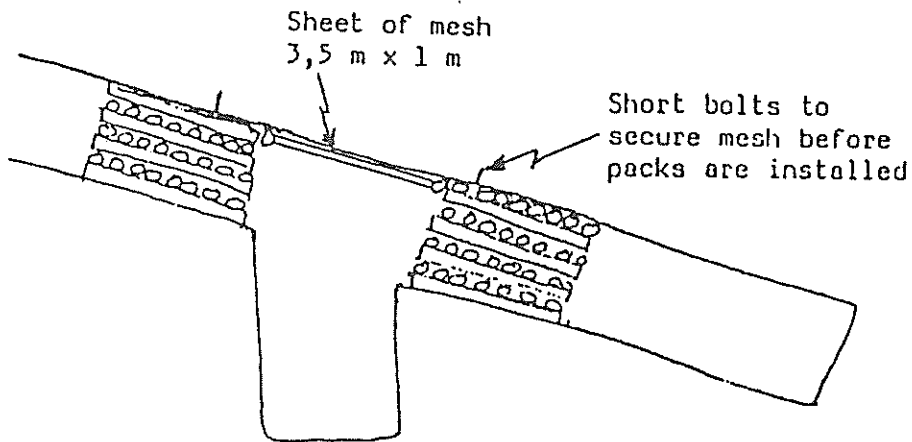
Figure 18e WIRE MESH STRIPS BRIDGING BETWEEN PACKS (POSSIBLY ASSISTED BY DIAGONAL STEEL BEAM SUSPENDED FROM CABLE LOOPS AT OPPOSITE CORNERS OF PACKS, SO AS TO CROSS GREATEST NUMBER OF FACE-PARALLEL HANGINGWALL SLABS)

1. Scraper could snag mesh and beams if gully very full especially after stope closure
2. High cost of steel beam and mesh
