# THE EFFECT OF CURING CONDITIONS ON BONDED REPAIR WITH BORON/EPOXY COMPOSITE PATCH OF AIRCRAFT SKIN

The purpose of this research is to define the influence of the curing time and temperature on bonded repair structures, by bonding the boron patch composite to the Aluminium 7075-T6 with the use of Structural Adhesive Film FM73K for lower residual stresses by analysis the distortion due the bending curvature. A bending behaviour is observed at the bond area of samples were made for a study of Fatigue crack growth in bonded repair of damaged aircraft structure. [2] Analysis on metallic aircraft structures development and qualification aspect, indicated secondary bending structures curvature from both single side and double side doubler in the repair area did influence the behaviour; they recommended that would require detailed investigation. One way of minimising the level of residual stress is to cure the repair at the lowest possible temperature. FM-73K is a fracture toughened adhesive used for bonded repairs that are typically cured at 120°C for 1 hour [3]. However, during the curing process, adhesively bonded composite/metal laminate structures that are held at elevated temperat

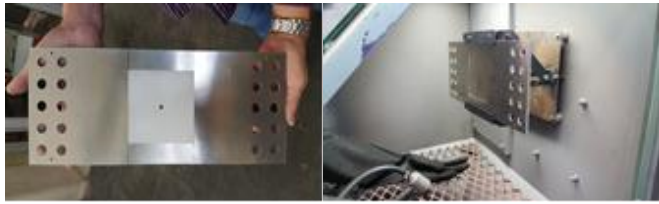
Fig.2 Surface preparation with sand blasting method

An important factor influencing the strength of the bonded joint is the surface preparation of the metal. In order to prepare the bonded area, the metal surface was subjected to mechanical abrasion (sandblasting) with

uniform grit blasting of the repair surface area as shown in Fig.2. The process employed 210µm alumina grit at a pressure of 300kPa and a working distance of 10 to 15cm to ensure the surface roughness without inducing compressive stresses. Trichloroethylene was used for cleaning to remove impurities and to avoid any oxidation.

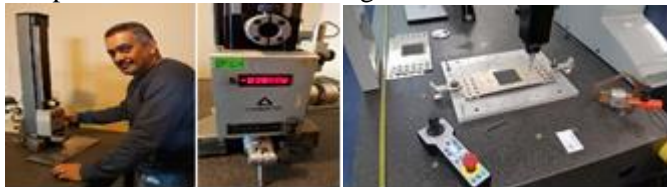
Fig.4 Thickness measurement with electronic height gage and distortion measurement with CMM

The thickness and distortion due to bending of the samples before and after curing was measured.

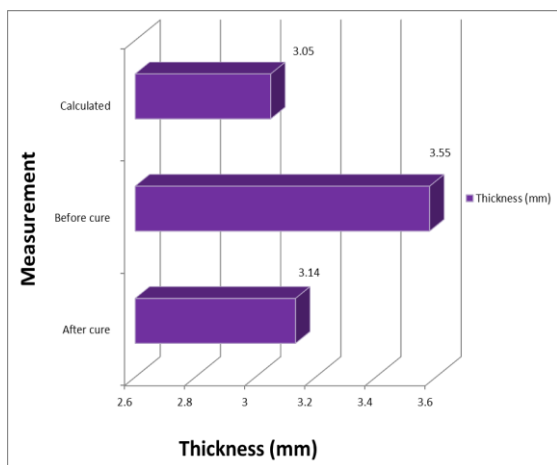
Fig. 7 Summary of the measured thicknesses

There was little variation in the cured laminate thickness across the samples with different curing condition; however the thickness was reduced by 11 percent from

the uncured samples to the cured ones, as shown in Fig.4. Results in Fig.5 indicate that samples prepared at 80°C for 8 hours (condition 3) had less bending curvature in comparison with other cycles but these may have reduced bond properties due to the lower temperature. Elevating the curing temperature may enhance the bonding between the metal surface and the composite patch, but this may also increase the residual stresses (condition 2). The prolonged curing time for this condition may ensure higher homogeneity but also more distortion, which results in higher stresses in the bond area. The combined cycle (condition4), can help reduce the distortion and thereby reduce the residual stresses without compromising on bond adhesion.

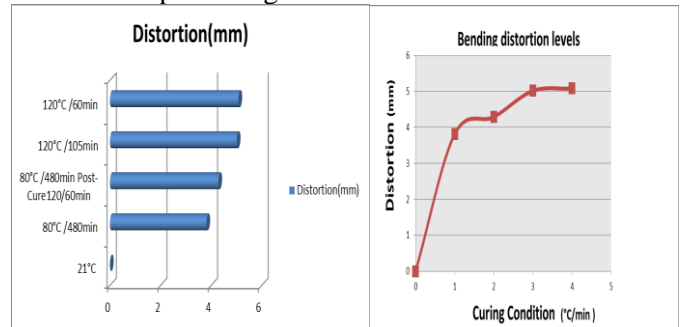
Fig.5 Distortion variation of bonded repair samples in different curing conditions

The understanding gained from this work suggests that the best process to minimise the curvature is the combined cure condition (condition number 4), which may enable increased durability at the lower temperature cure. This will form the basis of future work.
