Final Project Report

Safe mining face advance and support installation practice in mechanical miner workings under different geotechnical conditions

I Canbulat and JN van der Merwe

Research agency : CSIR : Division of Mining Technology
Project Number : COL 609
Date : March 2000
Report No : 2000-0154

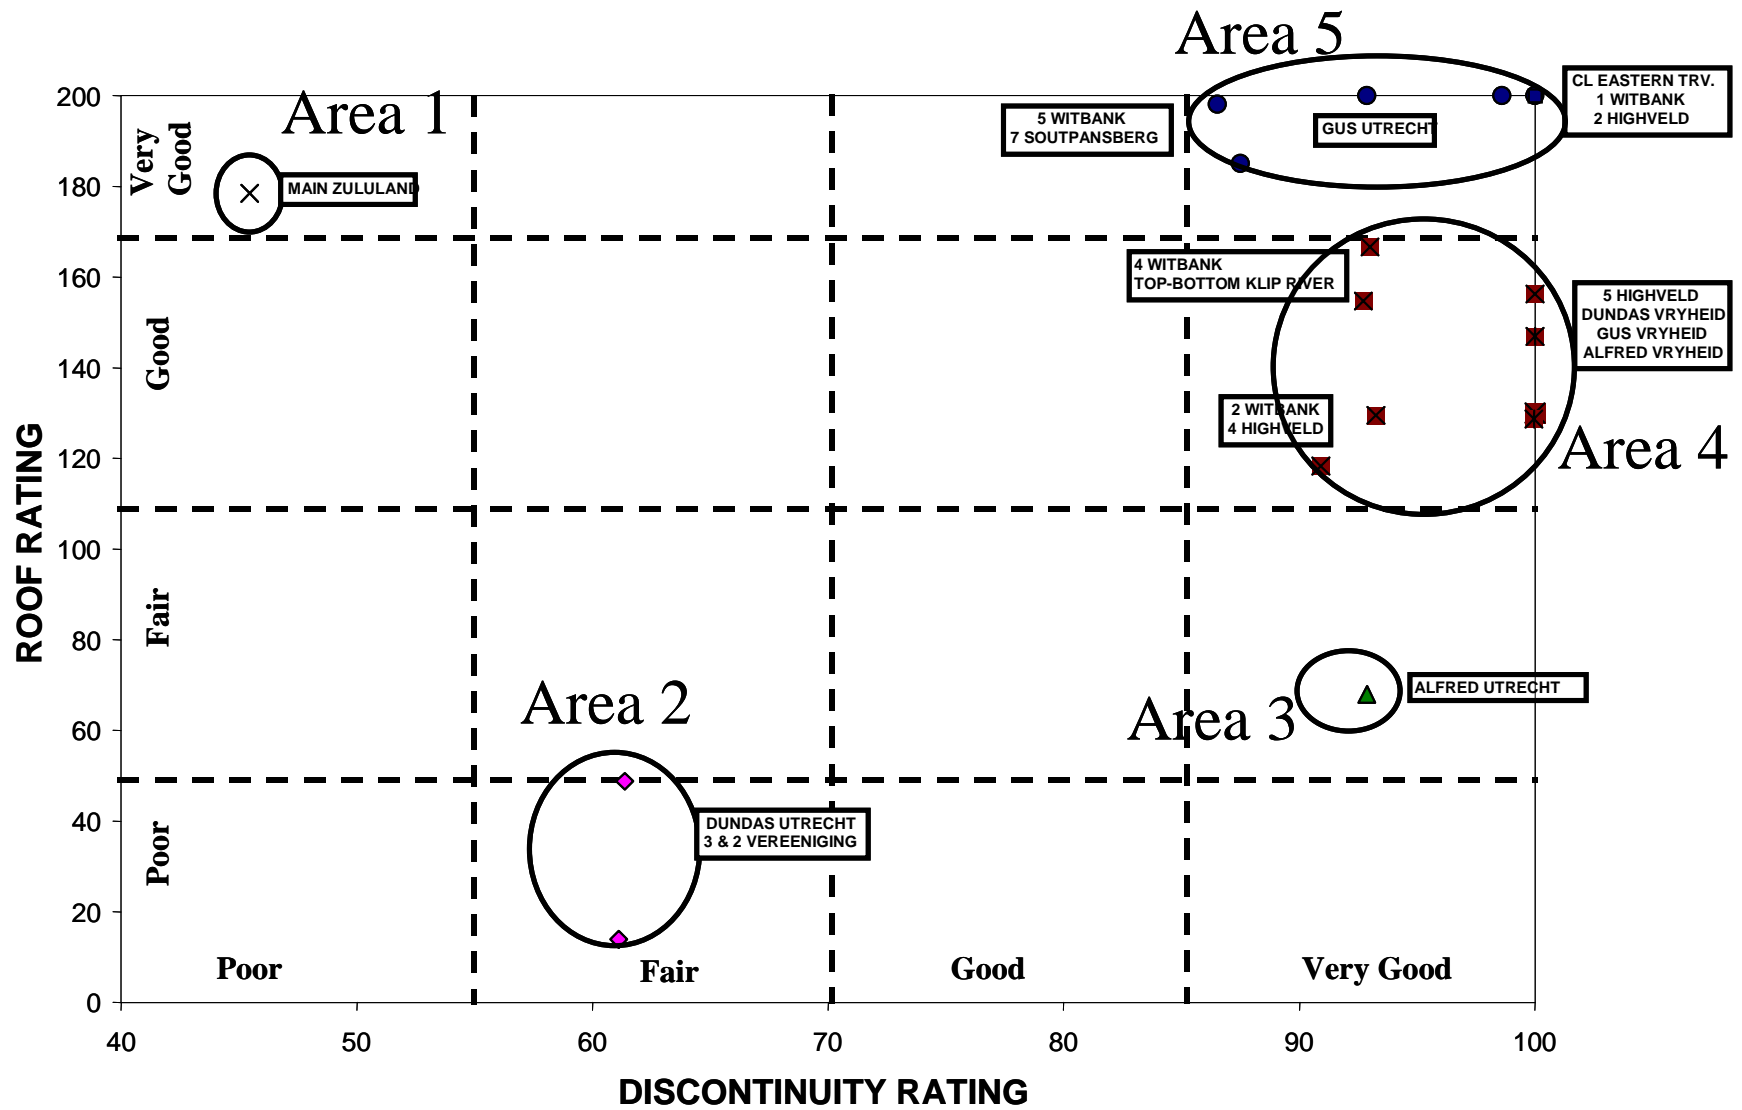
Figure 2-1 Geotechnical areas identified by discontinuity and roof ratings.

The averages of these two ratings for different seams are plotted in Figure 2-1. This figure highlights that, while in many seams the effect of discontinuities on pillar performance was similar, the roof rating can be significantly different and may determine the stability of the excavations and indicate relative support requirements.

Based on this figure, it was concluded that in South African seams five different geotechnical conditions can be broadly identified, which have a similar roof and discontinuity condition. These seams and the groups are as follows;

The data shown in Figure 2-1 are also given in Table 2-4 together with a number of observation sites and the standard deviations of each seam for both discontinuity and roof ratings.

As can be seen in Figure 2-1, most of the collieries, which produce approximately 95 per cent of coal, are situated in Area 4. Therefore, the underground monitoring sites were concentrated in collieries in Area 4.

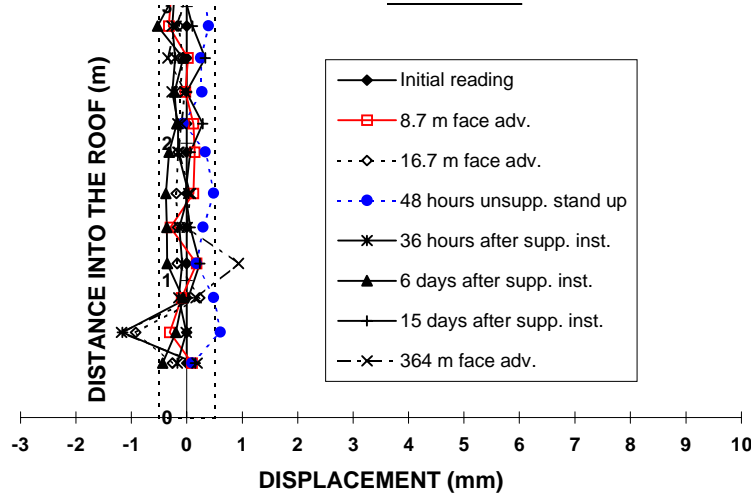
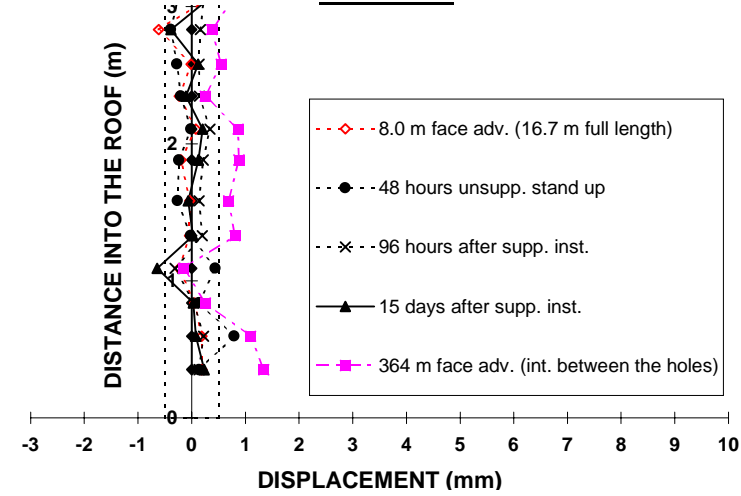
Figure 3-10 Colliery "A" Site 2

COLLIERY "A" - SITE 2
(CUT OUT DISTANCE 16.7 m)

DEPTH INTO THE ROOF (m)	SECTION	WIDTH (m)	RECORD OF STRATA
0.54		1.8	SHALE, black
0		0.54	SANDSTONE, gritty, silty

BOLT TYPE:	OZ-BAR
BOLT DIAMETER (mm):	20
HOLE DIAMETER (mm):	25
BOLT LENGTH (mm):	900
HOLE LENGTH (mm):	900
NUMBER OF BOLTS IN A ROW:	4
DISTANCE BETWEEN THE ROWS (m):	1.5
BOLT/m ²	0.41
RESIN CAPSULE DIAMETER (m):	19
RESIN TYPES	SLOW & FAST
NUMBER OF RESIN CAPSULES:	2
BORD WIDTH (m):	6.58
PILLAR WIDTH (m):	7.5
DEPTH (m):	59
MINING HEIGHT (m):	3.4
SAFETY FACTOR:	1.89

The results obtained from both holes during the experiment in Site 2 are presented in Figure 3-10. The results showed that after 364 m face advance, No 2 hole indicated some degree of displacement. However, it is known that after the initial phase of the experiment (up to 15 days after support installation, as indicated in Figure 3-10), an intersection was developed between the two holes during the mining cycle. Therefore, it was thought this movement was due to stress changes in the area. The summary of the site performance in this site is given in Table 3-4.

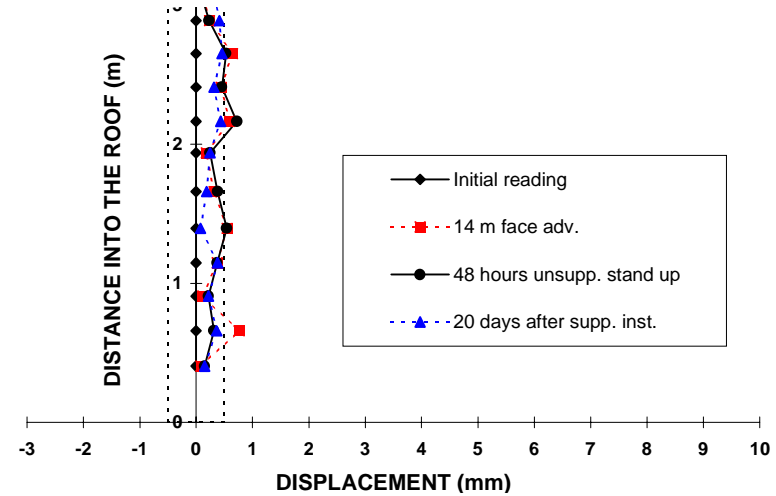
Figure 3-12 Colliery "B" Site 1

DEPTH INTO THE ROOF (m)	SECTION	WIDTH (m)	RECORD OF STRATA
1.46		0.59	SANDSTONE, grey, fine grained, micaceous bedding planes
1		0.46	SANDSTONE, shaly, with bioturbation
0		1	COAL

BOLT TYPE:	RE-BAR
BOLT DIAMETER (mm):	16
HOLE DIAMETER (mm):	24
BOLT LENGTH (mm):	1800
HOLE LENGTH (mm):	1800
NUMBER OF BOLTS IN A ROW:	2
DISTANCE BETWEEN THE ROWS (m):	2
BOLT/m ²	0.15
RESIN CAPSULE DIAMETER (m):	19
RESIN TYPES	SLOW & FAST
NUMBER OF RESIN CAPSULES:	3
BORD WIDTH (m):	6.5
PILLAR WIDTH (m):	10.5
DEPTH (m):	75
MINING HEIGHT (m):	4.4
SAFETY FACTOR:	1.86

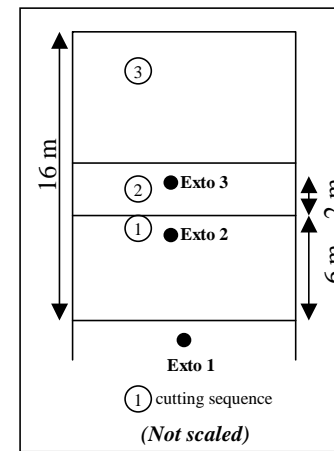
Figure 3-18 Colliery 'D' Site 1

BOLT TYPE:	Resin Point Anchor
BOLT DIAMETER (mm):	16
HOLE DIAMETER (mm):	22
BOLT LENGTH (mm):	1500
HOLE LENGTH (mm):	1500
NUMBER OF BOLTS IN A ROW:	3
DISTANCE BETWEEN THE ROWS (m):	2
BOLT/m ²	0.23
RESIN CAPSULE DIAMETER (m):	19
RESIN TYPES	FAST
NUMBER OF RESIN CAPSULES:	2
BORD WIDTH (m):	6.6
PILLAR WIDTH (m):	8.2
DEPTH (m):	53
MINING HEIGHT (m):	4.2
SAFETY FACTOR:	2.03

Cutting sequence

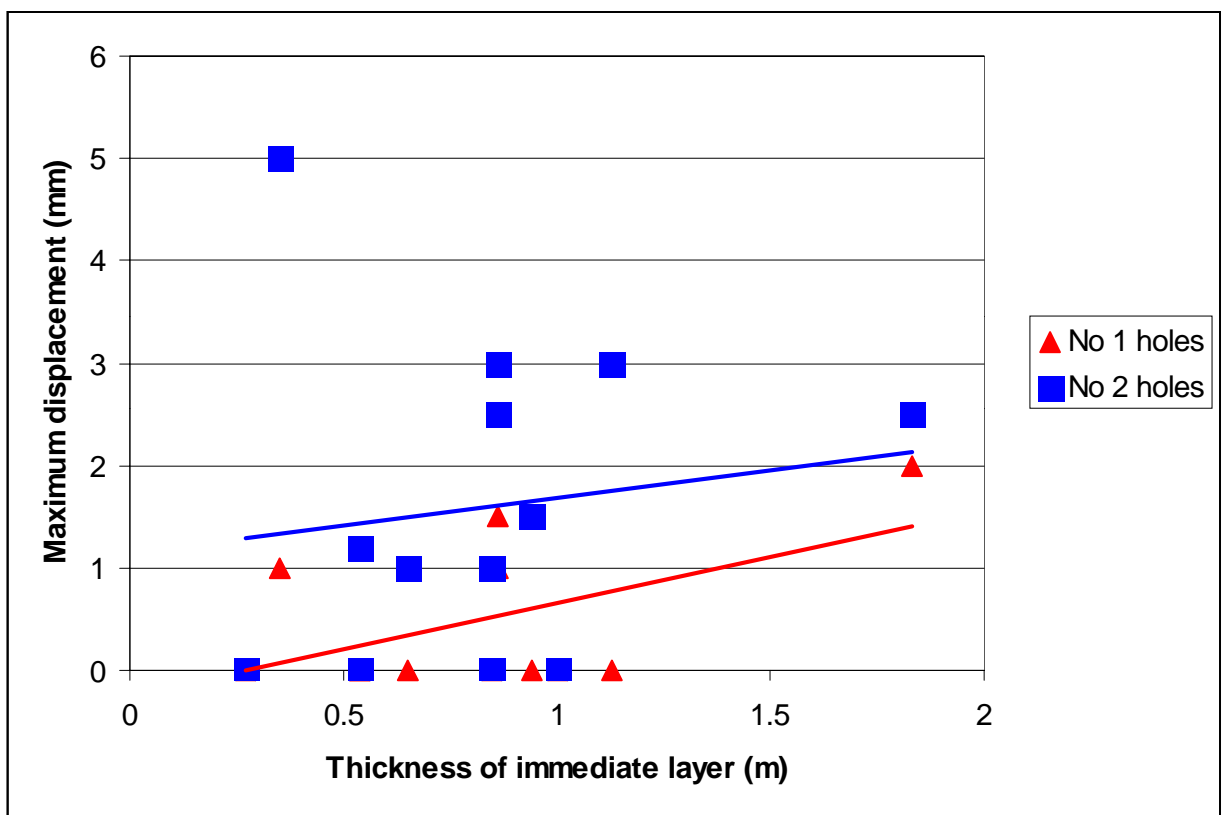
Figure 3-22 The relationship between the thickness of the immediate layer and total displacement

The relationships between the maximum dilation and the support density, roof lithology, bord width and cut out distance are shown from Figure 3-21 to Figure 3-24. It can be seen from these figures that there is no obvious correlation between roof dilation and the other variables. Consequently, the data does not show meaningful relationships between these parameters. There is thus no indication of the dependence of roof stability on cut out distance in the range of cut out distances that was investigated.

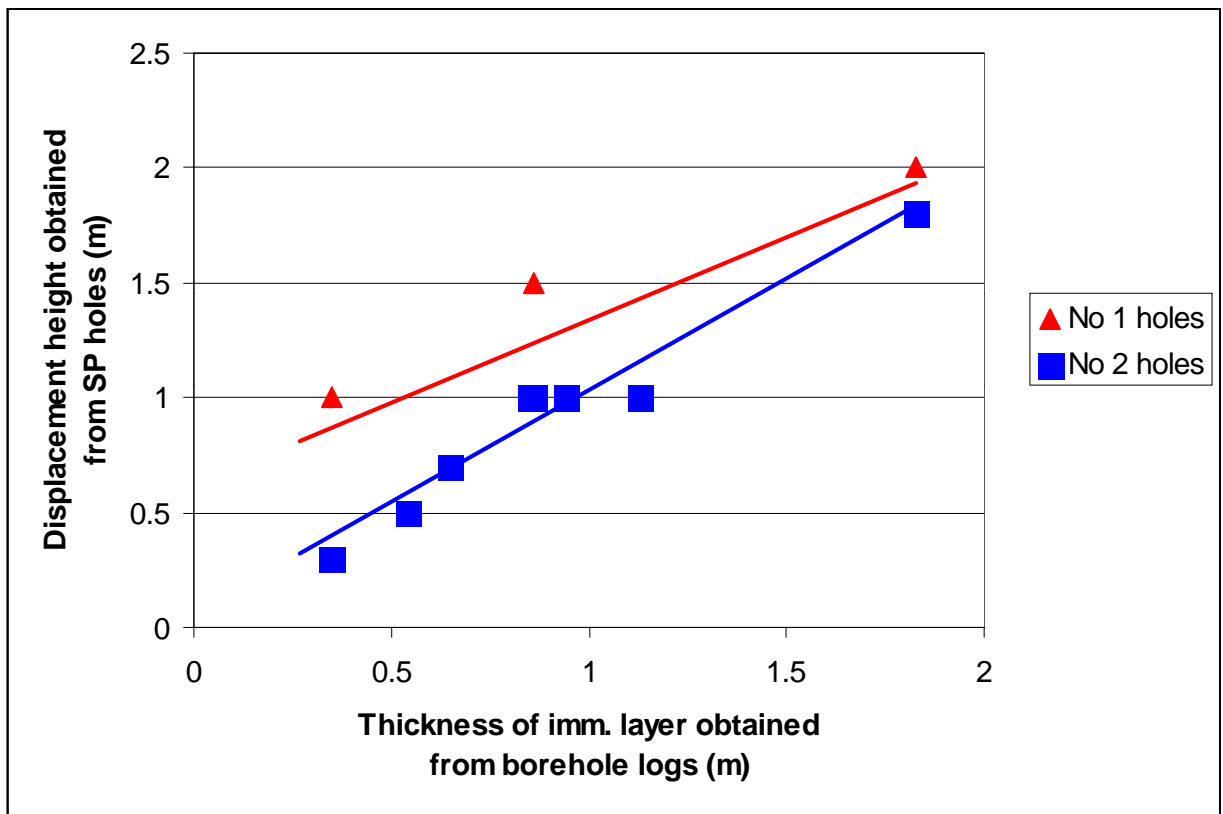
Figure 3-25 The relationship between the thickness of the immediate layer obtained from the borehole logs and height of the displacement obtained from underground sites where some degree of dilation was recorded

There was, however, one significant correlation observed, and this was the relationship between the position where separation occurred and the thicknesses of lithological units. This is shown in Figure 3-25. The immediate roof thicknesses were obtained from the borehole logs and the position of the separation from the sonic probe monitoring observations. This figure confirms that the position of dilation or separation in the roof agreed with the position of likely partings or change in rock type in the roof. This can assist mining personnel in selecting the correct support system and bolt length.

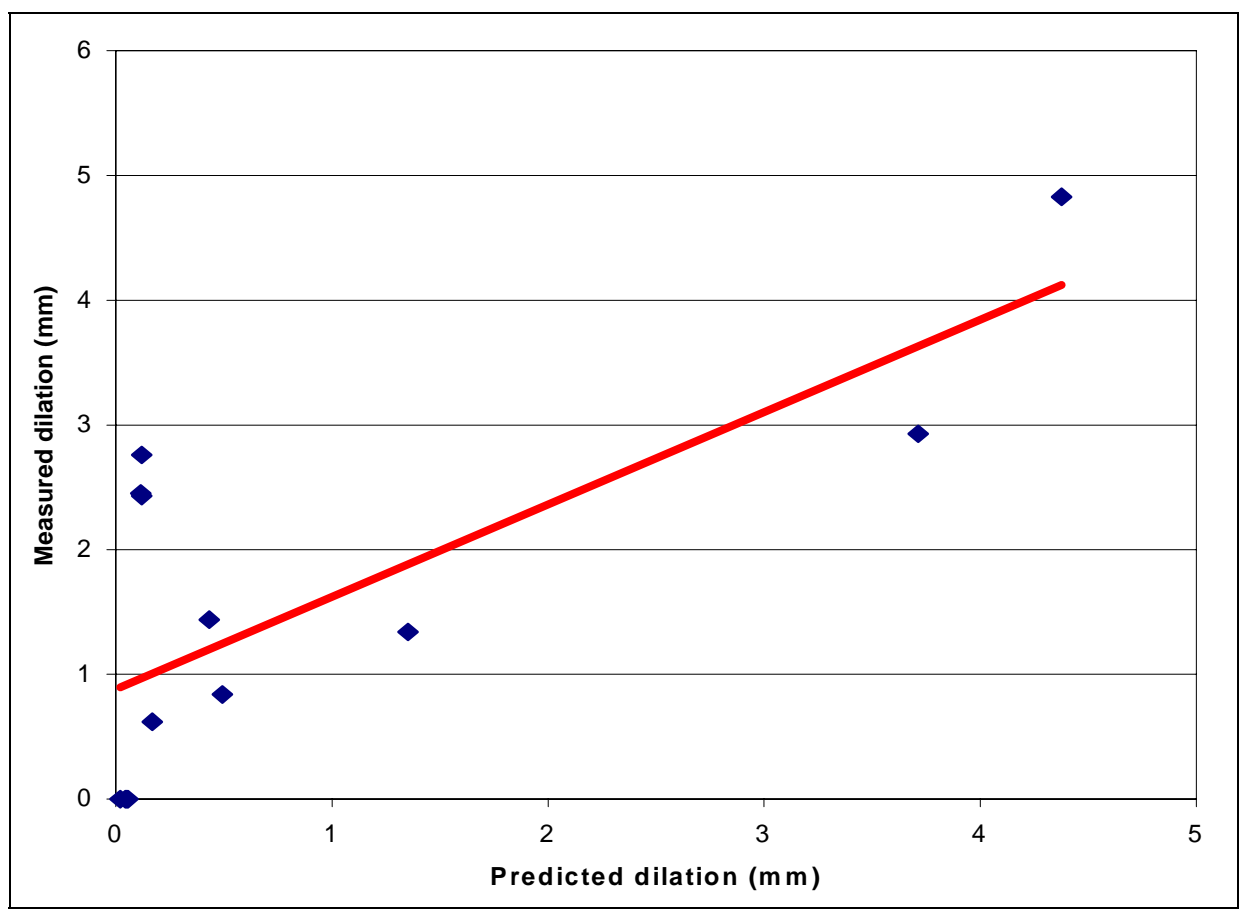
Figure 3-26 Relationship between measured and predicted dilation

The comparison between calculated and measured deflections is shown in Figure 3-26. The good correlation is immediately apparent, as is the fact that the magnitudes of the displacements are in the same range. It can therefore be concluded that the gravity loaded beam analogy is valid for predicting roof behaviour in the study area.

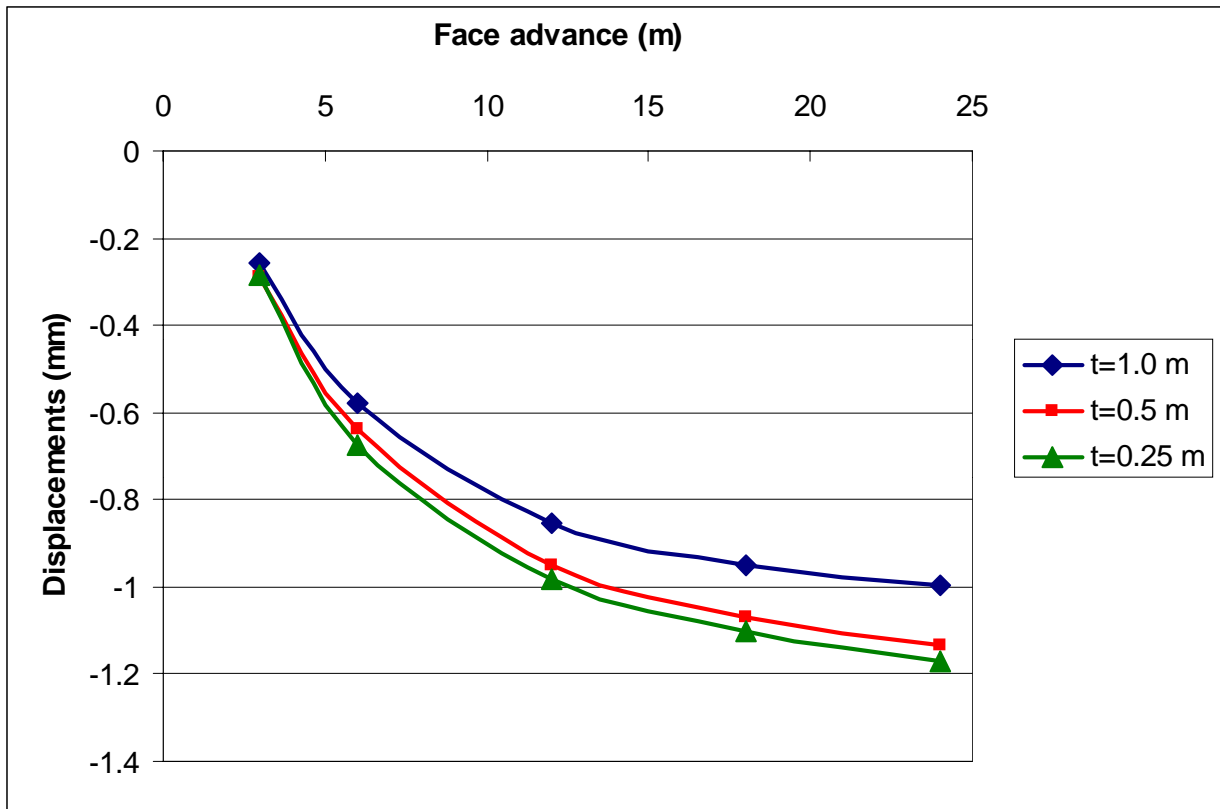
Figure 3-30 Effect of the thickness of the immediate layer on roof deformations

The effect of the thickness of the immediate layer was also investigated using the same model. In this model the k-ratio was kept constant at 3.0, and 0.25 m, 0.5 m and 1.0 m thick, immediate layers were modelled. The results indicated that decreasing the thickness of the immediate layer increases the displacements in the roof, Figure 3-30. This trend was also apparent in the monitoring, indicated by the good correlation between measured deflections and the beam predictions.

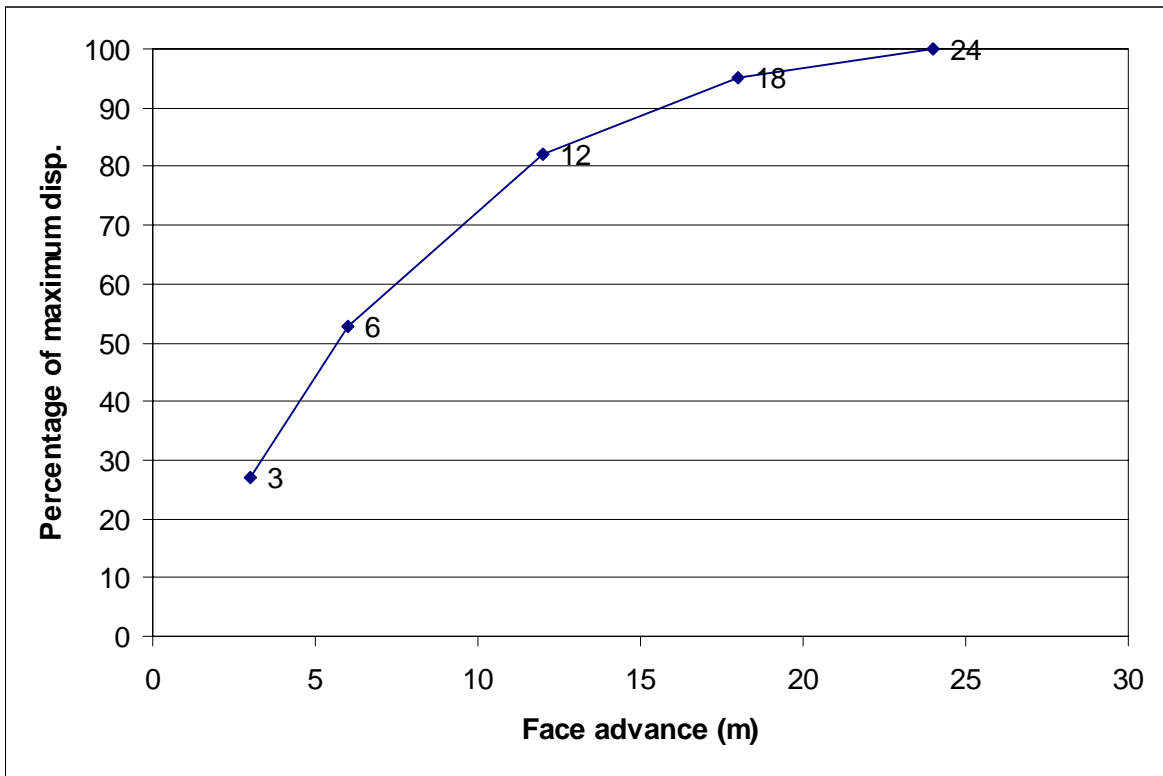
Figure 3-32 Effect of face advance in a 6.0 m bord width, obtained from numerical modelling

Dilations in the roof as the mining steps take place were also investigated using Map3D. The results are shown in Figure 3-32. A 6.0 m bord width was modelled with 6.0 m mining steps. This figure indicates that a significant portion of the displacements (80 per cent) takes place within the first 12 m of the face advance. This is an important trend, as it was seen underground that very little additional deflection occurred once the face had advanced beyond a distance equal to twice the bord width.
