# Bridge management systems: An asset management tool for road structures

4<sup>th</sup> Biennial Conference

Presented by: Paul A Nordengen

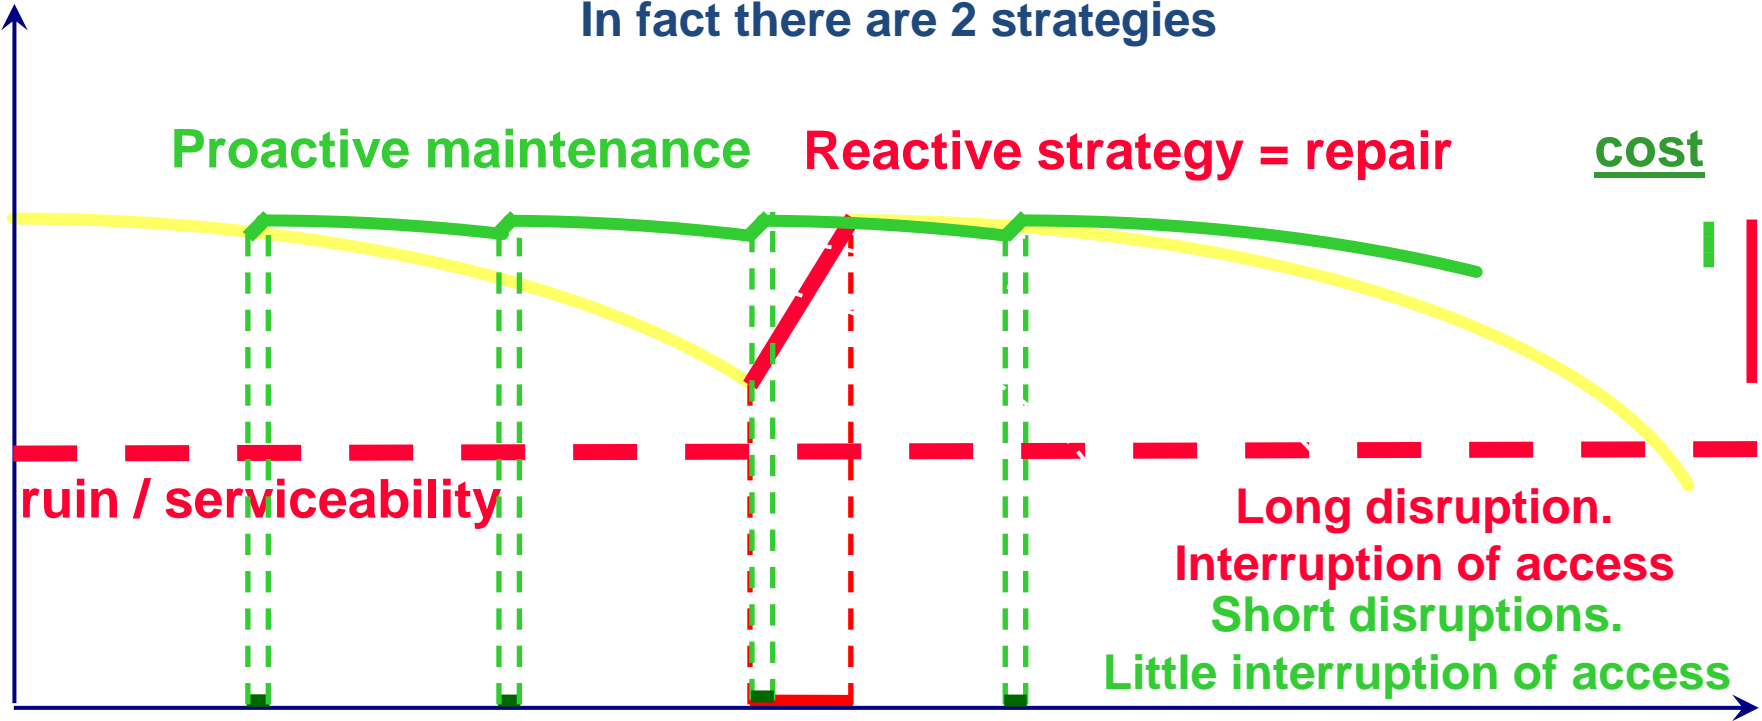
In fact there are 2 strategies

Condition

Early detection of defects, through prompt diagnosis of symptoms, allows defects to be treated quickly, thus allowing meaningful savings to be made on maintenance expenditure.

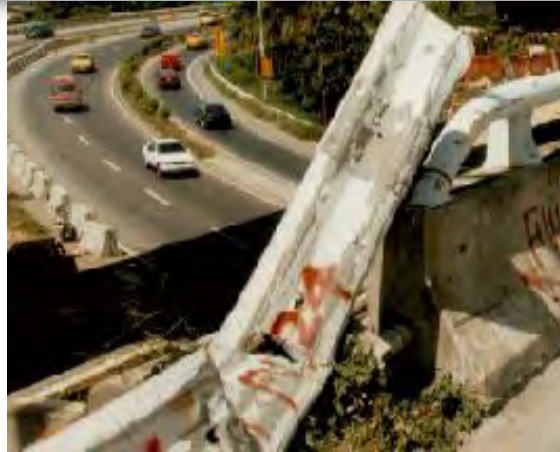
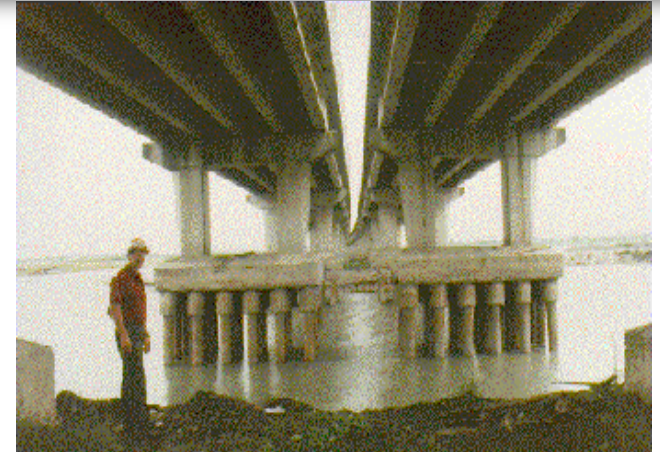
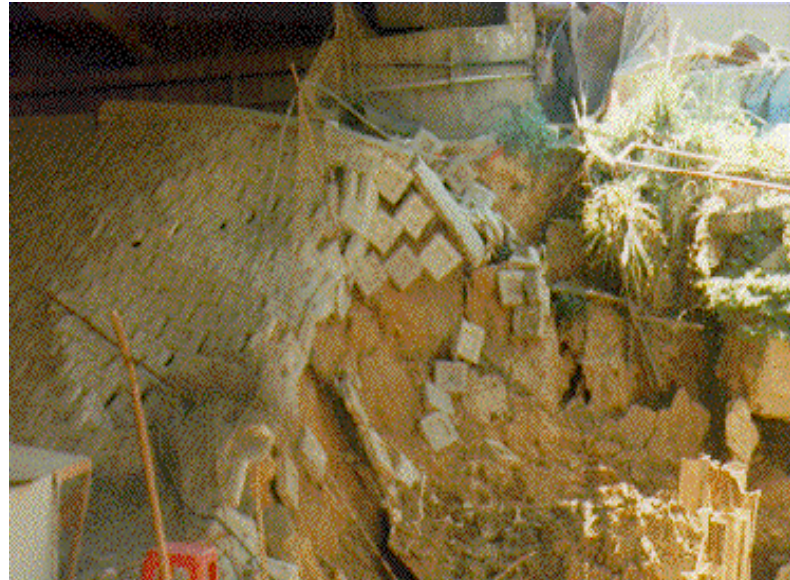
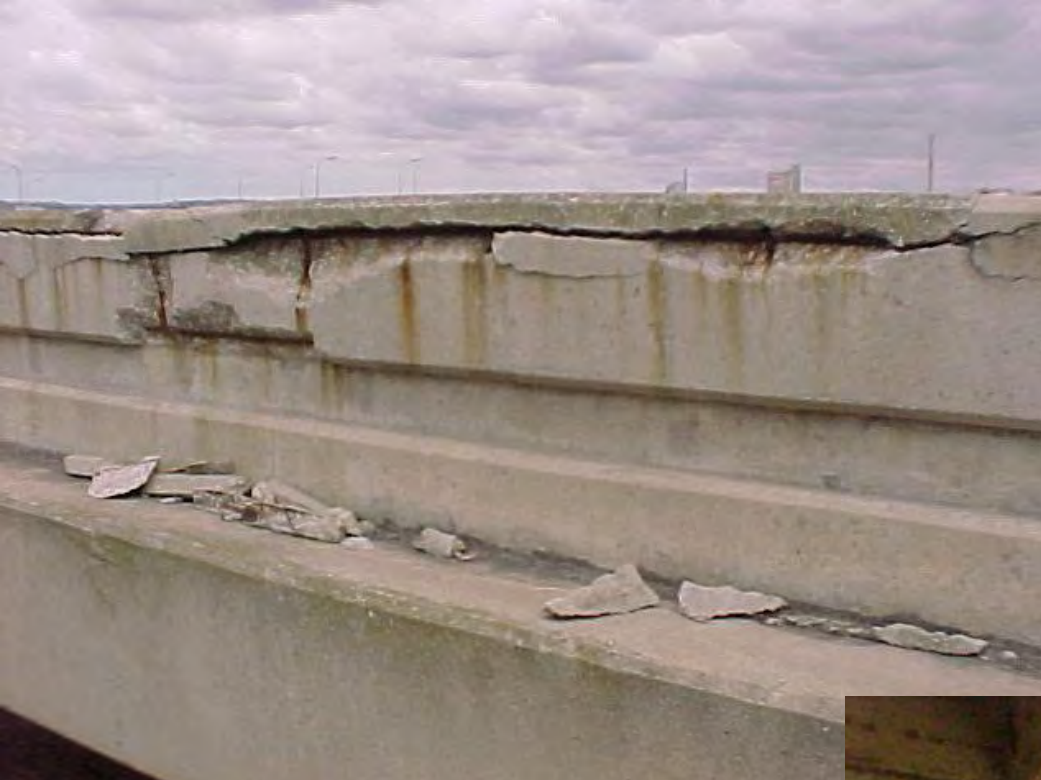
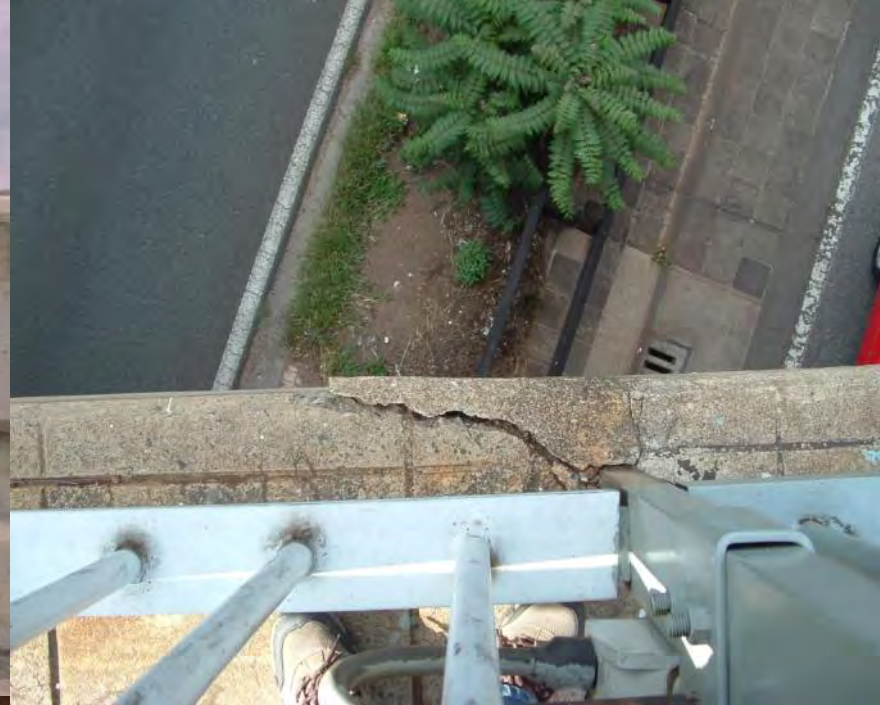
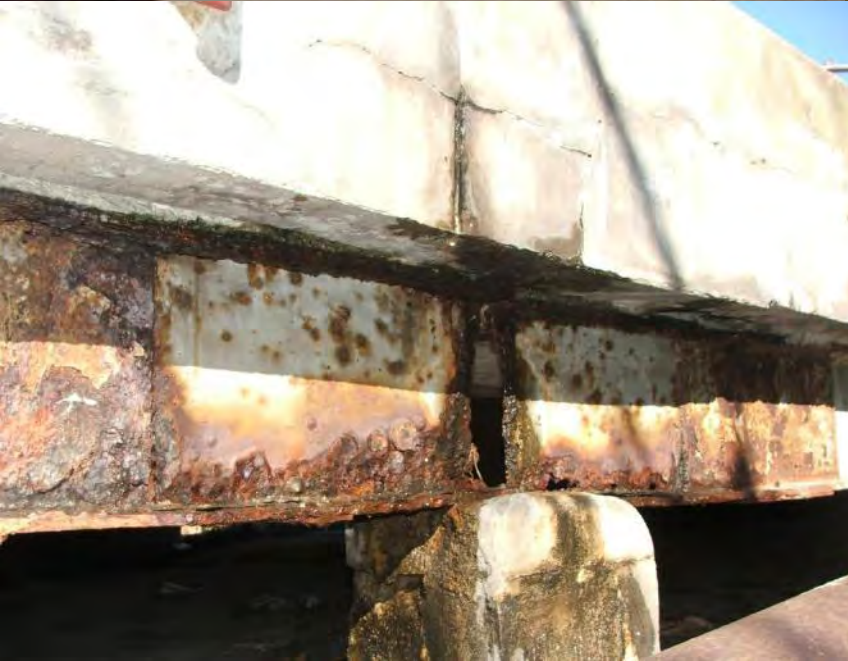
# Examples of Defects

- Spalling
- Scour
- Erosion
- Settlement
- Honeycombing
- Defective drains
- Cracks - bending, shear,...
- Rotating abutments
- Defective guardrails
- Insufficient cover to reinforcement
- Defective surfacing
- Excessive deflections
- Expansion joints not watertight
- Defects on concrete surface
- Flood debris accumulation

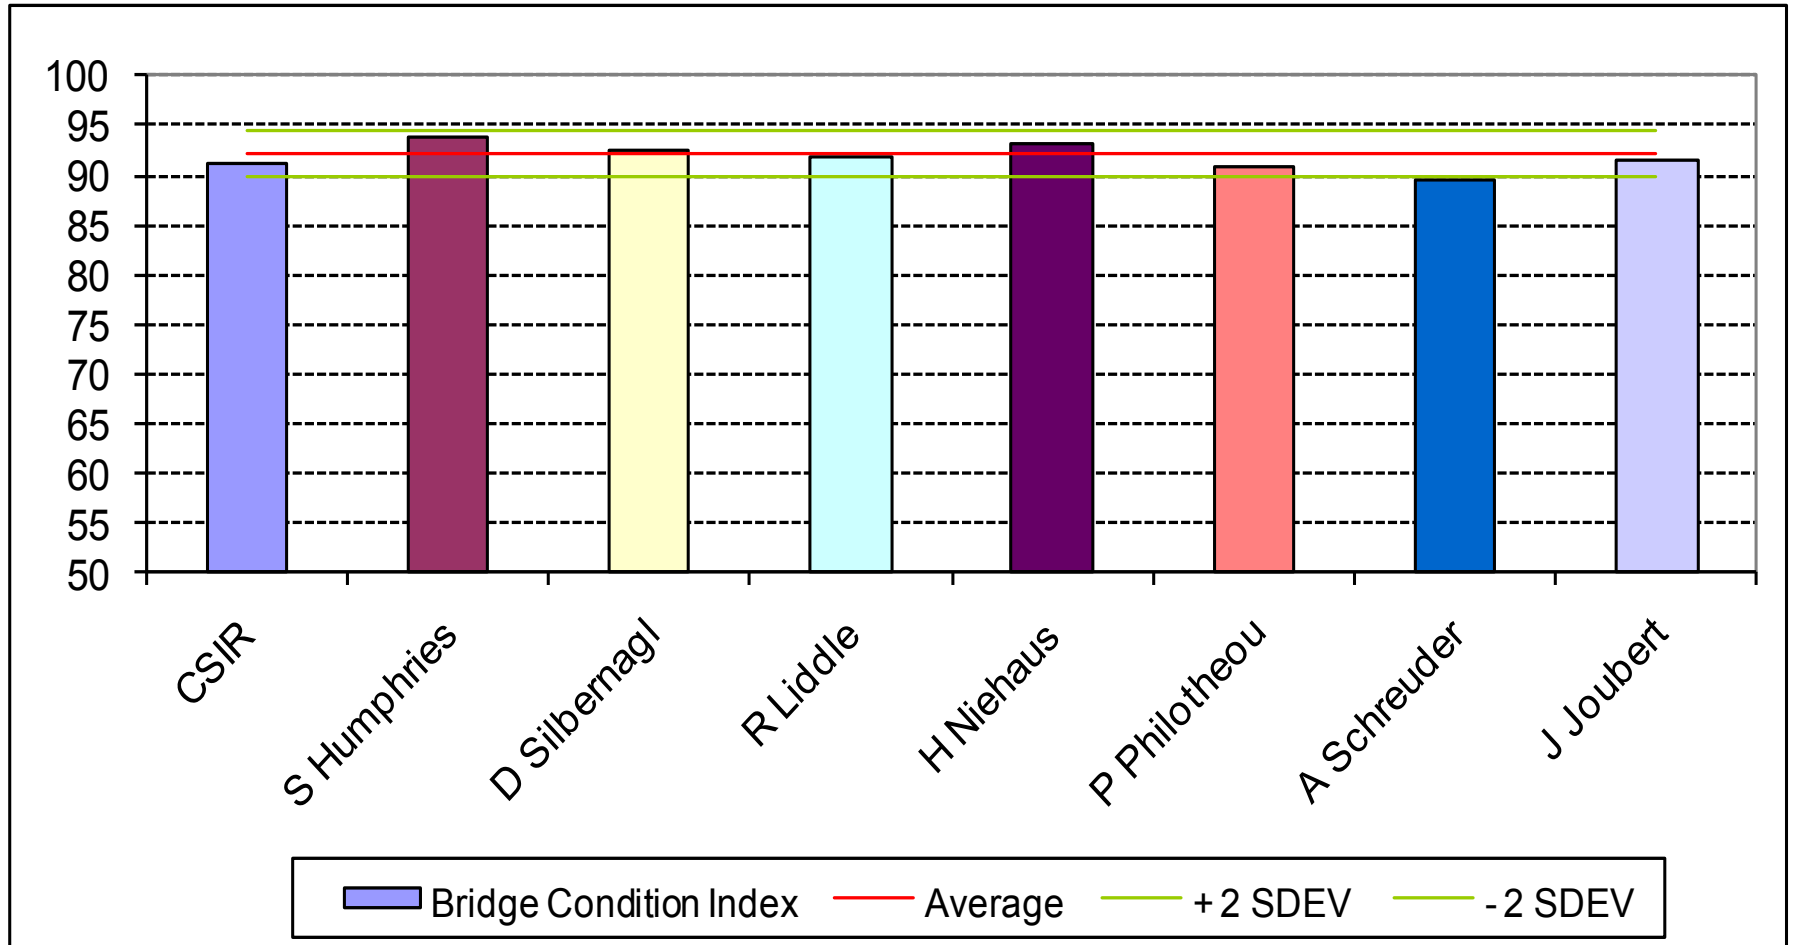
# Assessment of Bridge Inspectors: Calibration Inspections

**Bridge** Use: Yes Classification: Medium Bridge Status: Current Ownership: Roads Authority Namibia Road: D2475, 53.02 km

Structure Type: All Structures Module: Start Module

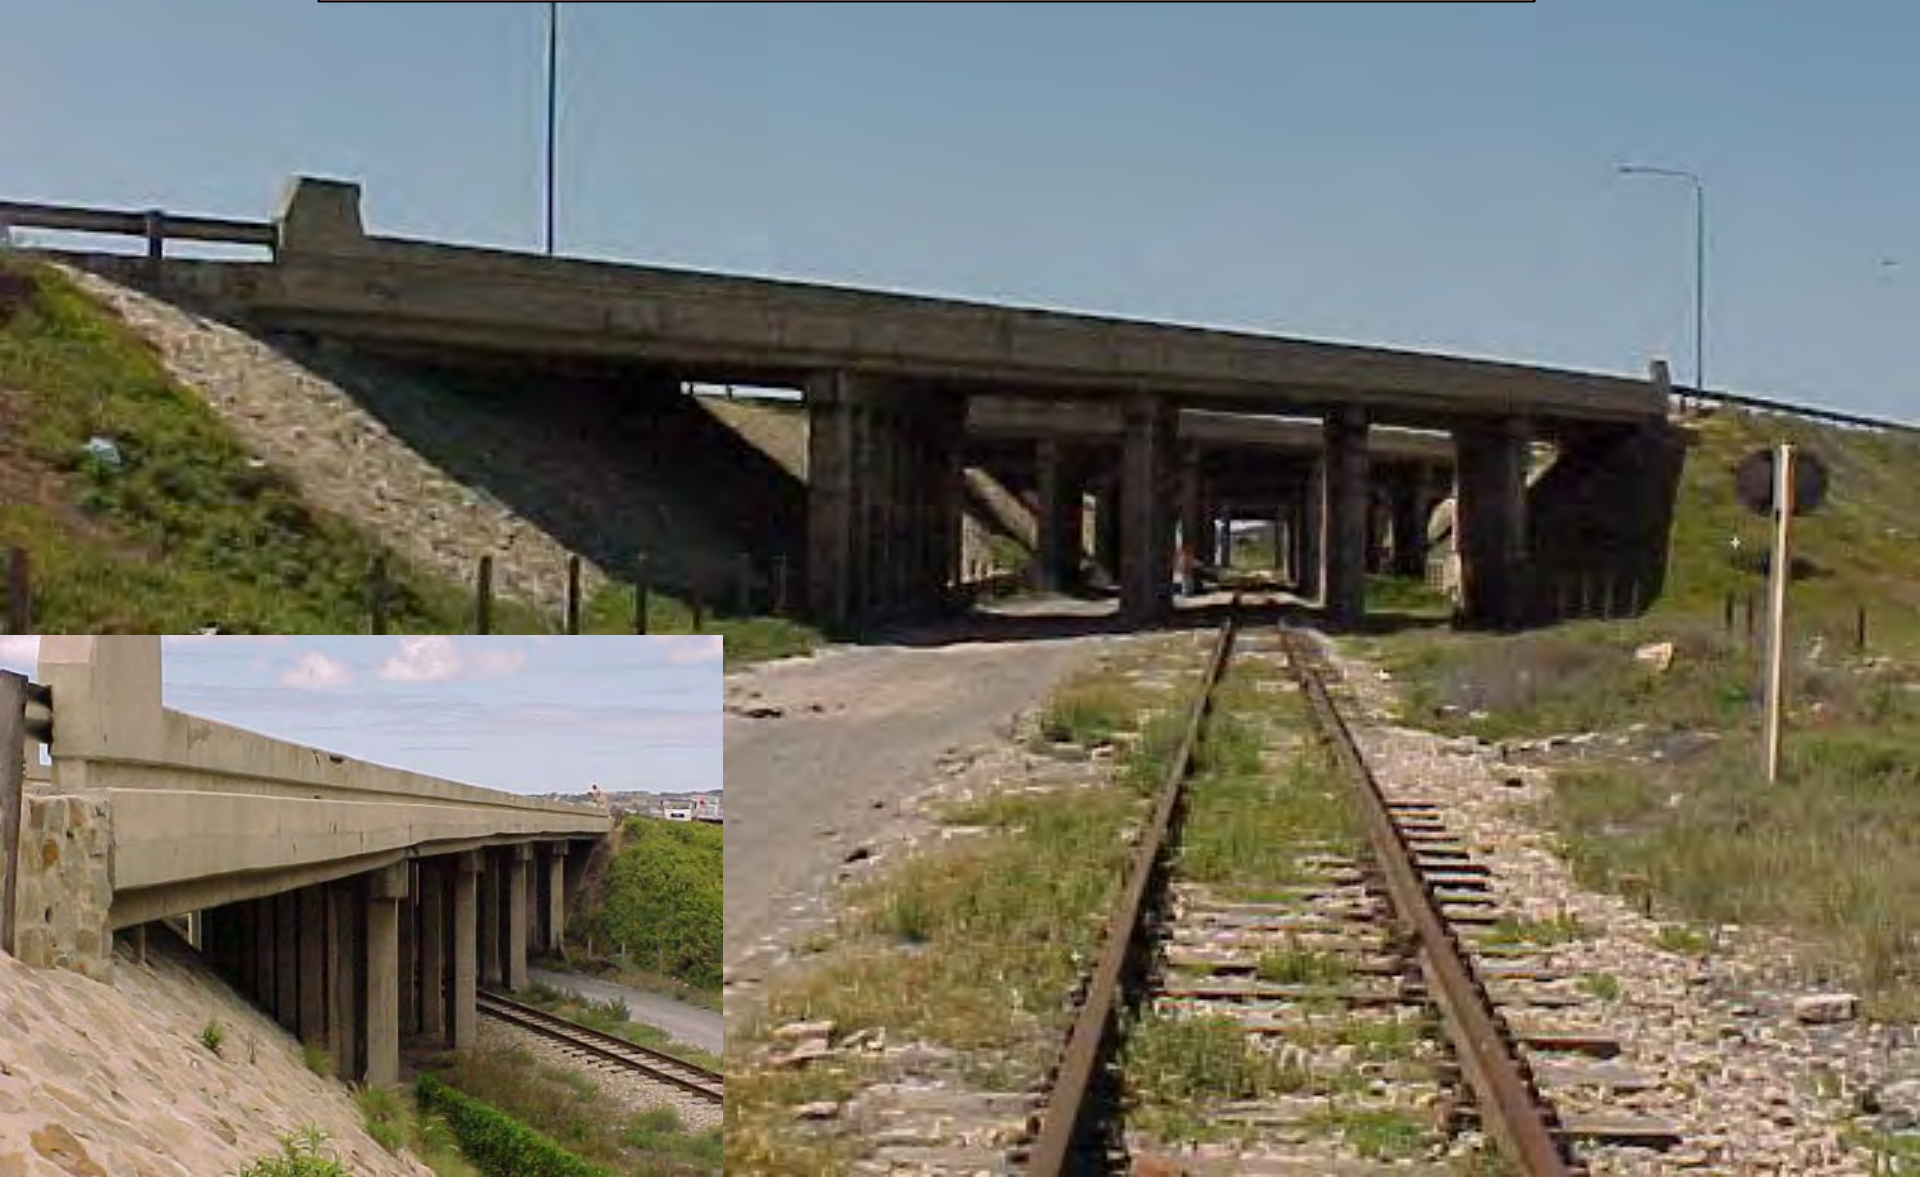
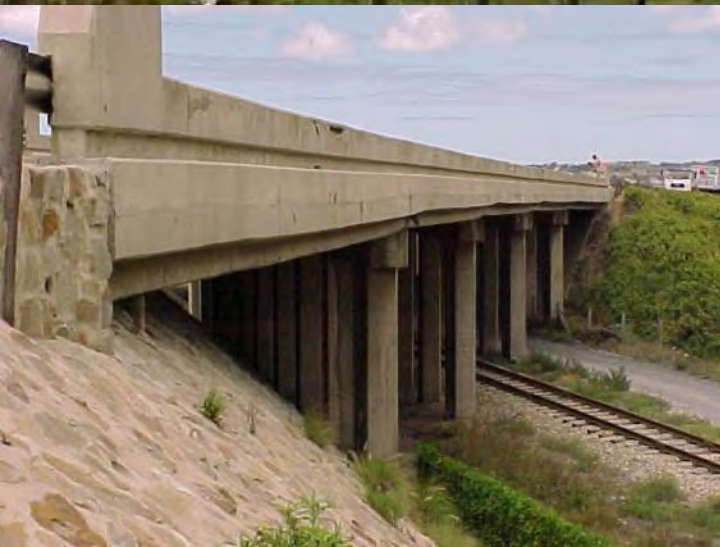
## Burman Road/Rail Bridge

# Case Study 1

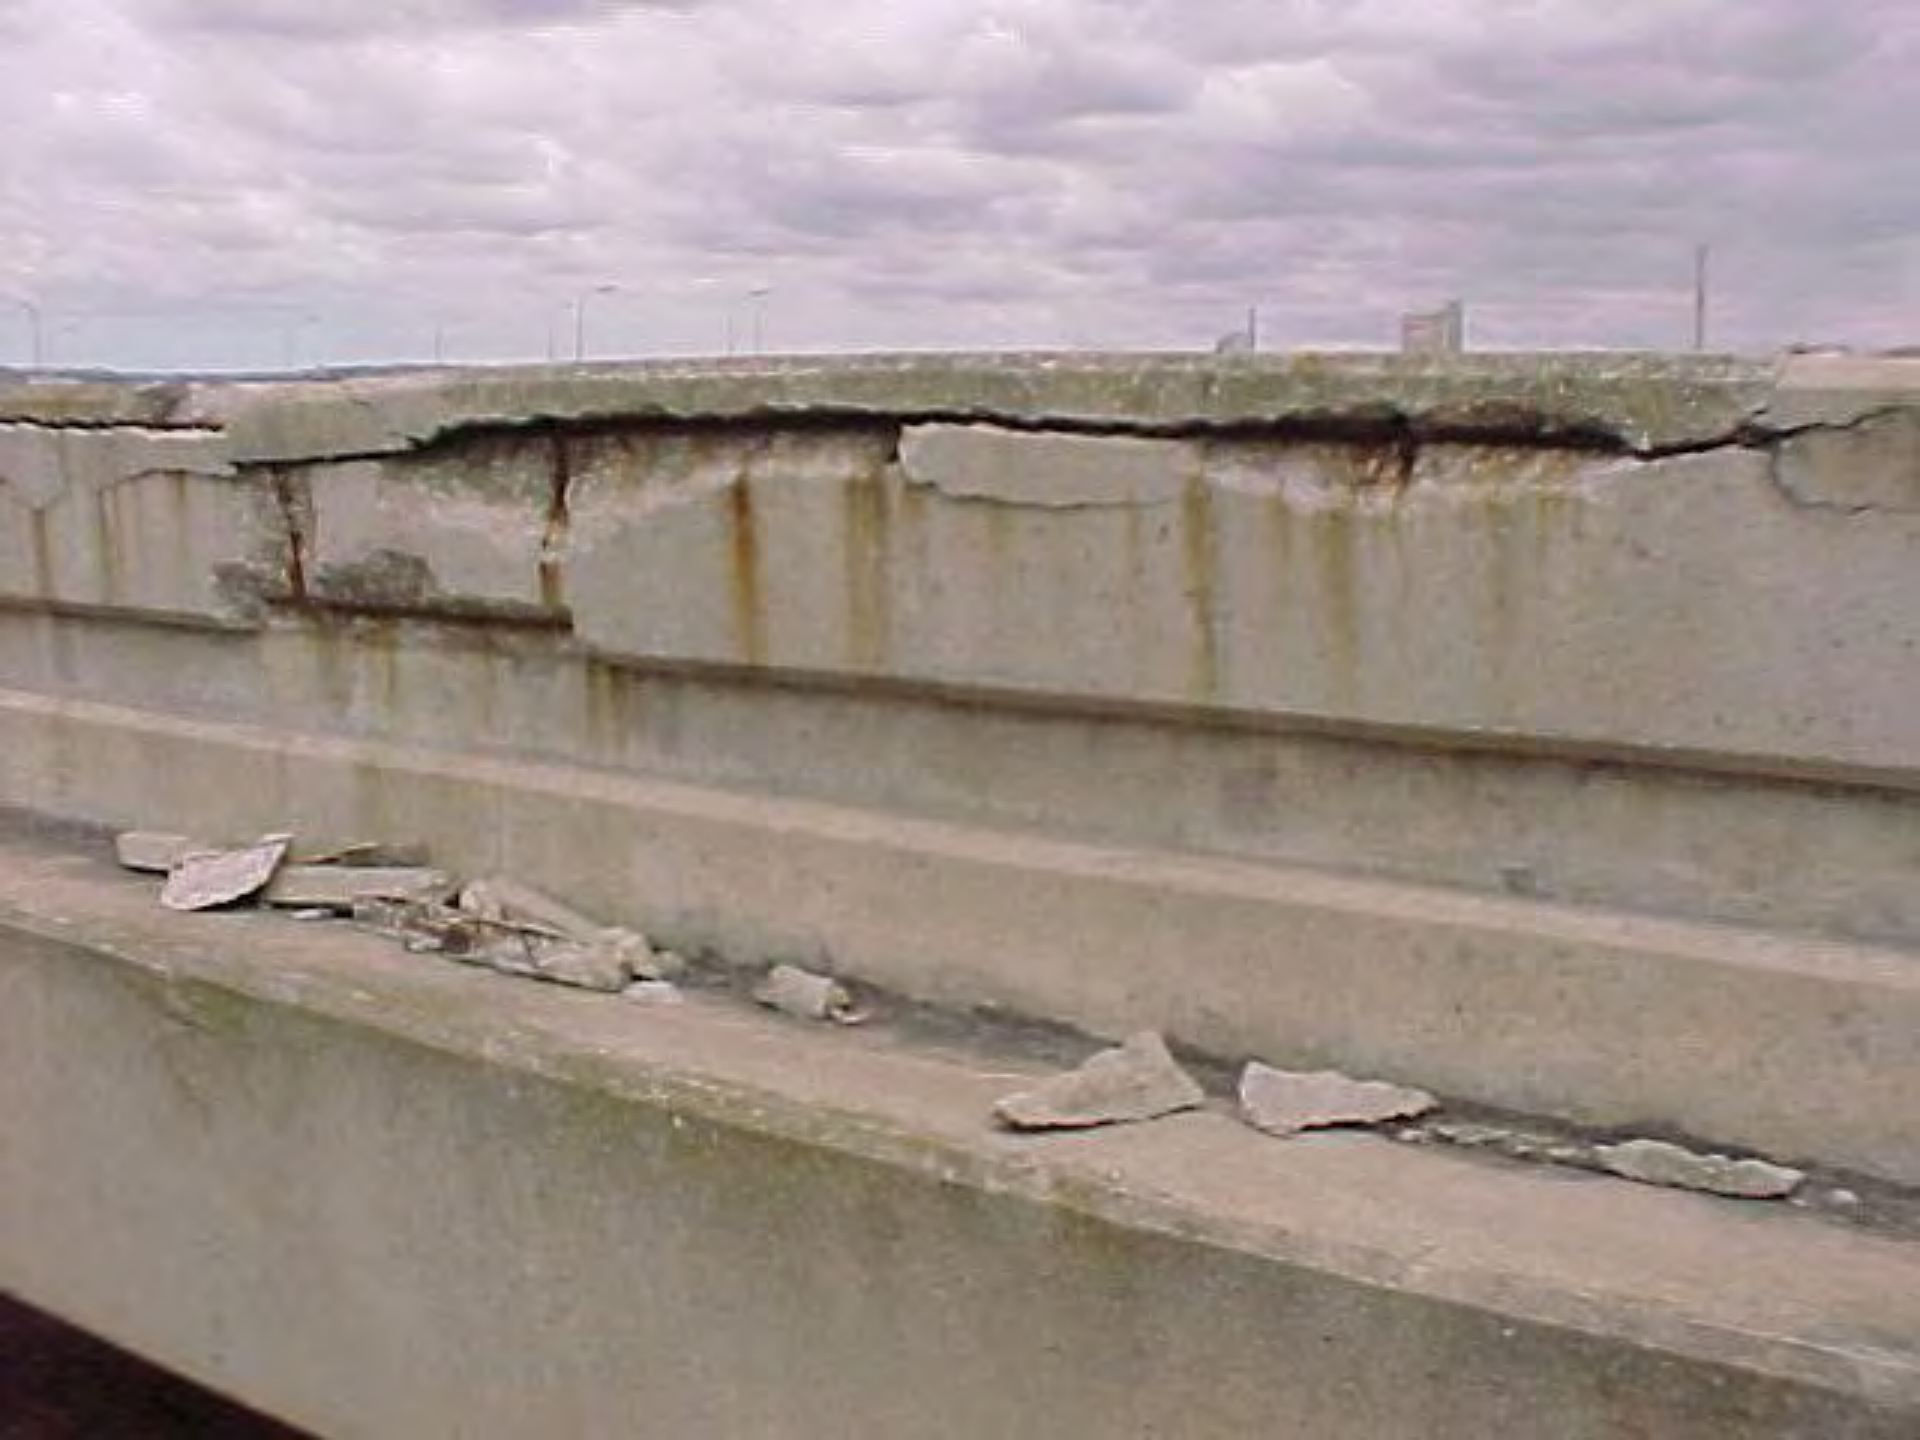
***D = 3 crack***

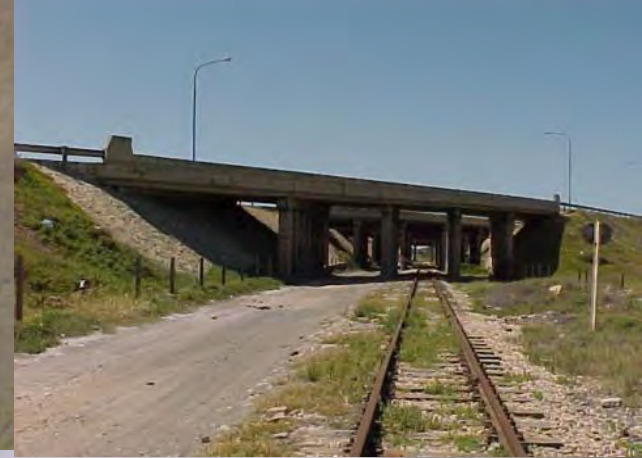
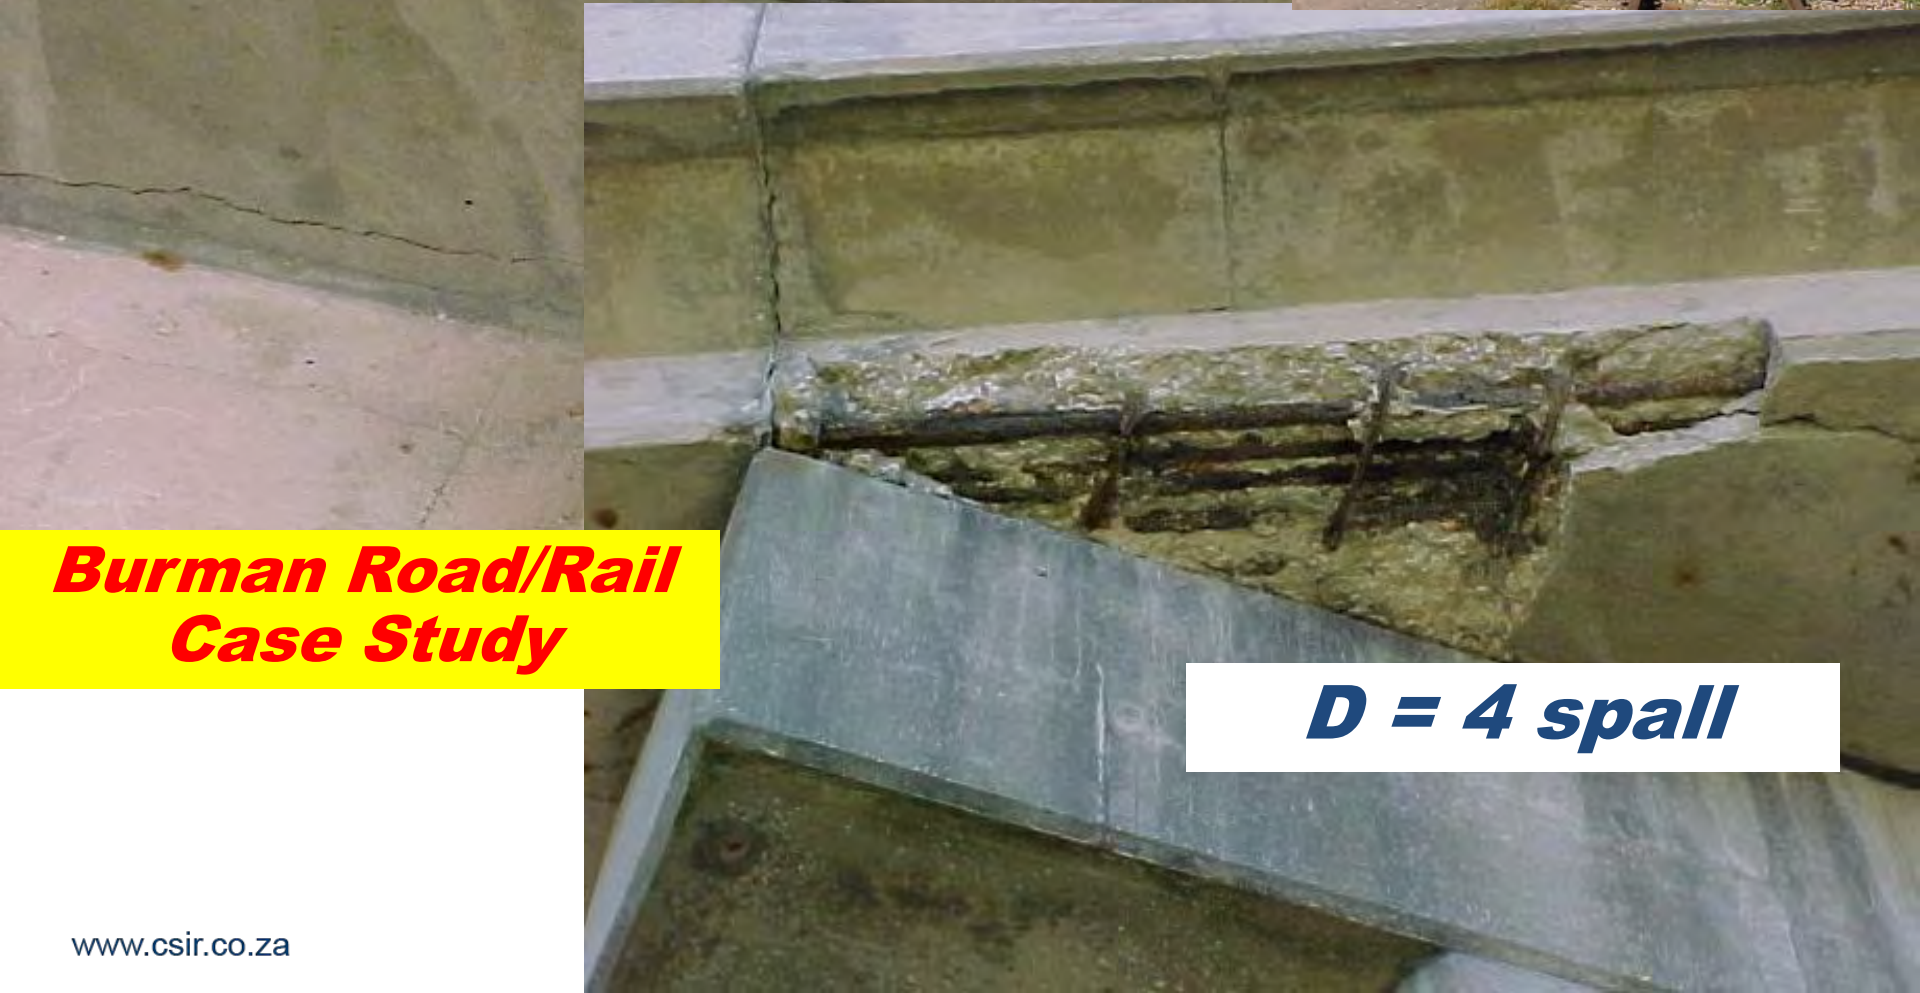
***Burman Road/Rail  
Case Study***

**D = 4    E = 3    R = 4**

***D = 4 spall***

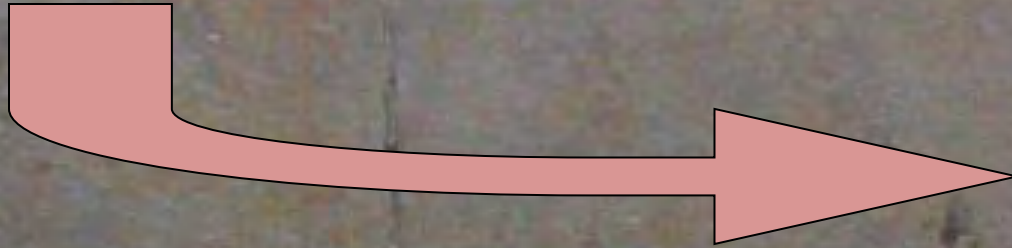
**1 to 2 mm transverse  
cracks in deck slab soffit  
(main bending)**

# Rating of defect (crack)

- *Thickness of slab 700mm*
- *Sag in deck edge – can be seen in elevation view*
- *3 mm joints in barrier had closed up*

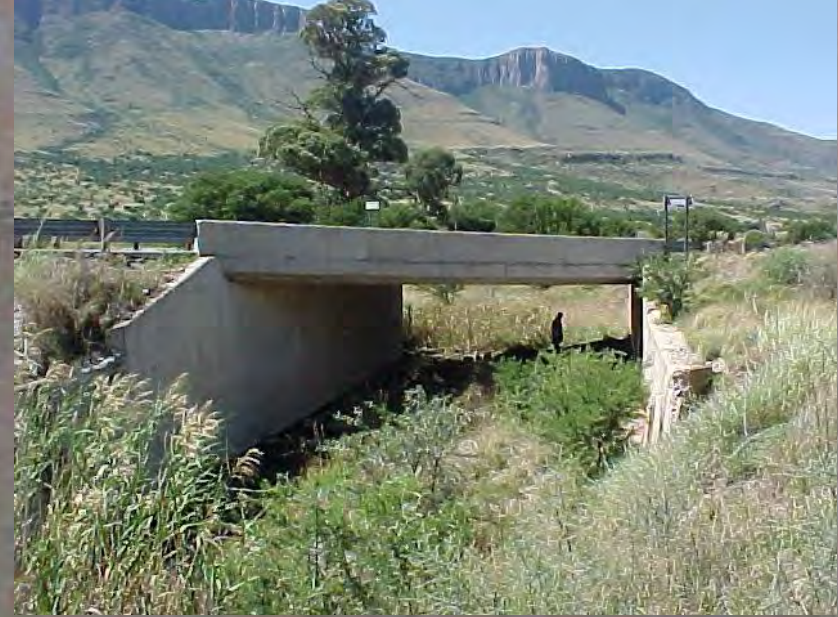
# Remedial Work

*OPI was No 52 out of 2 000*

- *A design check was done & deck found to have only 30% of LL Capacity*
- *Strengthening not feasible due to steel stressed beyond yield*
- *Could hear crunching of concrete when vehicles crossed*
- *Deck was demolished and replaced*
- *During demolition the deck collapsed under its own weight!*

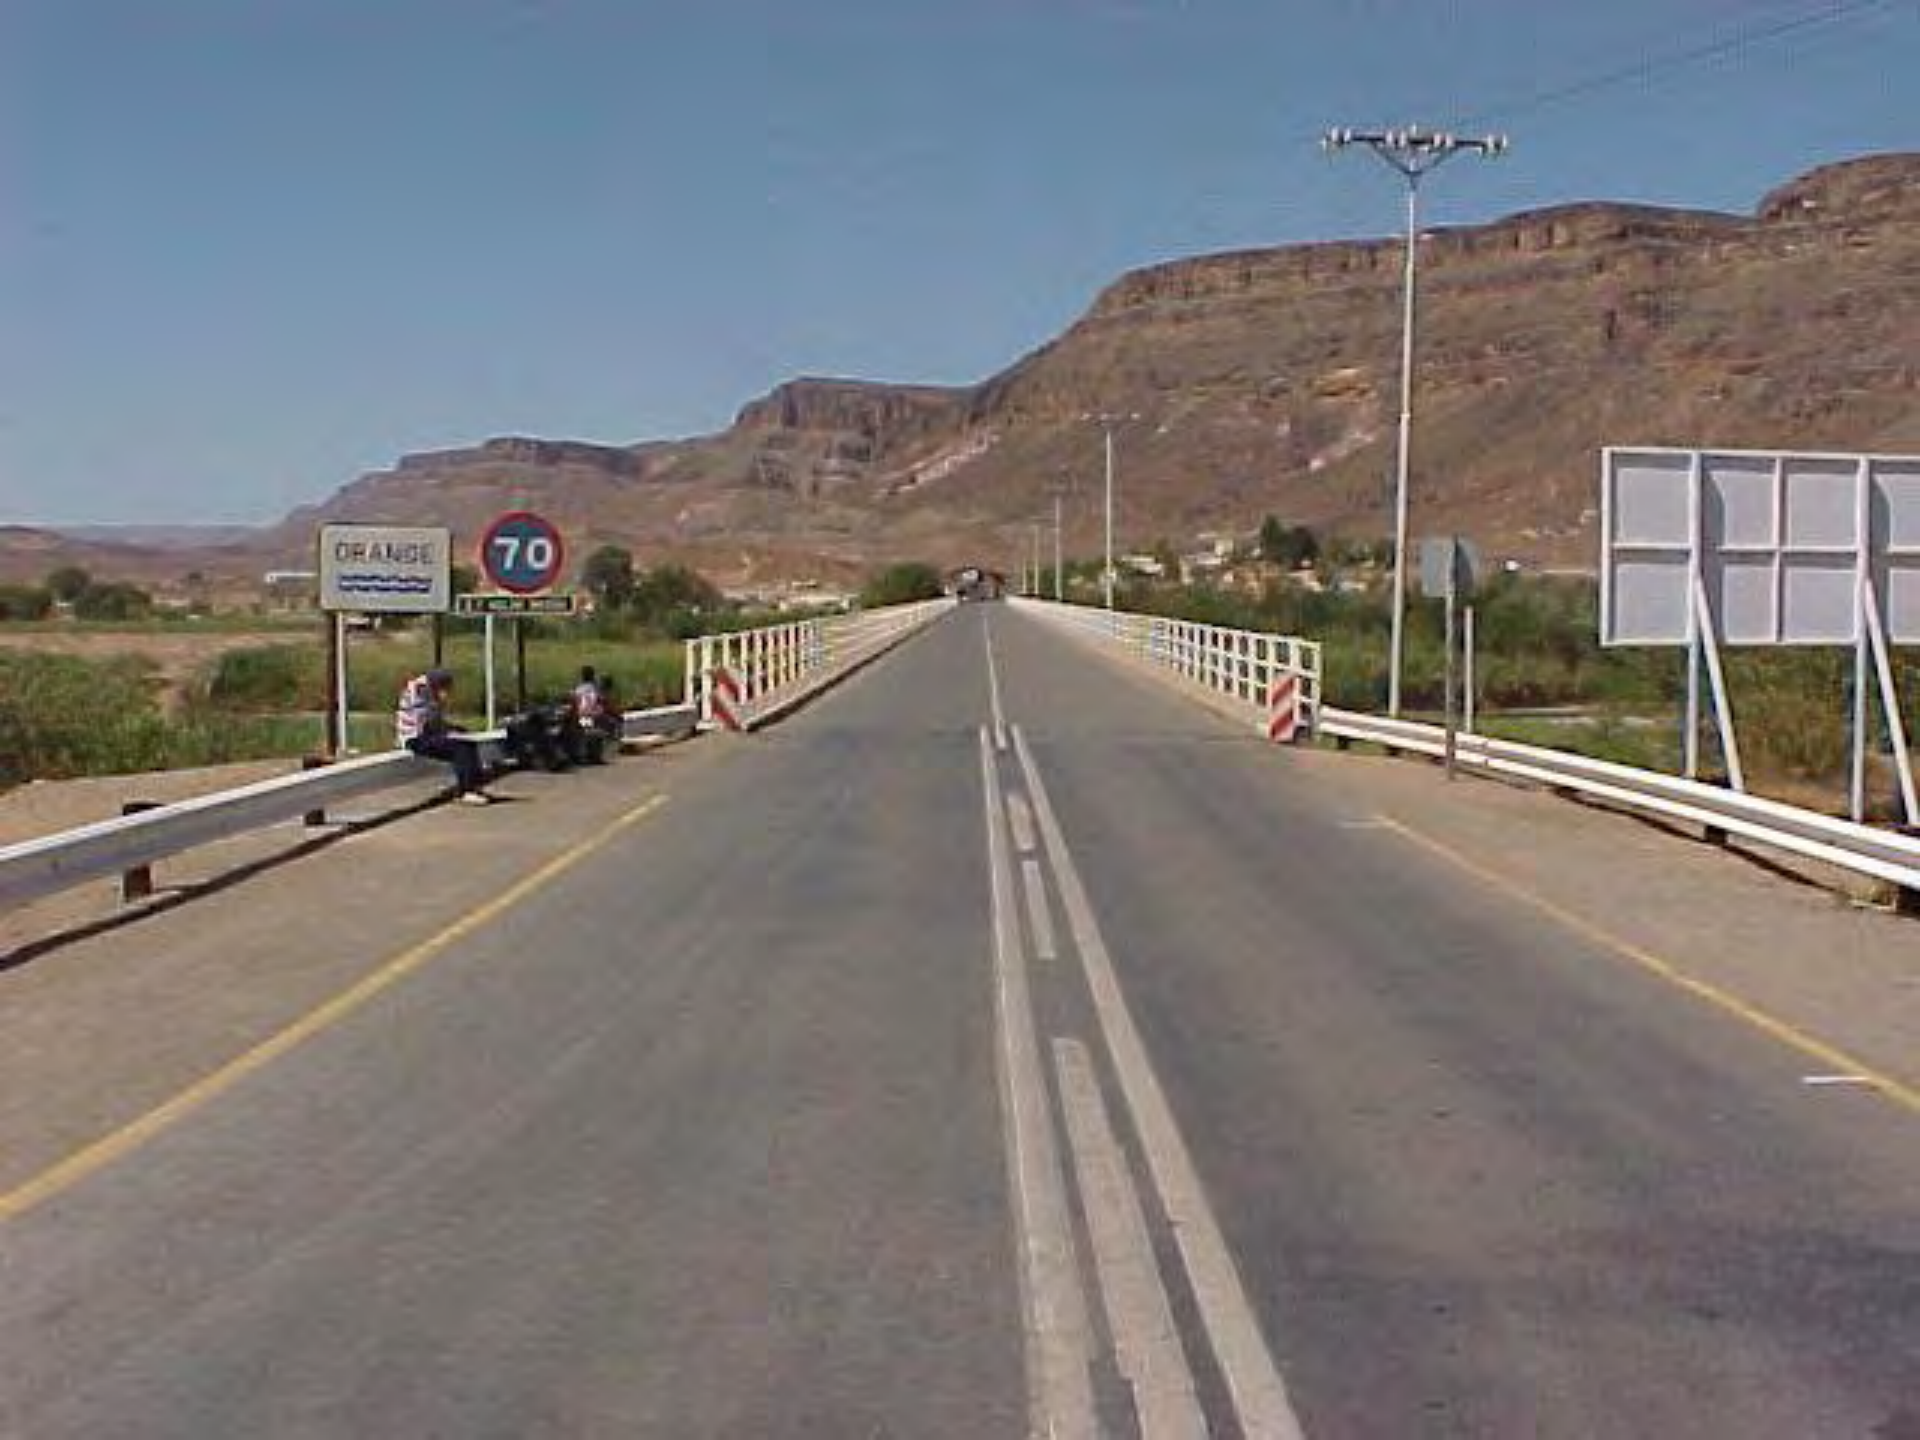
**Case Study 3**  
**Orange River Bridge**  
**Violsdrift/Noordoewer**

ORANJE

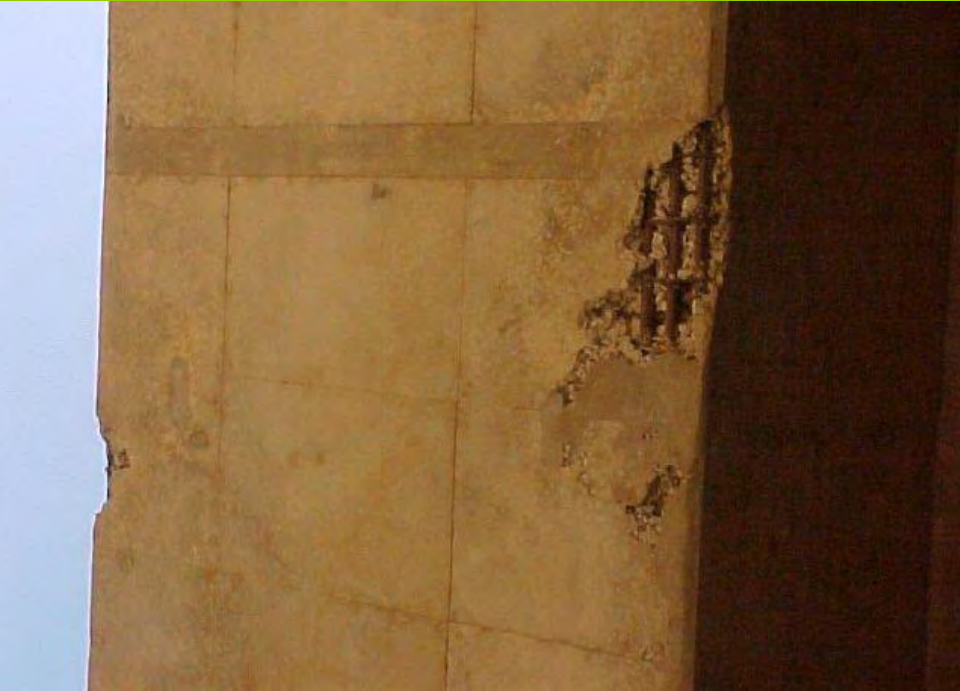
# Deck Rating (Honeycombed)

**$D = 3$**

**$E = 2$**

**$R = 2$**

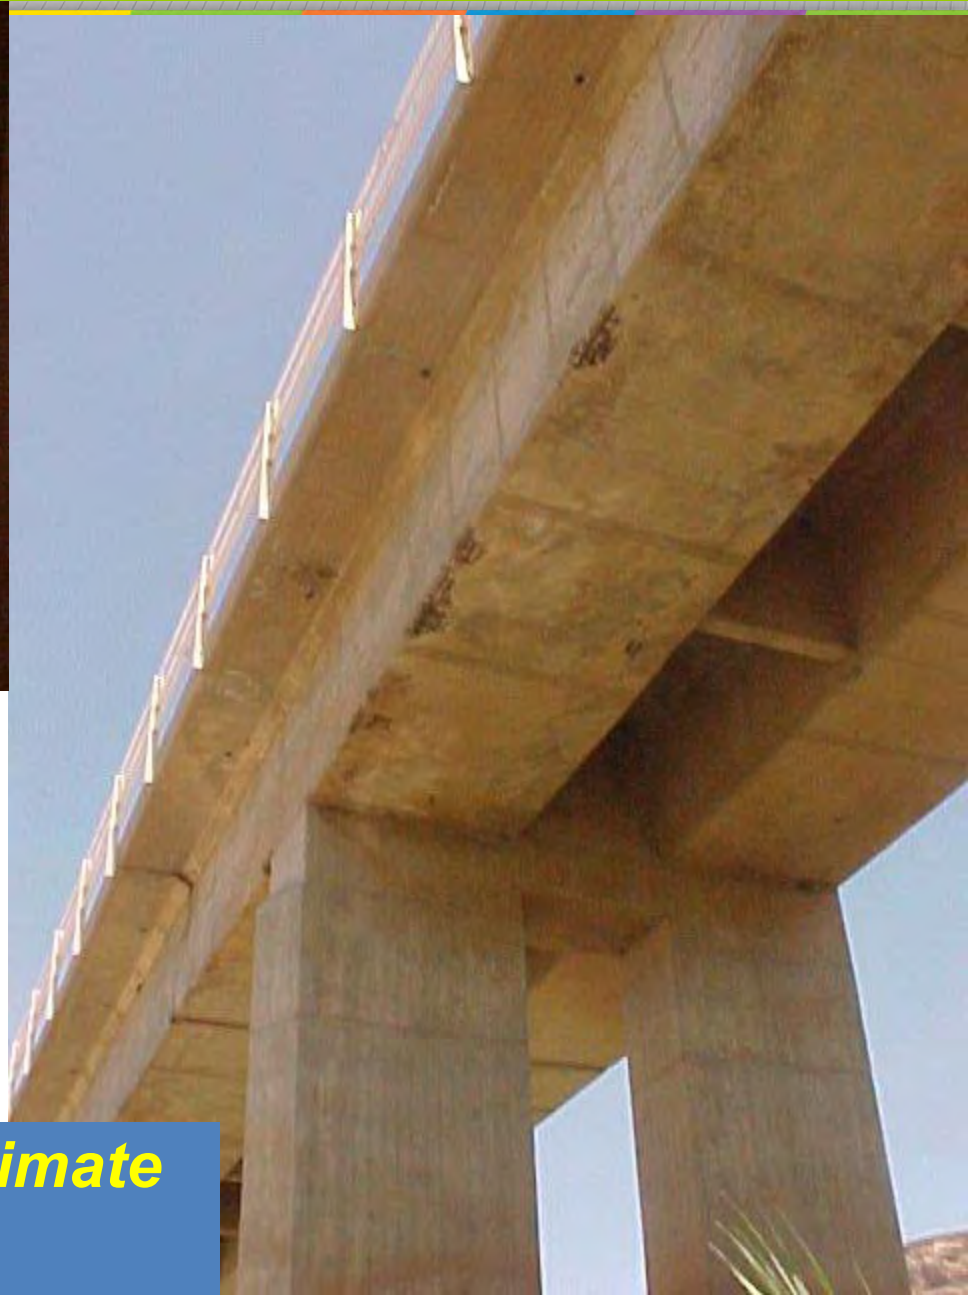
***NB: No corrosion due to dry climate  
Hence  $R = 2$  and not 3***

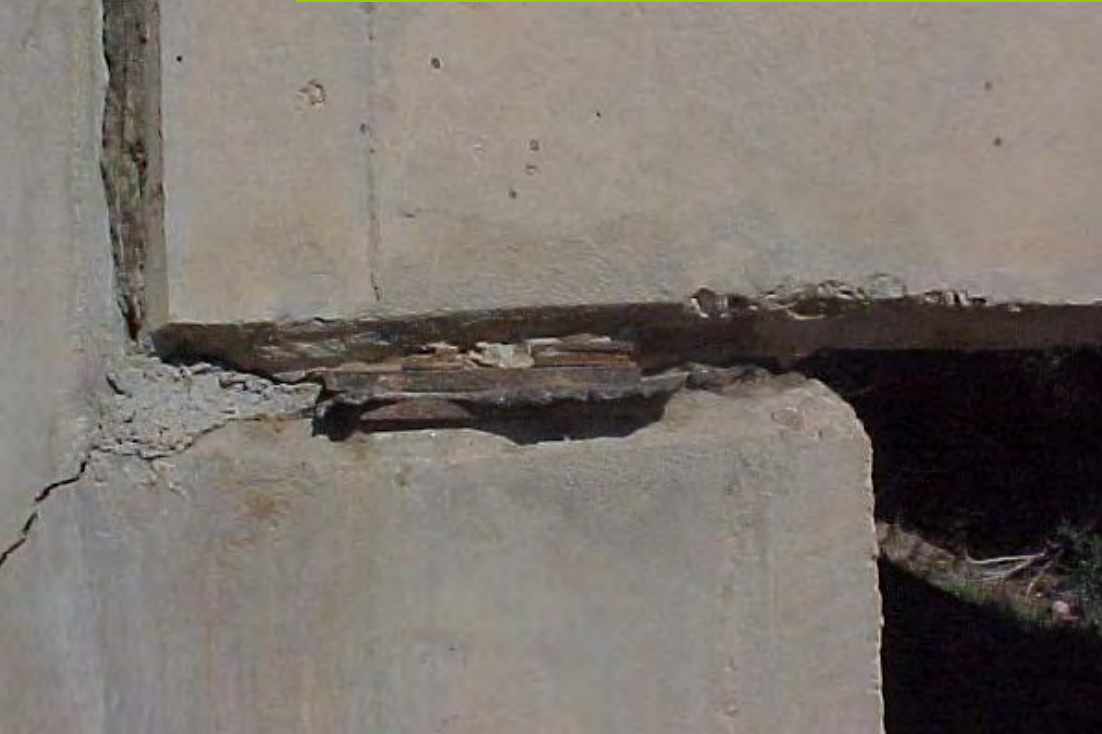
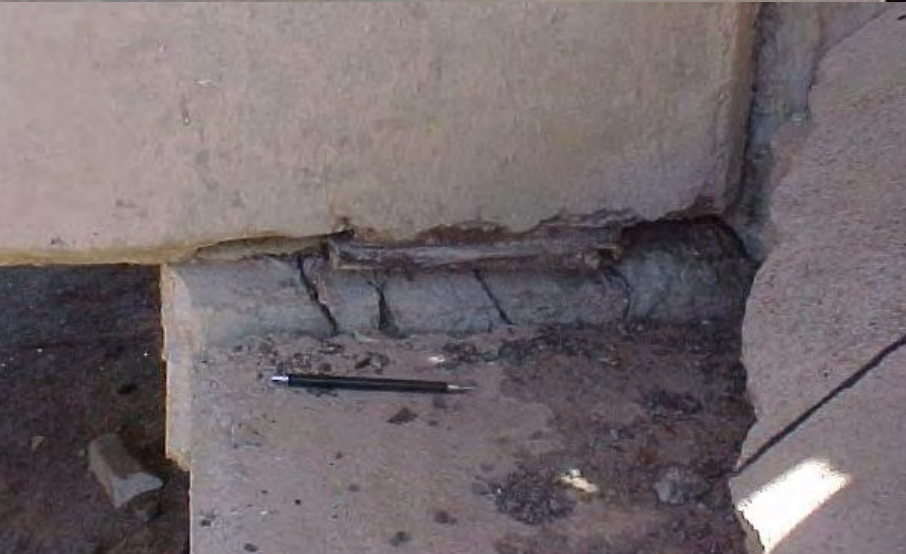
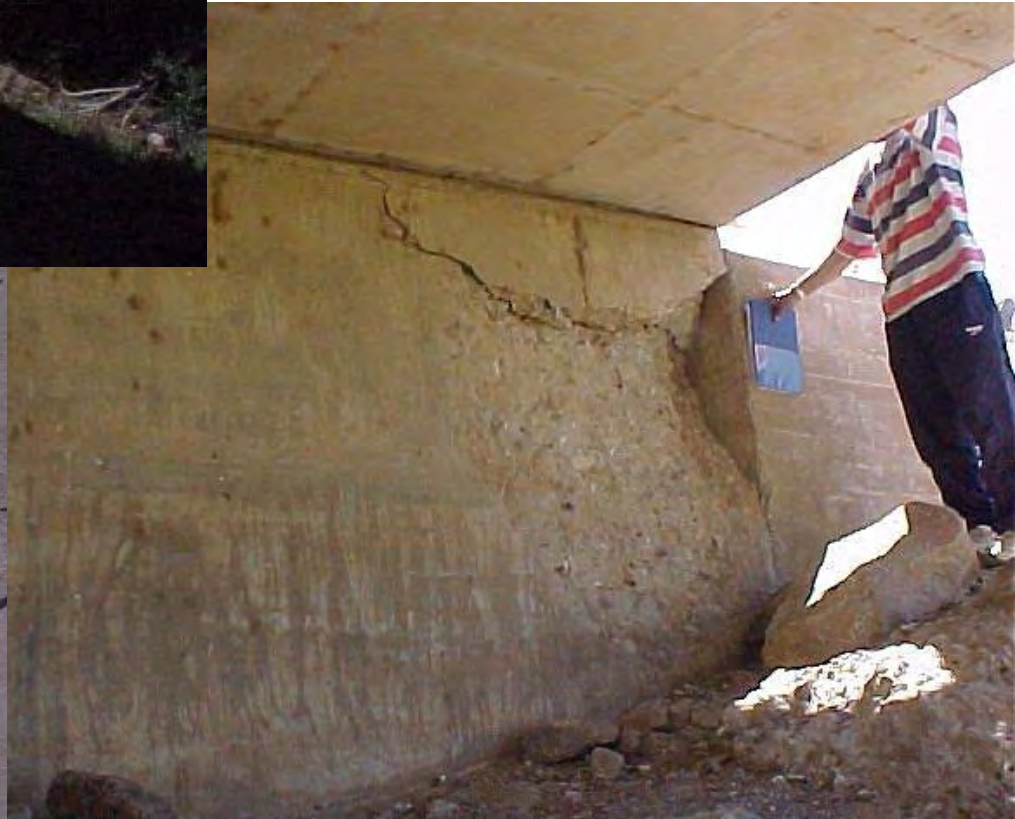
# Bearing and abutment failure

$E = 2$

$R = 4$
