# **Impact toughness of laser alloyed aluminium AA1200 alloys**

**L.A.B Mabhali<sup>1,2</sup>, S. Pityana<sup>1</sup> and N. Sacks<sup>2</sup>,**

<sup>1</sup>Council for Scientific and Industrial Research – National Laser Centre, PO Box 375, Pretoria, 0001, South Africa

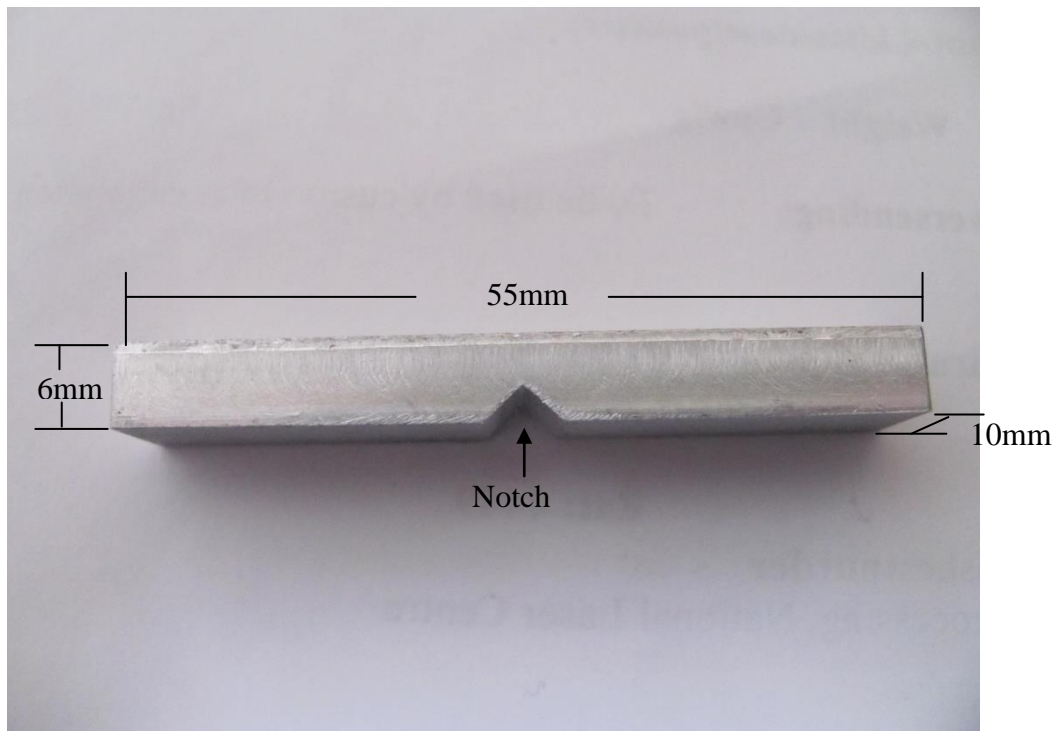
The alloyed samples were ground and polished to 0.04 (colloidal silica OP-S suspension) surface finishes and etched with Keller's reagent (3ml HCl + 2ml HF + 5ml HNO<sub>3</sub> + 190ml HO<sub>2</sub>) before analytical characterisation. The structural phases and microstructure of the alloyed samples was investigated by x-ray diffraction (XRD).and scanning electron microscopy (SEM) And the investigations were carried by and Metallurgical examination of the larger surface alloyed aluminium specimens were subjected to impact testing (Charpy V-notch) according to the ASTM G23-05 standard [9]. The impact test is a standardized strain-rate test which determines the amount of energy absorbed by a material during fracture. The tests were performed on a Tinius Olsen impact machine. Figure 1 shows a typical sample prepared for these tests. The specimens were machined to 55x10x6mm dimensions. A 2mm deep notch was machined at mid-length (27.5mm) at 45 degrees to the surface.

**Figure 1:** Specimen used for impact tests.

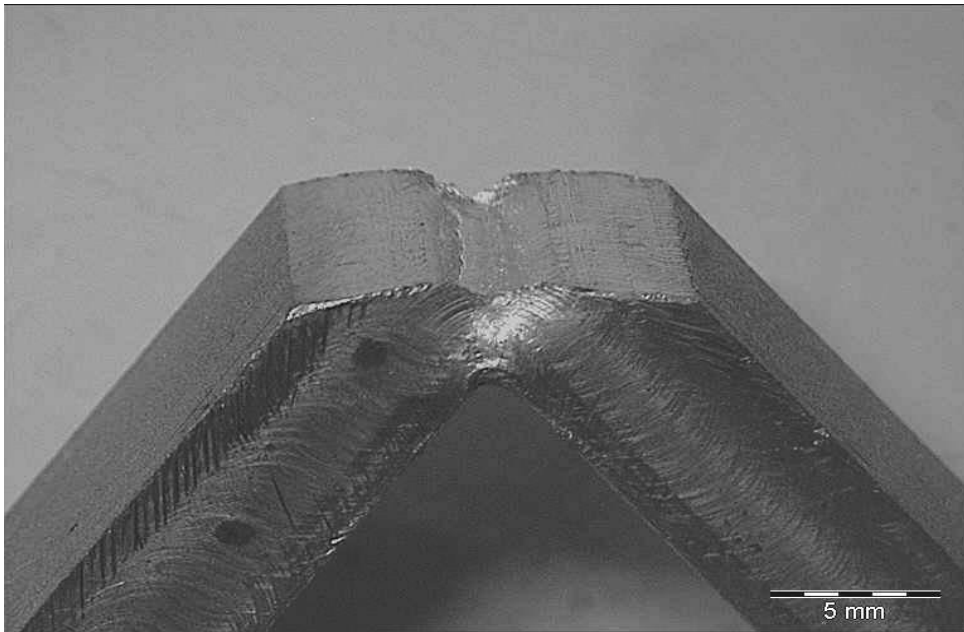
Figure 2 shows a macrograph of untreated aluminium after impact test. The untreated aluminium did not completely fracture but were plastically deformed and simply bent. This indicates that plastic deformations occurred in this surface and not fracture, The absorbed energy listed in Table 3 for aluminium is due to this plastic deformation.

**Figure 2:** Untreated aluminium AA1200 after impact test.

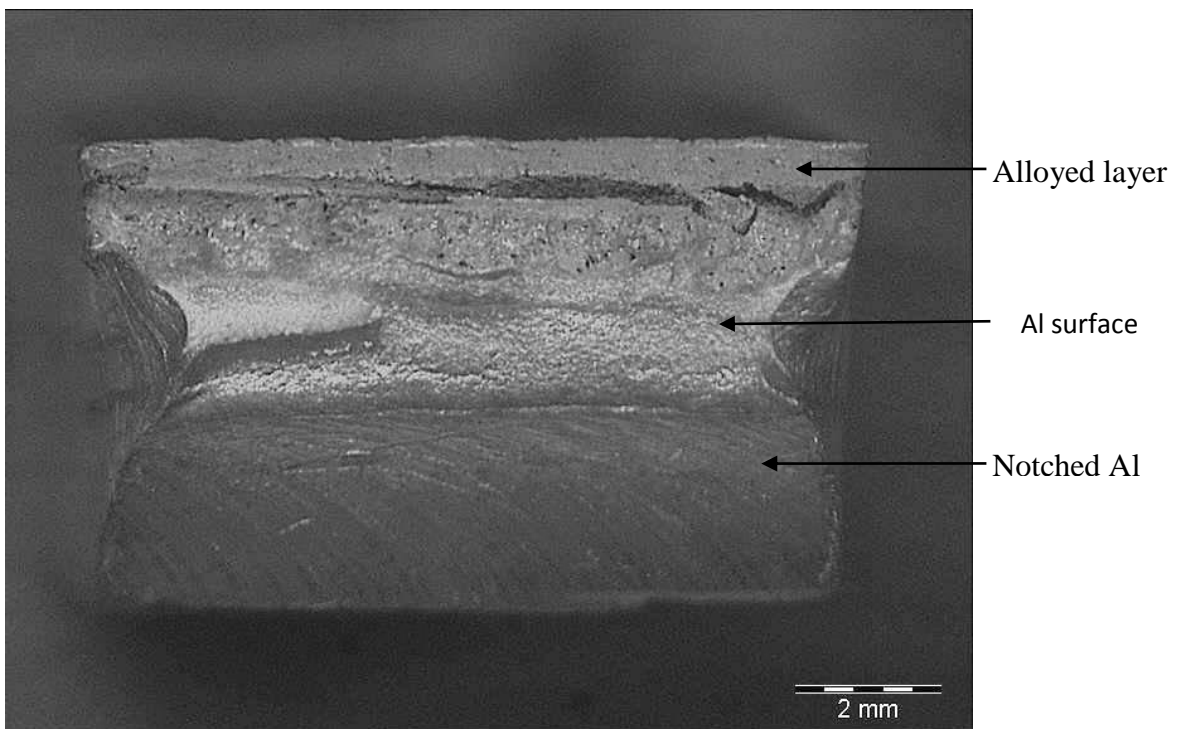
Figure 3 shows a typical fractured surface for the laser alloyed samples. Three different regions are observed; the laser alloyed layer followed by the aluminium surface and then the notched aluminium. The fractured surface of the aluminium surface region is shown in Figure 4. Cuplets characteristic of ductile fracture were observed in this region.

**Figure 3:** A typical fracture surface for the laser alloyed samples.

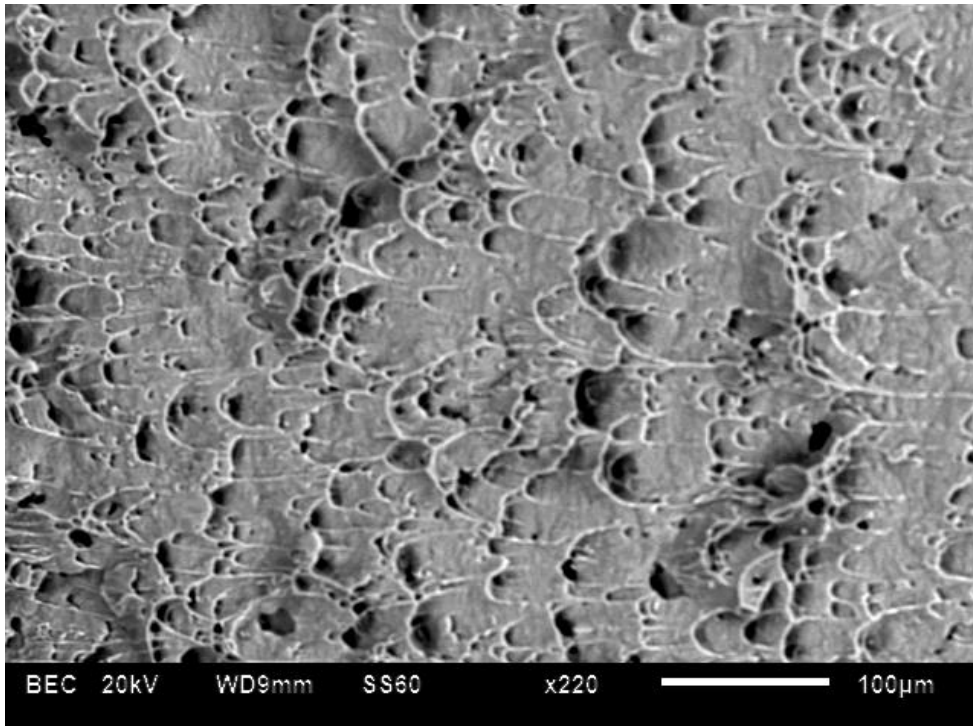
**Figure 4:** Fracture surface of the aluminium surface showing cuplets.

Laser surface alloying the Al AA1200 metal led to a 31-50% decrease in the impact resistance of the pure metal. This is predominantly due to the increased hardness achieved by the laser alloying process [4]. Ozden et al. [12] also observed an increase in impact resistance for untreated aluminium alloys (AA2124, AA5083 and AA6063) compared to the aluminium MMCs. The high impact resistance of the pure aluminium was noted by the high degree of plastic deformation experienced by the samples during impact testing. The pure aluminium samples did not fracture; they simply bent. All the laser alloyed samples fractured and displayed similar fracture characteristics. Cleavage occurred in the SiC particles and transgranular cracking occurred in the intermetallic phases. Alloyed surfaces with large  $\alpha$ -Al mean free paths resulted in high absorbed energies being recorded during fracture. This was observed in microstructures which had high volumes of dendritic  $\text{Al}_3\text{Ti}$ , needle-like  $\text{Al}_4\text{C}_3$  or platelet  $\text{Al}_4\text{SiC}_4$  phases, i.e. alloys with high Ti and SiC content. Cuplets characteristic of ductile fracture were observed in the bulk aluminium.

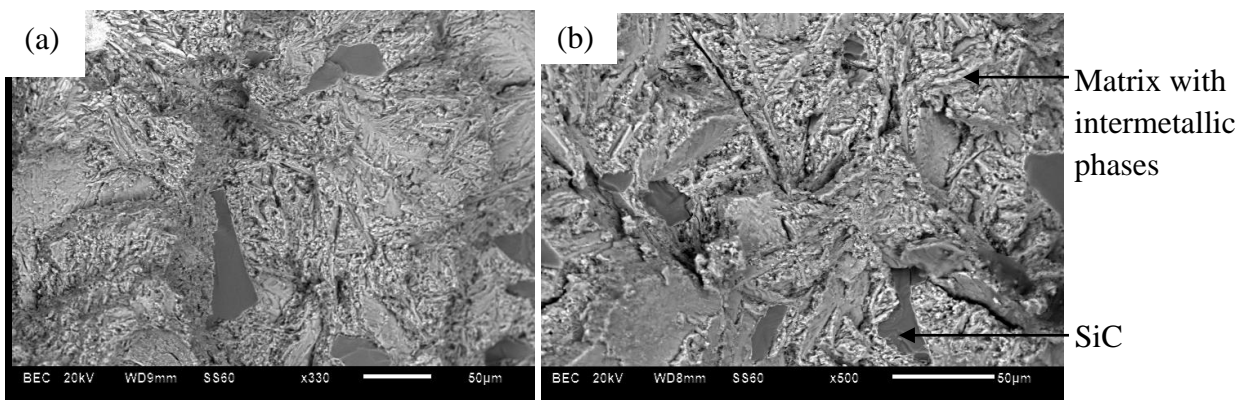
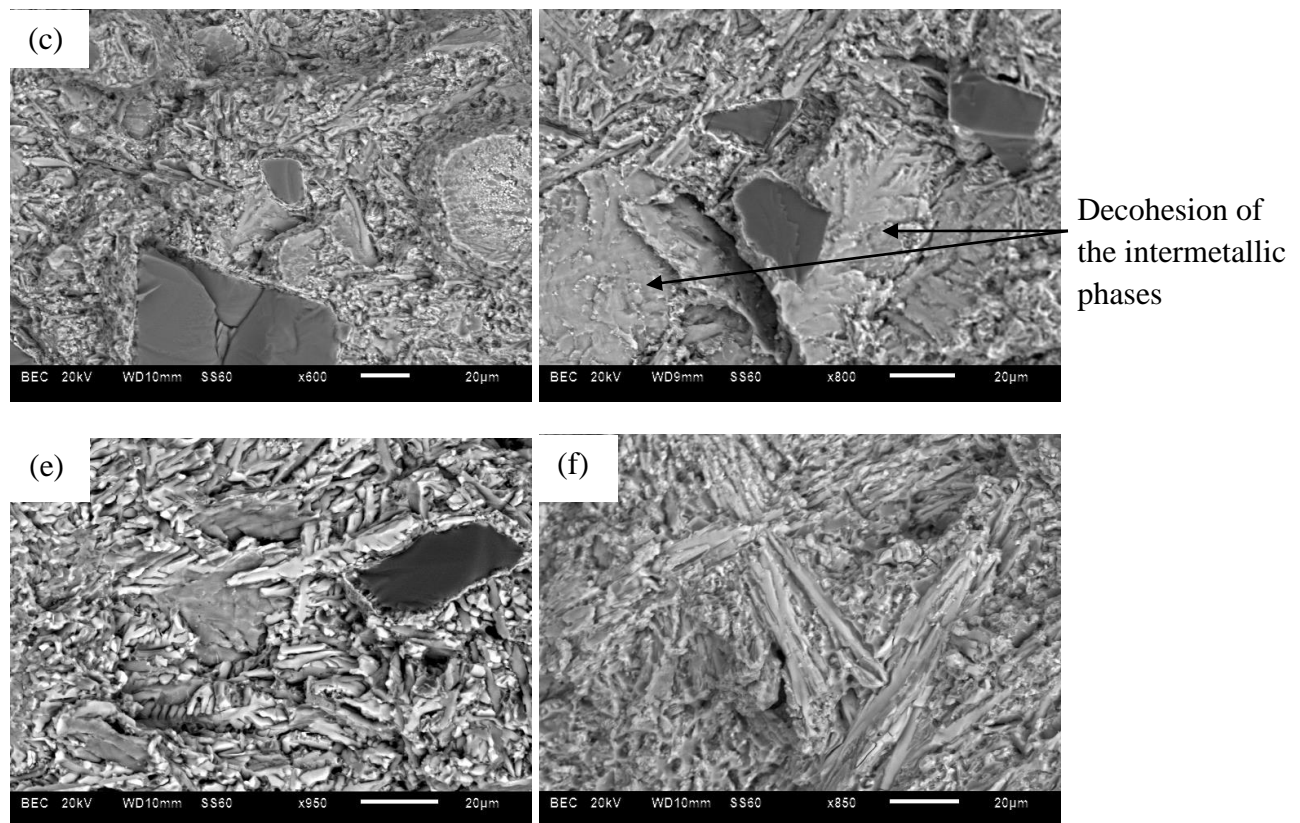
Figure 5 shows a series of fractured surfaces that were laser alloyed at different powder mixtures. In alloys with a high SiC content (Figure 5(a-d)), crack propagation was promoted by transgranular fracture of these hard SiC particles. Fracture of the SiC particles occurred by cleavage which is characteristic of brittle fracture while the matrix was dull and fibrous which is characteristic of ductile fracture. Cleavage is known to occur due to transgranular fracture [6]. Few cracks were observed in alloys with a low SiC content, but decohesion of the intermetallic phases was observed as shown in Figures 5(e-f). This was also observed by Vreeling et al. [7] while studying the failure mechanisms in an Al/SiC metal matrix composite. Cracking of the intermetallic phases was also observed in the fractographs. In general the overall fracture was ductile.

**Figure 5:** SEM fractographs of the samples laser alloyed with (a) 20wt%Ni + 30wt%Ti + 50wt%SiC, (b) 20wt%Ni + 40wt%Ti + 40wt%SiC, (c) 33.3wt%Ni + 33.3wt%Ti + 33.3wt%SiC (d) 50wt%Ni + 20wt%Ti + 30wt%SiC, (e) 60wt%Ni + 30wt%Ti + 10wt%SiC, (e) 10wt%Ni + 70wt%Ti + 20wt%SiC. (a-d) are alloys with high SiC content ( $\geq 30\text{wt}\%$ ) while (e-f) are alloys with low SiC content ( $< 30\text{wt}\%$ ).

The intermetallic phases assist in anchoring the SiC particles to the Al matrix by preventing decohesion of the SiC particles. Vreeling et al. [7] reported that when the matrix is deformed, the intermetallic phases transfer the stress to the SiC particle surface which leads to fracture of the SiC particles. The brittle fracture of the SiC particles is initiated by cleavage mechanisms. Vreeling et al. [7] concluded that suppressing the formation of

intermetallic phases would postpone the fracture initiation process. For alloys with a low SiC content, decohesion and cracking of the intermetallic phases resulted in fracture of the alloys. Ozden et al. [12] reported that when the distribution of SiC particles in the matrix is heterogeneous, formation of clusters occur which decreases the matrix-reinforcement bonding and reduces the impact strength of the composite as the clustered particles are easily separated during impact loading. Interfacial debonding occurs and voids nucleate around the SiC particles. In regions of clustering and decohesion of the interface, a low Al mean free path facilitates linkage between neighbouring voids and cracks as a direct result of a decreased propagation distance between cracked SiC particles. This behaviour was observed in several alloyed surface layers in the current project. The impact strength has been shown to increase with SiC particle size [12] but in this work the SiC particle size distribution was wide (14-800µm) and this effect was not observed.
